LEVEL II SCOUR ANALYSIS FOR  
BRIDGE 81 (MARSUS00020081) on  
U.S. HIGHWAY 2, crossing the  
WINOOSKI RIVER,  
MARSHFIELD, VERMONT

Open-File Report 97-809

By MICHAEL A. IVANOFF

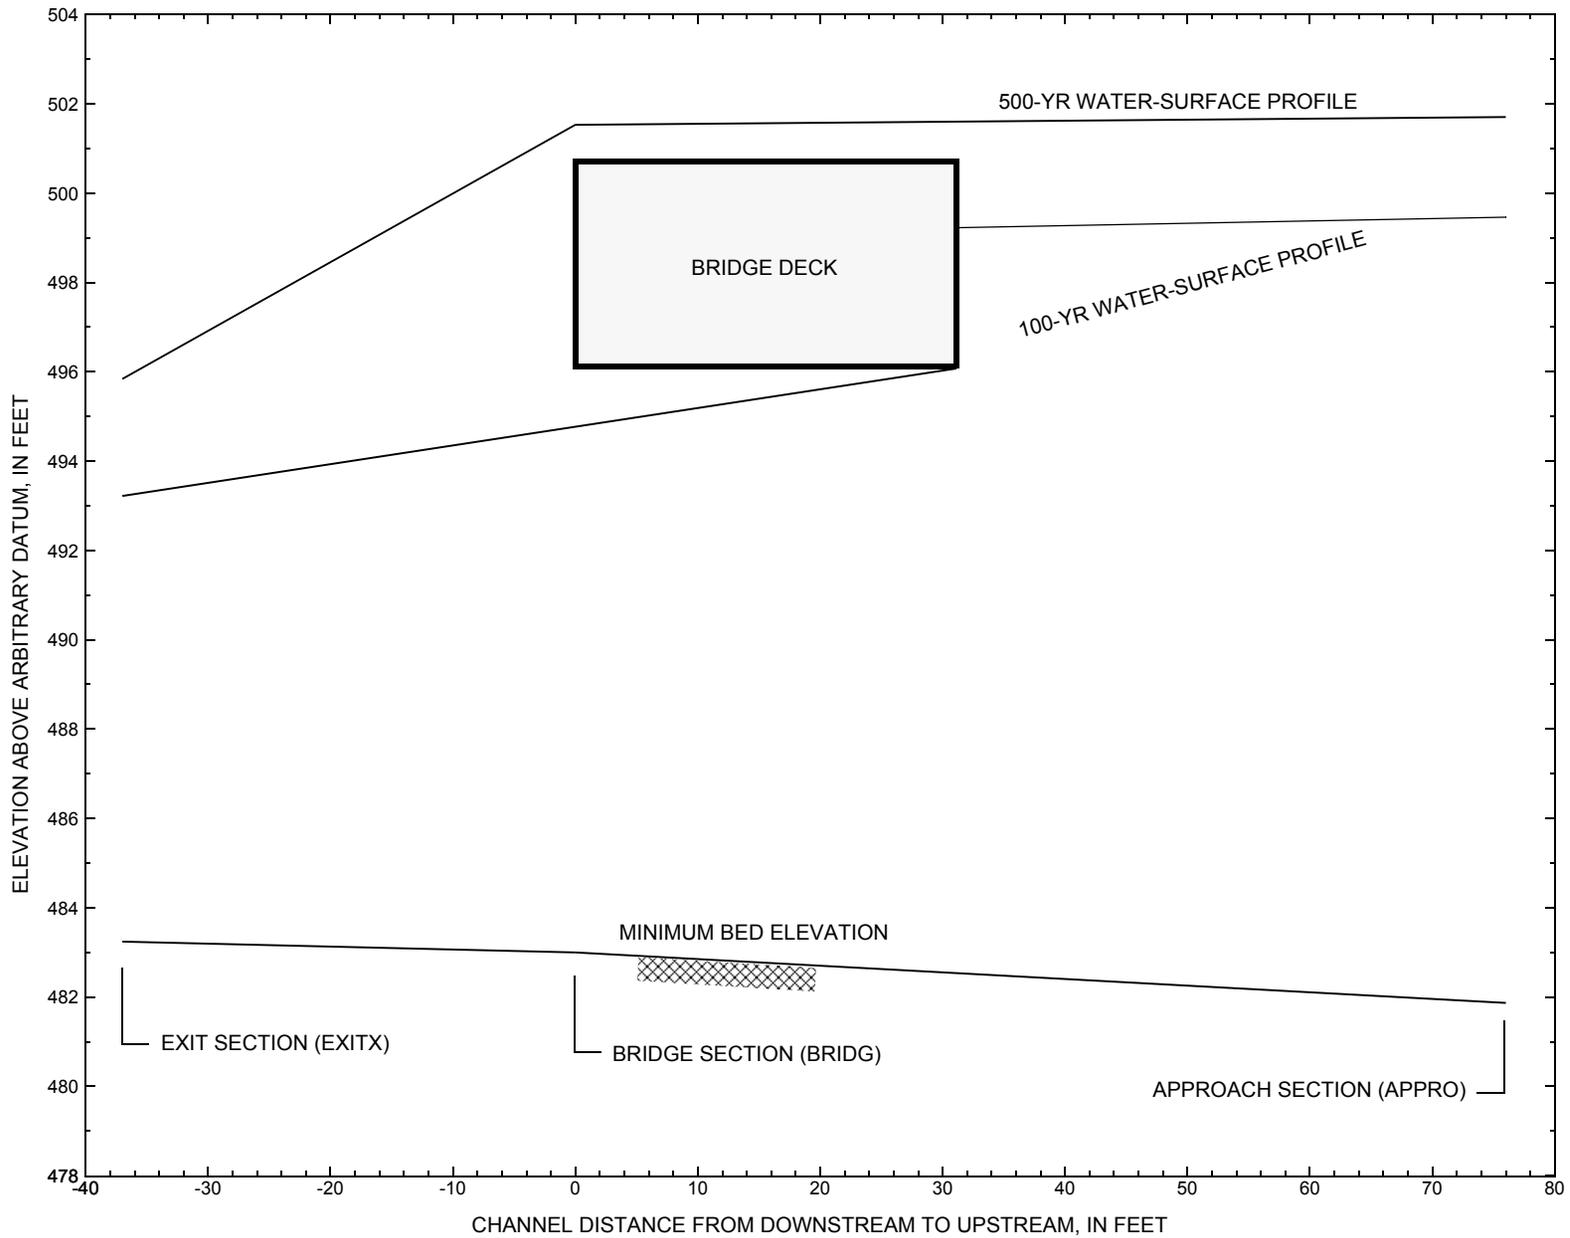
Figure 7. Water-surface profiles for the 100- and 500-yr discharges at structure MARSUS00020081 on U.S. Highway 2, crossing the Winooski River, Marshfield, Vermont.

Hydraulic analyses of the reach were done by use of the Federal Highway Administration's WSPRO step-backwater computer program (Shearman and others, 1986, and Shearman, 1990). The analyses reported herein reflect conditions existing at the site at the time of the study. Furthermore, in the development of the model it was necessary to assume no accumulation of debris or ice at the site. Results of the hydraulic model are presented in the Bridge Hydraulic Summary, Appendix B, and figure 7.

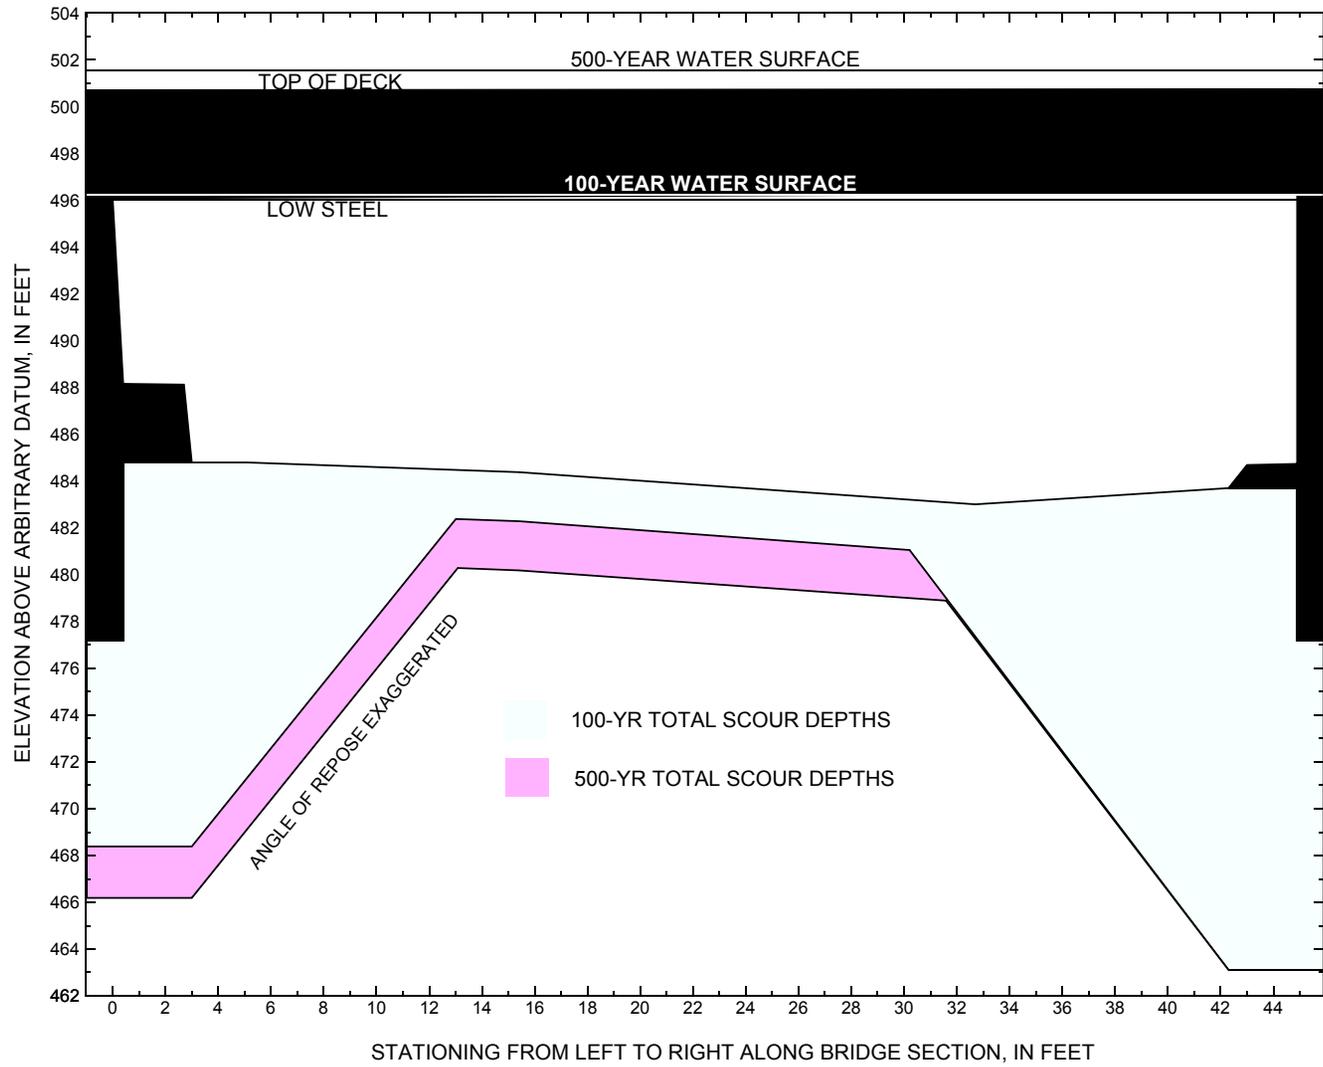
Figure 8. Scour elevations for the 100-yr and 500-yr discharges at structure MARSUS00020081 on U.S. Highway 2, crossing the Winooski River, Marshfield, Vermont.

Scour depths were computed using the general guidelines described in Hydraulic Engineering Circular 18 (Richardson and others, 1995). Scour depths were calculated assuming an infinite depth of erosive material and a homogeneous particle-size distribution. At this site the channel bottom is predominantly bedrock upstream and through the bridge which will limit scour. The results of the scour analysis for the 100-year and 500-year discharges are presented in Tables 1 and 2 and the scour depths are presented graphically in Figure 8.

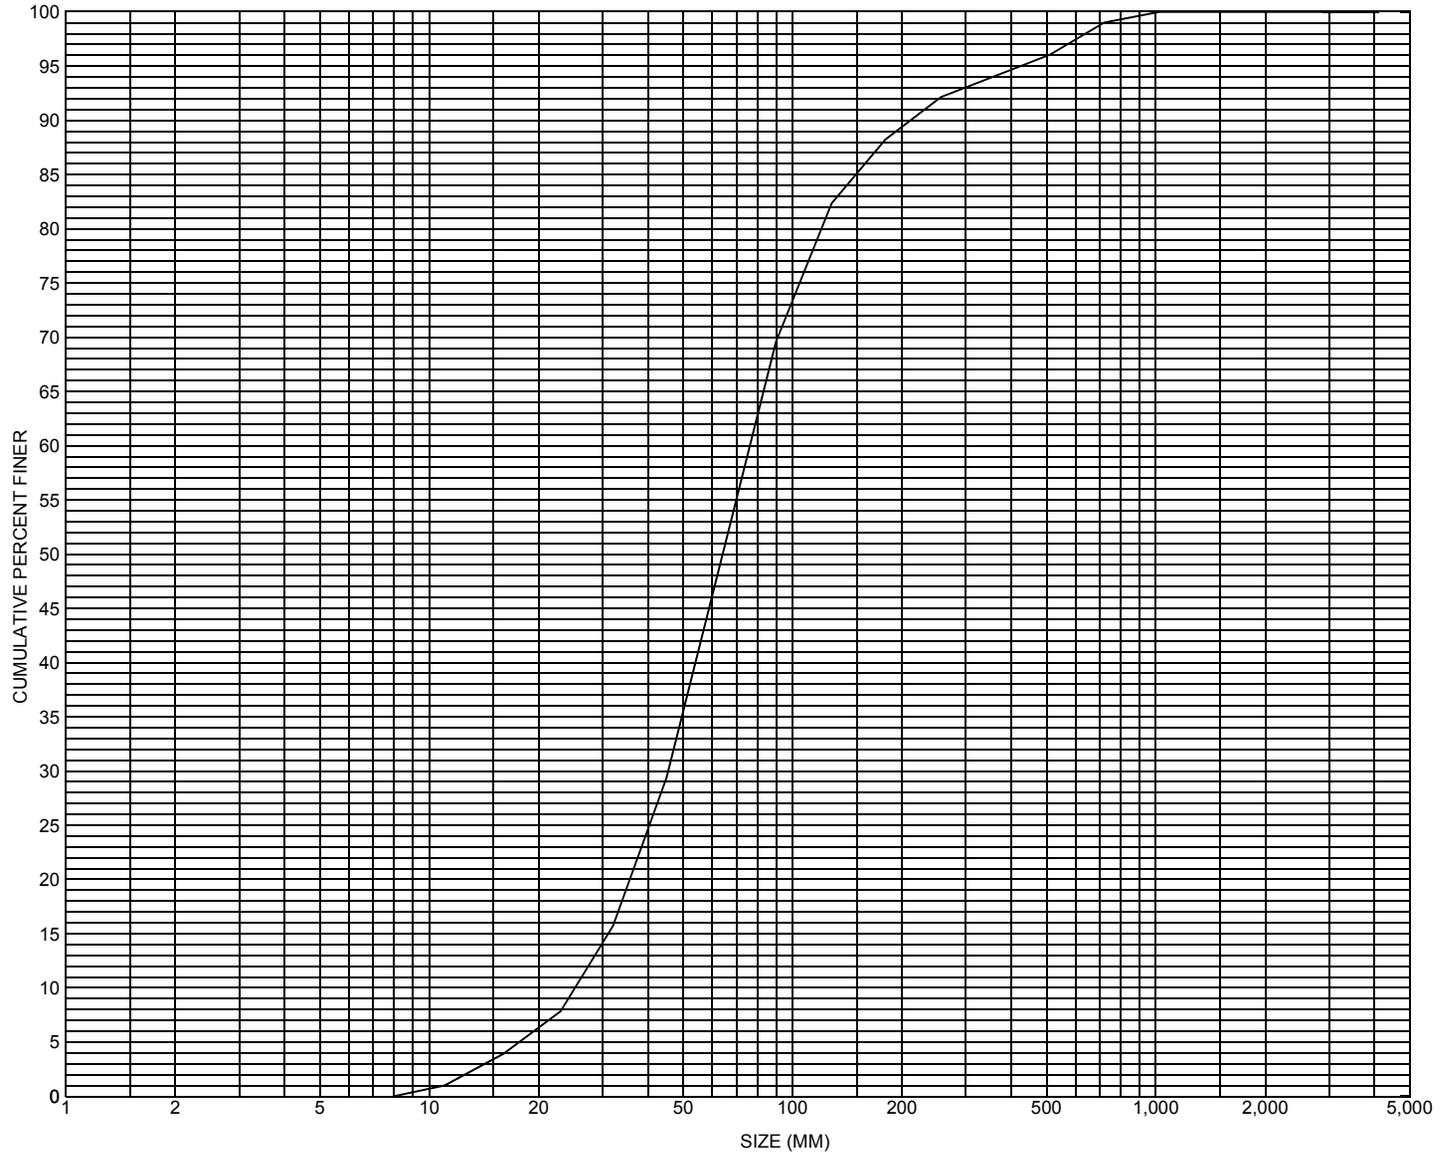
Appendix C. Bed material particle-size distribution for a pebble count in the channel approach of structure MARSUS00020081, in Marshfield, Vermont.
