LEVEL II SCOUR ANALYSIS FOR  
BRIDGE 16 (NEWBTH00500016) on  
TOWN HIGHWAY 50, crossing  
HALLS BROOK,  
NEWBURY, VERMONT

Open-File Report 97-814

By RONDA L. BURNS and JAMES R. DEGNAN

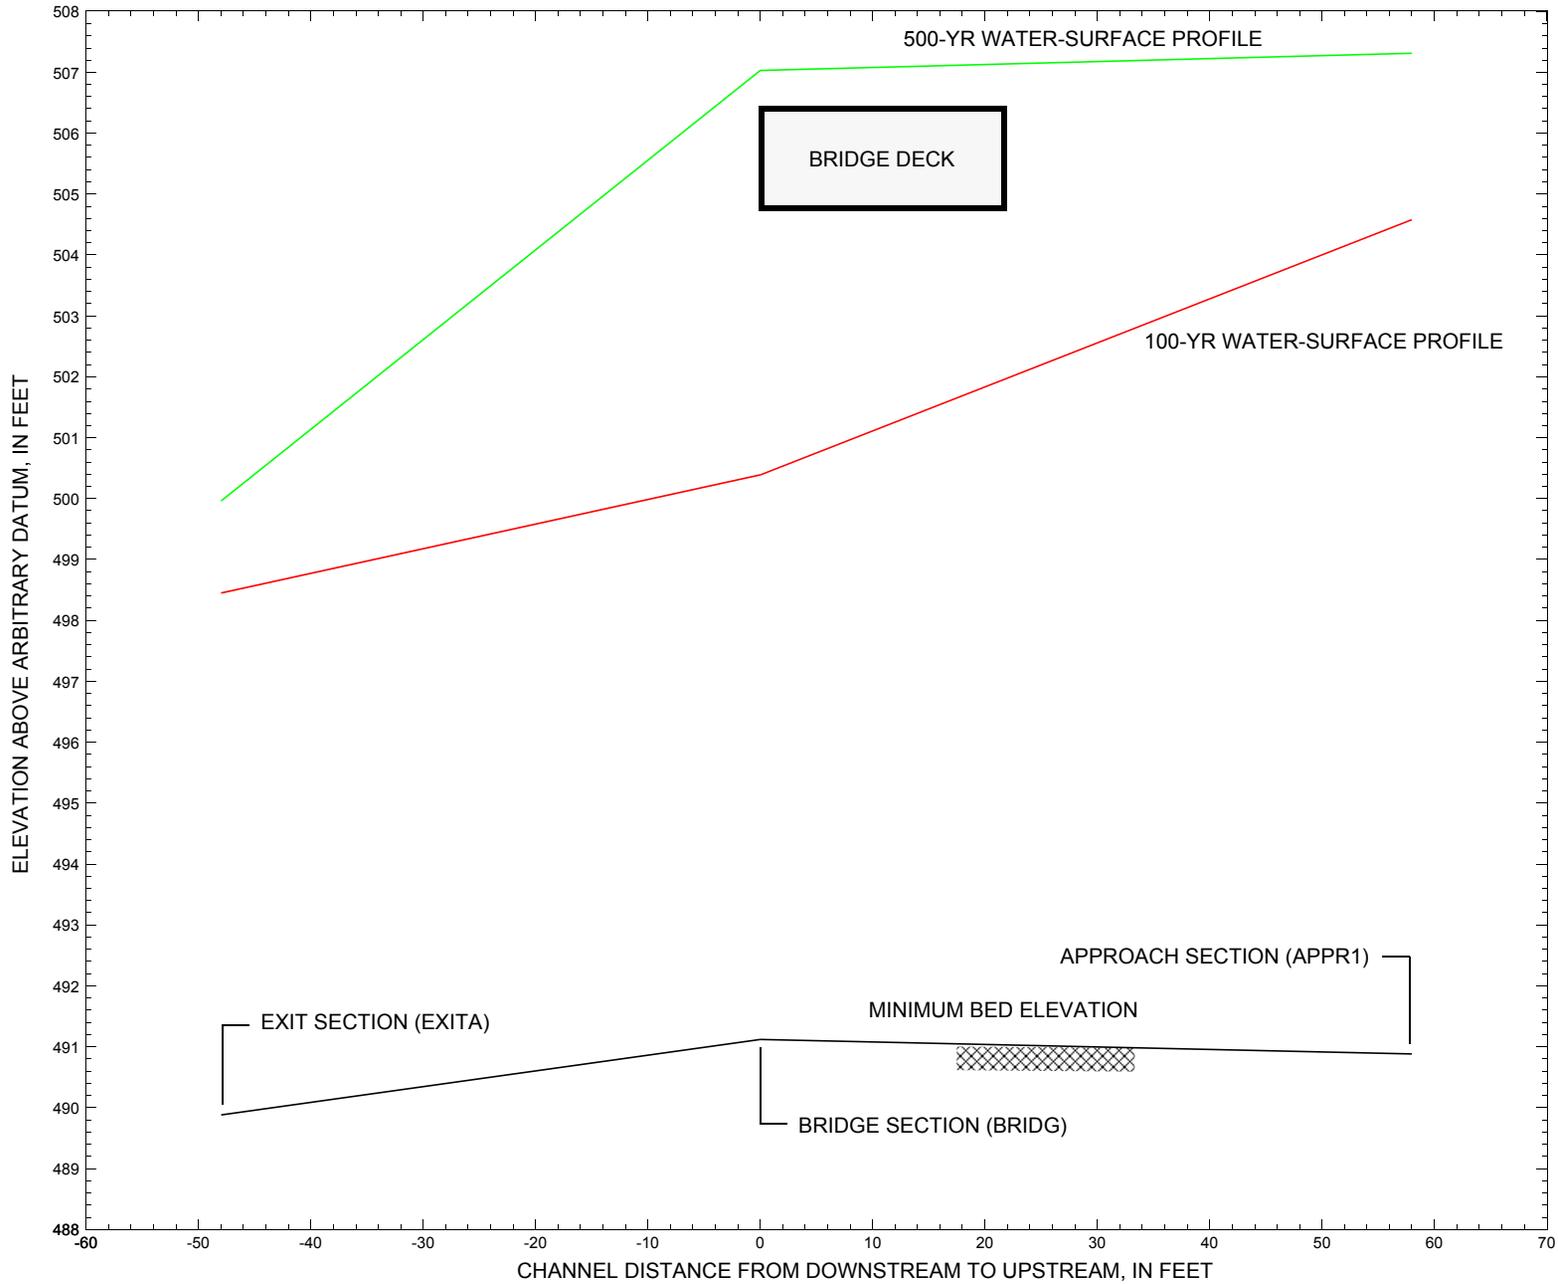
Figure 7. Water-surface profiles for the 100- and 500-yr discharges at structure NEWBTH00500016 on Town Highway 50, crossing Halls Brook, Newbury, Vermont.

Hydraulic analyses of the reach were done by use of the Federal Highway Administration's WSPRO step-backwater computer program (Shearman and others, 1986, and Shearman, 1990). The analyses reported herein reflect conditions existing at the site at the time of the study. Furthermore, in the development of the model it was necessary to assume no accumulation of debris or ice at the site. Results of the hydraulic model are presented in the Bridge Hydraulic Summary, Appendix B, and Figure 7.

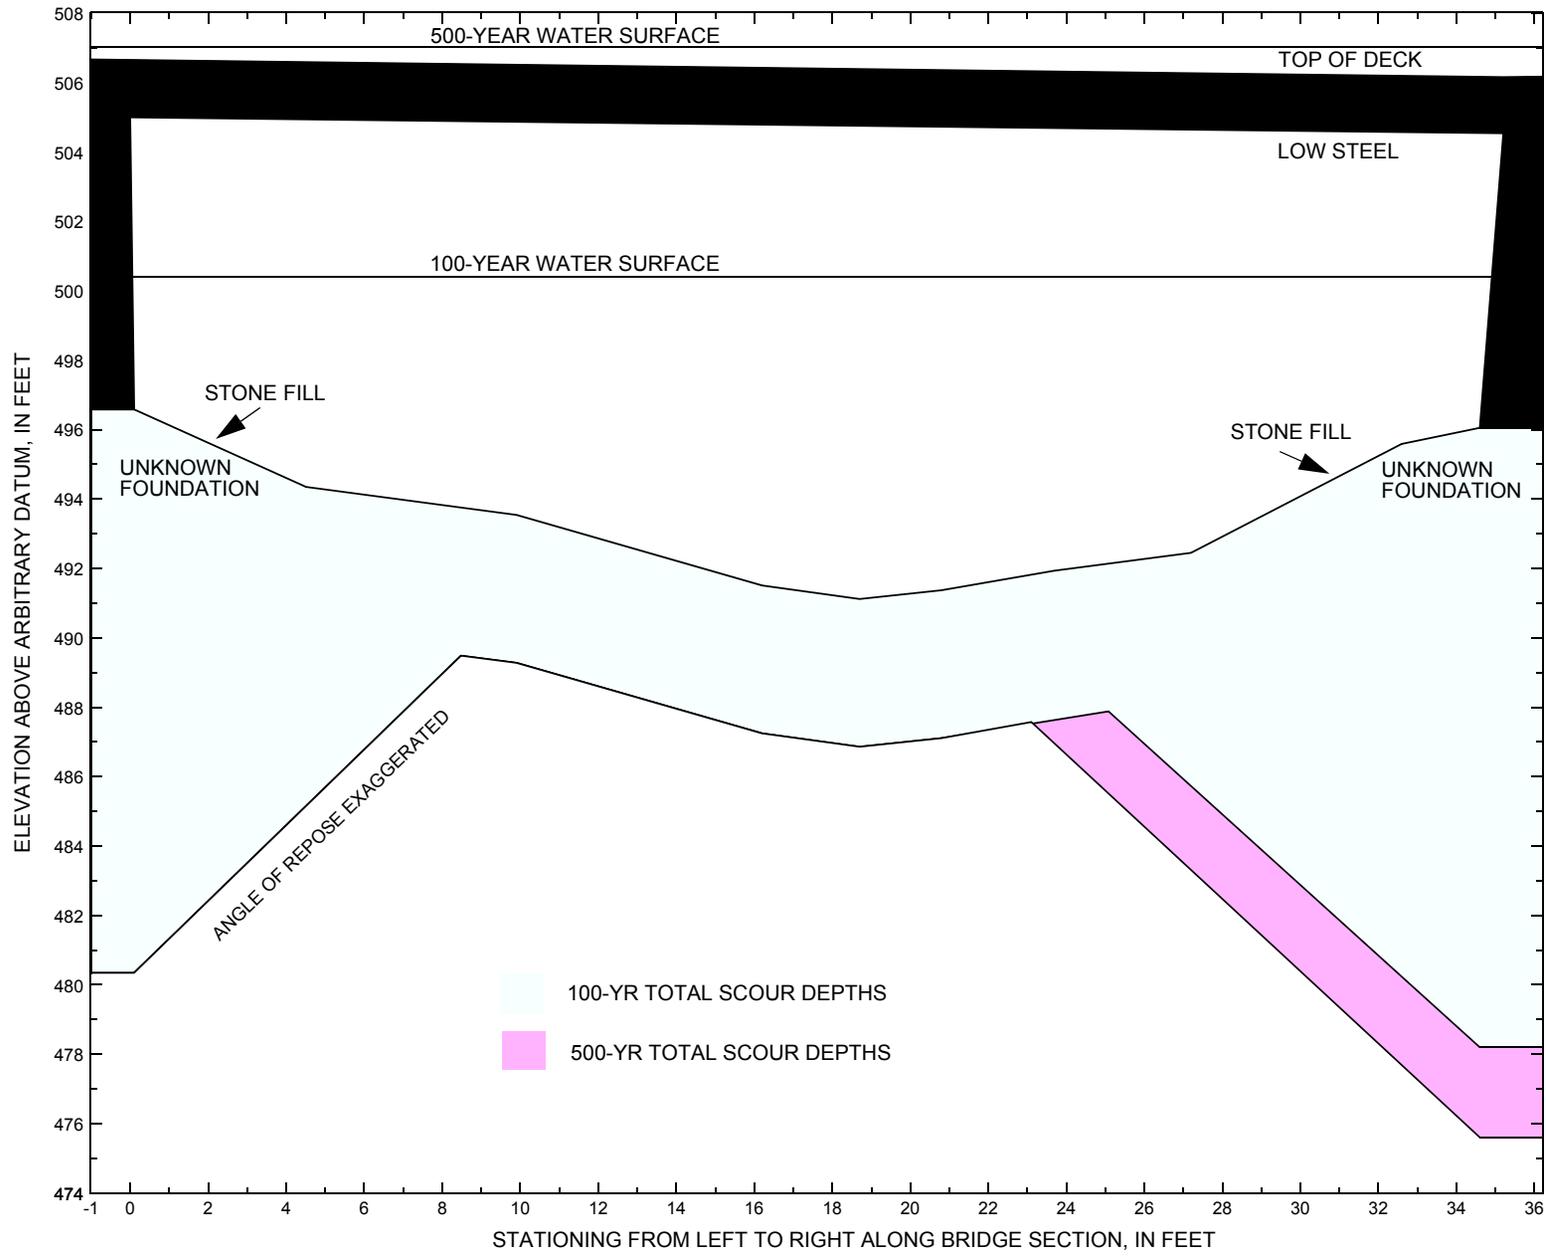
Figure 8. Scour elevations for the 100-yr and 500-yr discharges at structure NEWBTH00500016 on Town Highway 50, crossing Halls Brook, Newbury, Vermont.

Scour depths were computed using the general guidelines described in Hydraulic Engineering Circular 18 (Richardson and others, 1995). Scour depths were calculated assuming an infinite depth of erosive material and a homogeneous particle-size distribution. The results of the scour analysis for the 100- and 500-year discharges are presented in Tables 1 and 2 and a graph of the scour depths is presented in Figure 8.

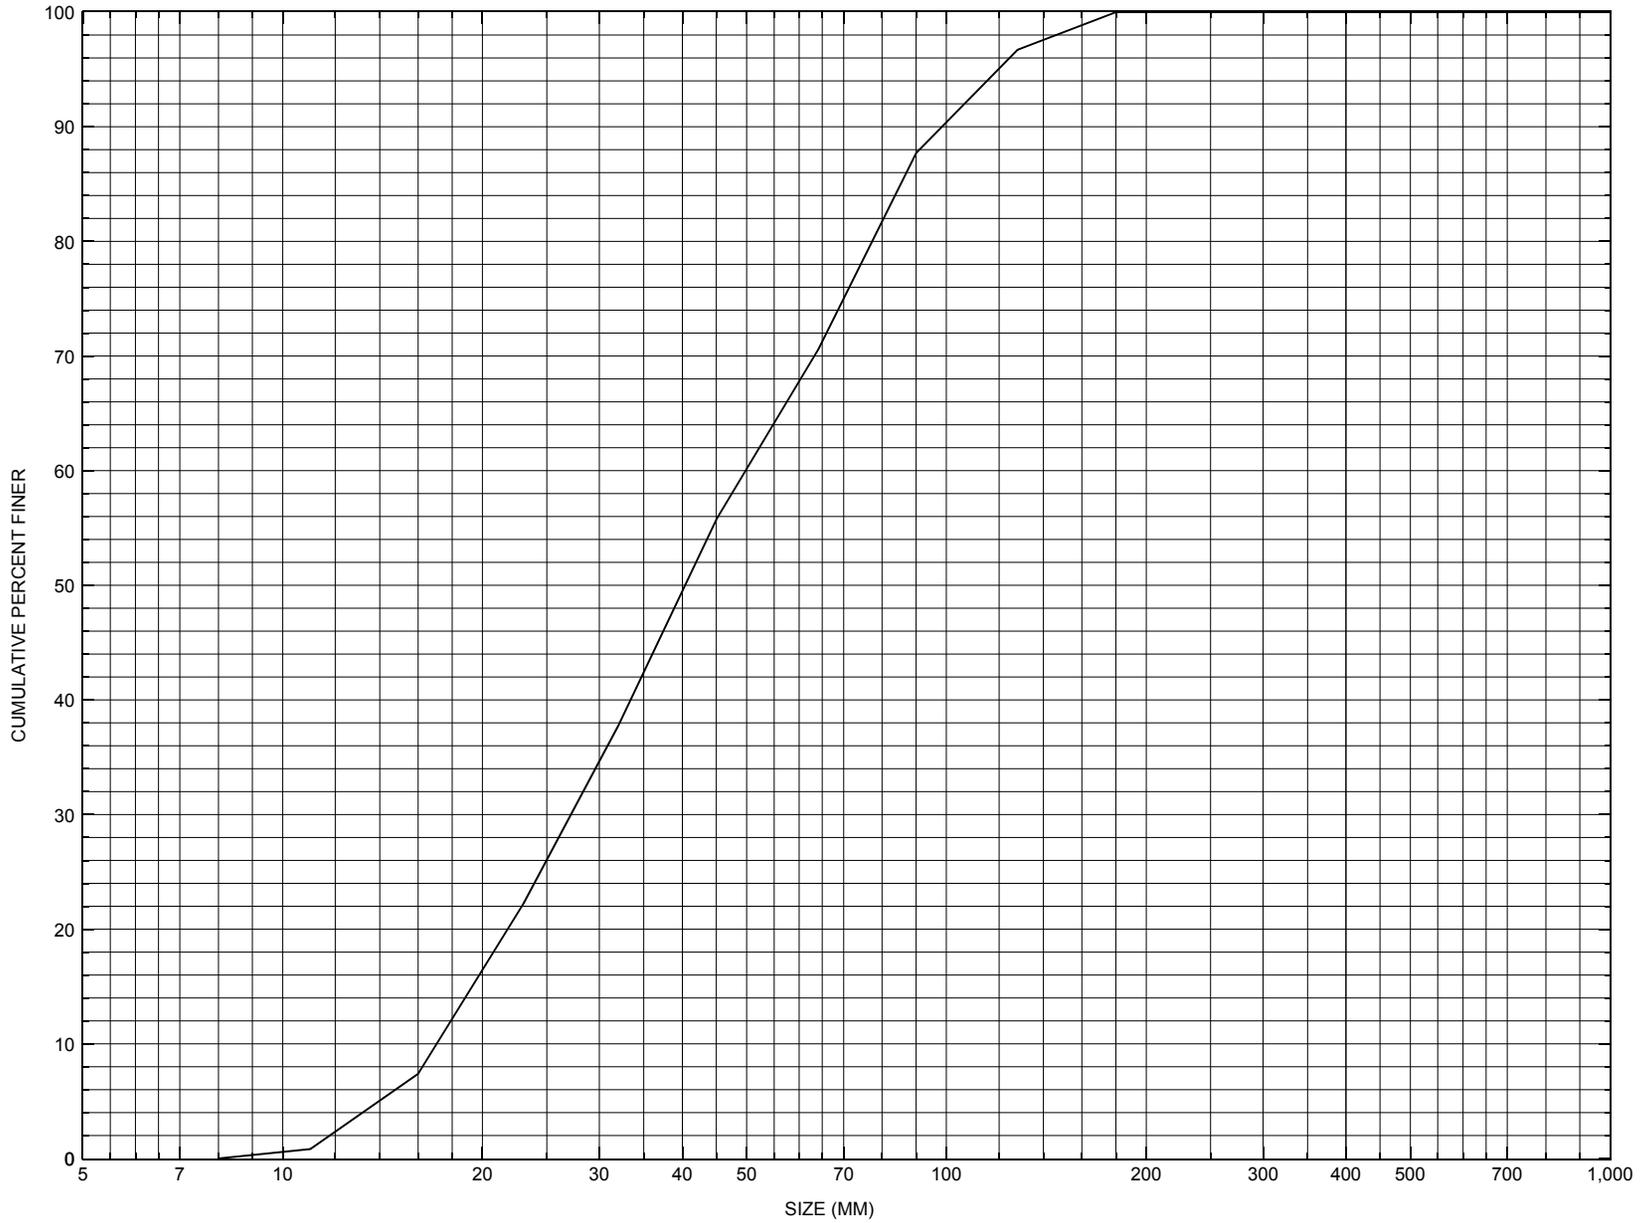
Appendix C. Bed material particle-size distribution for a pebble count in the channel approach of structure NEWBTH00500016, in Newbury, Vermont.
