LEVEL II SCOUR ANALYSIS FOR BRIDGE 22 (TOPSTH00490022) on TOWN HIGHWAY 49, crossing the WAITS RIVER, TOPSHAM, VERMONT

Open-File Report 97-822

By LORA K. STRIKER AND JAMES R. DEGNAN

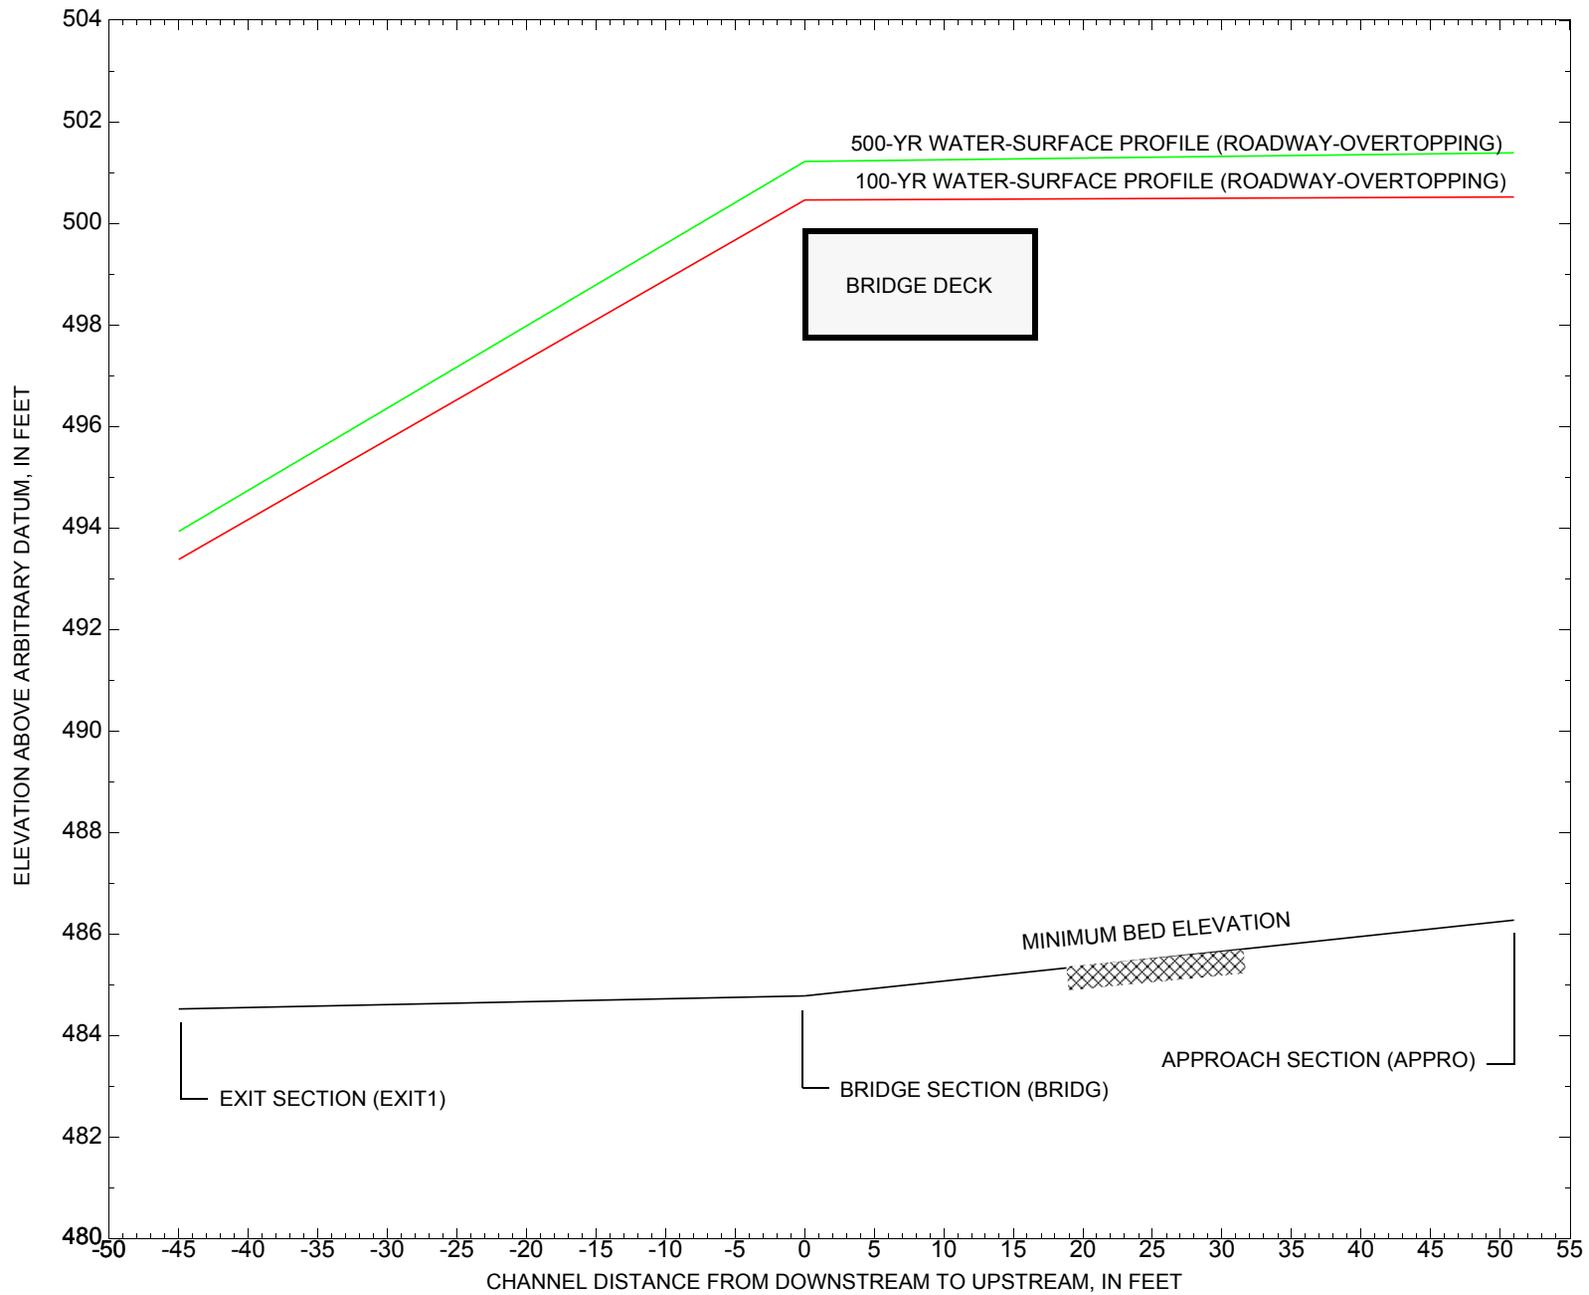
Figure 7. Water-surface profiles for the 100-year and 500-year discharges at structure TOPSTH00490022 on Town Highway 49, crossing the Waits River, Topsham, Vermont.

Hydraulic analyses of the reach were done by use of the Federal Highway Administration's WSPRO step-backwater computer program (Shearman and others, 1986, and Shearman, 1990). The analyses reported herein reflect conditions existing at the site at the time of the study. Furthermore, in the development of the model it was necessary to assume no accumulation of debris or ice at the site. Results of the hydraulic model are presented in the Bridge Hydraulic Summary, Appendix B, and figure 7.

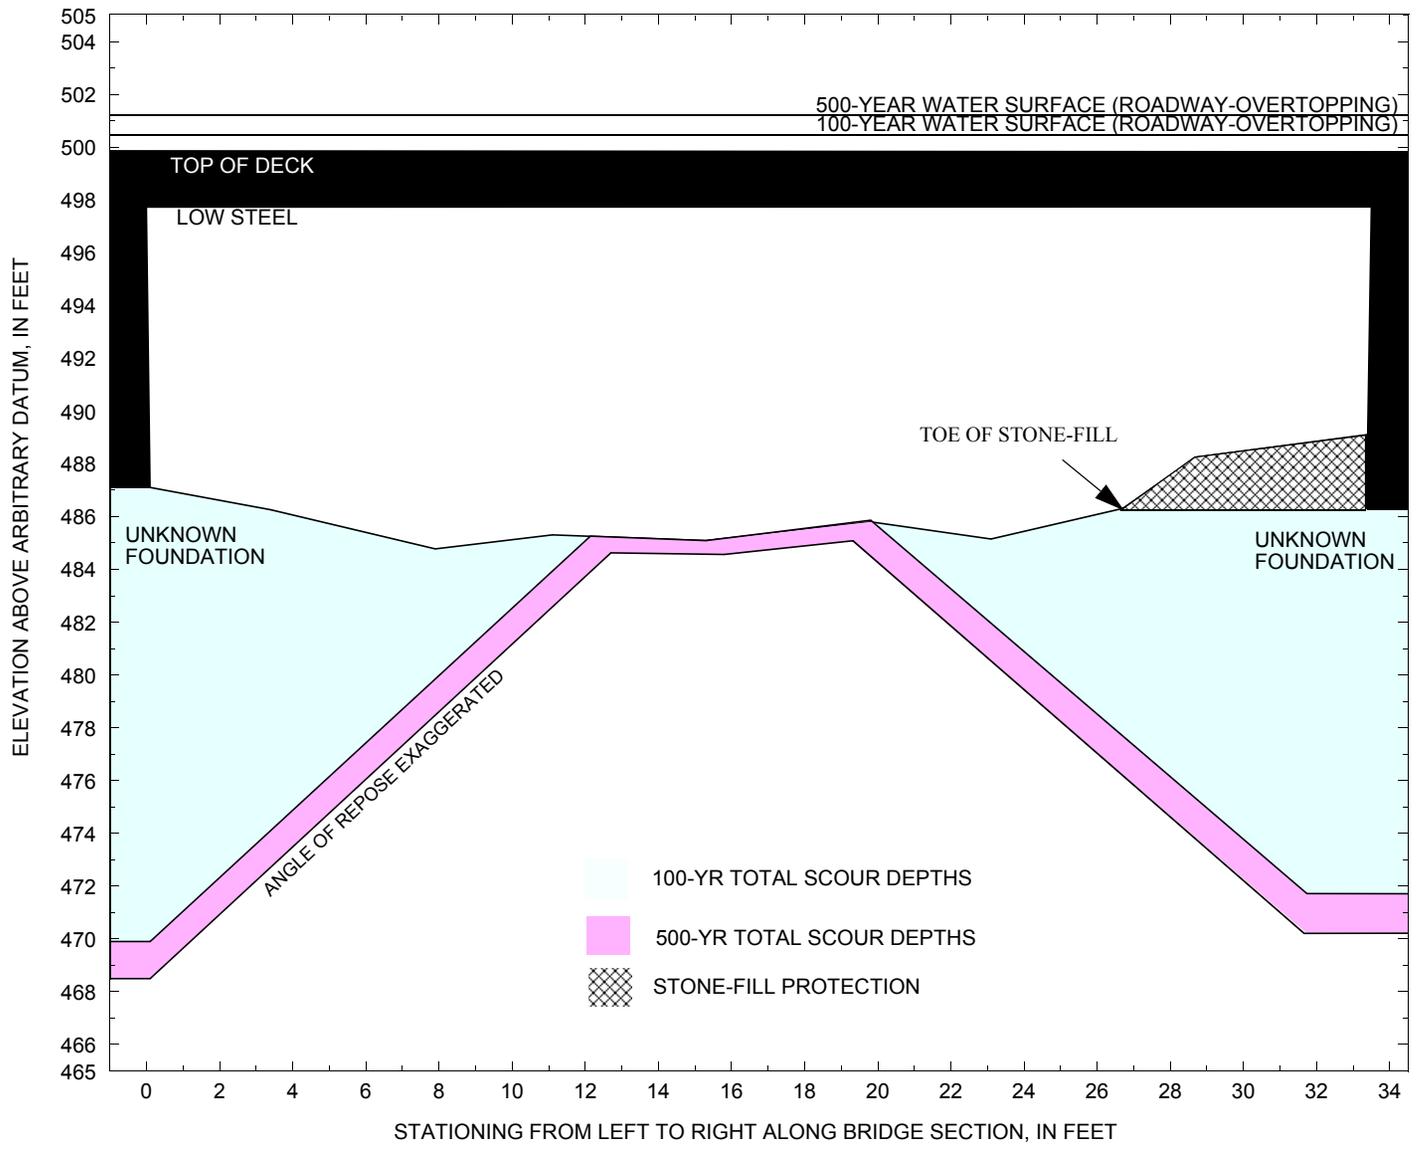
Figure 8. Scour elevations for the 100-year and 500-year discharges at structure TOPSTH00490022 on Town Highway 49, crossing the Waits River, Topsham, Vermont.

Scour depths were computed using the general guidelines described in Hydraulic Engineering Circular 18 (Richardson and others, 1995). Scour depths were calculated assuming an infinite depth of erosive material and a homogeneous particle-size distribution. The results of the scour analysis for the 100- and 500-year discharges are presented in tables 1 and 2 and a graph of the scour depths is presented in figure 8.

Because the influence of scour processes on the extensive stone fill abutment protection is uncertain, the scour depth at the vertical right abutment wall was computed at the toe of the stone-fill. The computed total scour depth was applied to the elevation at the toe of the stone fill in front of the right abutment and is shown in Tables 1 and 2 and Figure 8.

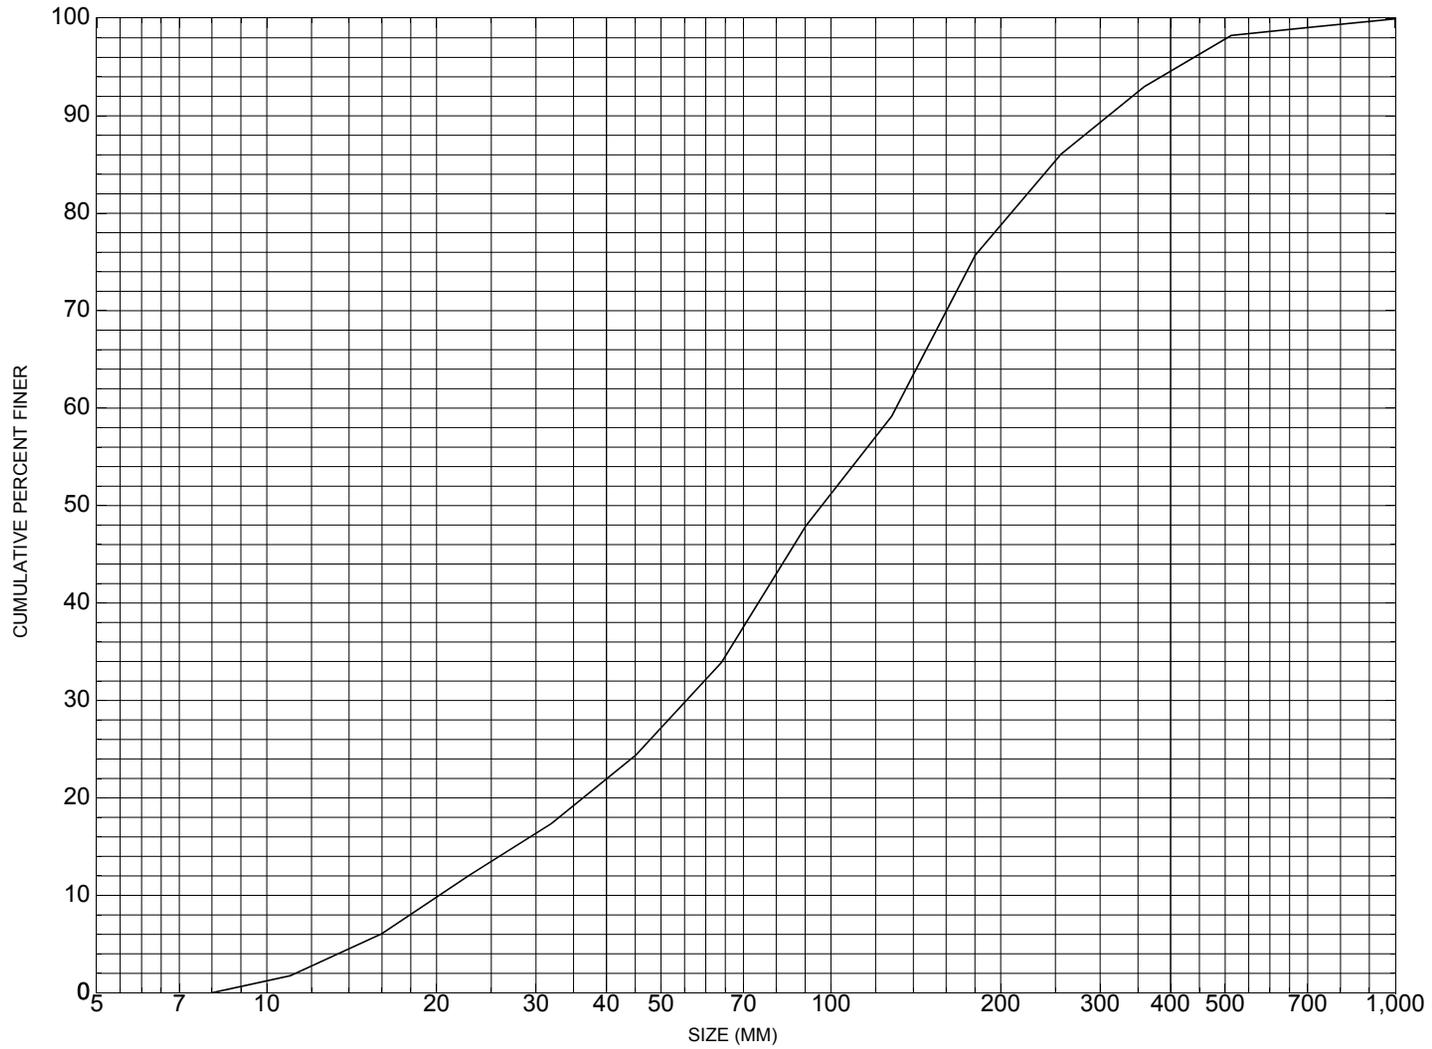
Appendix C. Bed material particle-size distribution for a pebble count in the channel approach of structure TOPSTH00490022, in Topsham, Vermont.
