LEVEL II SCOUR ANALYSIS FOR BRIDGE 57(CHESTH00090057) on TOWN HIGHWAY 9, crossing CHASE BROOK, CHESTER, VERMONT

Open-File Report 97-823

Prepared in cooperation with
VERMONT AGENCY OF TRANSPORTATION
and

FEDERAL HIGHWAY ADMINISTRATION

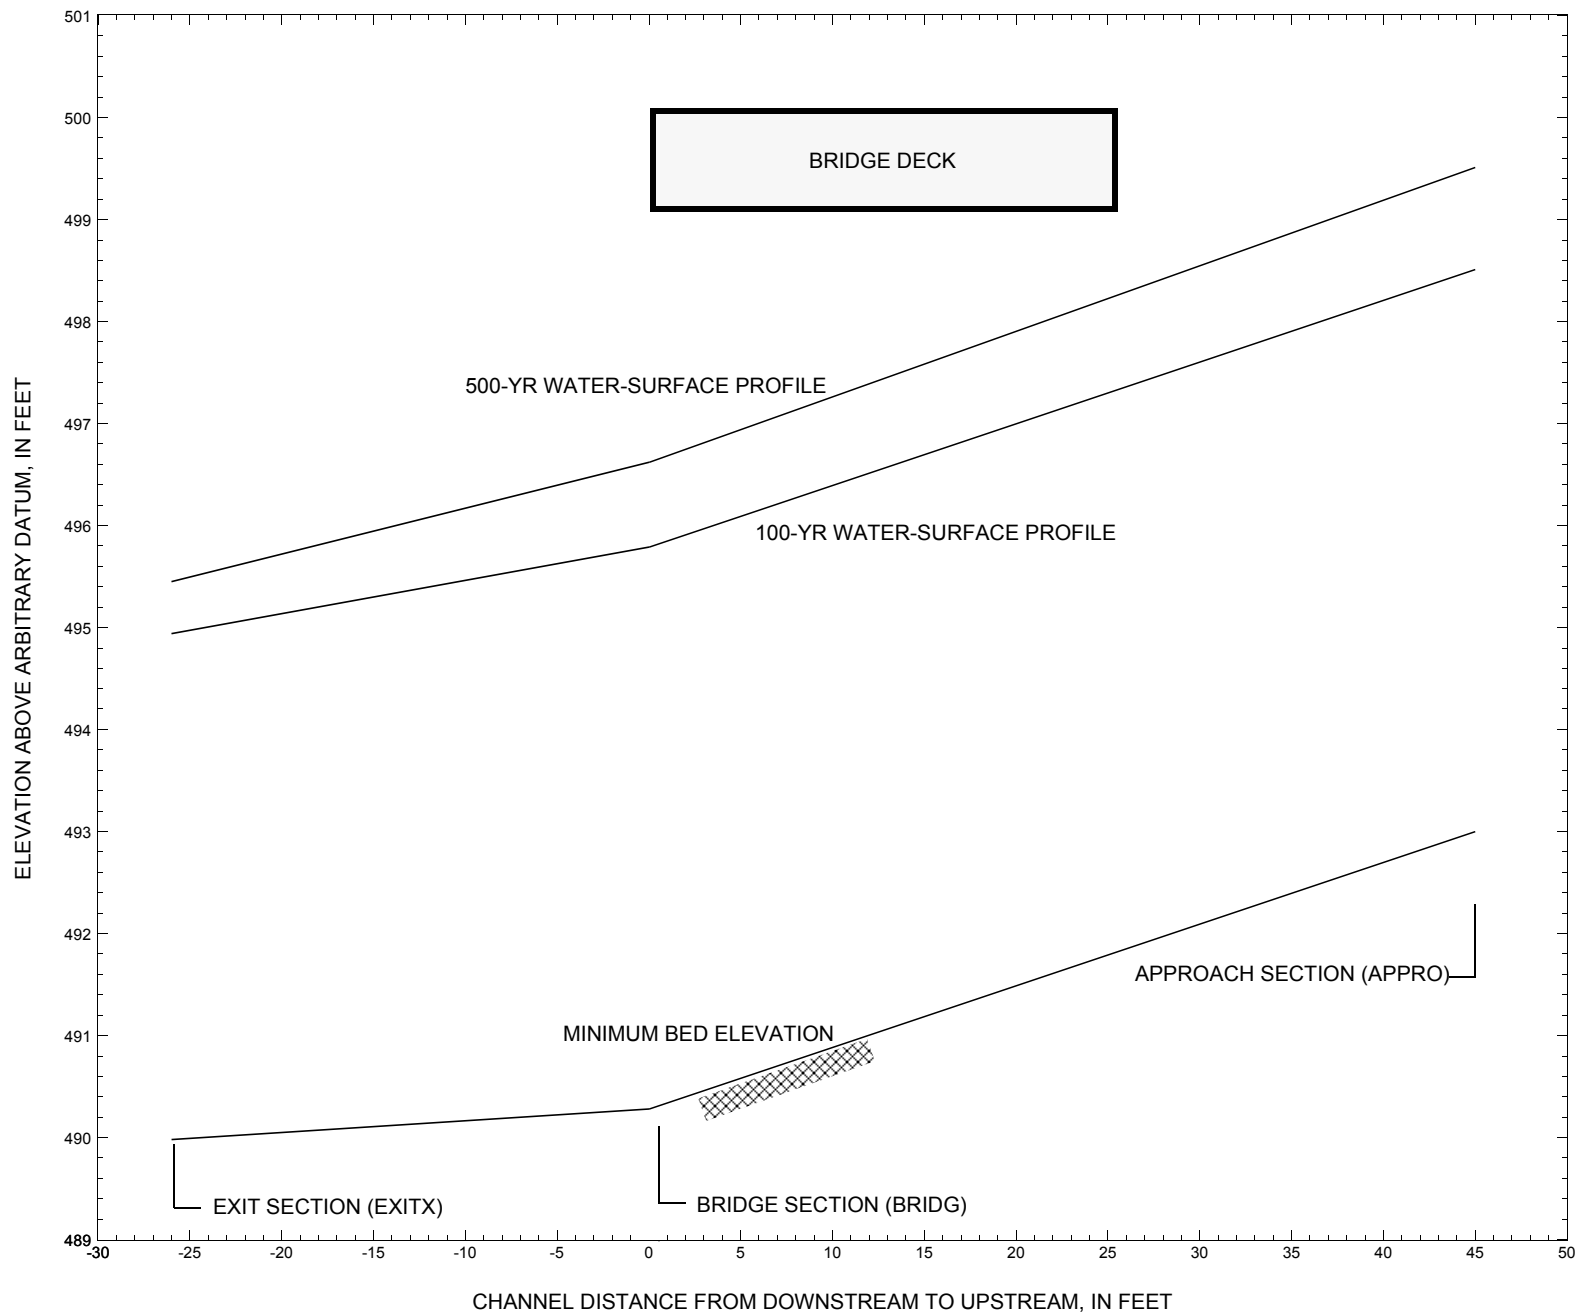
Figure 7. Water-surface profiles for the 100- and 500-yr discharges at structure CHESTH00090057 on Town Highway 9, crossing Chase Brook, Chester, Vermont.

Hydraulic analyses of the reach were done by use of the Federal Highway Administration's WSPRO step-backwater computer program (Shearman and others, 1986, and Shearman, 1990). The analyses reported herein reflect conditions existing at the site at the time of the study. Furthermore, in the development of the model it was necessary to assume no accumulation of debris or ice at the site. Results of the hydraulic model are presented in the Bridge Hydraulic Summary, Appendix B, and figure 7.

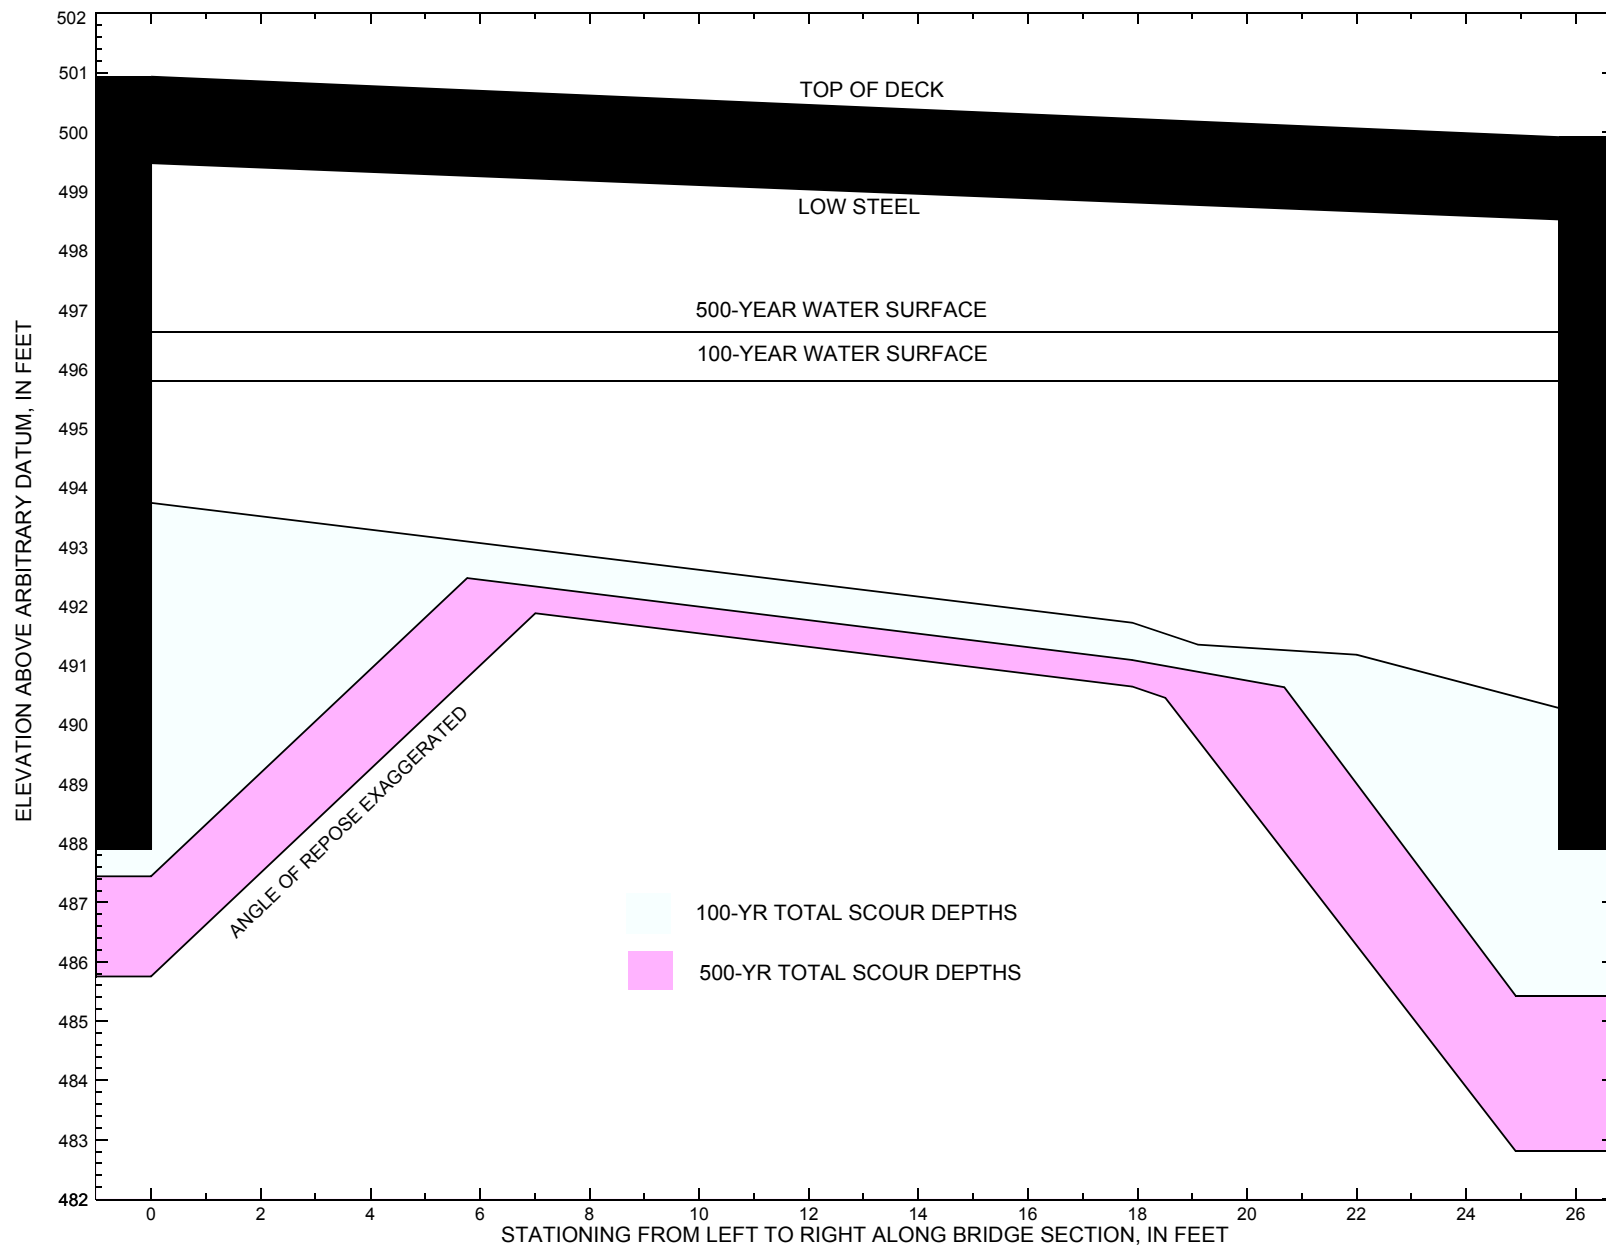
Figure 8. Scour elevations for the 100-yr and 500-yr discharges at structure CHESTH00090057 on Town Highway 9, crossing Chase Brook, Chester, Vermont.

Scour depths were computed using the general guidelines described in Hydraulic Engineering Circular 18 (Richardson and others, 1995). Scour depths were calculated assuming an infinite depth of erosive material and a homogeneous particle-size distribution. The results of the scour analysis are presented in tables 1 and 2 and a graph of the scour depths is presented in figure 8.

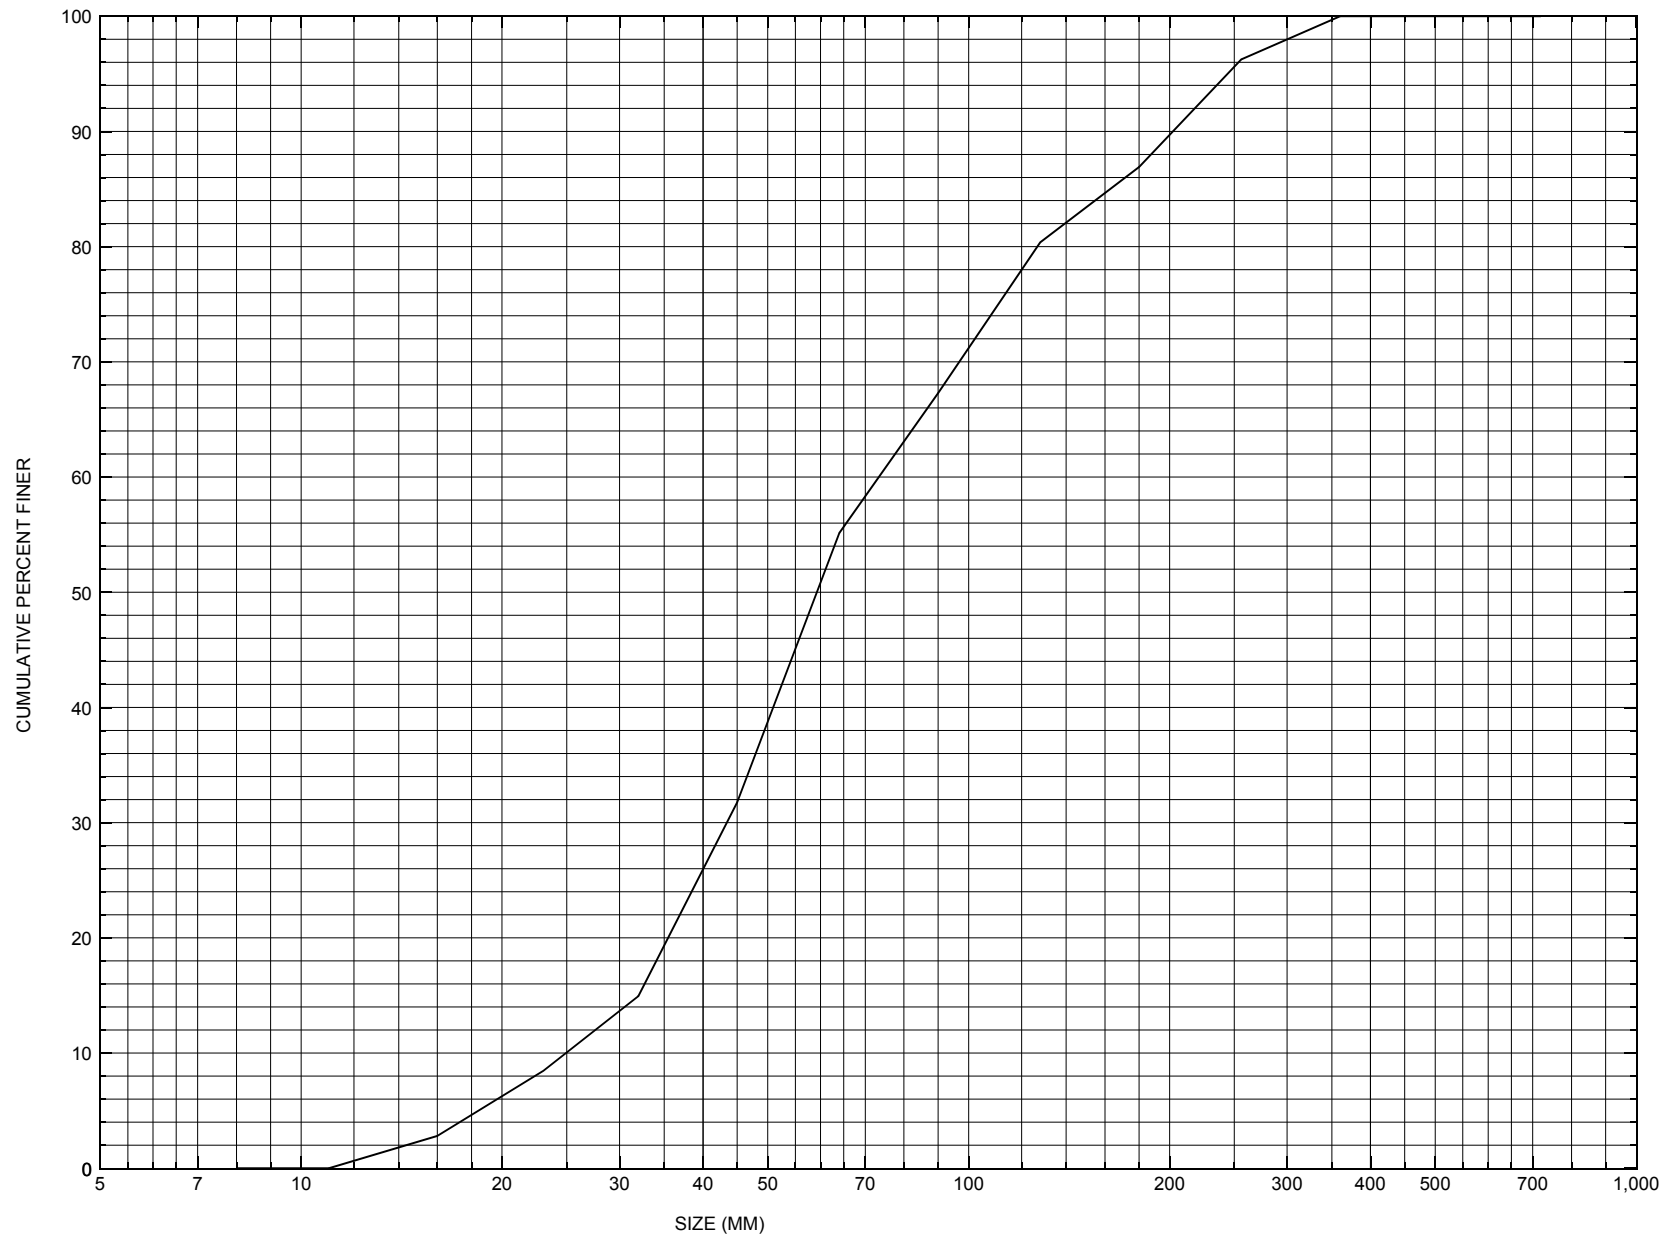
Appendix C. Bed material particle-size distribution for a pebble count in the channel approach of structure CHESTH00090057, in Chester, Vermont.
