# LEVEL II SCOUR ANALYSIS FOR BRIDGE 2 (WHITTH00020002) on TOWN HIGHWAY 2, crossing the SOUTH BRANCH DEERFIELD RIVER, WHITINGHAM, VERMONT

Open-File Report 98-008

Prepared in cooperation with  
VERMONT AGENCY OF TRANSPORTATION  
and  
FEDERAL HIGHWAY ADMINISTRATION

By RONDA L. BURNS and ROBERT H. FLYNN

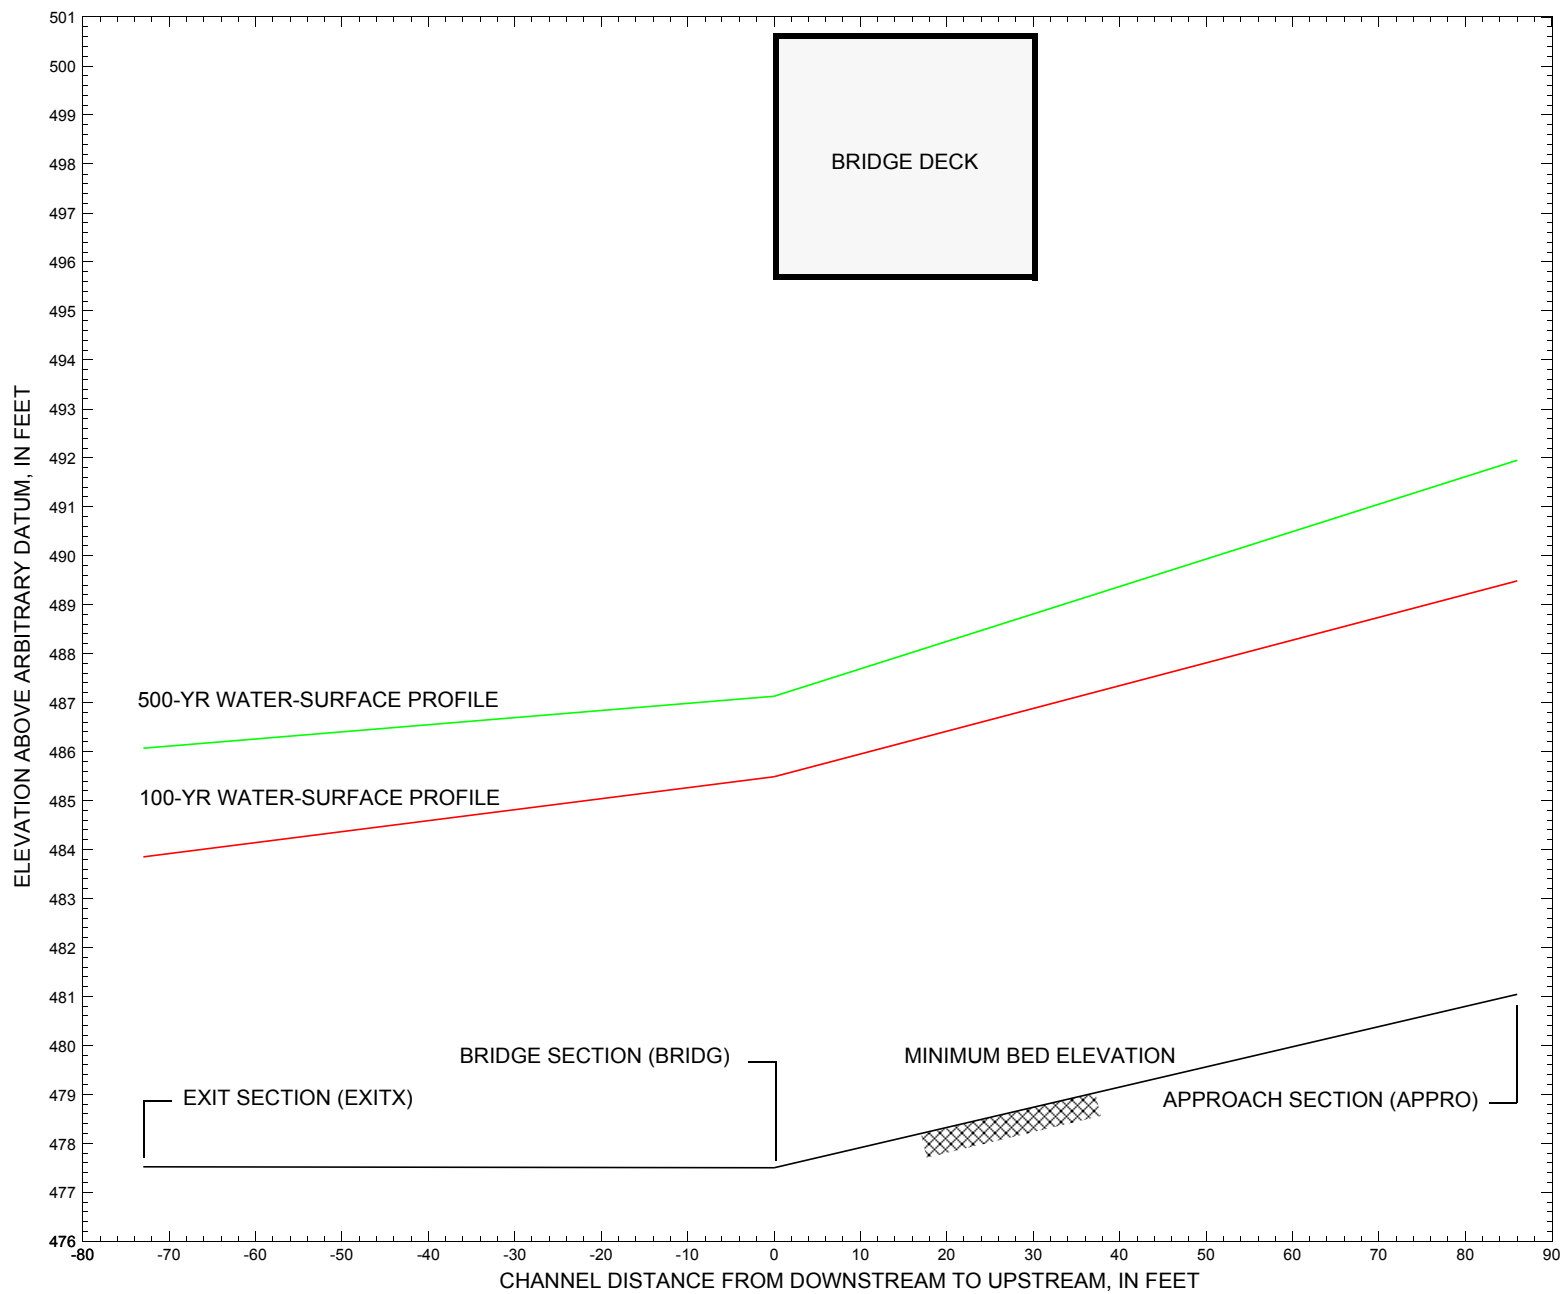
Figure 7. Water-surface profiles for the 100- and 500-yr discharges at structure WHITTH00020002 on Town Highway 2, crossing the South Branch Deerfield River, Whitingham, Vermont.

Hydraulic analyses of the reach were done by use of the Federal Highway Administration's WSPRO step-backwater computer program (Shearman and others, 1986, and Shearman, 1990). The analyses reported herein reflect conditions existing at the site at the time of the study. Furthermore, in the development of the model it was necessary to assume no accumulation of debris or ice at the site. Results of the hydraulic model are presented in the Bridge Hydraulic Summary, Appendix B, and Figure 7.

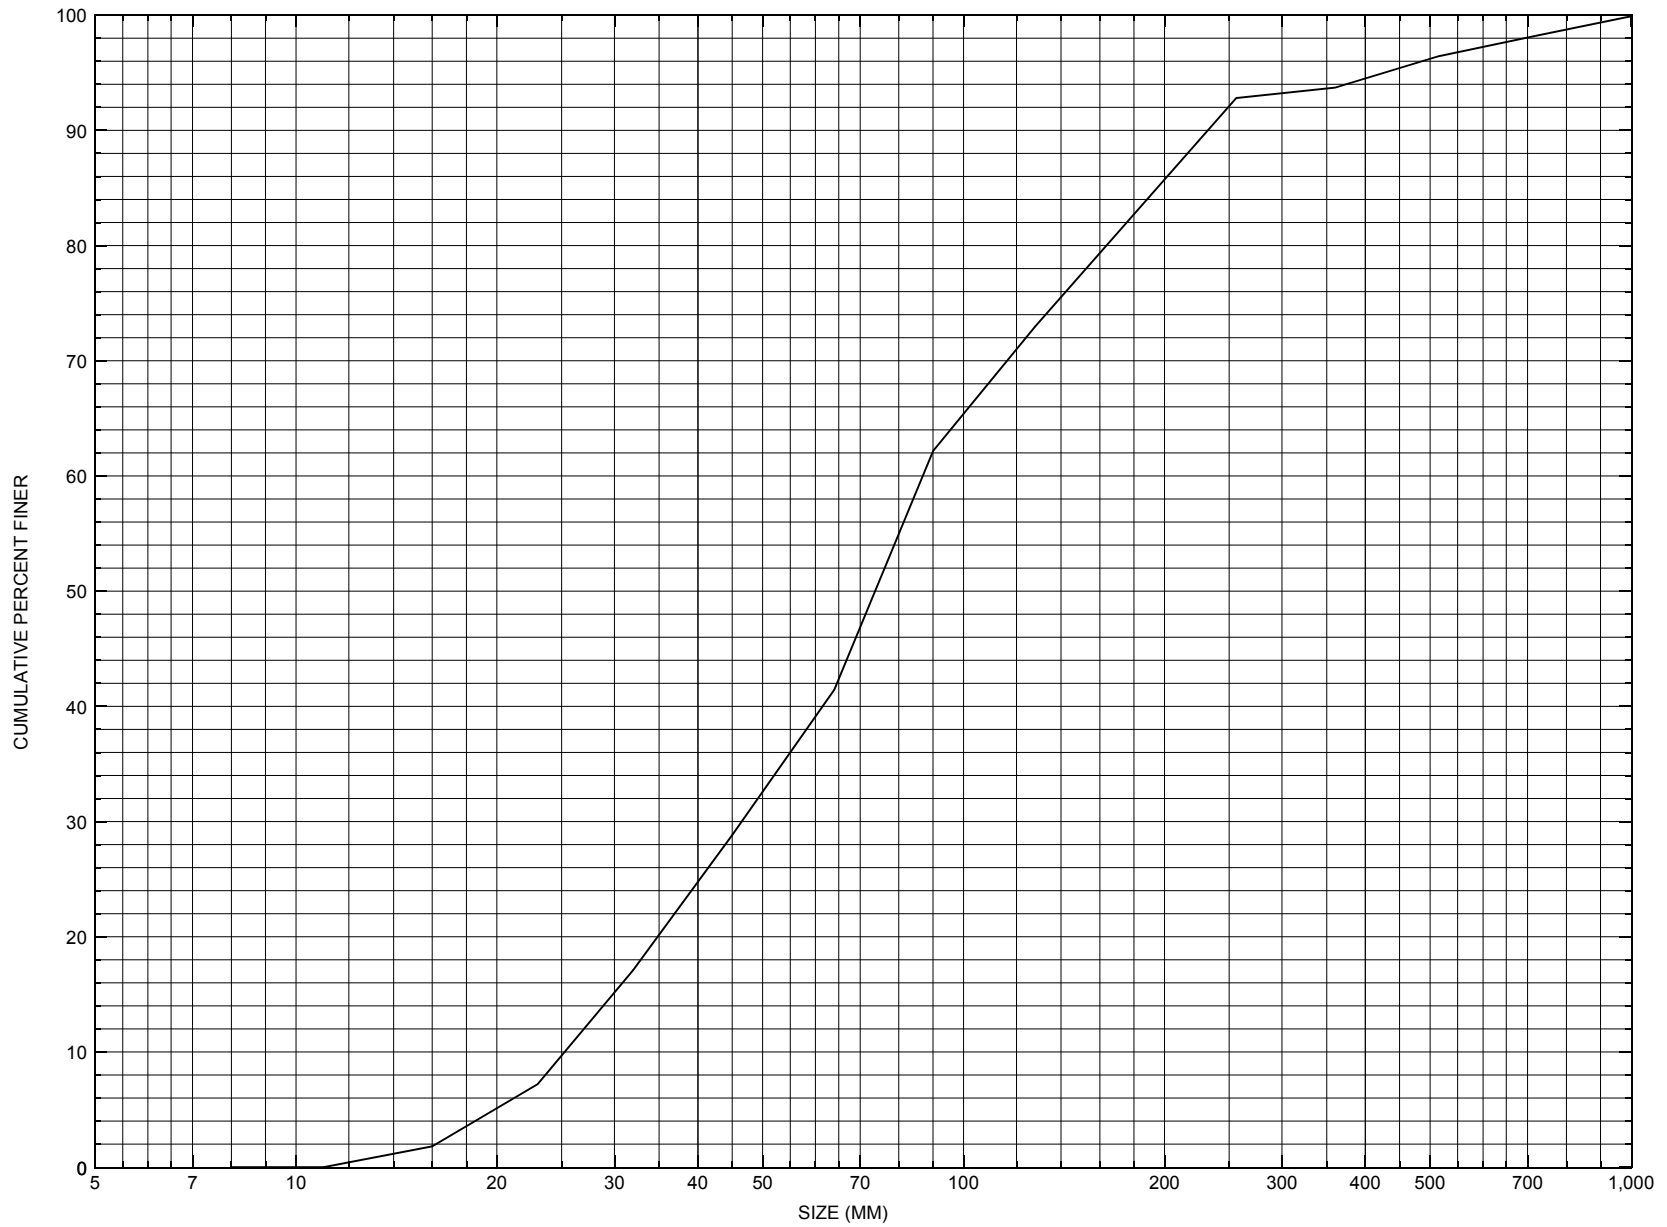
Appendix C. Bed material particle-size distribution for a pebble count at the approach cross-section for structure WHITTH00020002, in Whitingham, Vermont.
