LEVEL II SCOUR ANALYSIS FOR
BRIDGE 11 (BAKETH00030011) on
TOWN HIGHWAY 3, crossing
"THE BRANCH",
BAKERSFIELD, VERMONT

U.S. Geological Survey
Open-File Report 98-014

Prepared in cooperation with
VERMONT AGENCY OF TRANSPORTATION
and
FEDERAL HIGHWAY ADMINISTRATION

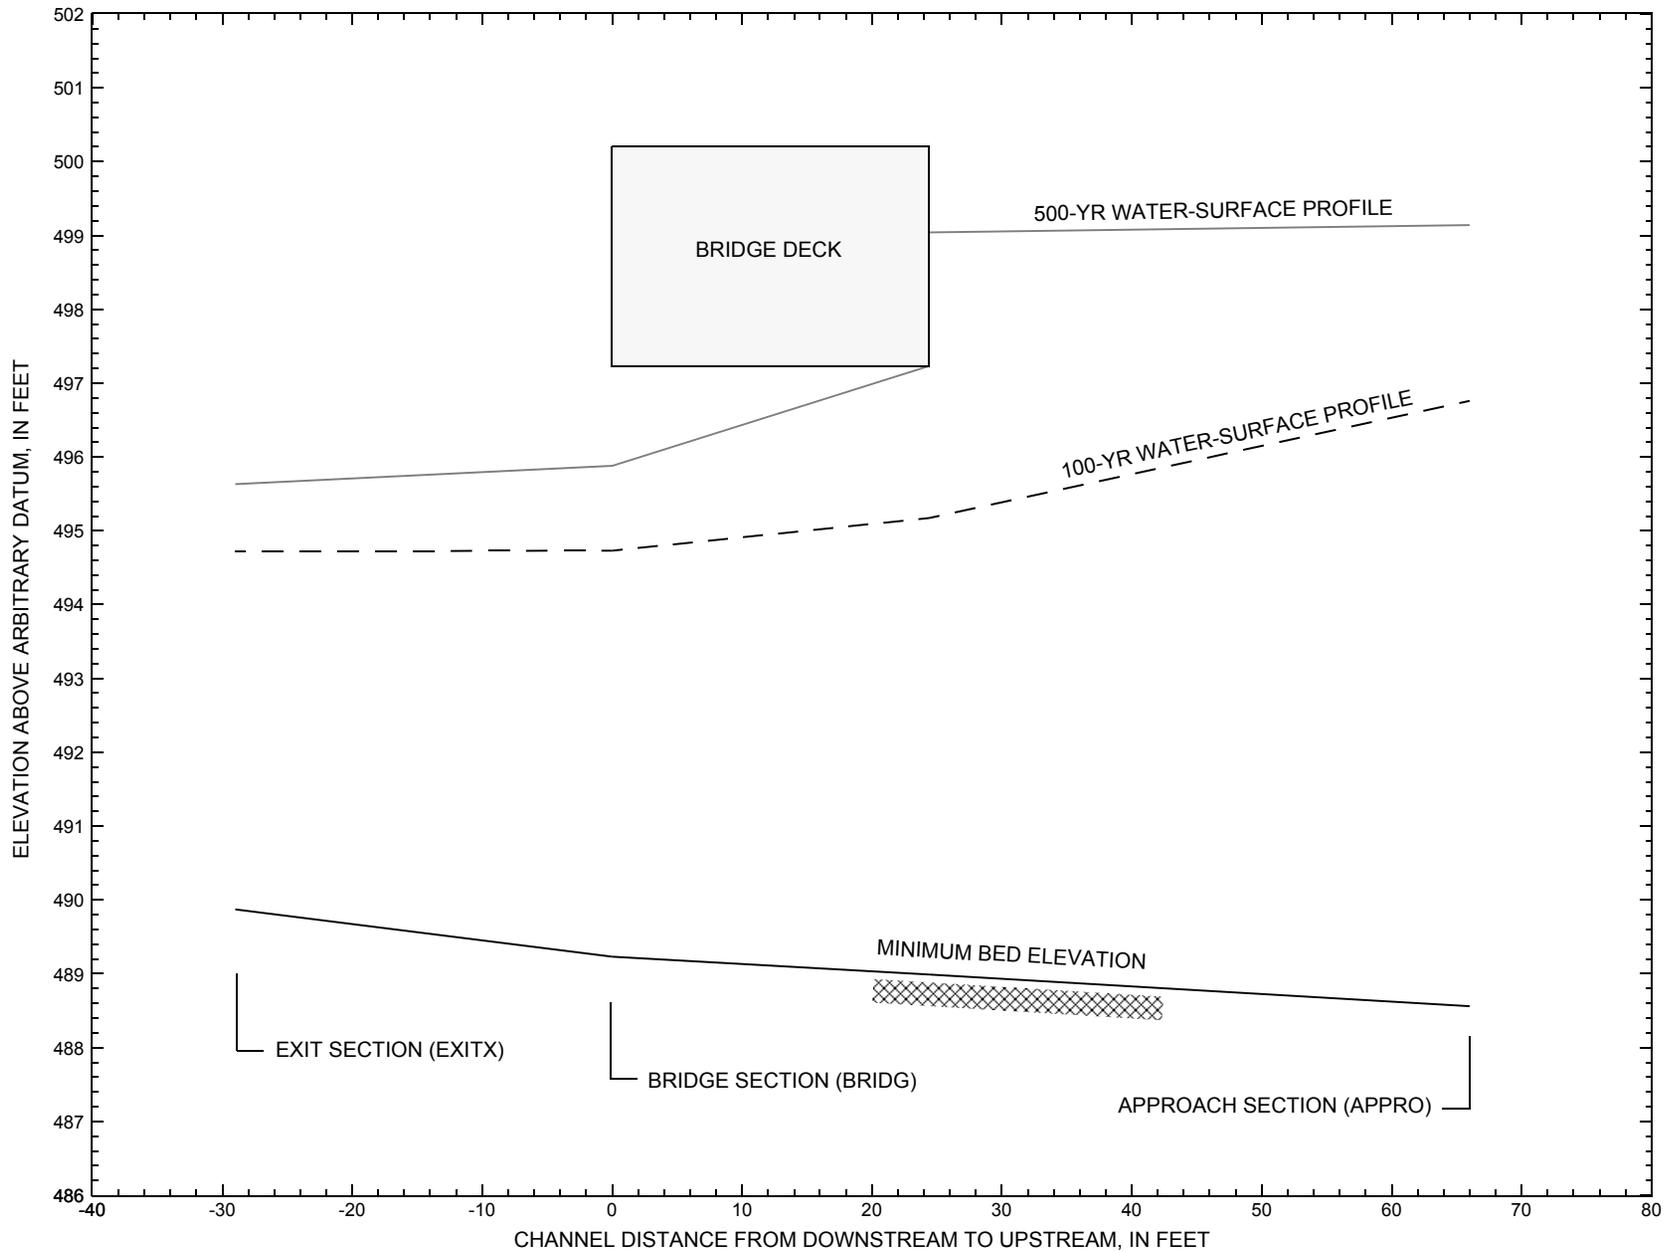
Figure 7. Water-surface profiles for the 100- and 500-yr discharges at structure BAKETH00030011 on Town Highway 3, crossing "The Branch", Bakersfield, Vermont.

Hydraulic analyses of the reach were done by use of the Federal Highway Administration's WSPRO step-backwater computer program (Shearman and others, 1986, and Shearman, 1990). The analyses reported herein reflect conditions existing at the site at the time of the study. Furthermore, in the development of the model it was necessary to assume no accumulation of debris or ice at the site. Results of the hydraulic model are presented in the Bridge Hydraulic Summary, appendix B, and figure 7.

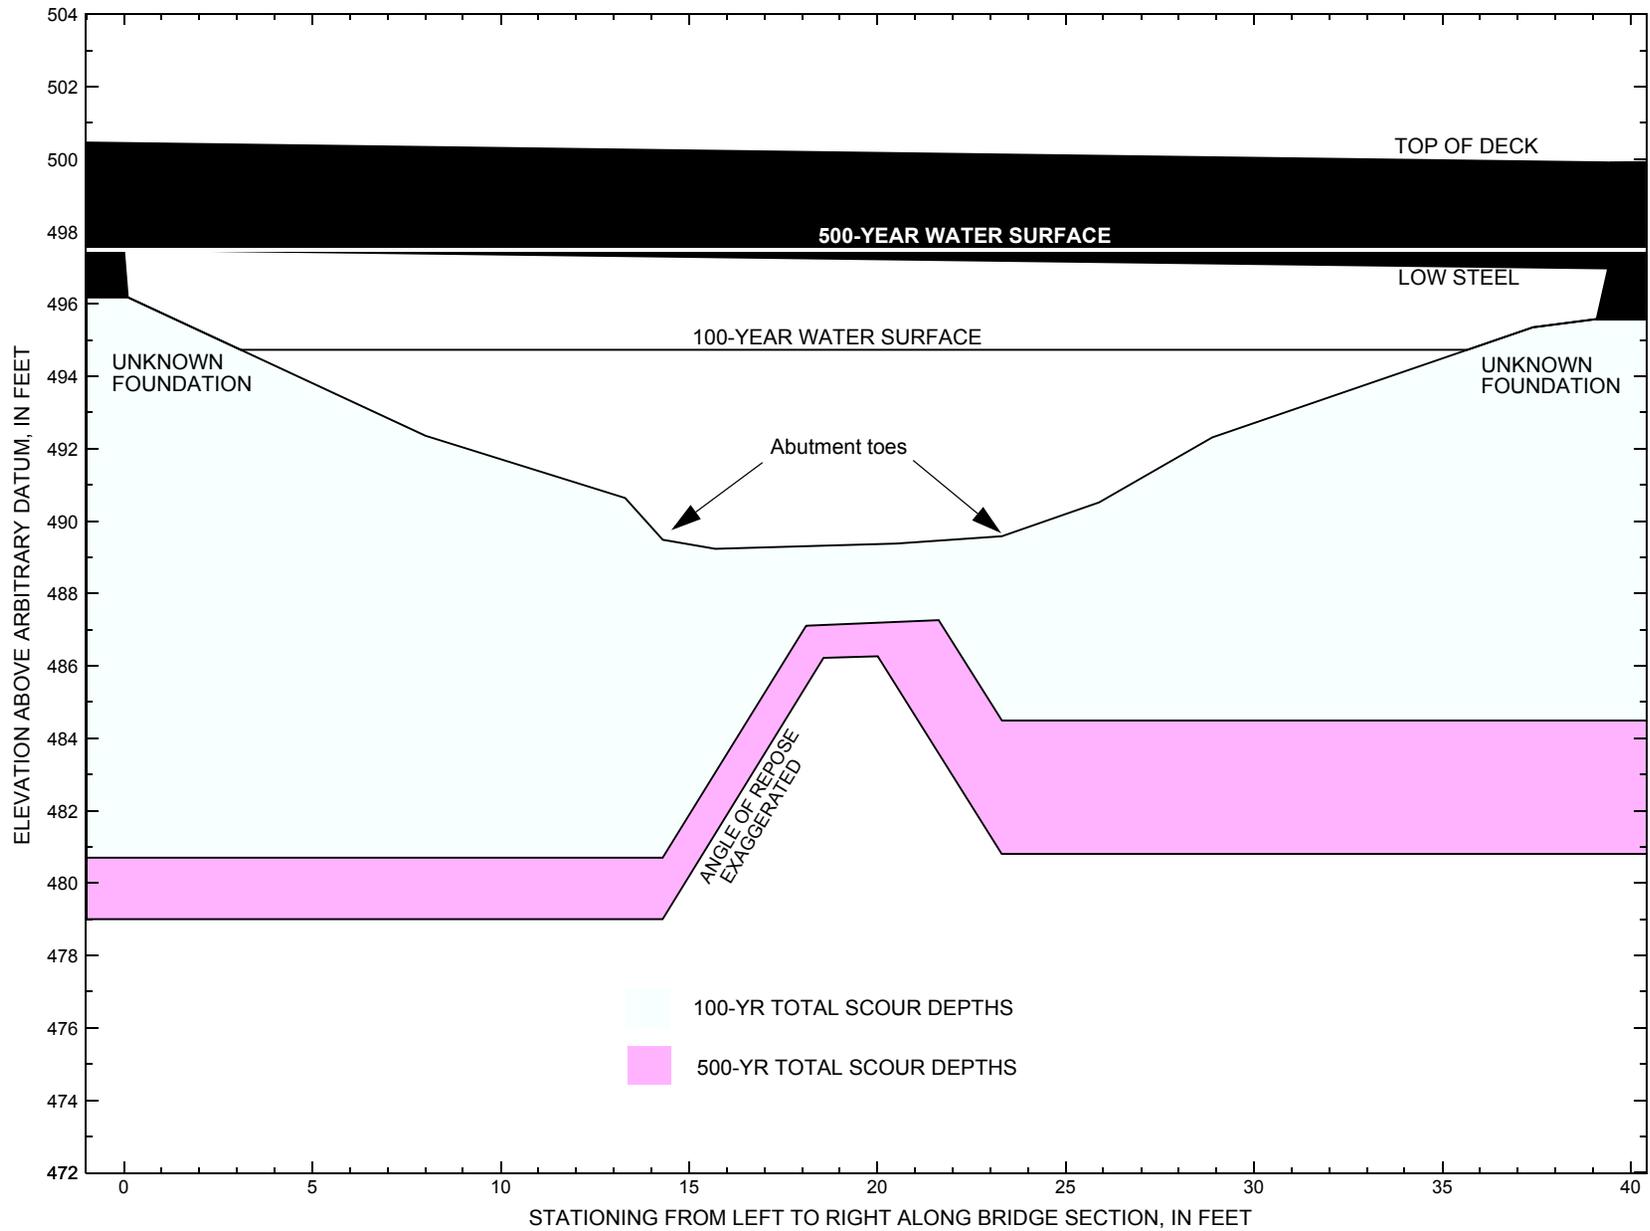
Figure 8. Scour elevations for the 100- and 500-yr discharges at structure BAKETH00030011 on Town Highway 3, crossing "The Branch", Bakersfield, Vermont.

Scour depths were computed using the general guidelines described in Hydraulic Engineering Circular 18 (Richardson and Davis, 1995). Scour depths were calculated assuming an infinite depth of erosive material and a homogeneous particle-size distribution. Results of the scour analyses are shown in tables 1 and 2 and the scour depths are presented graphically in figure 8.

Because the influence of scour processes on the spill-through embankment material is uncertain, the scour depth at the vertical concrete abutment walls is unknown. Therefore, the elevation of scour was computed based on the elevation at the toe of each spill-through embankment and applied for the entire area of each embankment as shown in figure 8.

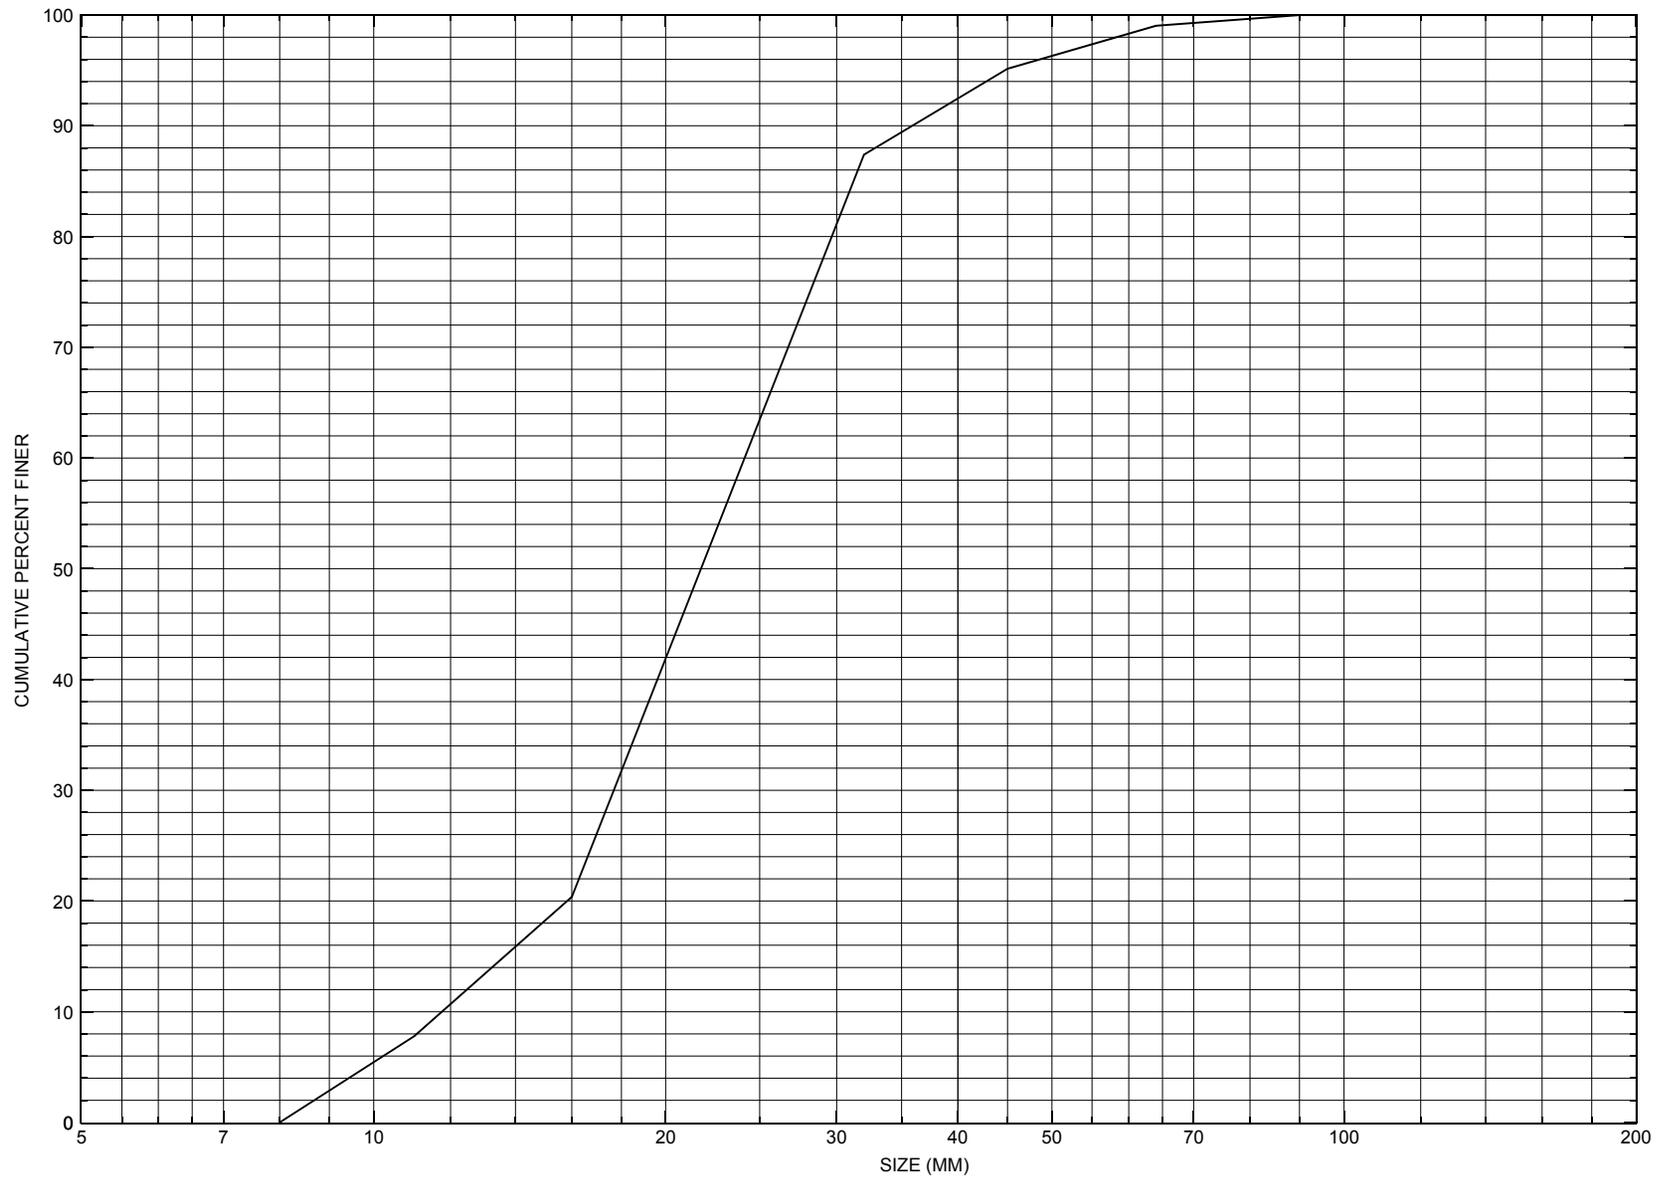
Appendix C. Bed material particle-size distribution for a pebble count in the channel approach of structure BAKETH00030011, in Bakersfield, Vermont.
