LEVEL II SCOUR ANALYSIS FOR BRIDGE 32 (FERRTH00190032) on TOWN HIGHWAY 19, crossing the SOUTH SLANG LITTLE OTTER CREEK, FERRISBURGH, VERMONT

Open-File Report 98-025

U.S. Geological Survey
Open-File Report 98-025

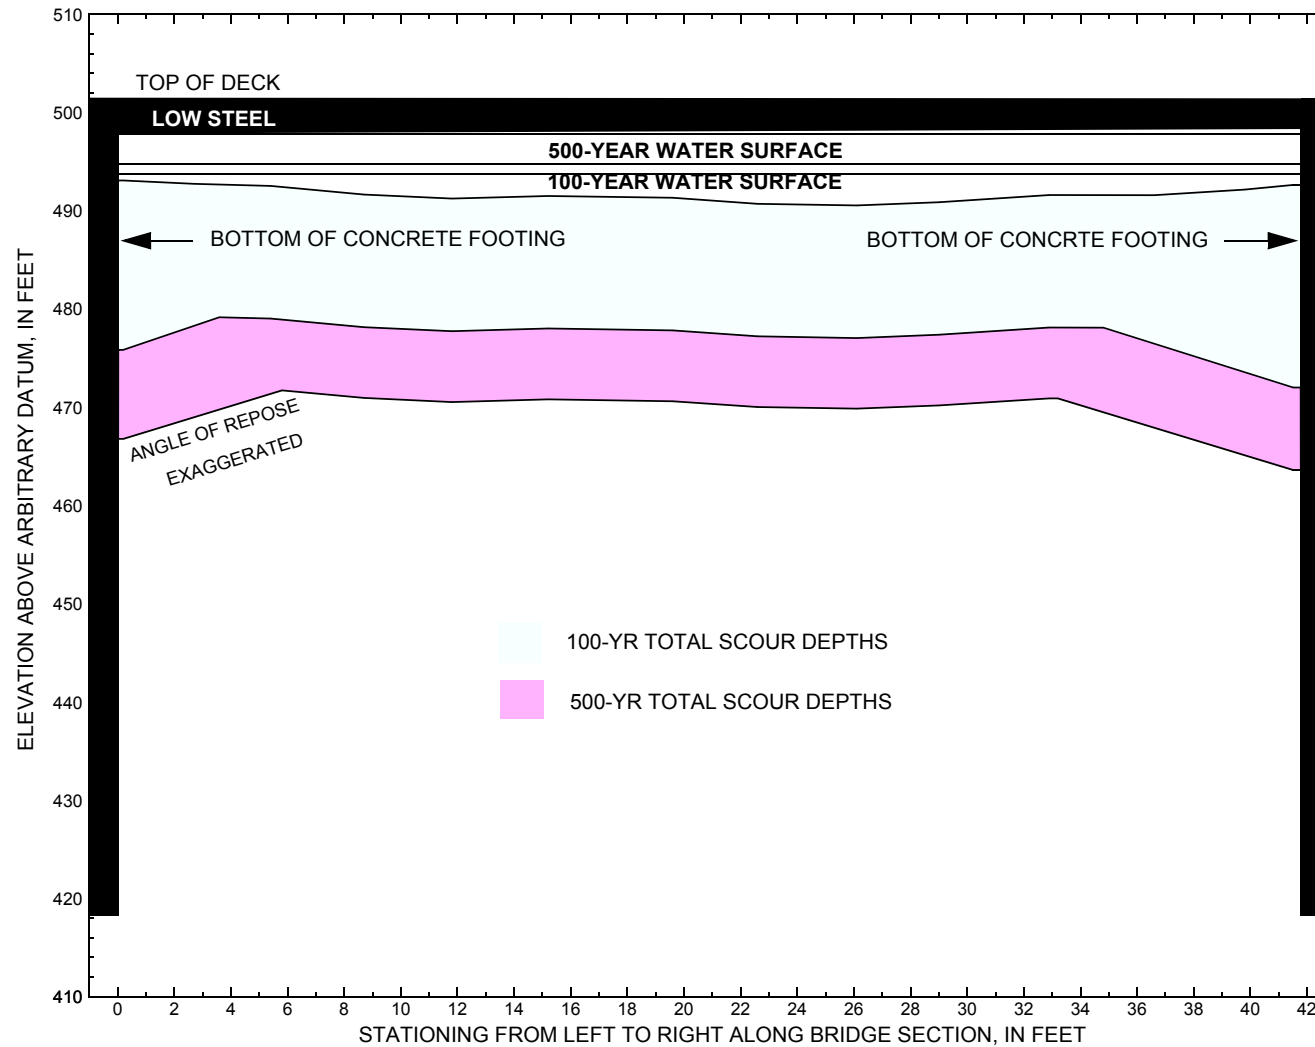
Figure 8. Scour elevations for the 100-year and 500-year discharges at structure FERRTH00190032 on Town Highway 19, crossing the South Slang Little Otter Creek, Ferrisburg, Vermont.

Scour depths were computed using the general guidelines described in Hydraulic Engineering Circular 18 (Richardson and Davis, 1995). Scour depths were calculated assuming an infinite depth of erosive material and a homogeneous particle-size distribution. The results of the 100-year and 500-year discharges scour analysis are presented in tables 1 and 2 and the scour depths are presented graphically in figure 8.
