LEVEL II SCOUR ANALYSIS FOR  
BRIDGE 61 (MTHOTH00100061) on  
TOWN HIGHWAY 10, crossing  
PERRY BROOK,  
MOUNT HOLLY, VERMONT

Open-File Report 98-054

By MICHAEL A. IVANOFF

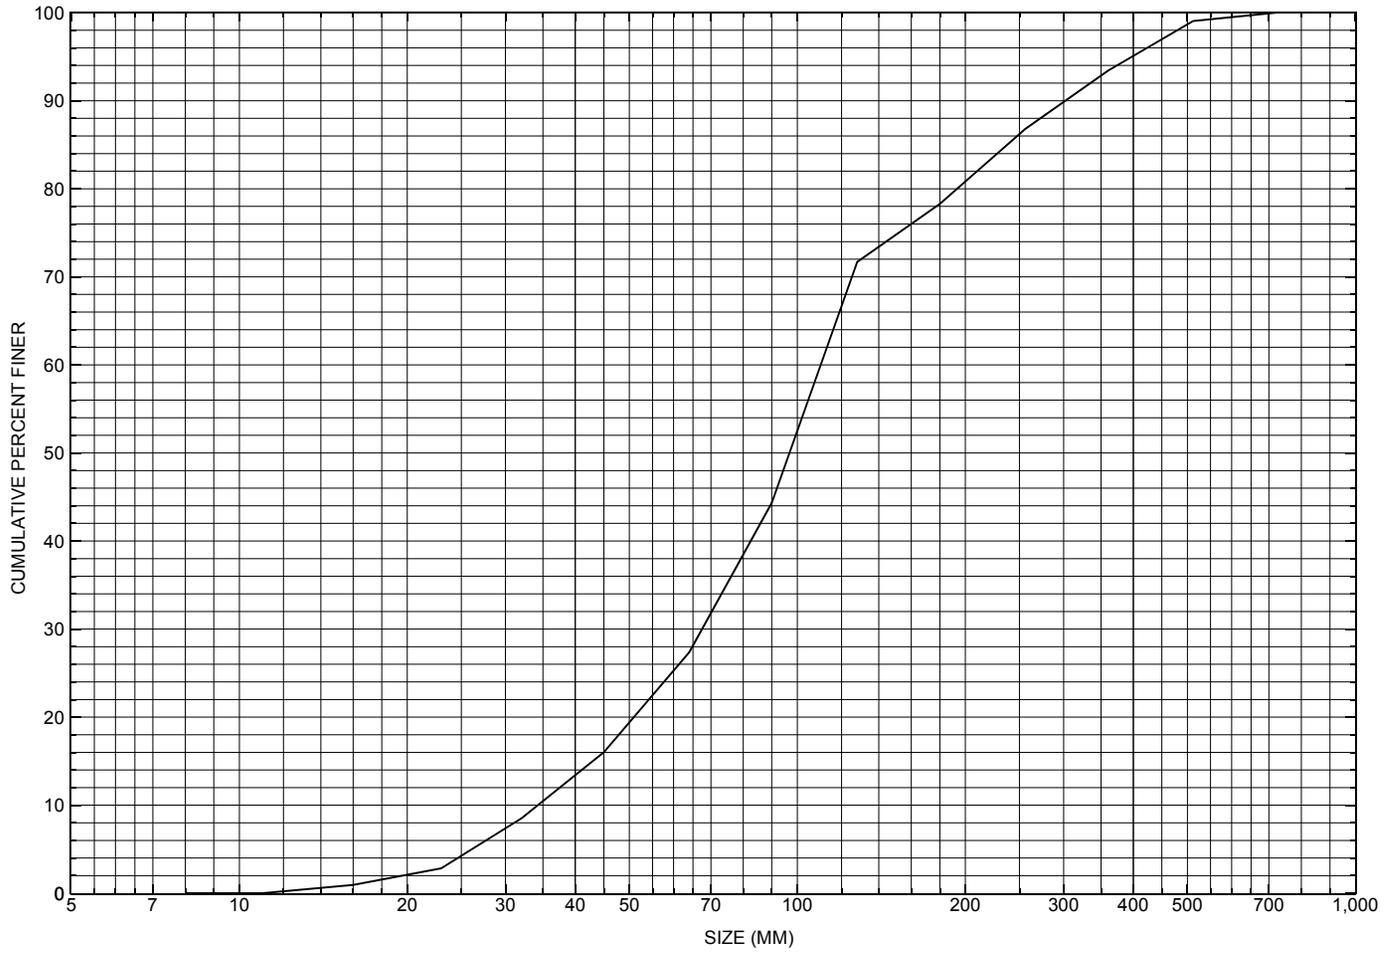
Appendix C. Bed material particle-size distribution for a pebble count in the channel approach of structure MTHOTH00100061, in Mount Holly, Vermont.
