LEVEL II SCOUR ANALYSIS FOR  
BRIDGE 4 (PROCTH00060004) on  
TOWN HIGHWAY 6, crossing  
OTTER CREEK,  
PROCTOR, VERMONT

Open-File Report 98-055

By MICHAEL A. IVANOFF AND LAURA MEDALIE

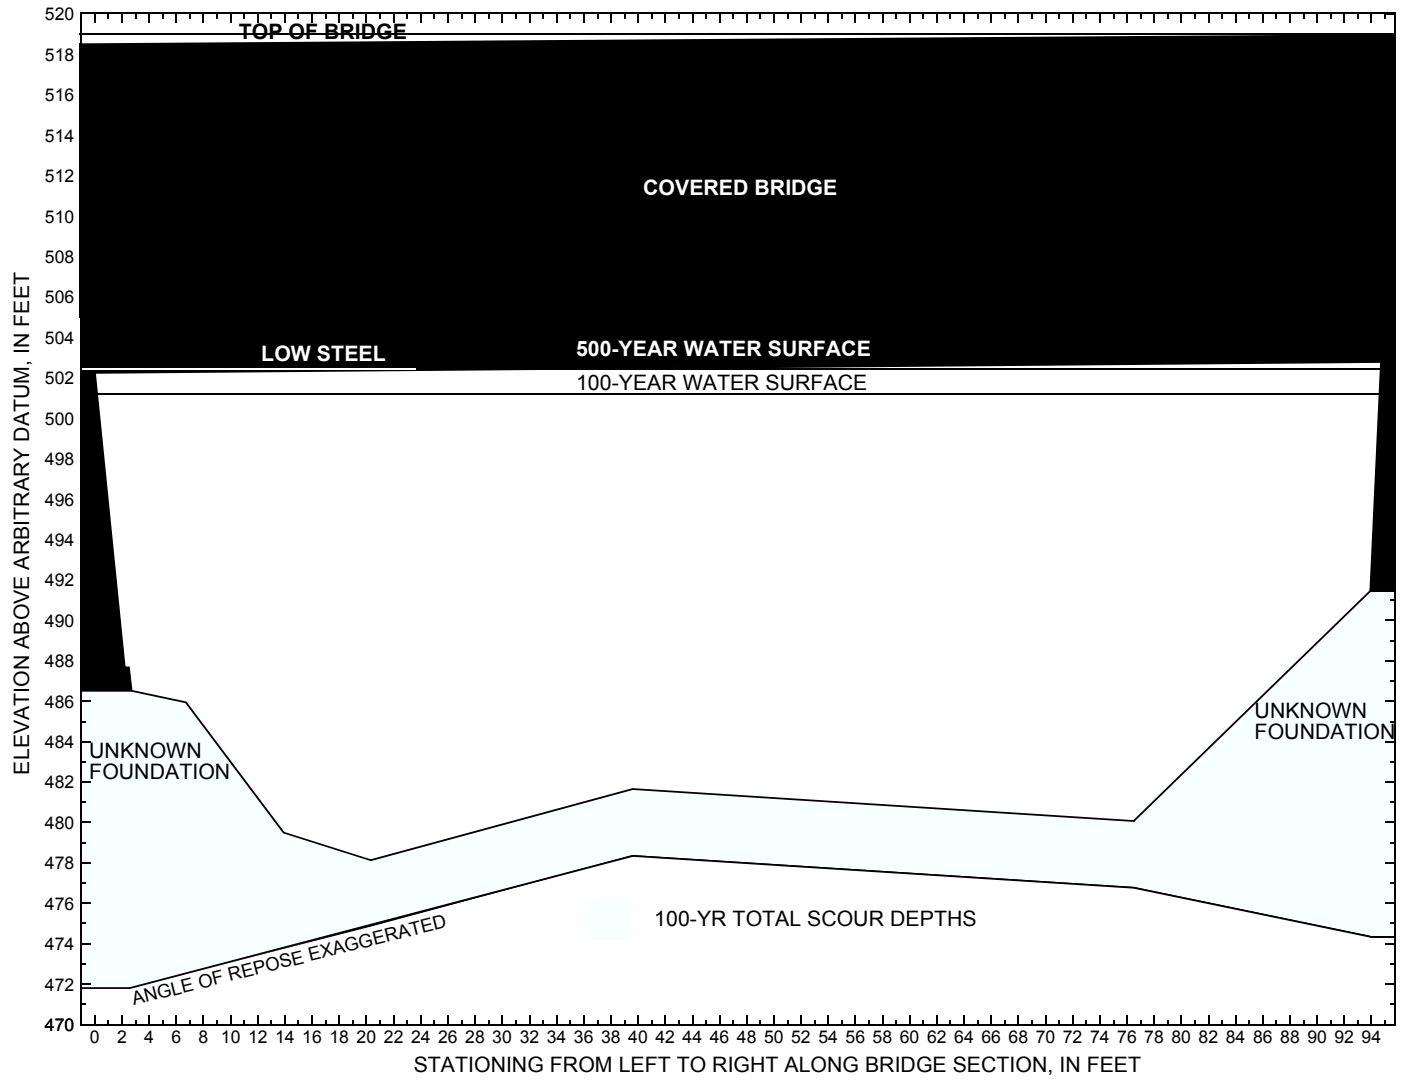
Figure 8. Scour elevations for the 100- and 500-year discharges at structure PROCTH00060004 on Town Highway 6, crossing Otter Creek, Proctor, Vermont.

Contraction scour for the 100-year, 500-year, and incipient roadway-overtopping discharges was computed by use of the Laursen live-bed contraction scour equation (Richardson and Davis, 1995, p. 30, equation 17). The results of the scour analyses for the 100- and 500-year discharges are presented in tables 1 and 2 and the scour depths are shown graphically in figure 8.
