LEVEL II SCOUR ANALYSIS FOR BRIDGE 58 (SPRITH00060058) on TOWN HIGHWAY 6, crossing BALTIMORE BROOK, SPRINGFIELD, VERMONT

Open-File Report 98-056

U.S. Geological Survey
Open-File Report 98-056

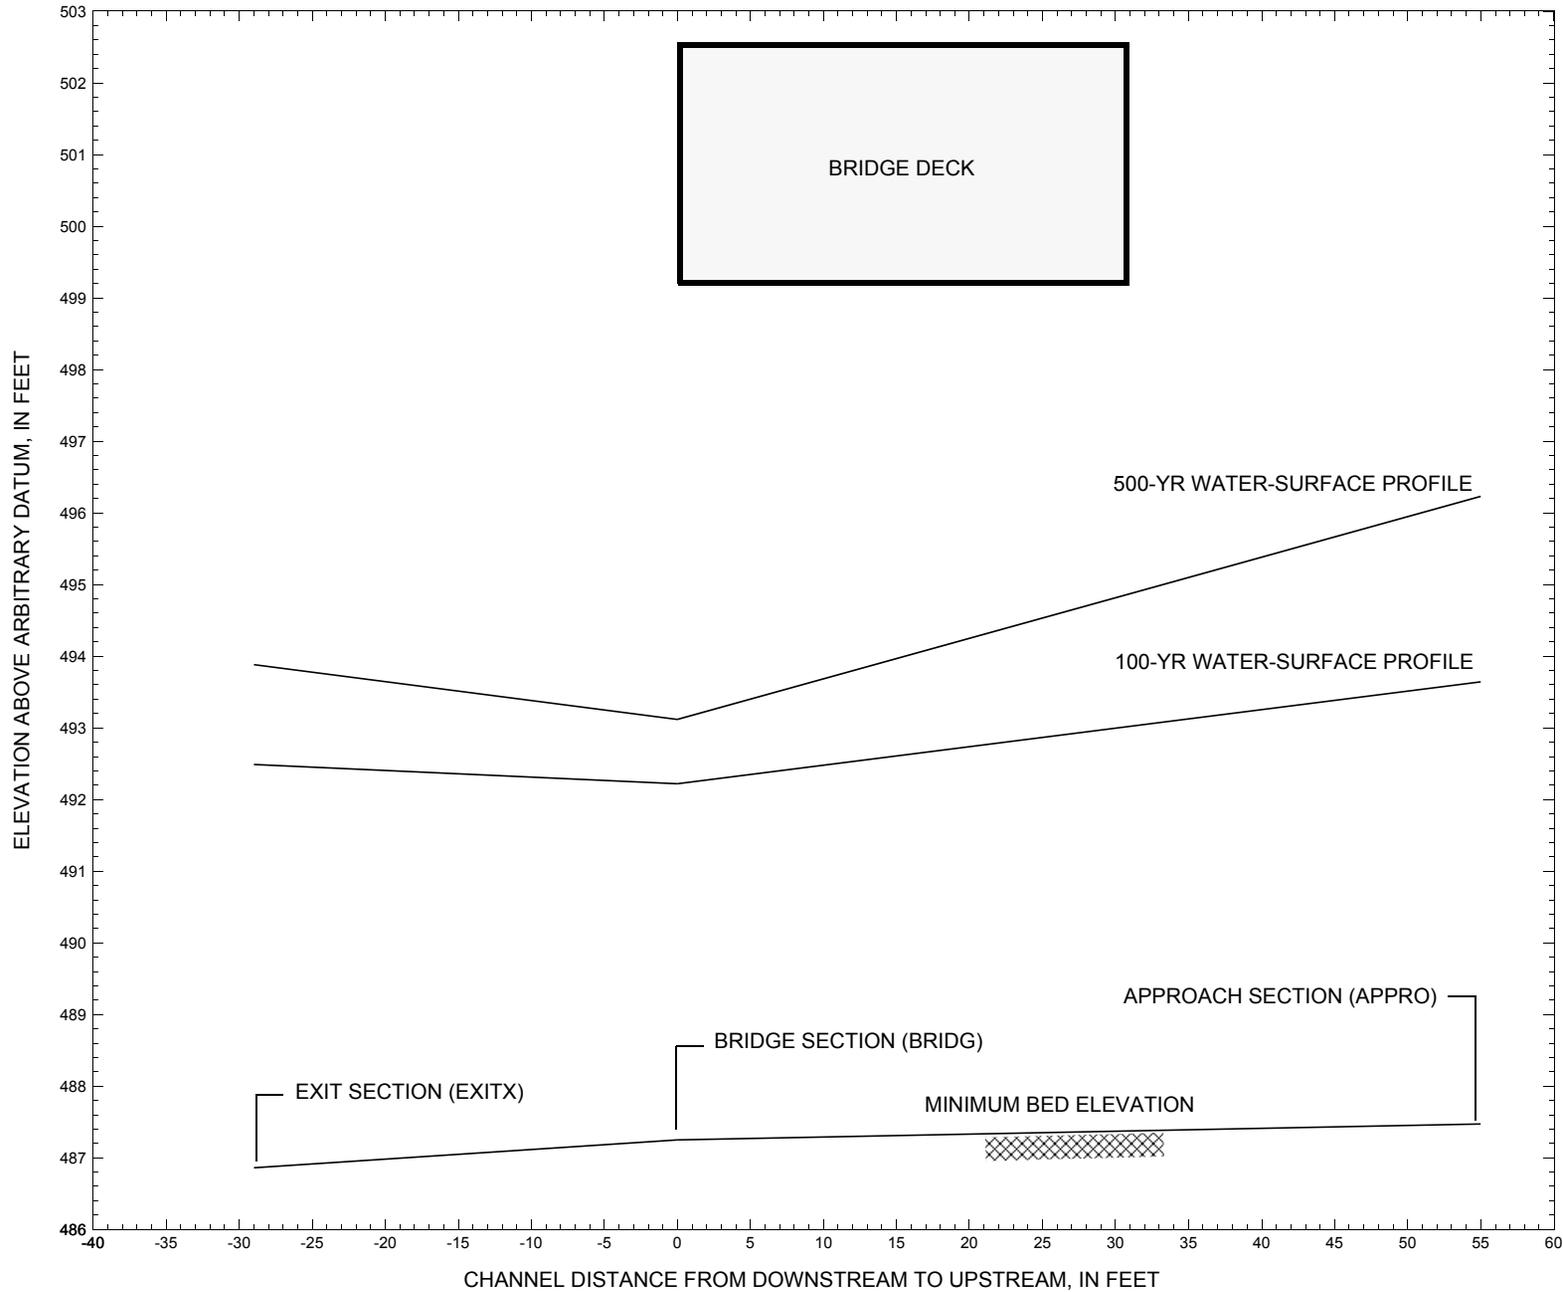
Figure 7. Water-surface profiles for the 100- and 500-yr discharges at structure SPRITH00060058 on Town Highway 6, crossing Baltimore Brook, Springfield, Vermont.

Hydraulic analyses of the reach were done by use of the Federal Highway Administration's WSPRO step-backwater computer program (Shearman and others, 1986, and Shearman, 1990). The analyses reported herein reflect conditions existing at the site at the time of the study. Furthermore, in the development of the model it was necessary to assume no accumulation of debris or ice at the site. Results of the hydraulic model are presented in the Bridge Hydraulic Summary, appendix B, and figure 7.

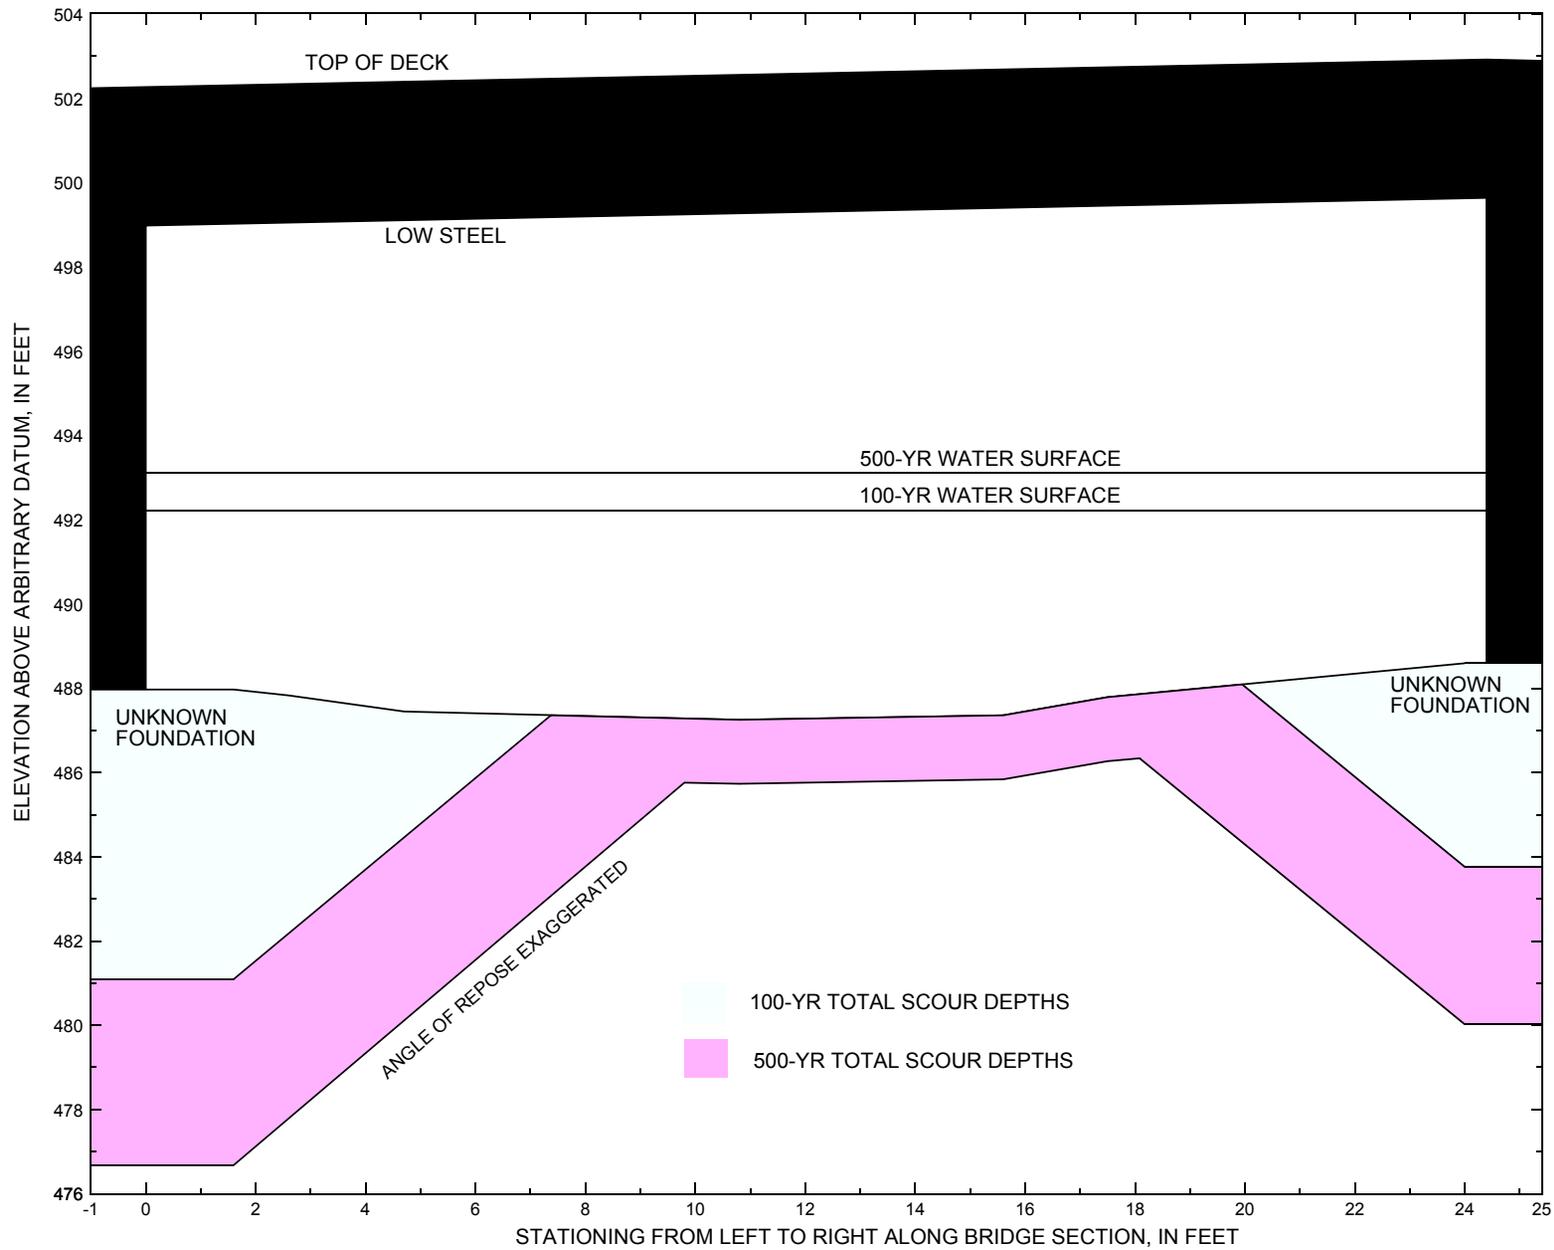
Figure 8. Scour elevations for the 100- and 500-yr discharges at structure SPRITH00060058 on Town Highway 6, crossing Baltimore Brook, Springfield, Vermont.

Scour depths were computed using the general guidelines described in Hydraulic Engineering Circular 18 (Richardson and Davis, 1995). Scour depths were calculated assuming an infinite depth of erosive material and a homogeneous particle-size distribution. The results of the scour analyses for the 100- and 500-year discharges are presented in tables 1 and 2 and the scour depths are shown graphically in figure 8.

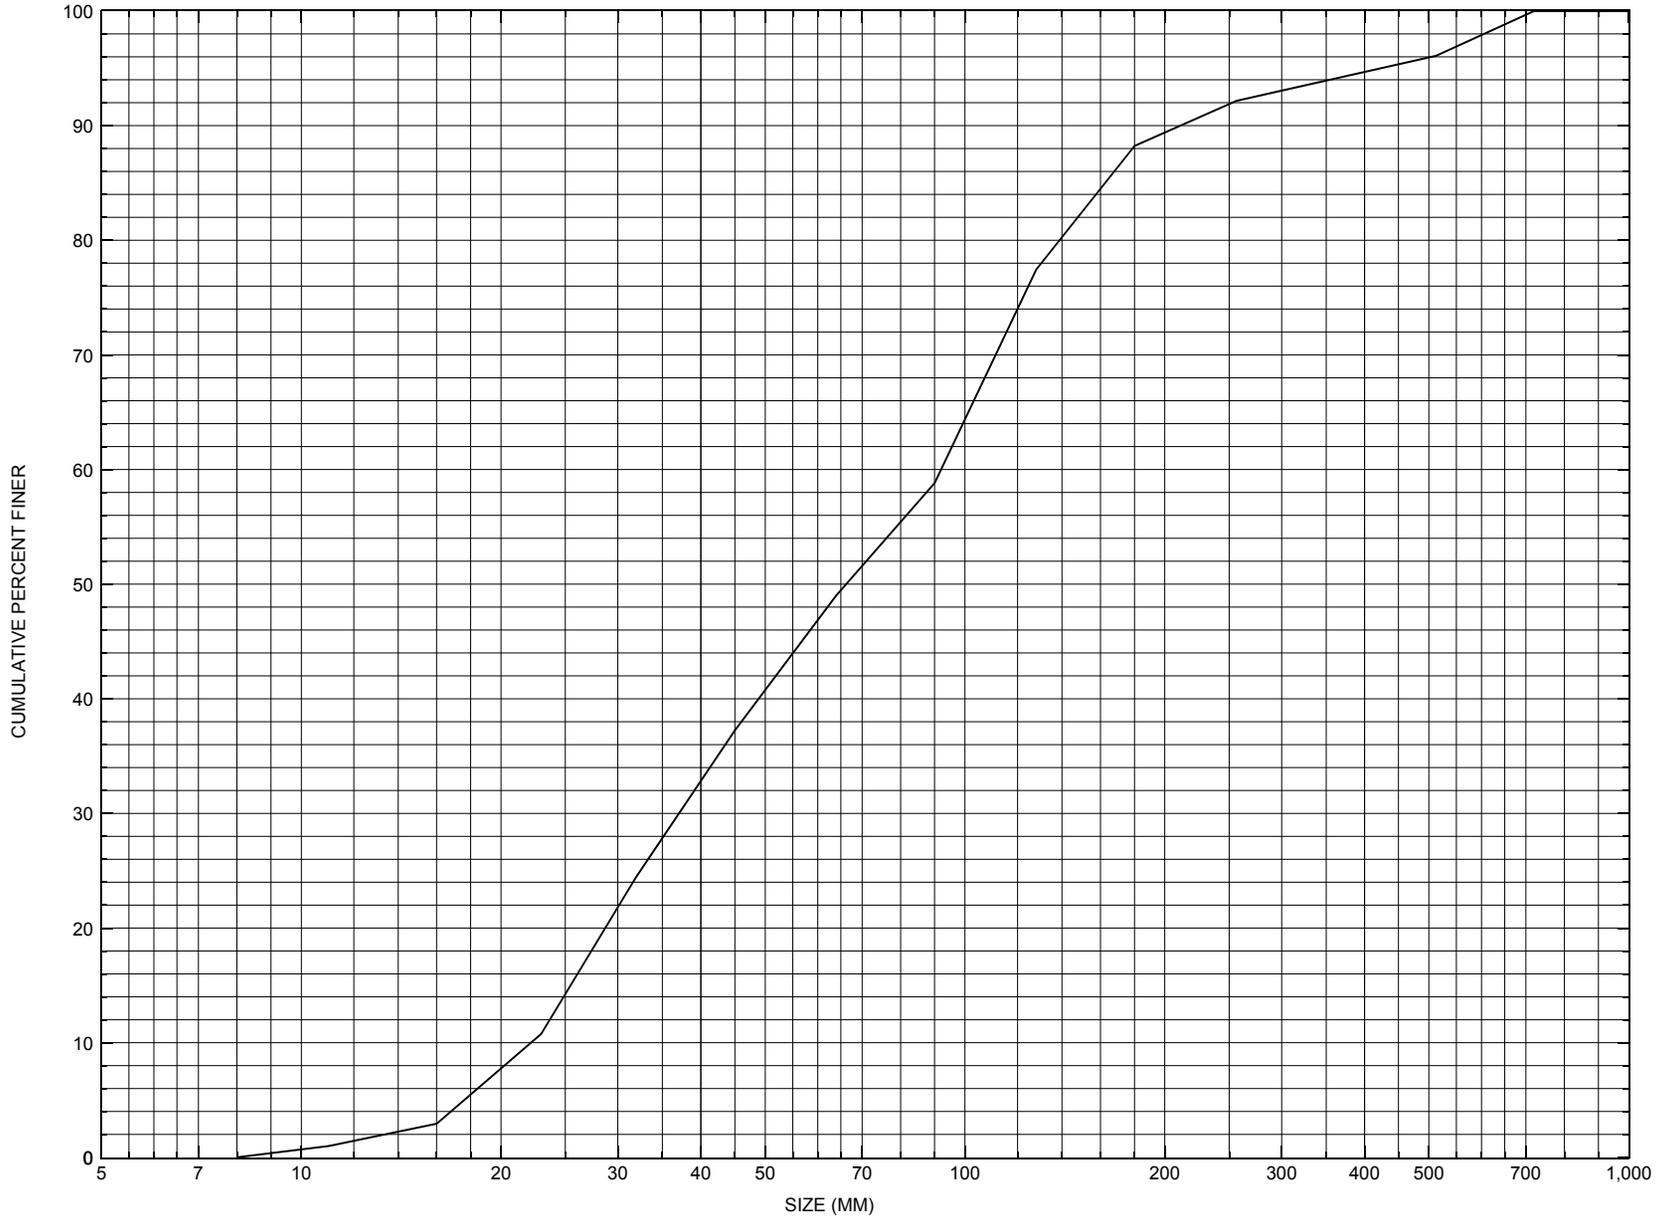
Appendix C. Bed material particle-size distribution for a pebble count in the channel approach of structure SPRITH00060058, in Springfield, Vermont.
