LEVEL II SCOUR ANALYSIS FOR  
BRIDGE 30 (NEWHTH00050030) on  
TOWN HIGHWAY 5, crossing the  
NEW HAVEN RIVER,  
NEW HAVEN, VERMONT

Open-File Report 98-058

By RONDA L. BURNS and EMILY C. WILD

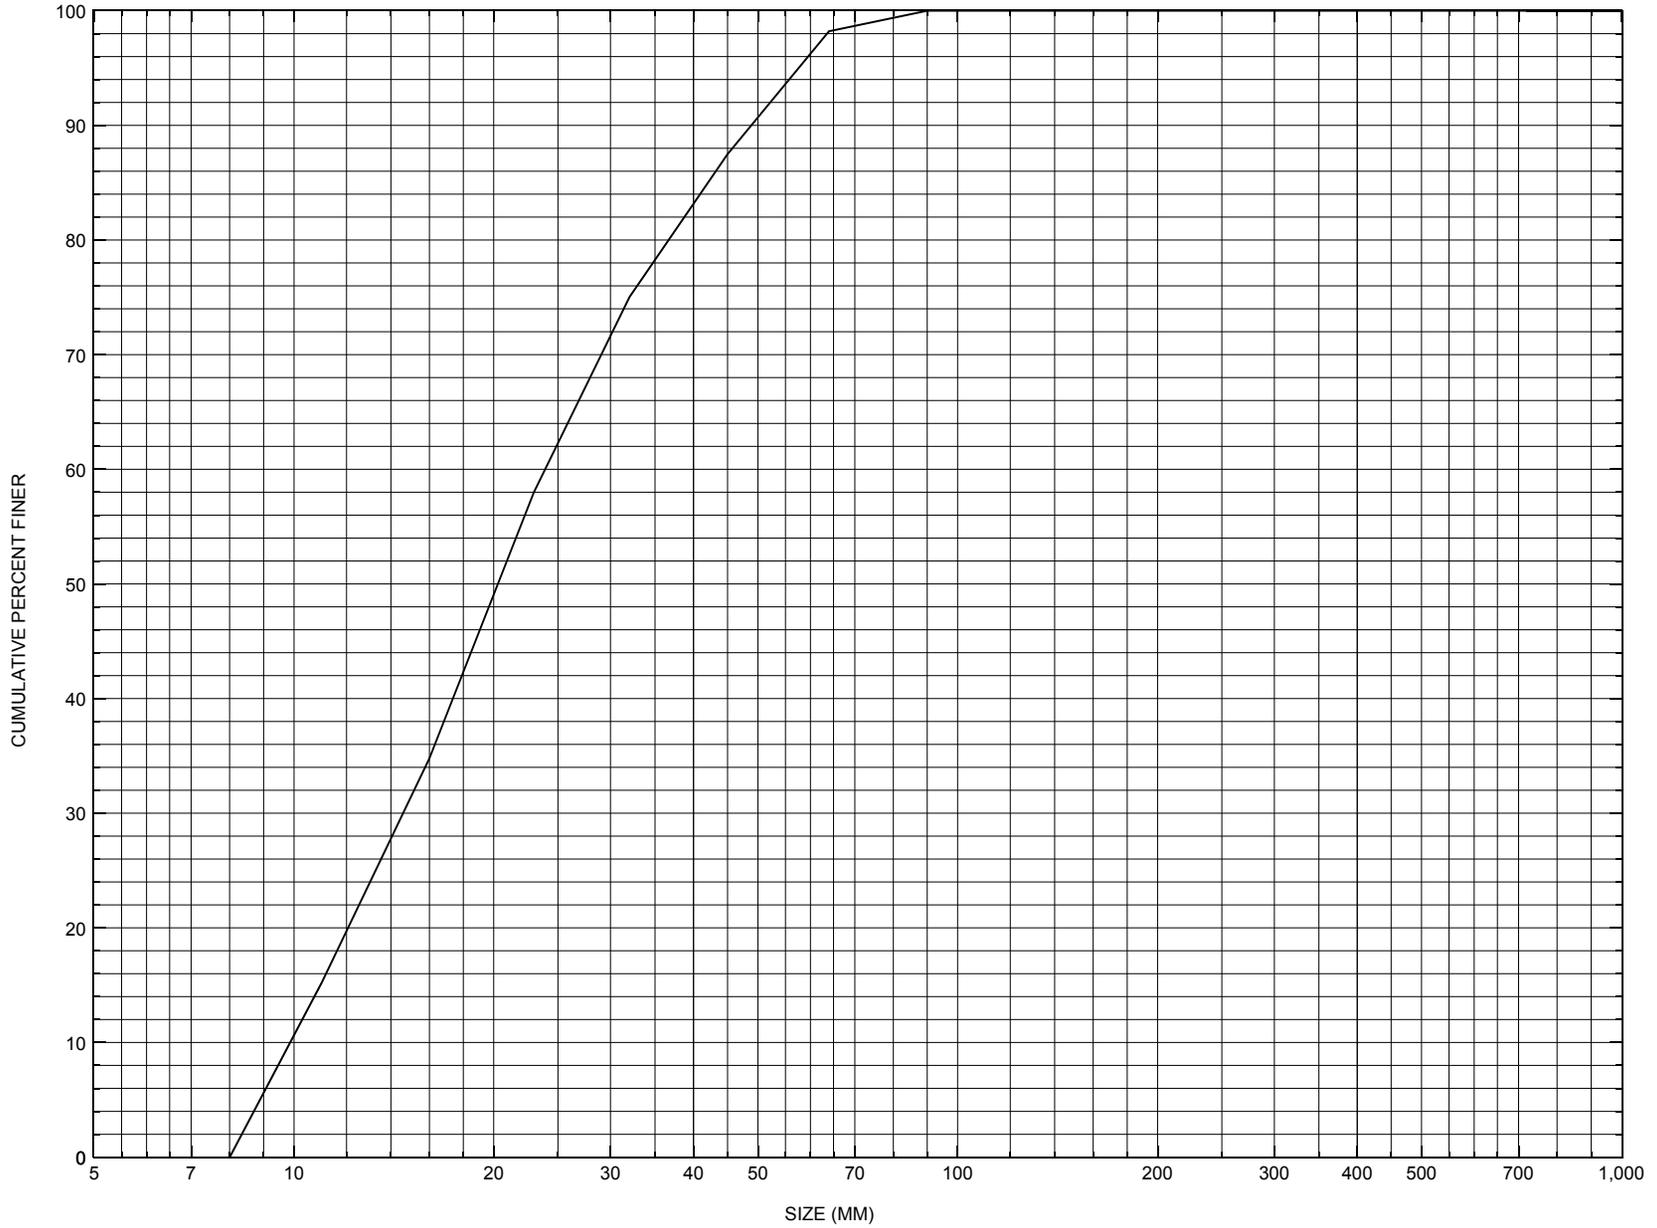
Appendix C. Bed material particle-size distribution for a pebble count in the channel approach of structure NEWHTH00050030, in New Haven, Vermont.
