# LEVEL II SCOUR ANALYSIS FOR BRIDGE 39 (BETHTH00060039) on TOWN HIGHWAY 6, crossing the SECOND BRANCH WHITE RIVER, BETHEL, VERMONT

Open-File Report 98-060

Prepared in cooperation with  
VERMONT AGENCY OF TRANSPORTATION  
and  
FEDERAL HIGHWAY ADMINISTRATION

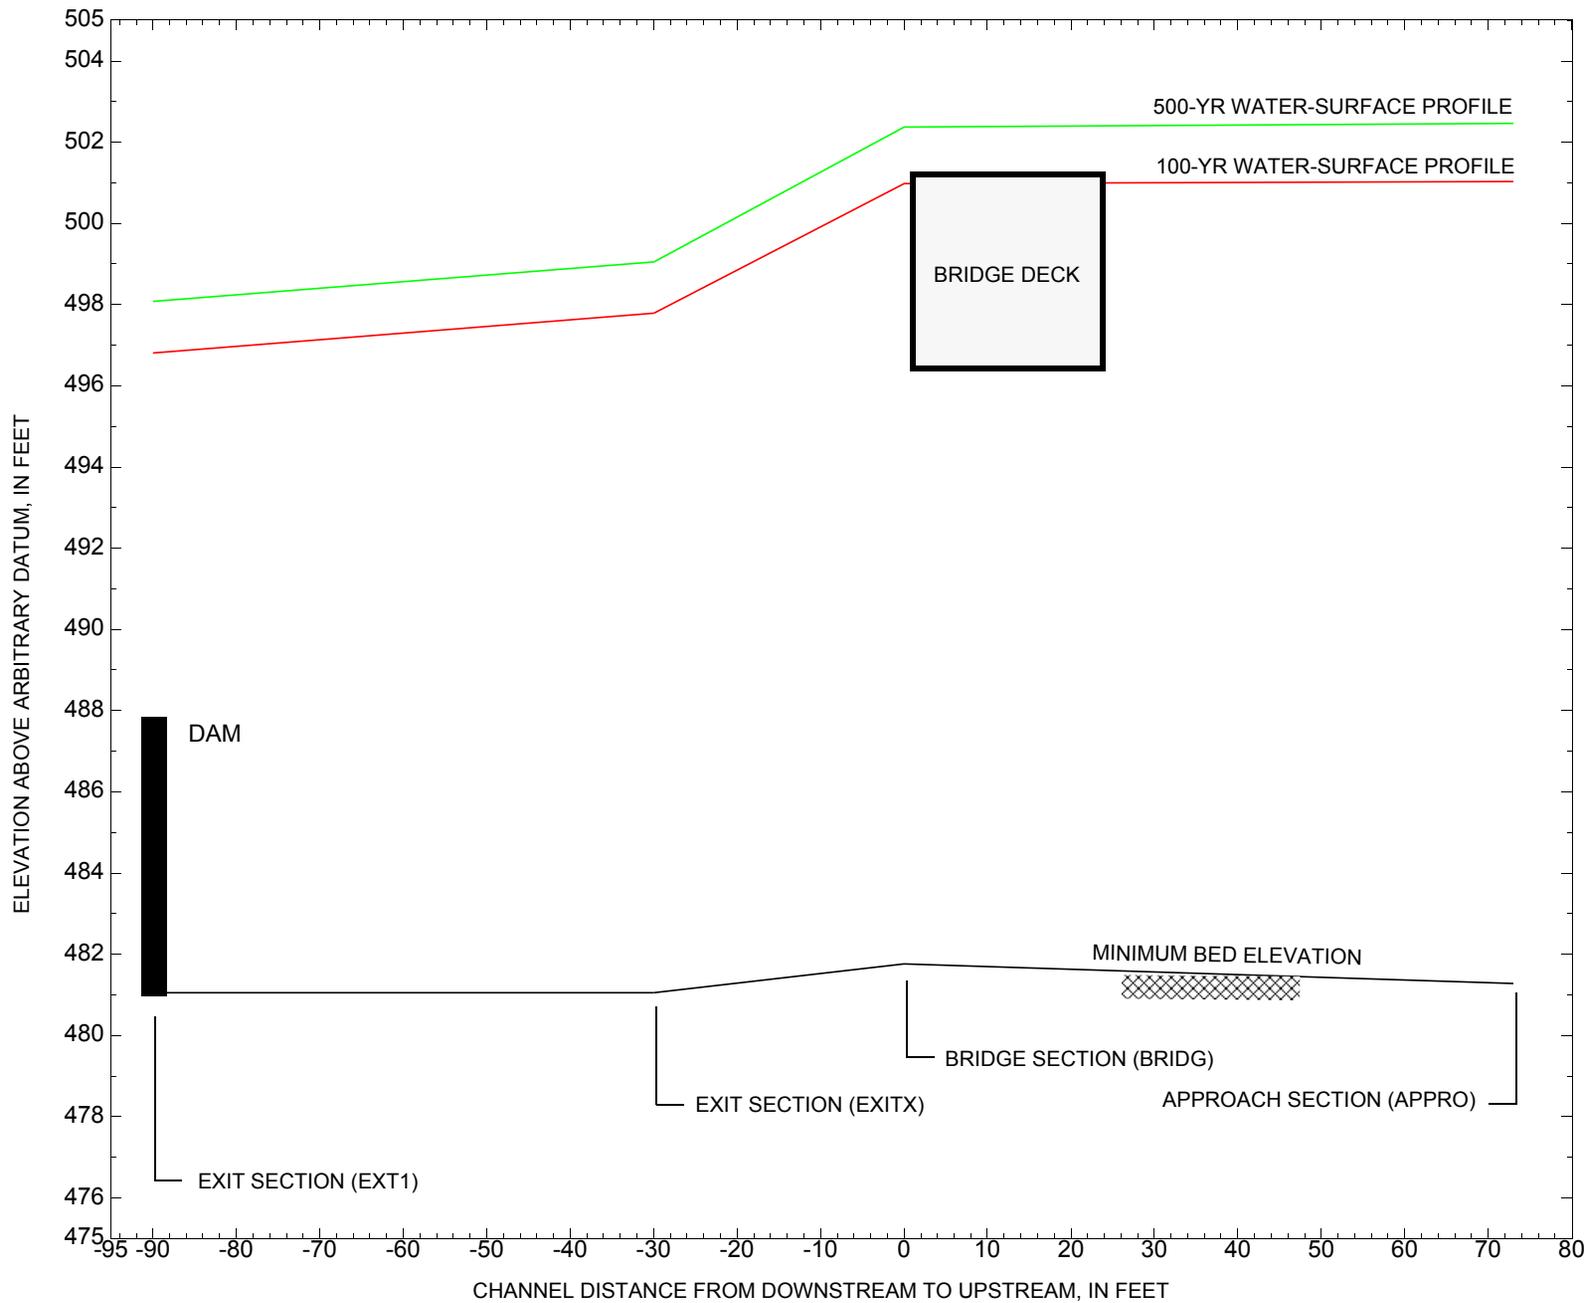
Figure 7. Water-surface profiles for the 100- and 500-year discharges at structure BETHTH00060039 on Town Highway 6, crossing the Second Branch White River, Bethel, Vermont.

Hydraulic analyses of the reach were done by use of the Federal Highway Administration's WSPRO step-backwater computer program (Shearman and others, 1986, and Shearman, 1990). The analyses reported herein reflect conditions existing at the site at the time of the study. Furthermore, in the development of the model it was necessary to assume no accumulation of debris or ice at the site. Results of the hydraulic model are presented in the Bridge Hydraulic Summary, Appendix B, and figure 7.

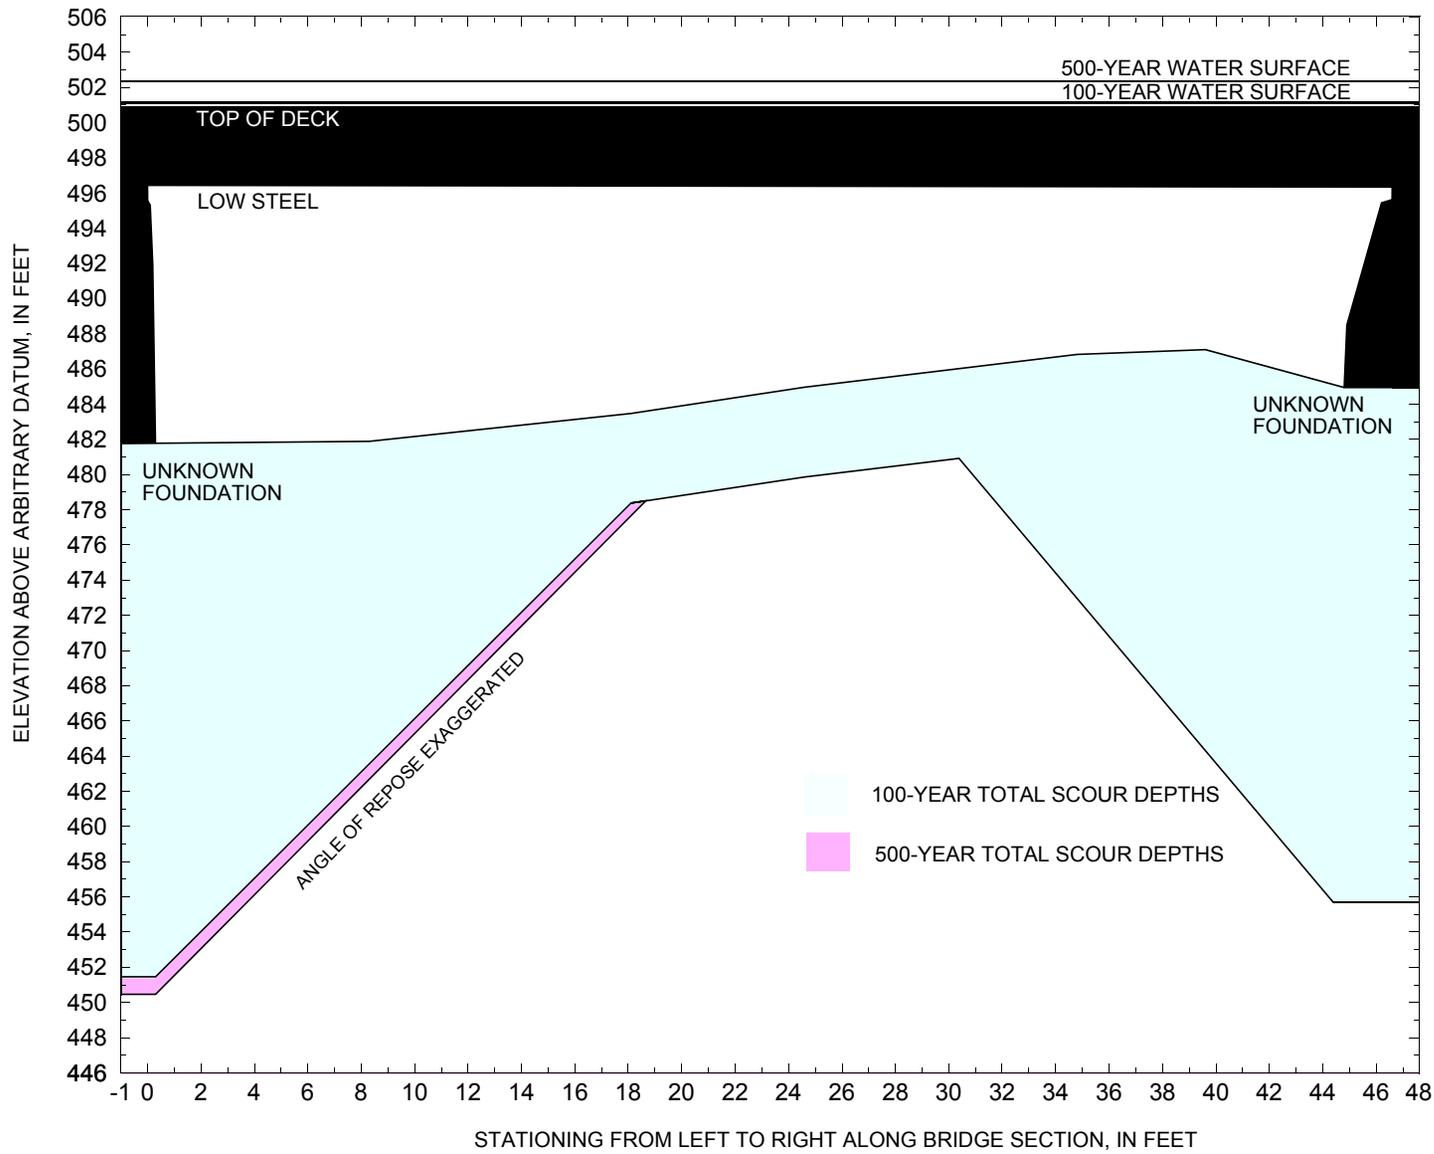
Figure 8. Scour elevations for the 100- and 500-year discharges at structure BETHTH00060039 on Town Highway 6, crossing the Second Branch White River, Bethel, Vermont.

Scour depths were computed using the general guidelines described in Hydraulic Engineering Circular 6 (Richardson and Davis, 1995). Scour depths were calculated assuming an infinite depth of erosive material and a homogeneous particle-size distribution. The results of the scour analysis for the 100- and 500-year discharges are shown in tables 1 and 2 and the scour depths are shown graphically in figure 8.

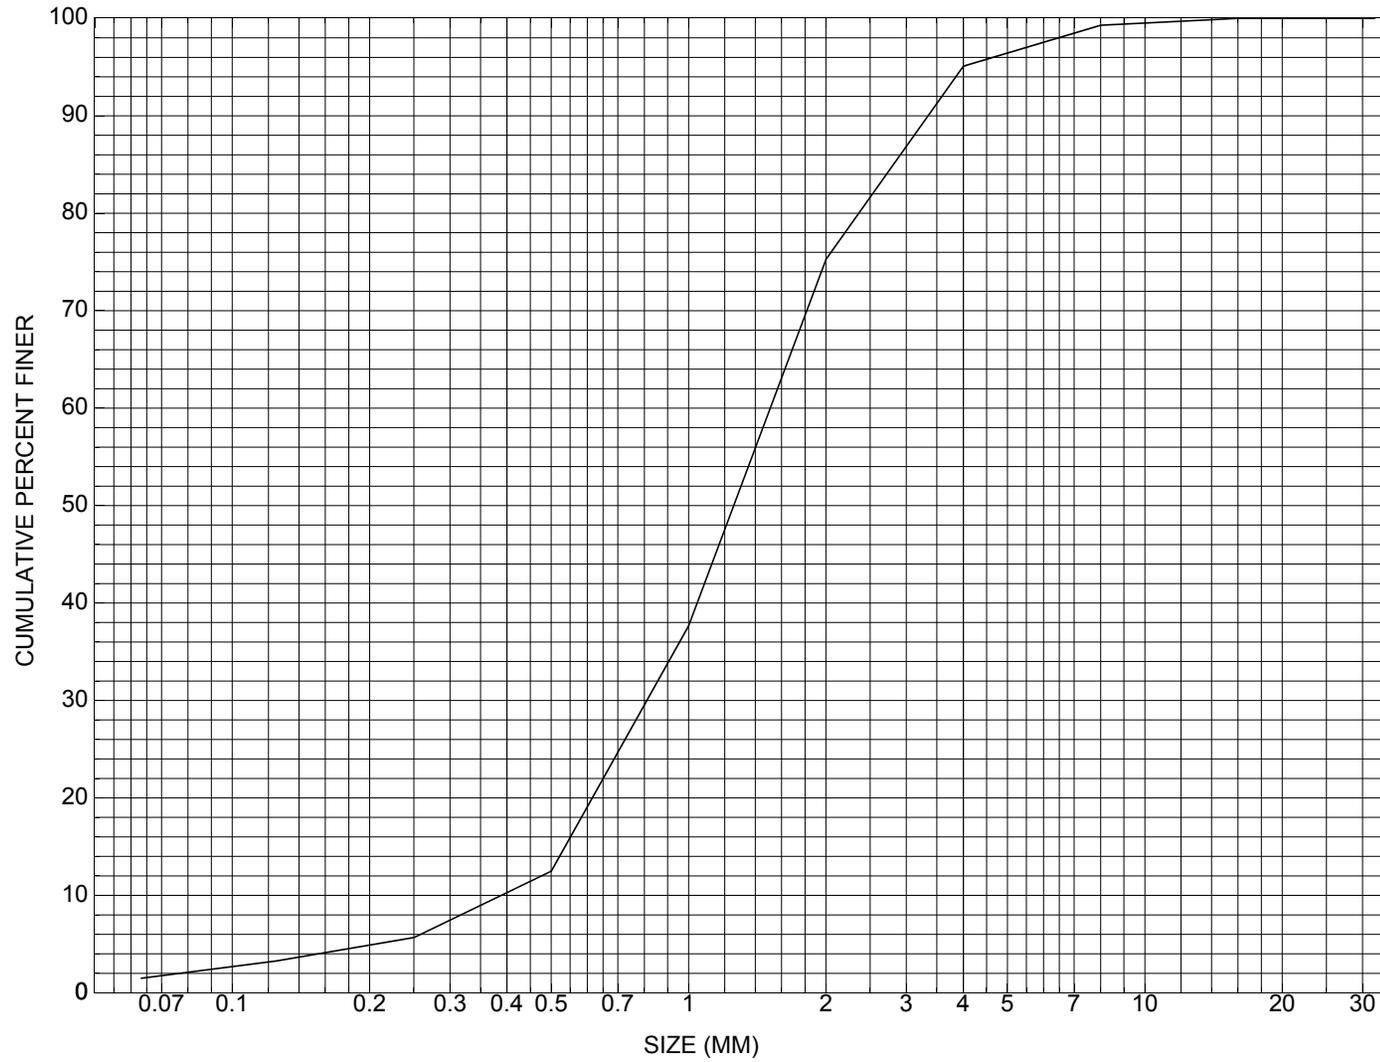
Appendix C. Bed material particle-size distribution for sediment sample from the channel approach of structure BETHTH00060039, in Bethel, Vermont.
