LEVEL II SCOUR ANALYSIS FOR BRIDGE 35 (ANDOVTT00110035) on STATE ROUTE 11, crossing the MIDDLE BRANCH WILLIAMS RIVER, ANDOVER, VERMONT

Open-File Report 98-87

Prepared in cooperation with
VERMONT AGENCY OF TRANSPORTATION
and
FEDERAL HIGHWAY ADMINISTRATION

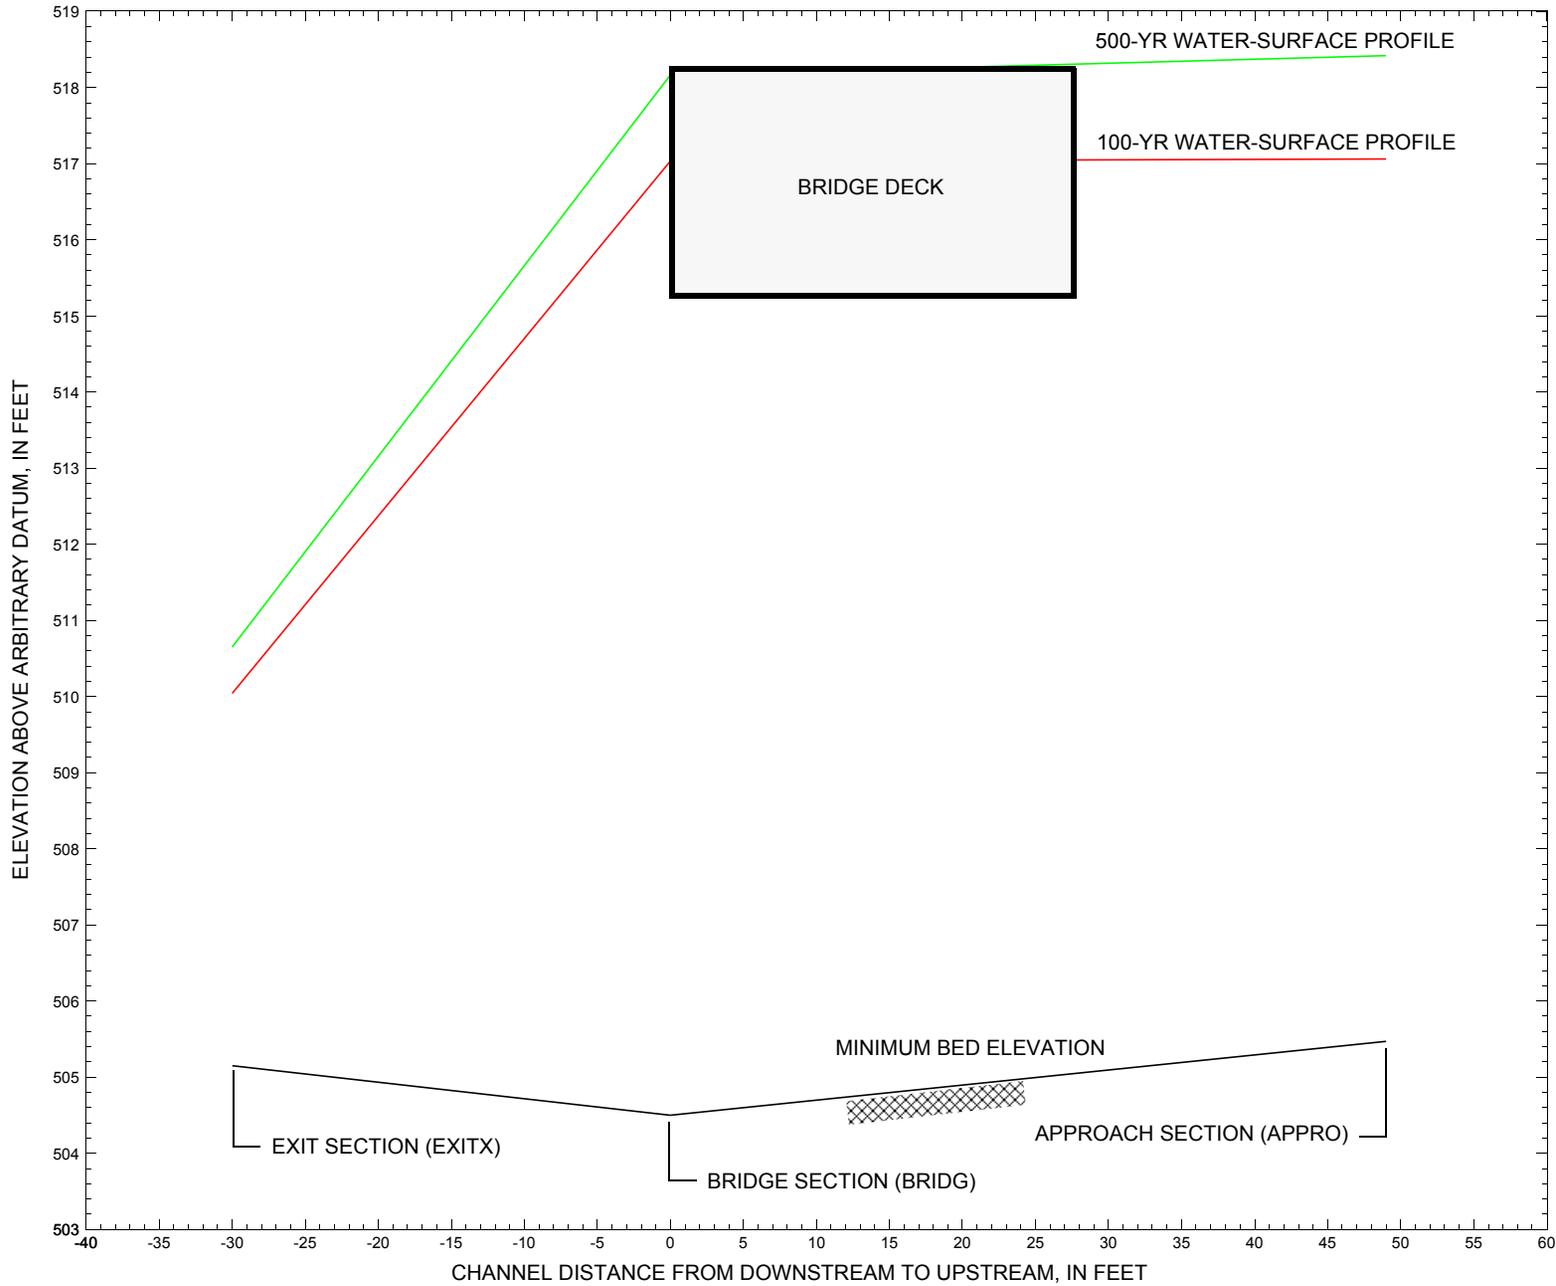
Figure 7. Water-surface profiles for the 100- and 500-yr discharges at structure ANDOVT00110035 on State Route 11, crossing the Middle Branch Williams River, Andover, Vermont.

Hydraulic analyses of the reach were done by use of the Federal Highway Administration's WSPRO step-backwater computer program (Shearman and others, 1986, and Shearman, 1990). The analyses reported herein reflect conditions existing at the site at the time of the study. Furthermore, in the development of the model it was necessary to assume no accumulation of debris or ice at the site. Results of the hydraulic model are presented in the Bridge Hydraulic Summary, appendix B, and figure 7.

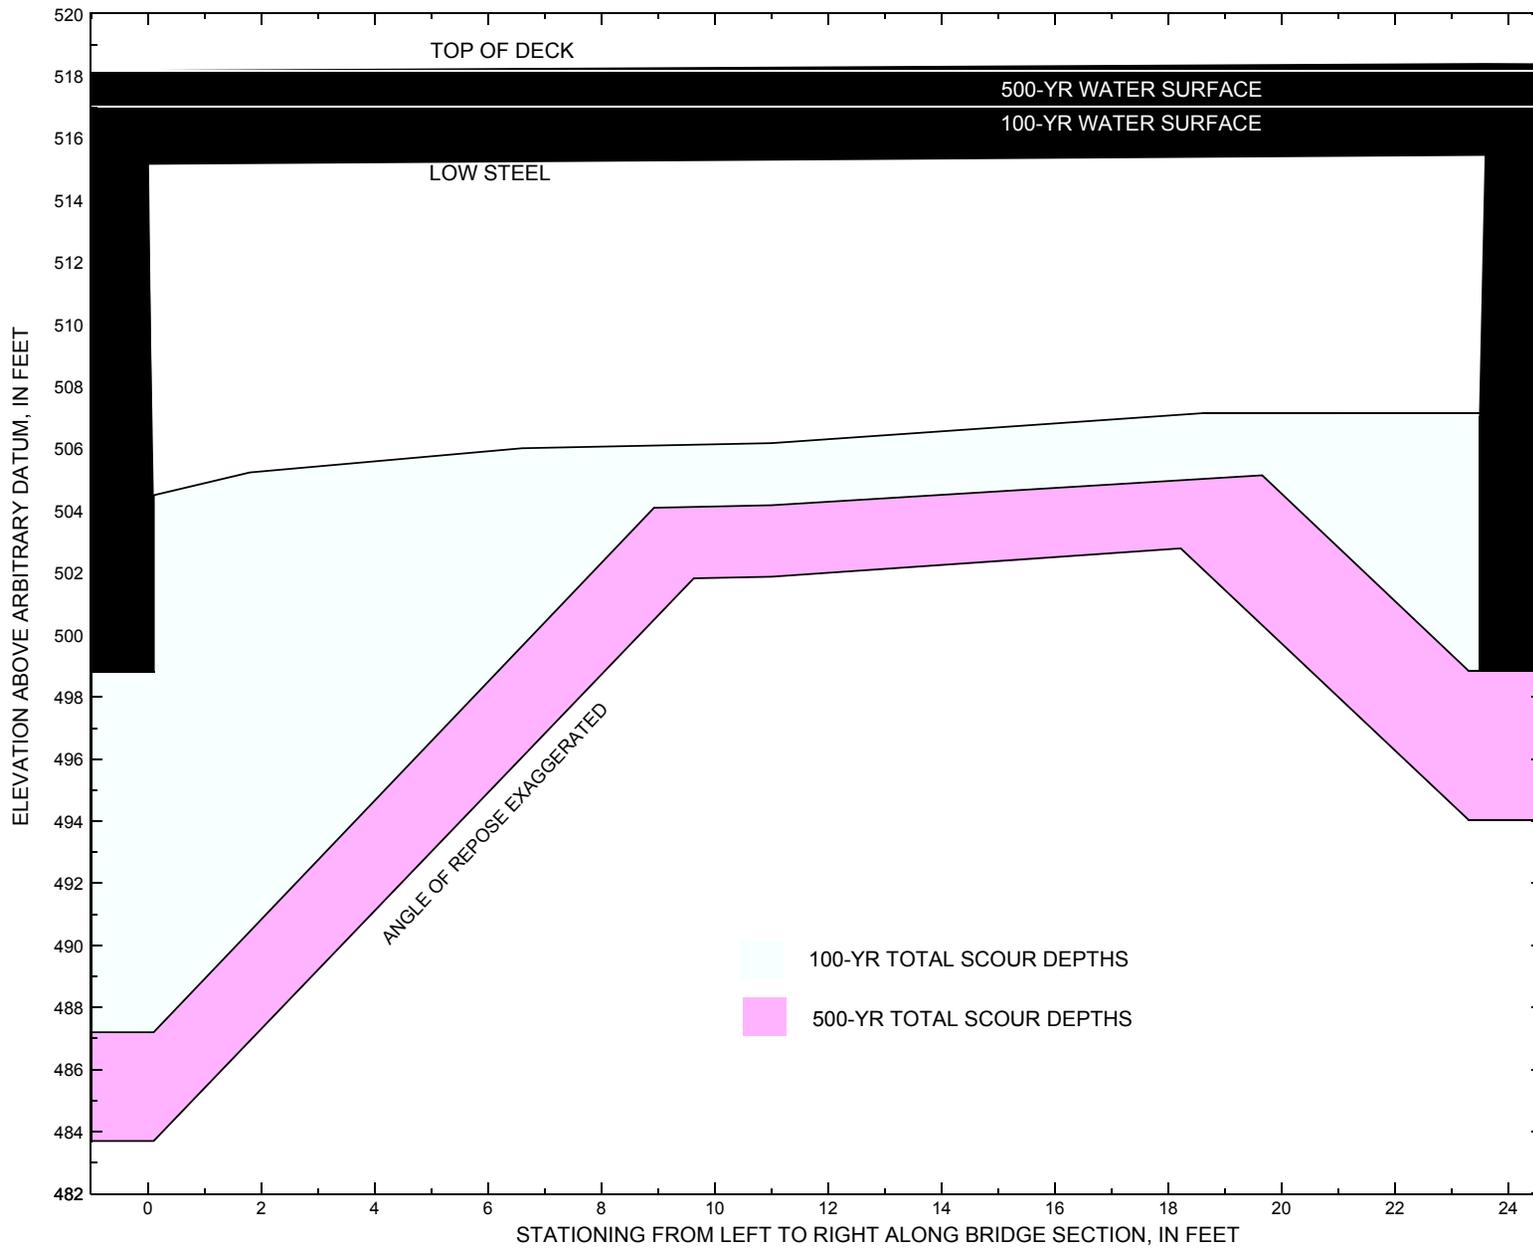
Figure 8. Scour elevations for the 100- and 500-yr discharges at structure ANDOVT00110035 on State Route 11, crossing the Middle Branch Williams River, Andover, Vermont.

Scour depths were computed using the general guidelines described in Hydraulic Engineering Circular 18 (Richardson and Davis, 1995). Scour depths were calculated assuming an infinite depth of erosive material and a homogeneous particle-size distribution. The results of the scour analyses for the 100- and 500-year discharges are presented in tables 1 and 2 and the scour depths are shown graphically in figure 8.

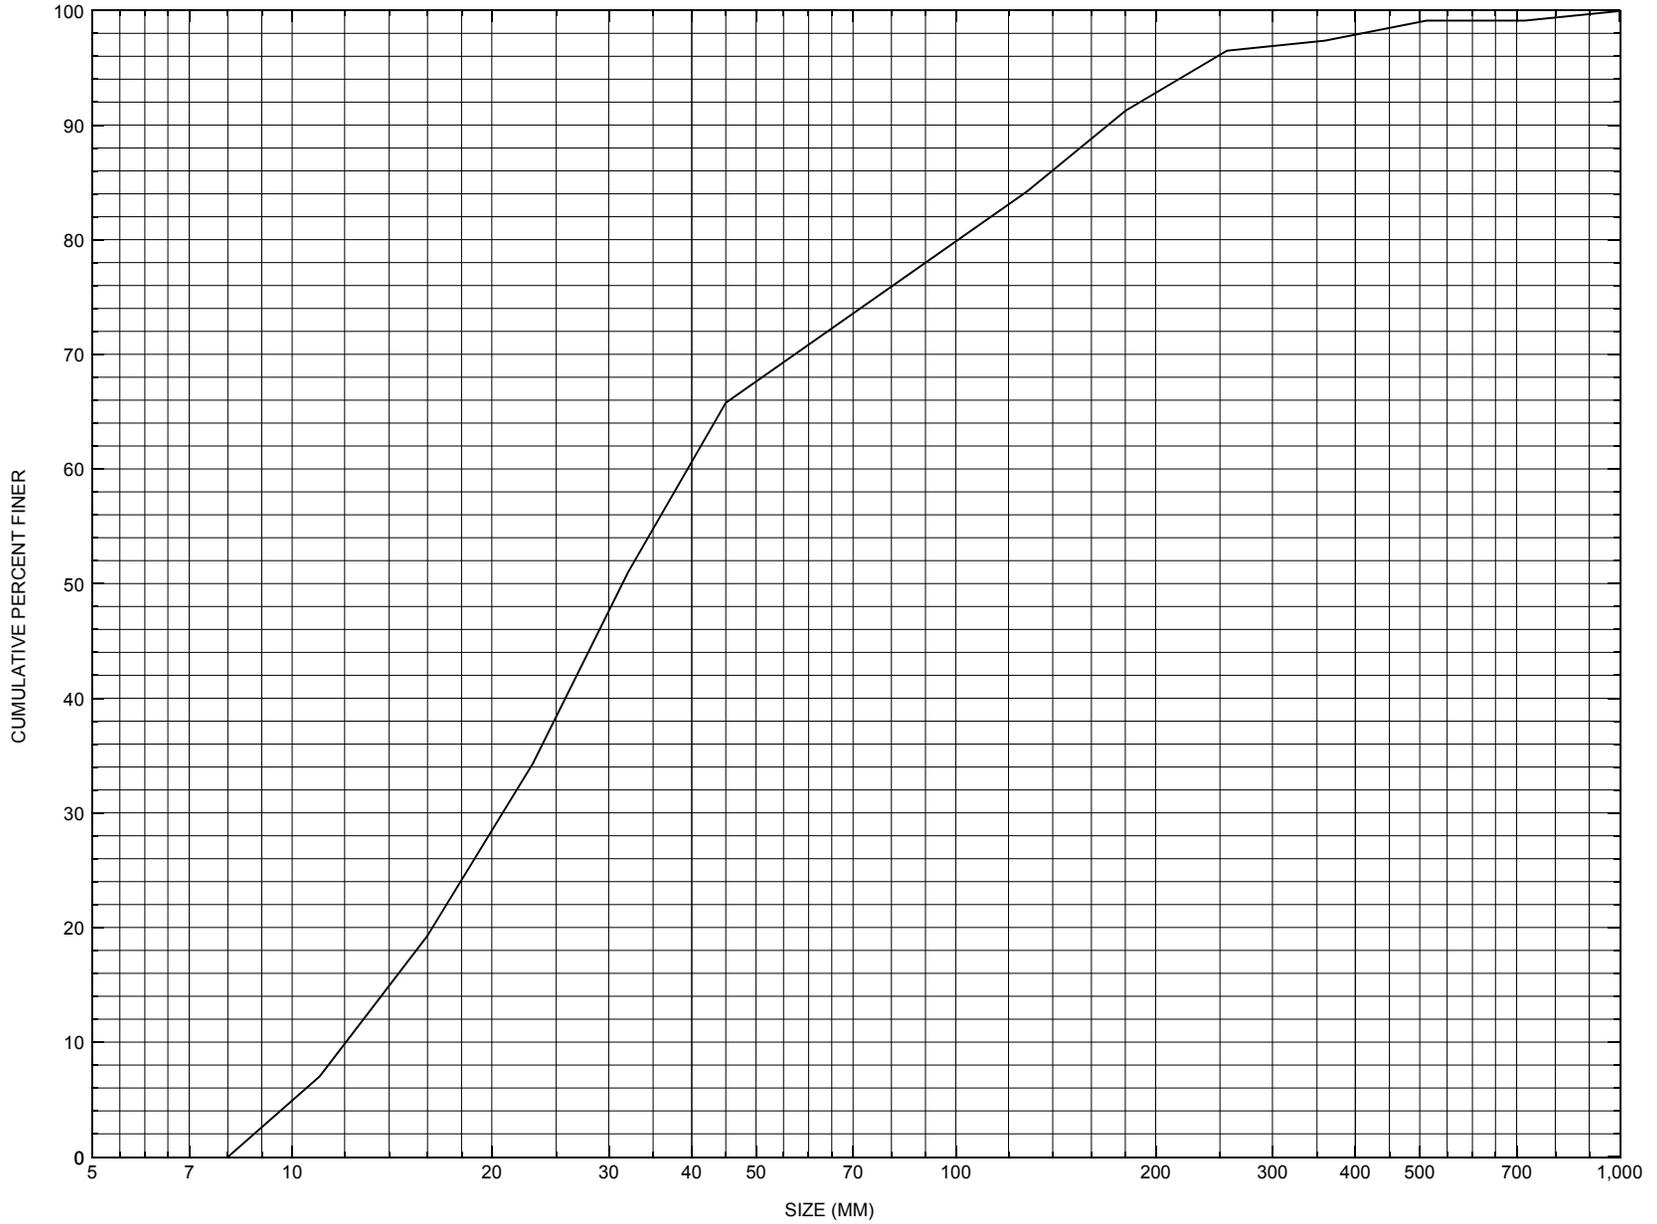
Appendix C. Bed material particle-size distribution for a pebble count in the channel approach of structure ANDOVT00110035, in Andover, Vermont.
