History of Movement of the Clear Creek Forks Landslide, Clear Creek County, Colorado

Open-File Report 98-150

Abstract: The Clear Creek Forks landslide near Central City, Colorado, threatens a major highway junction in Colorado's Front Range. Movement of the landslide was first reported during the mid-1940's when highway engineers noted deformation in bridges at the base of the landslide. Displacements of fixed points on the landslide have been surveyed at various times over the past 46 years. Displacement rates ranged up to 0.6 m/yr in the early 1950's but currently appear to be decreasing or negligible. However, ongoing reconfiguration of the highway junction, and planned removal of a bridge at the base of the landslide in the spring of 1998, raise the possibility of renewed movement.

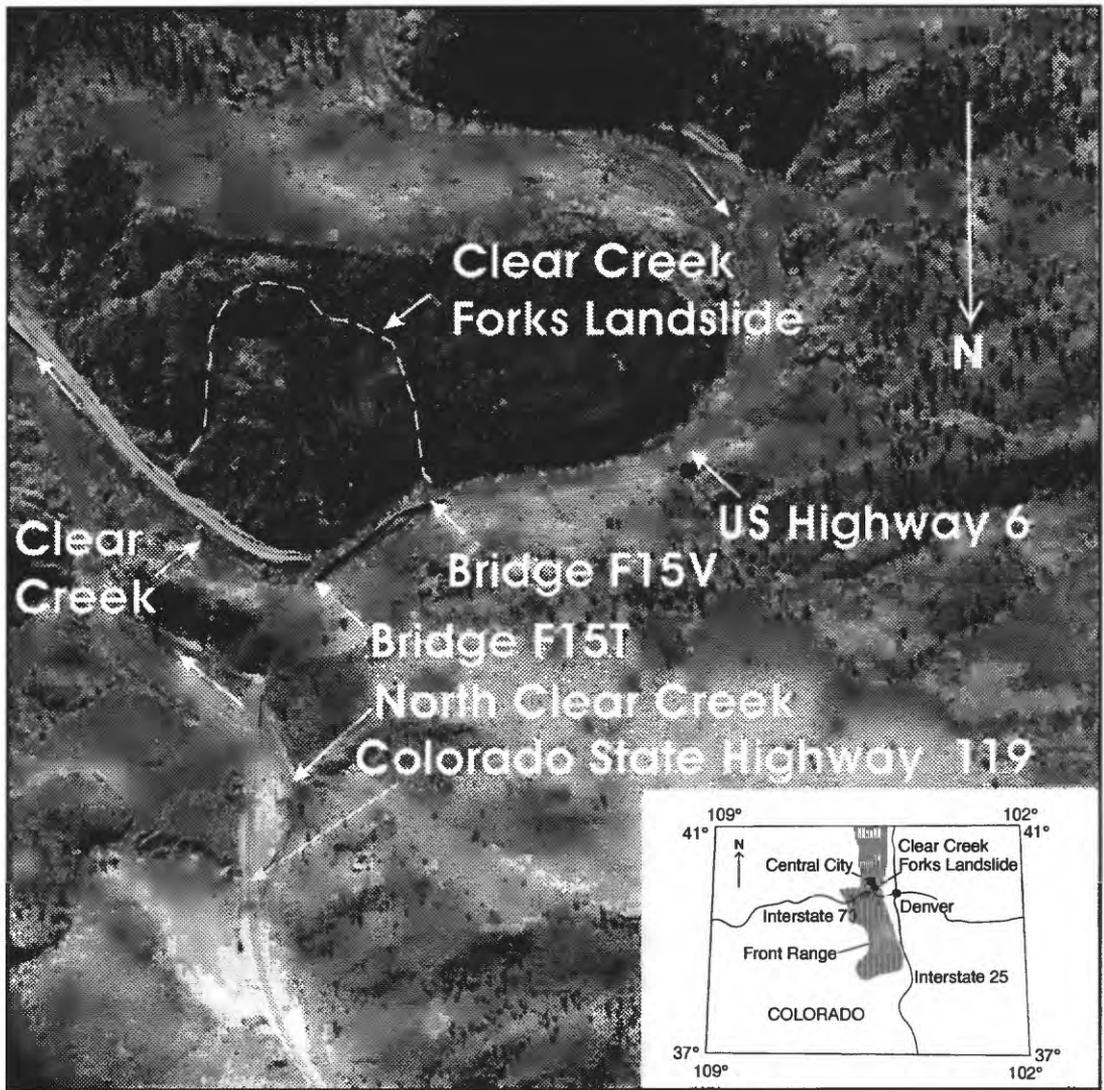
Figure 1. Aerial view of the Clear Creek Forks landslide, the west part of the junction of U.S. Highway 6 and Colorado State Highway 119, and the confluence of Clear Creek and North Clear Creek. Small, white arrows in streams indicate direction of flow.

The Clear Creek Forks landslide is an unstable rock and colluvial slope at the junction of U.S. Highway 6 and Colorado State Highway 119 in Clear Creek County, Colorado (Fig. 1). The bedrock is gneiss of Precambrian age (Sheridan and Marsh, 1976). The foliation is locally irregular, but in the vicinity of the slide it generally strikes west and dips north at about the same angle as the surface of the ground (Fig. 2). This is probably the primary geologic factor influencing stability of the slope.

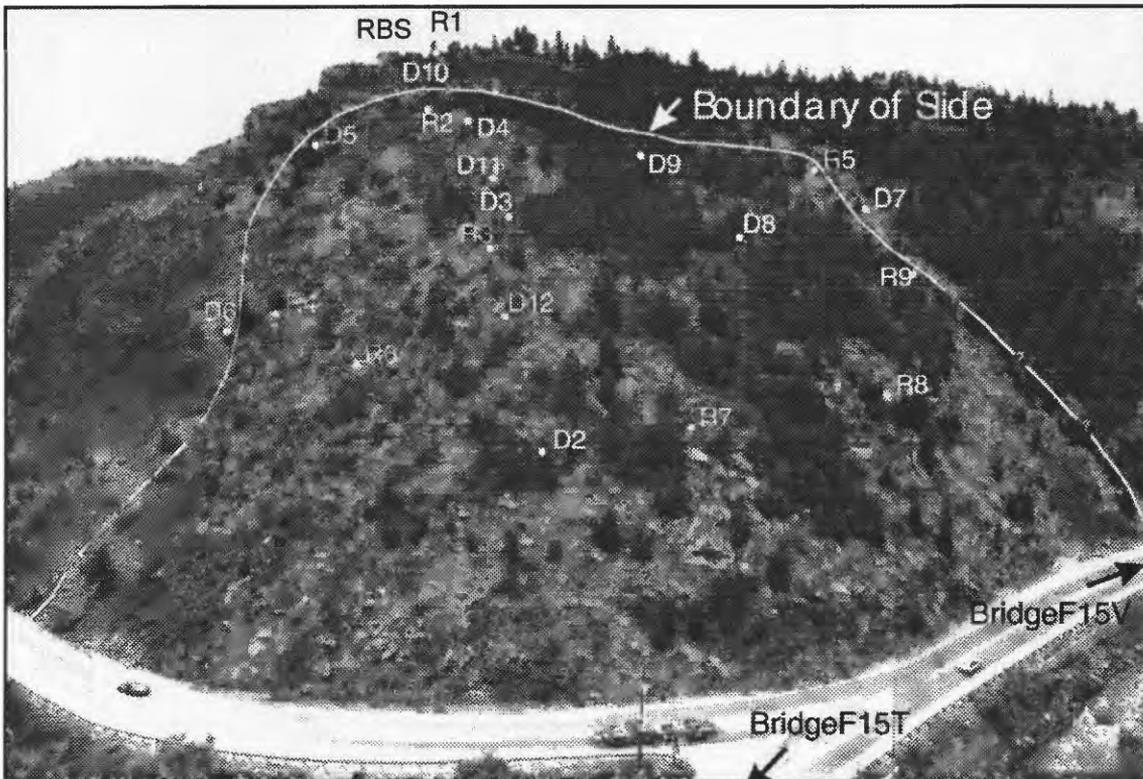
Figure 2. Photo-mosaic showing the landslide boundary and surveyed points. View is to the south. Scale varies in this perspective view. Vehicles on road give scale of foreground. Distances from the road to the top of the ridge are about 150 m vertical and 240 m horizontal. Photos taken May 31, 1996, by J.A. Coe.

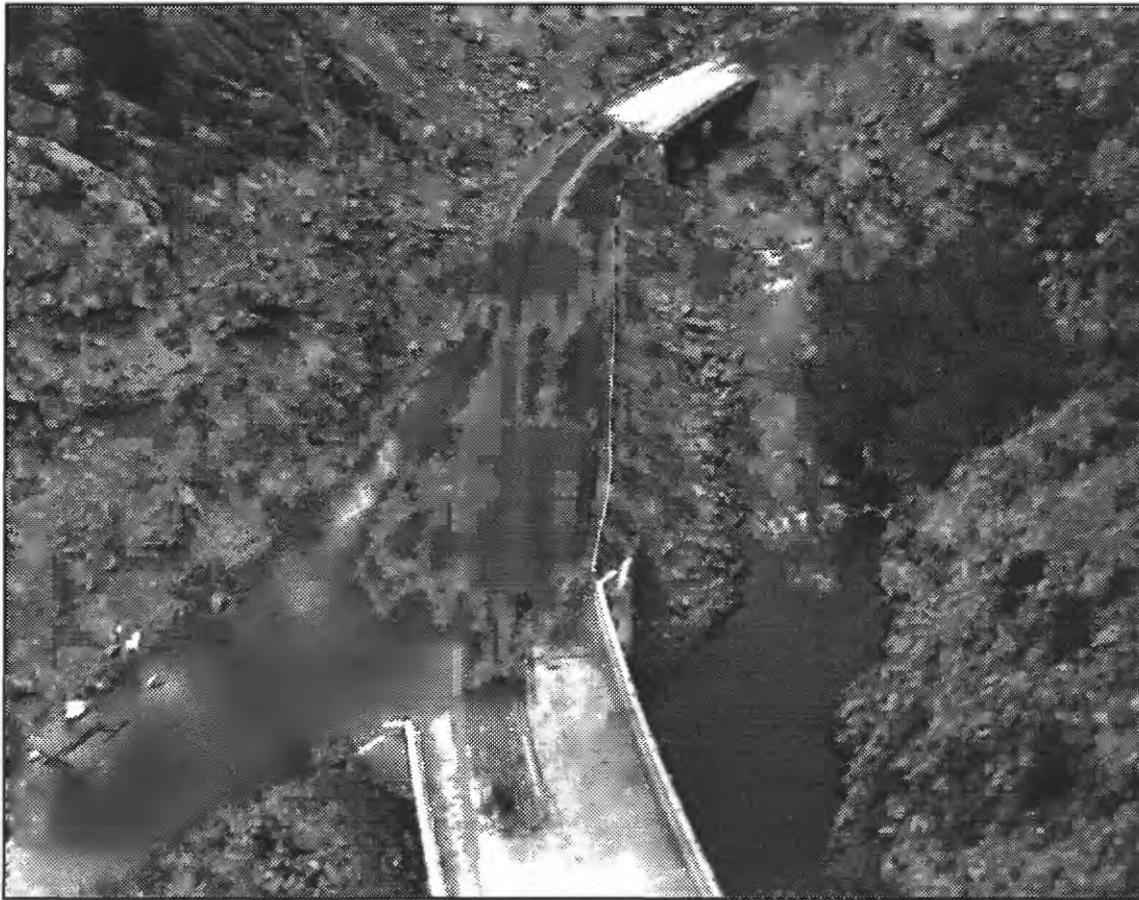
Figure 3. View of deformation in State Highway 119 (now named U.S. Highway 6) and deformation of guardrail between bridge F15T, lower center, and bridge F15V, top. Photo taken October 1951, by D.J. Varnes.

Movement of the landslide was first reported during the mid-1940's when highway engineers noted deformation in the highway (Fig. 3) and in bridges F15T and F15V (built in the late 1930's) spanning Clear Creek at the base of the landslide (D.J. Varnes, U.S. Geological Survey, unpub. report 1952). The bridge deformation, which was clearly related to movement of the landslide, was expressed by cracking of the abutments, northward tilting of the rockers (Fig. 4) supporting the bridge stringers, and complete closure of the original 7-9 cm clearance between ends of the stringers and the abutments of both bridges. During redecking of bridge F15T in 1985 the tipped rockers supporting the stringers were completely encased in new concrete, and cracks in abutments and wing walls were repaired (Lou Kingsley, CDOT, pers. commun. 3/24/98). As part of the ongoing highway reconfiguration, it is planned that the north abutment, stringers, and decking of bridge F15T will be removed in the spring of 1998.

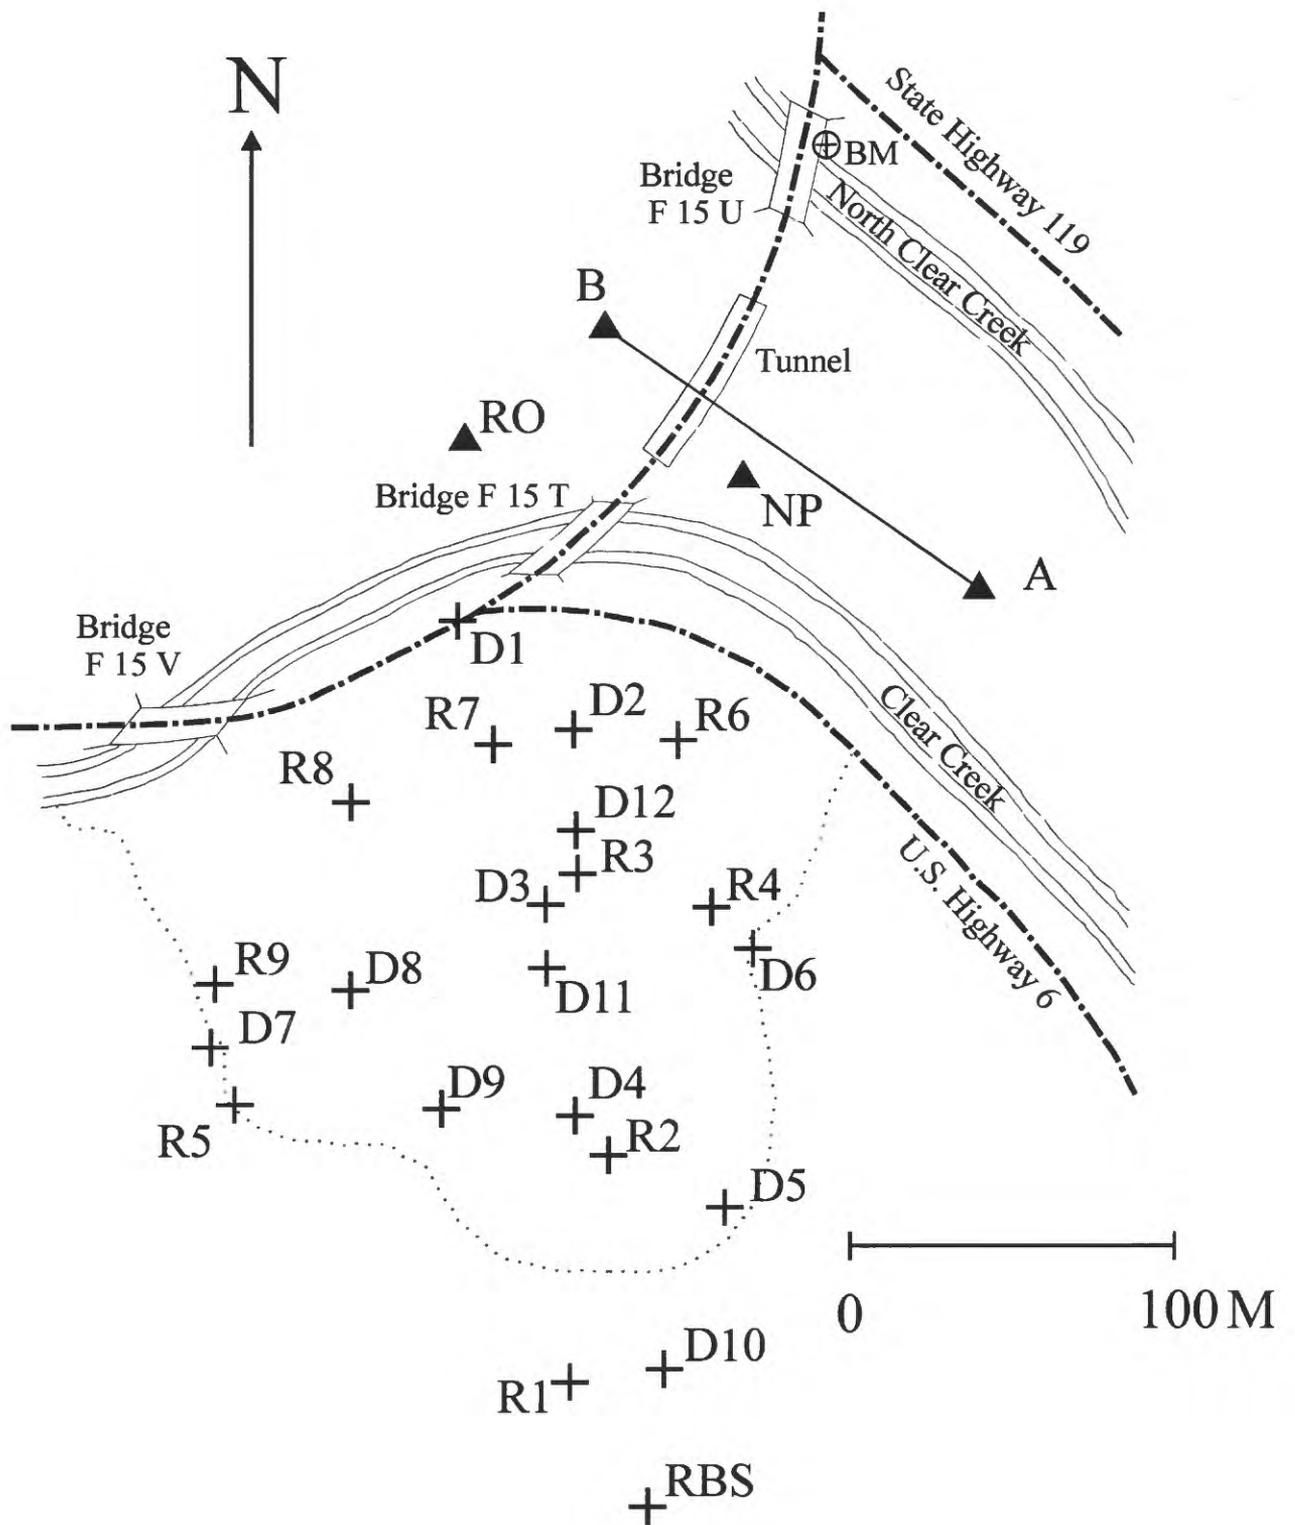
Figure 5. Map showing landslide boundary, triangulation baseline (line between points A and B), and survey points on the landslide (D and R points). Points NP, RO, and RBS have been used as base and backsight points for theodolite and EDM surveys in the 1980's and 1990's.

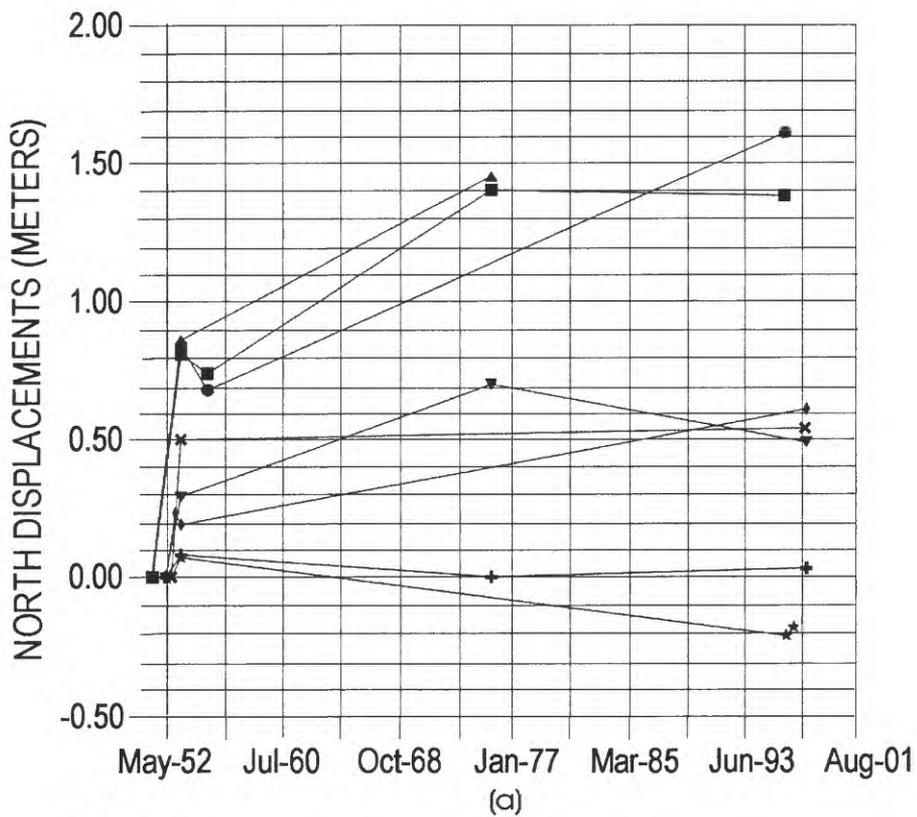
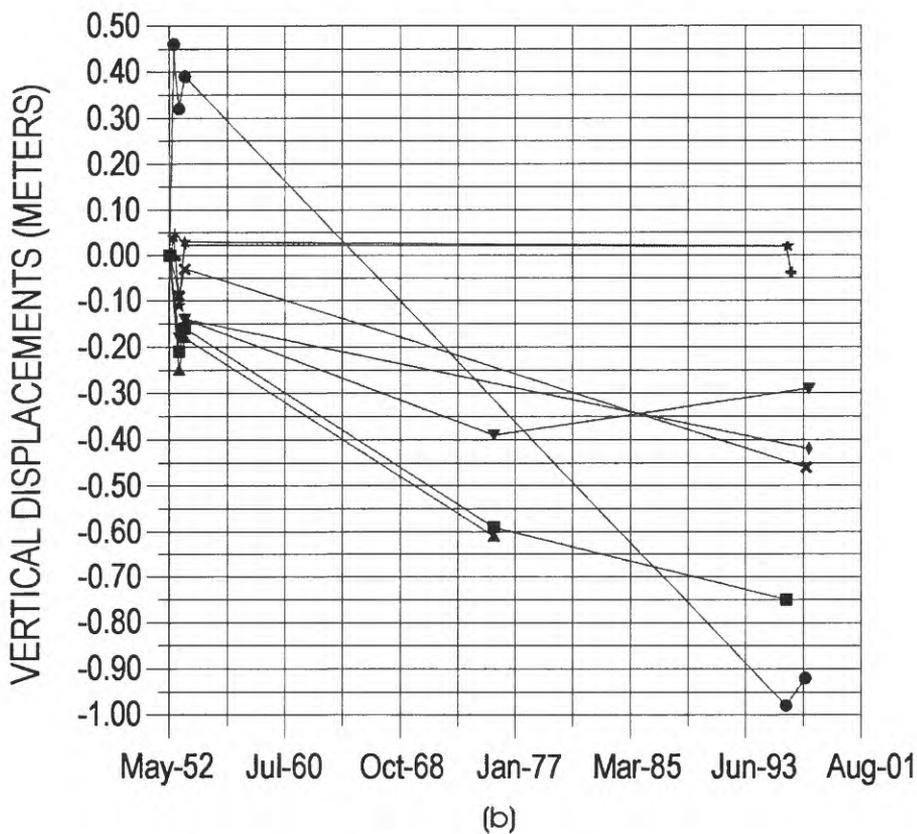
Figure 6. North (a) and vertical (b) components of displacements of "D" survey points. Total cumulative displacements to the east over the entire monitoring period (46 years) are all less than 0.2 m and are not shown.

Measured displacements provide, for some points, a 46-year record of movement and reveal that the landslide has moved down and generally toward the north. The measured displacement data are given in Tables 1, 2, and 3, and shown graphically in Figures 6, 7, and 8. Points with labels beginning with D have the longest record of survey observations, from 1951 to 1997. Measured displacements of D points with complete sets of survey observations (points D2, D5, and D6 in Fig. 6a, and D2 and D5 in Fig. 6b), suggest that most of the horizontal and vertical movement occurred prior to 1976. Displacement of D points to the north over the 25-year period prior to 1976, ranged from near zero for points D6 and D10 on or outside the boundary of the landslide, to about 1.5 m for points D2 and D3 along the central portion of the slide. About half of the total cumulative, pre-1976, north displacements occurred in the first years of monitoring (1951-52). Present rates of north displacement of D points appear to have decreased or become negligible (Fig. 6a). Vertical displacements are 50-70% of corresponding north displacements and show a similar decreasing trend (Fig. 6b). The post-1976 record of movement is further documented by displacements of R points (Fig. 7), which were set in 1987. At first glance, it appears that R points have been displaced to the

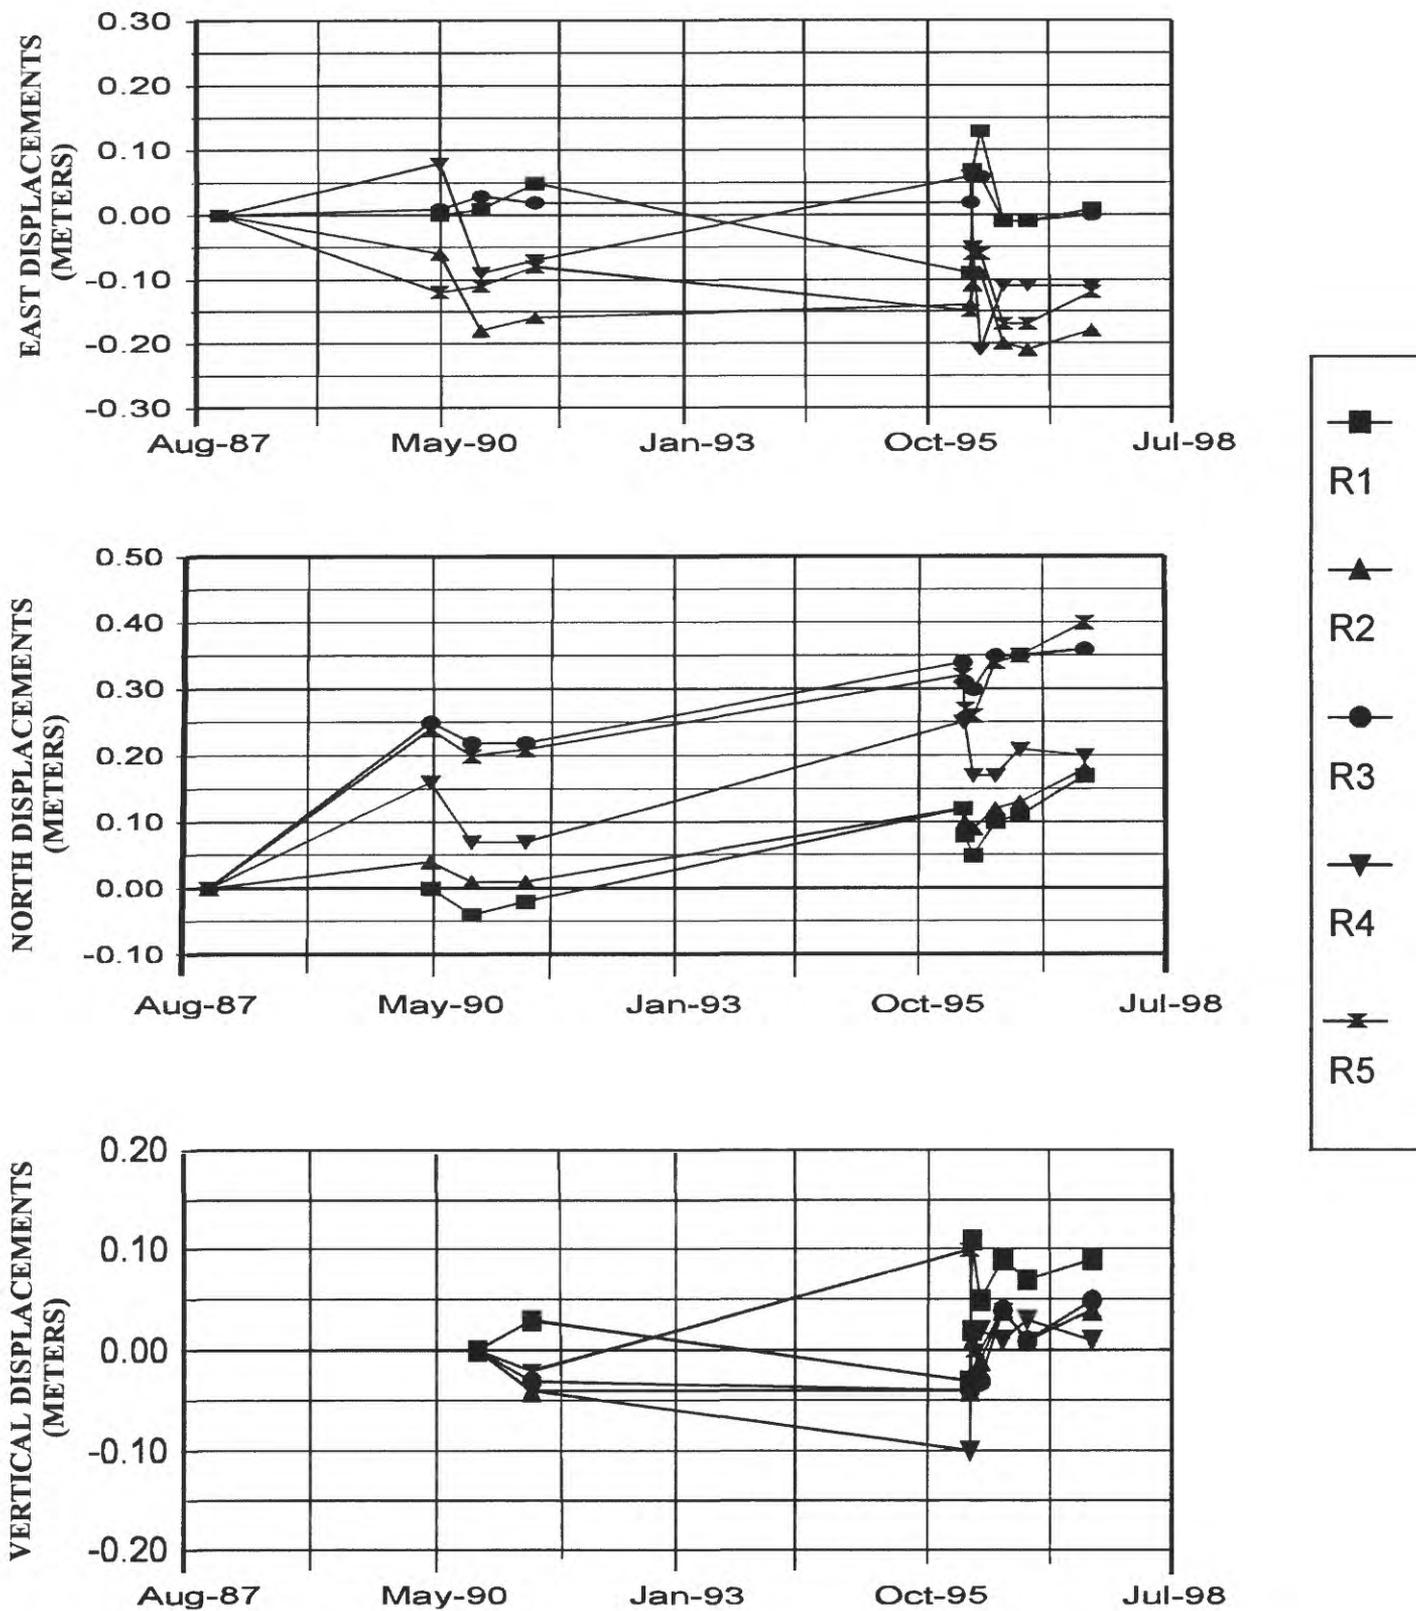
Figure 7. Displacements of "R" survey points. Displacements of points R6-R9 are not shown because only one set of survey observations (1997) currently exists.

north by as much as 0.4 m, and to the east and vertically downward by as much as 0.2 m. However, surveying observations before 1996 were made using a total station and hand-held range rod, whereas observations after 1996 were predominantly made using more accurate GPS techniques. Taking observing errors into account, we conclude that since 1987 the east and vertical displacements are near zero, and that north displacements are in the 0.15- to 0.25-m range.

This report documents roughly 46 years of movement at the Clear Creek Forks landslide from a series of measurements made in the 1950's, 1970's and 1990's. Movement was first recognized in the mid-1940's, shortly after excavation for the current alignment of U.S. Highway 6 at the base of the landslide. Measurements of displacements of fixed survey points were begun in the early 1950's. Within the first 2 years of monitoring (1951-52), displacements of points along the central portion of the landslide reached a maximum of about 0.6 m/yr. Since 1952, movement rates of the landslide (as indicated by the D points in Fig. 6) have decreased. Movement rates since 1987 (as indicated by R points in Fig. 7) have generally been less than 0.03 m/yr.

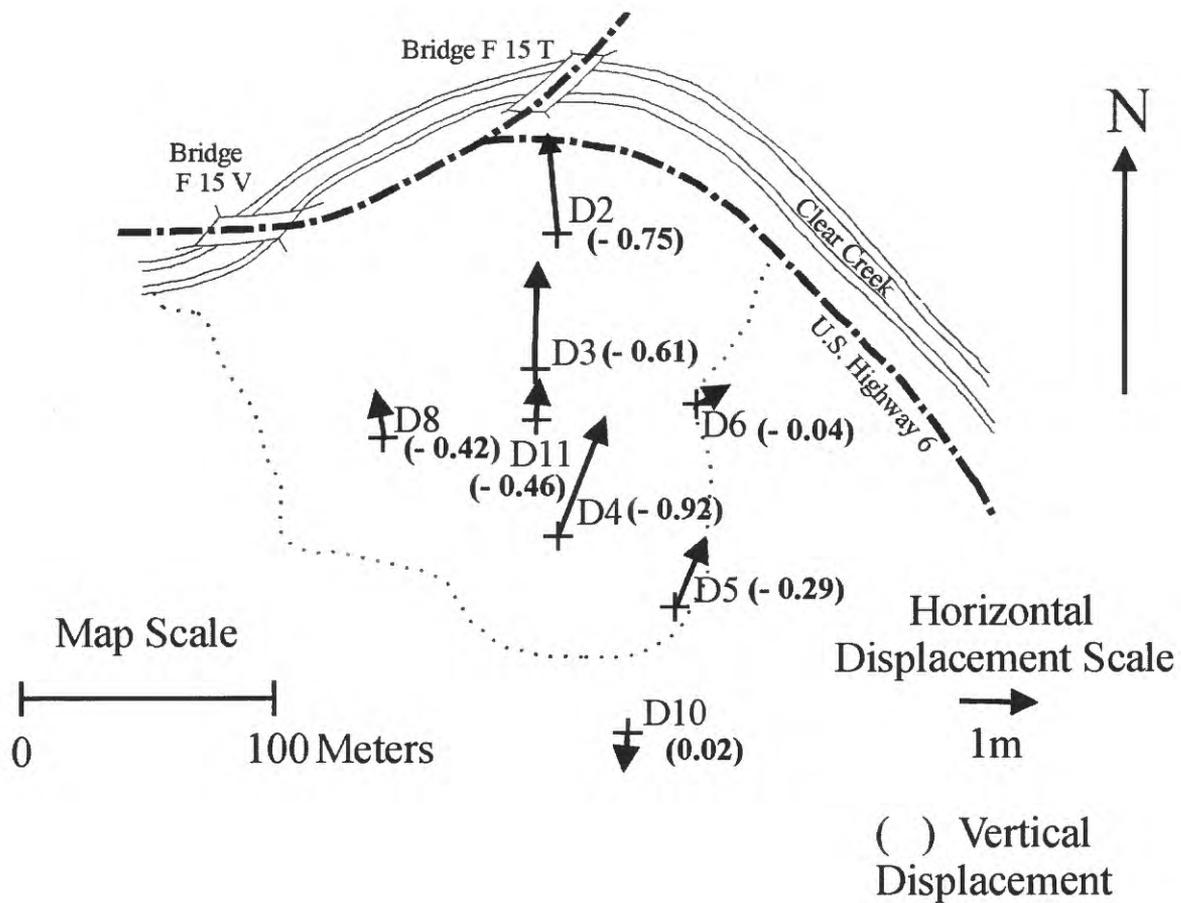
Figure 8. Map showing cumulative (1951-1997) displacement vectors for "D" points shown in Figure 6. Vertical displacements are shown in parentheses. Units are meters and are designated with negative and positive numbers for downward and upward movement, respectively.

The upper portion of the slide has moved slightly toward the northeast, whereas the lower portion moved almost directly north (Fig 8). Vectors of cumulative north displacements in the central and lower portion of the slide are focused almost directly toward bridge F15T (Fig. 8).
