LEVEL II SCOUR ANALYSIS FOR  
BRIDGE 13 (LINCTH00010013) on  
TOWN HIGHWAY 1, crossing  
COTA BROOK,  
LINCOLN, VERMONT

Open-File Report 98-157

By EMILY C. WILD

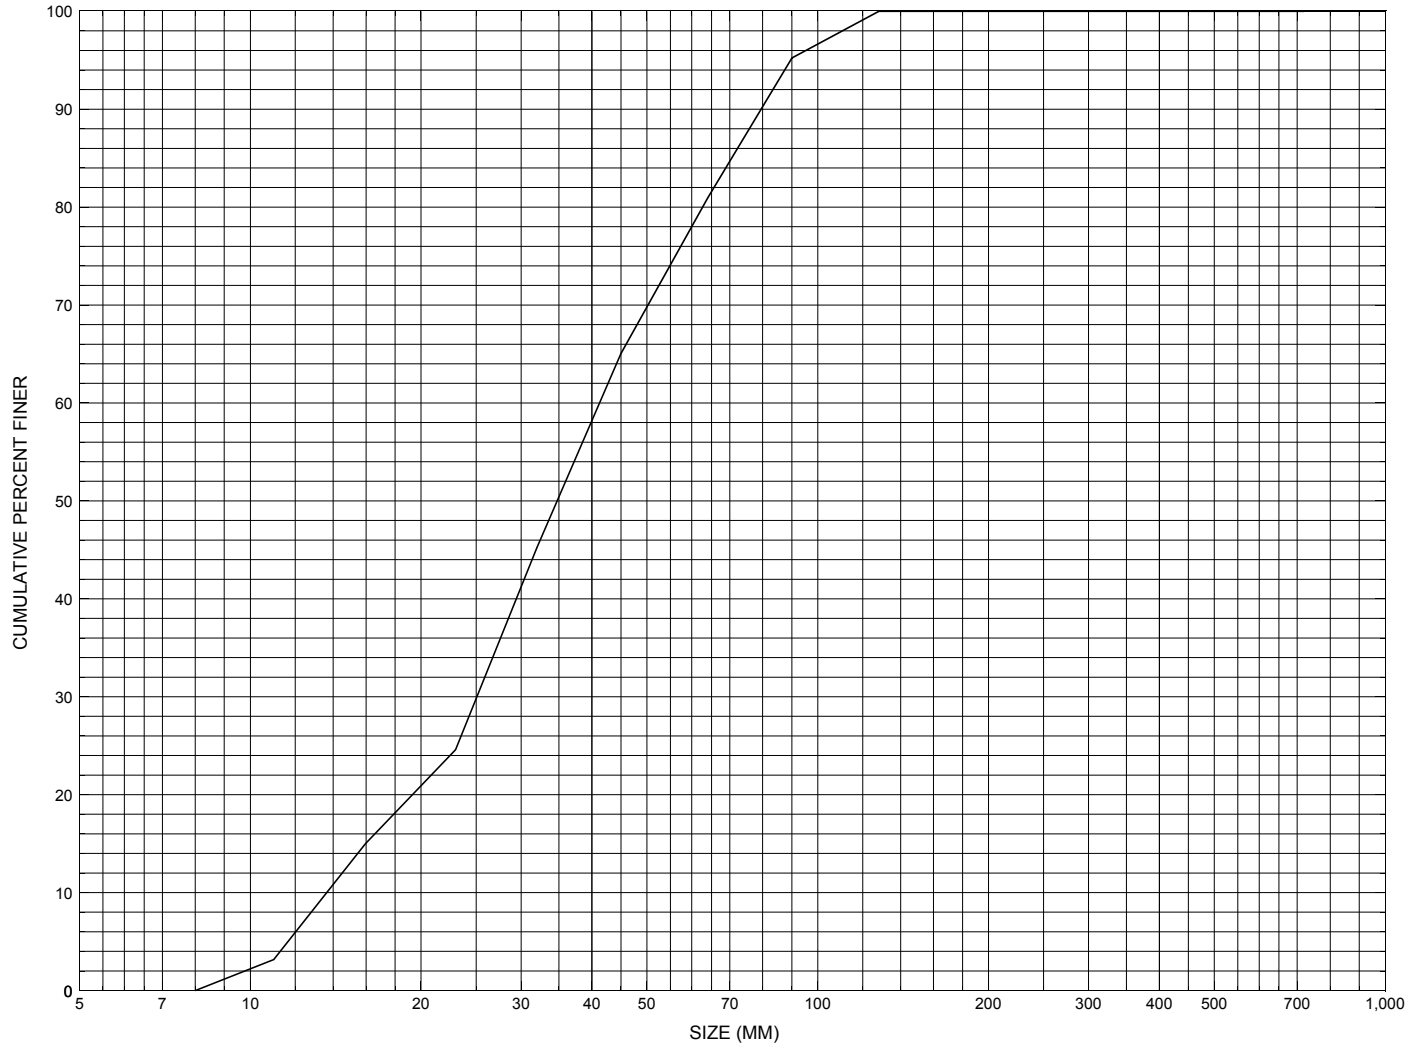
Appendix C. Bed material particle-size distribution for a pebble count in the channel approach of structure LINCTH00010013, in Lincoln, Vermont.
