LEVEL II SCOUR ANALYSIS FOR BRIDGE 23 (BRADTH00090023) on TOWN HIGHWAY 9, crossing MILL POND BROOK, BRADFORD, VERMONT

Open-File Report 98-195

Prepared in cooperation with
VERMONT AGENCY OF TRANSPORTATION
and
FEDERAL HIGHWAY ADMINISTRATION

By MICHAEL A. IVANOFF AND TIM SEVERANCE

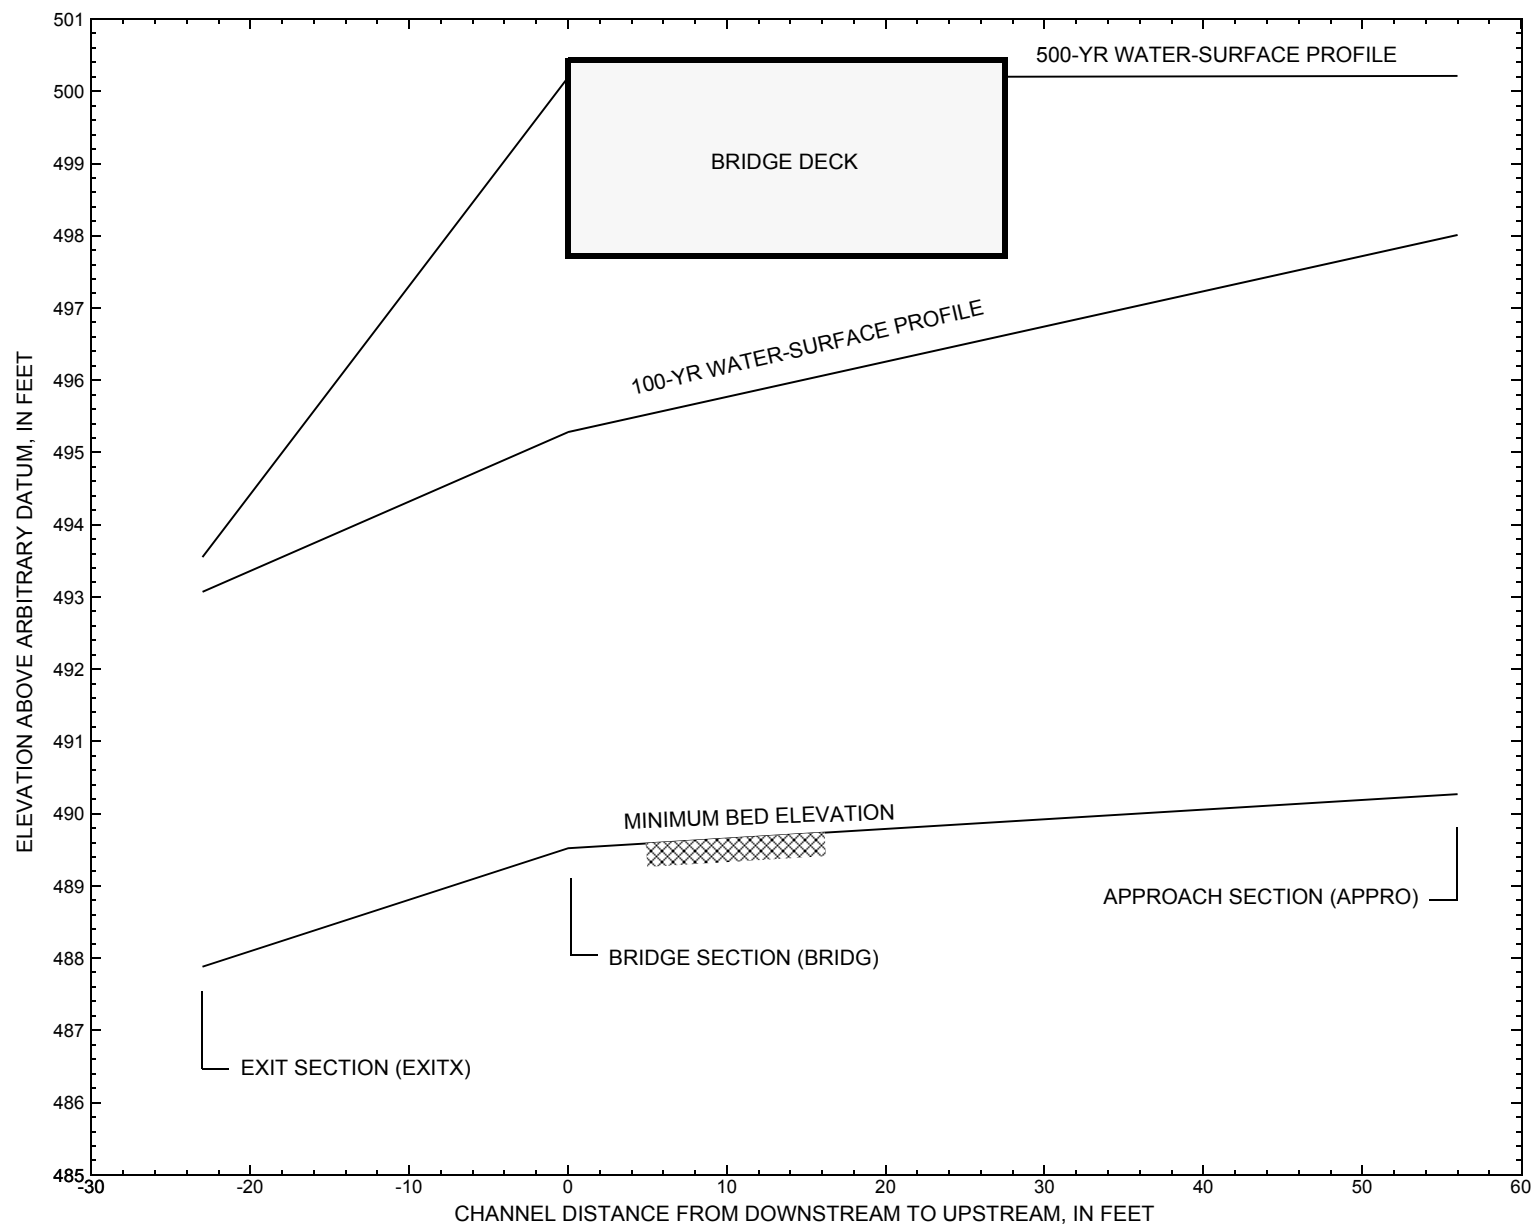
Figure 7. Water-surface profiles for the 100- and 500-year discharges at structure BRADTH00090023 on Town Highway 9, crossing Mill Pond Brook, Bradford, Vermont.

Hydraulic analyses of the reach were done by use of the Federal Highway Administration's WSPRO step-backwater computer program (Shearman and others, 1986, and Shearman, 1990). The analyses reported herein reflect conditions existing at the site at the time of the study. Furthermore, in the development of the model it was necessary to assume no accumulation of debris or ice at the site. Results of the hydraulic model are presented in the Bridge Hydraulic Summary, appendix B, and figure 7.

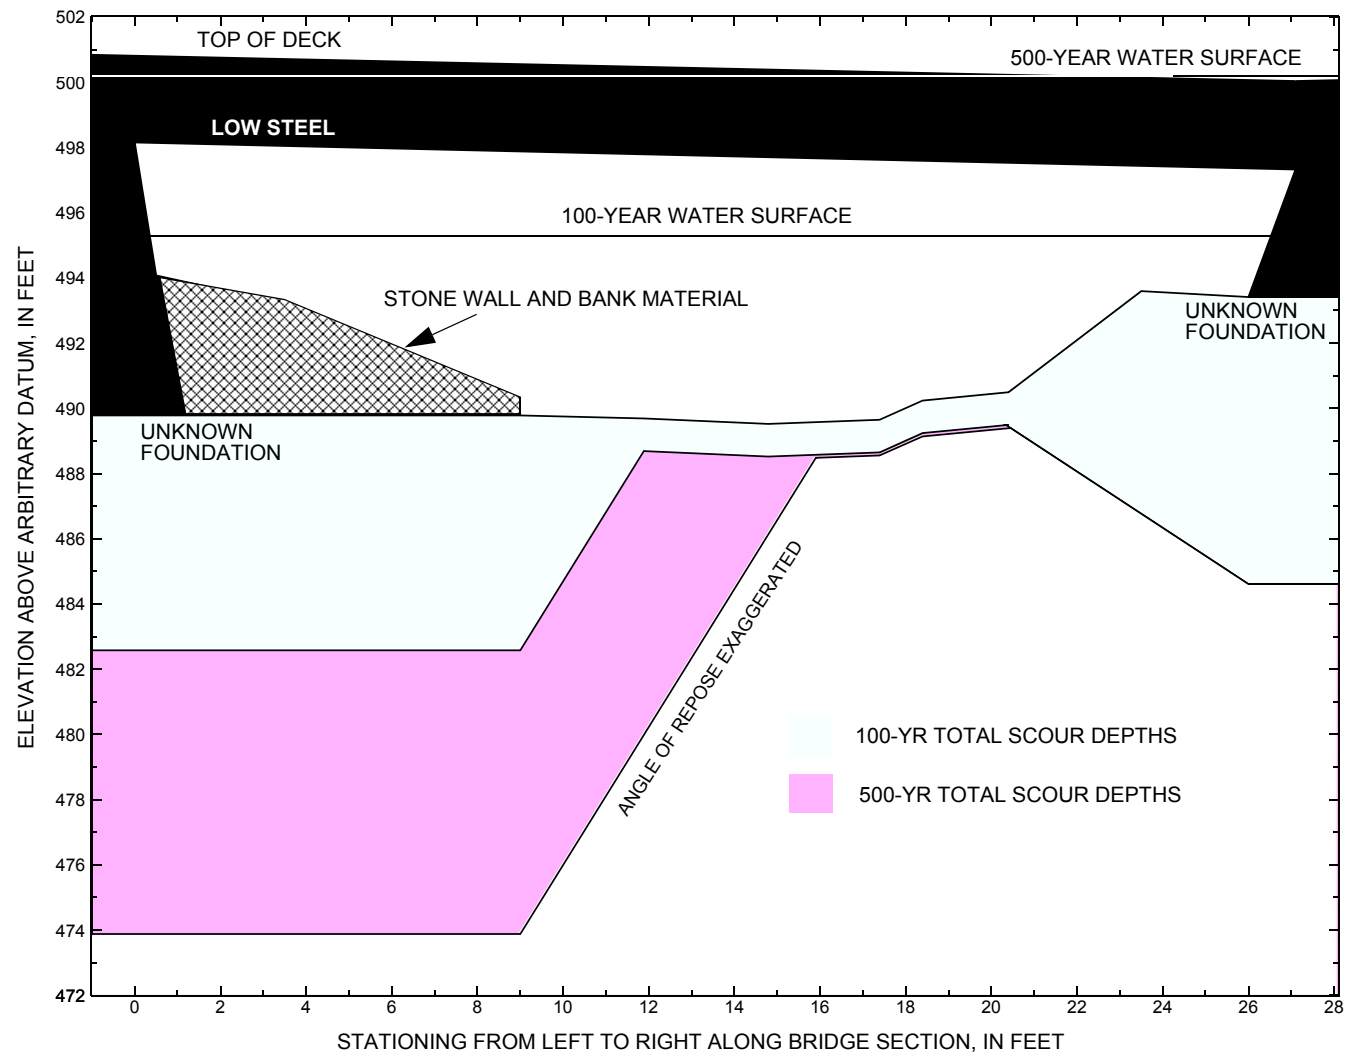
Figure 8. Scour elevations for the 100- and 500-year discharges at structure BRADTH00090023 on Town Highway 9, crossing Mill Pond Brook, Bradford, Vermont.

Scour depths were computed using the general guidelines described in Hydraulic Engineering Circular 18 (Richardson and Davis, 1995). Scour depths were calculated assuming an infinite depth of erosive material and a homogeneous particle-size distribution. The results of the scour analyses for the 100- and 500-year discharges are presented in tables 1 and 2 and the scour depths are shown graphically in figure 8.

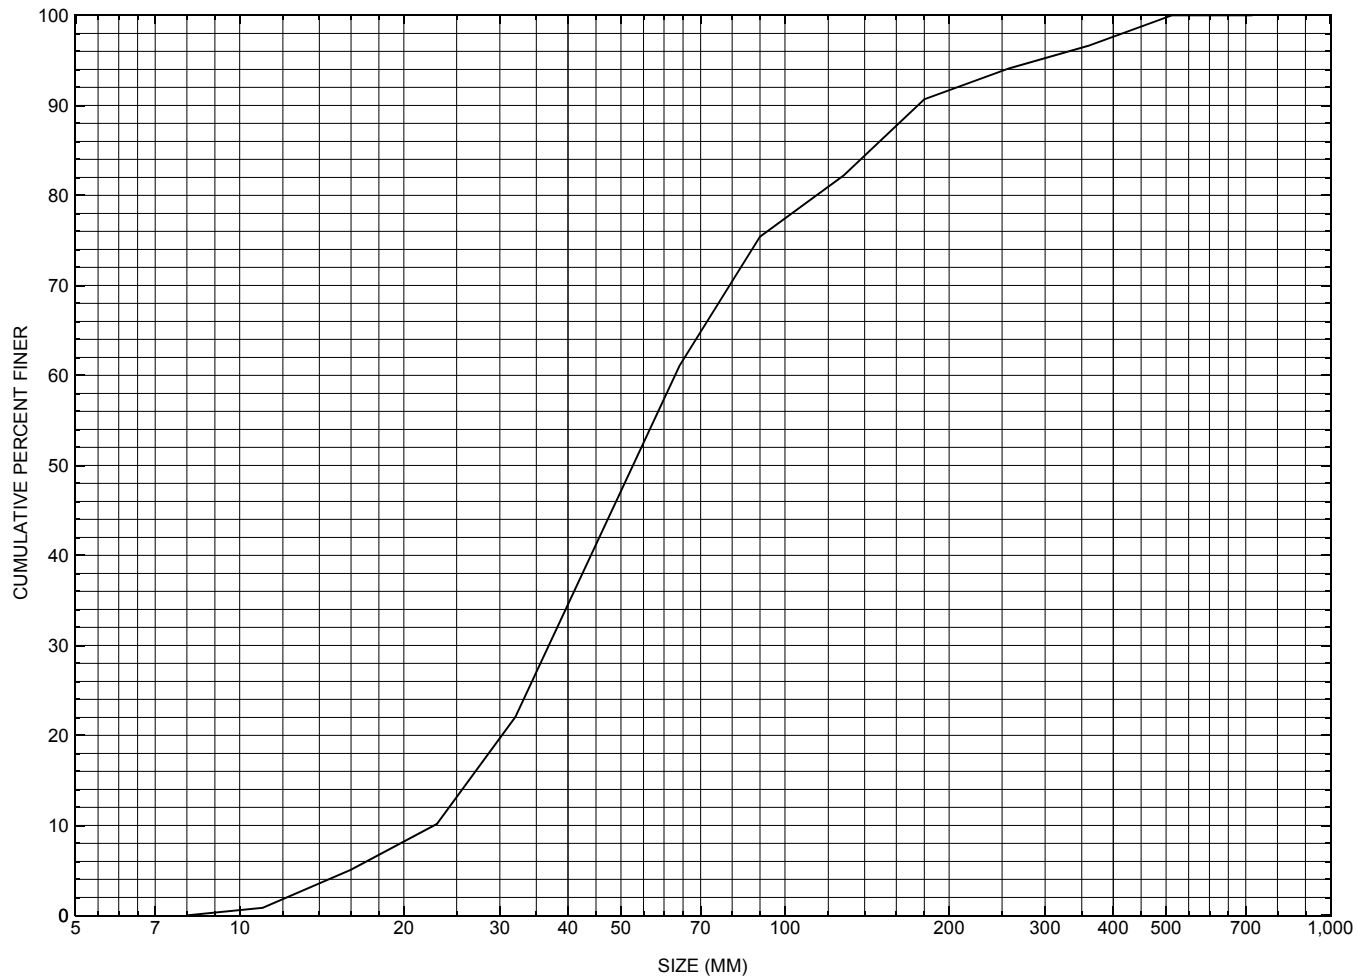
Appendix C. Bed material particle-size distribution for a pebble count in the channel approach of structure BRADTH00090023, in Bradford, Vermont.
