LEVEL II SCOUR ANALYSIS FOR
BRIDGE 13 (JERITH00030013) on
TOWN HIGHWAY 3, crossing
MILL BROOK,
JERICHO, VERMONT

Open-File Report 98-259

U.S. Geological Survey
Open-File Report 98-259

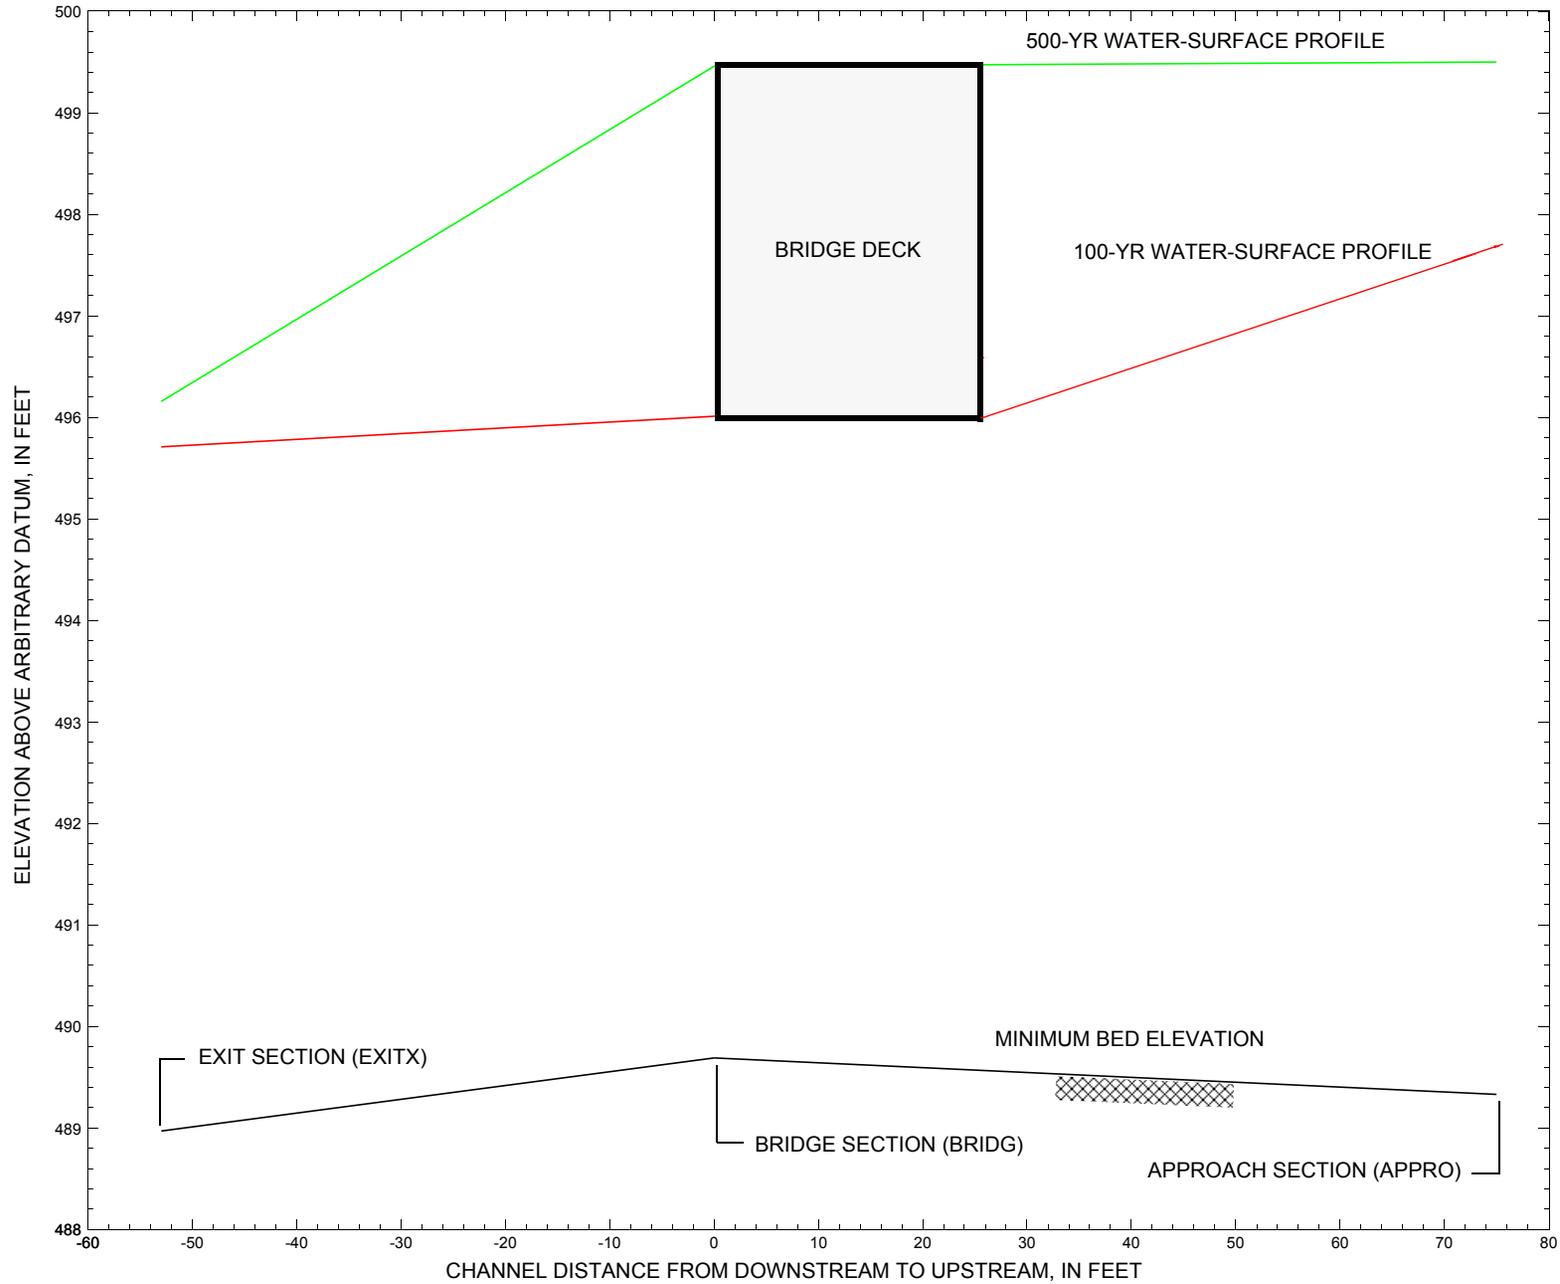
Figure 7. Water-surface profiles for the 100- and 500-yr discharges at structure JERITH00030013 on Town Highway 3, crossing Mill Brook, Jericho, Vermont.

Hydraulic analyses of the reach were done by use of the Federal Highway Administration's WSPRO step-backwater computer program (Shearman and others, 1986, and Shearman, 1990). The analyses reported herein reflect conditions existing at the site at the time of the study. Furthermore, in the development of the model it was necessary to assume no accumulation of debris or ice at the site. Results of the hydraulic model are presented in the Bridge Hydraulic Summary, appendix B, and figure 7.

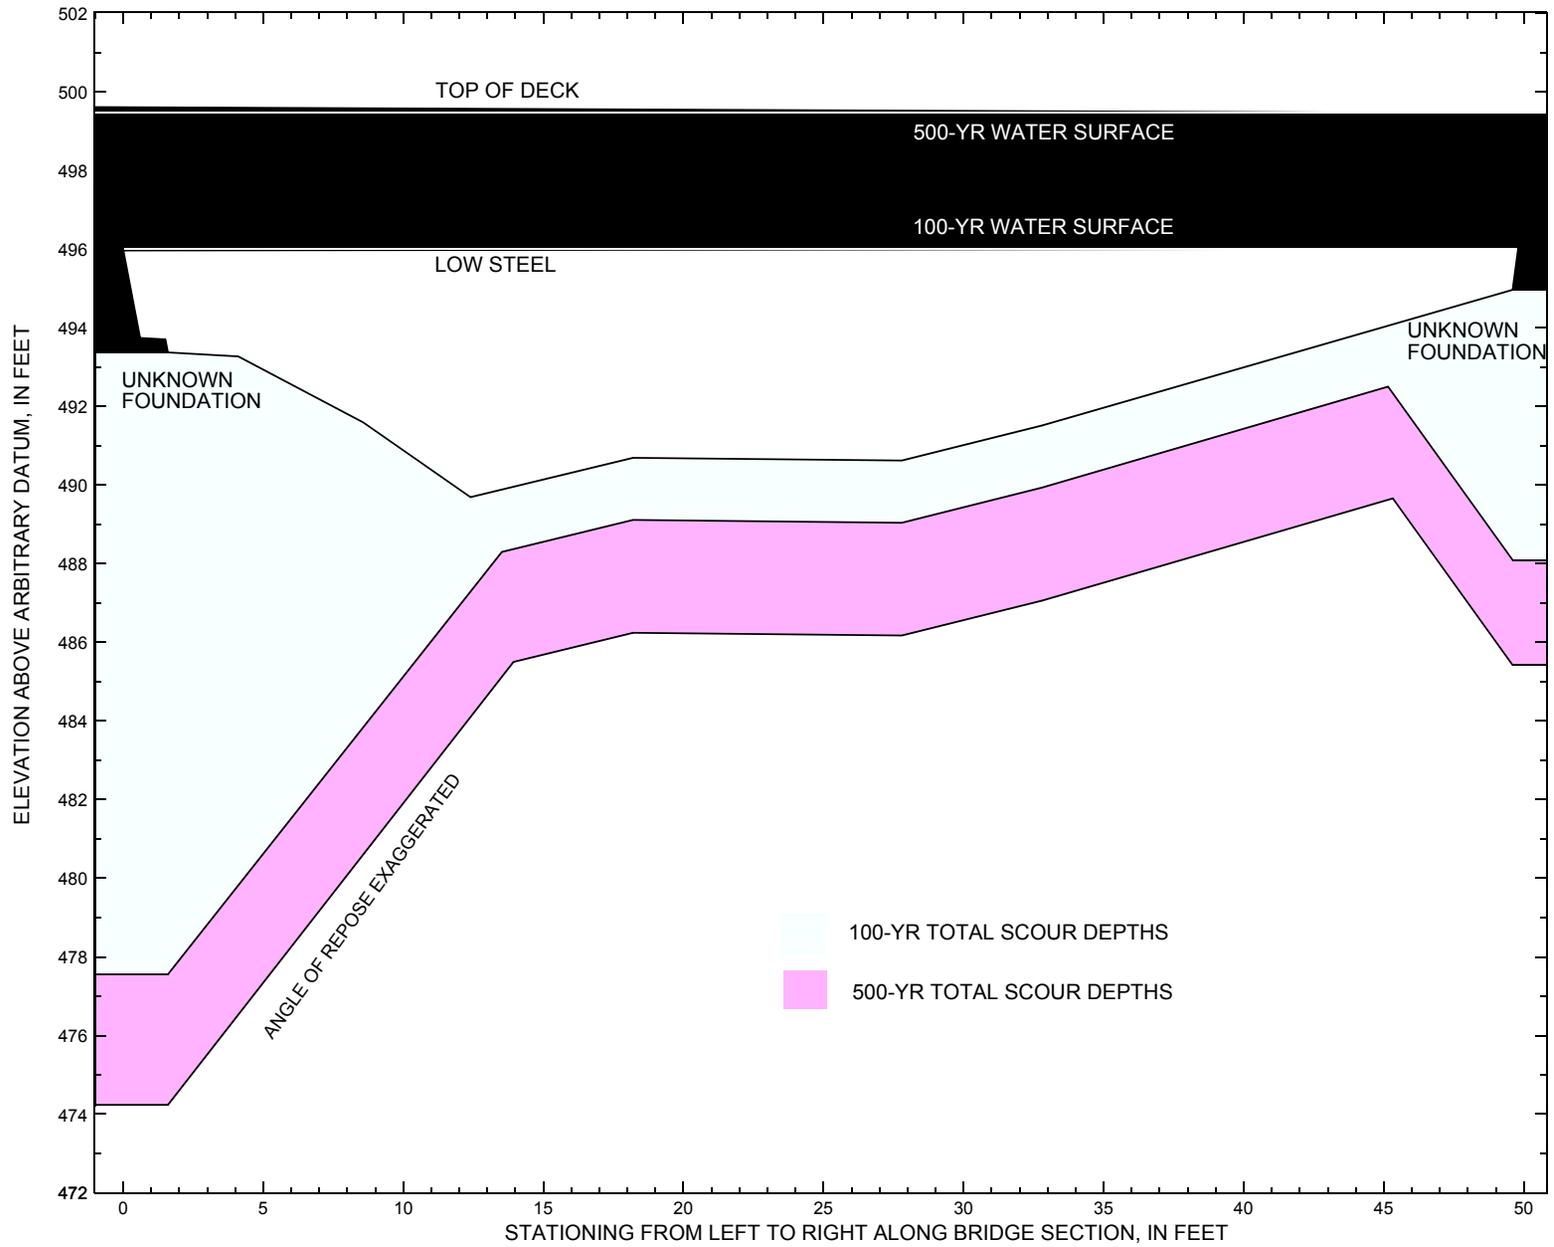
Figure 8. Scour elevations for the 100- and 500-yr discharges at structure JERITH00030013 on Town Highway 3, crossing Mill Brook, Jericho, Vermont.

Scour depths were computed using the general guidelines described in Hydraulic Engineering Circular 18 (Richardson and others, 1995). Scour depths were calculated assuming an infinite depth of erosive material and a homogeneous particle-size distribution. The results of the scour analysis for the 100- and 500-year discharges are presented in tables 1 and 2 and a graph of the scour depths is presented in figure 8.

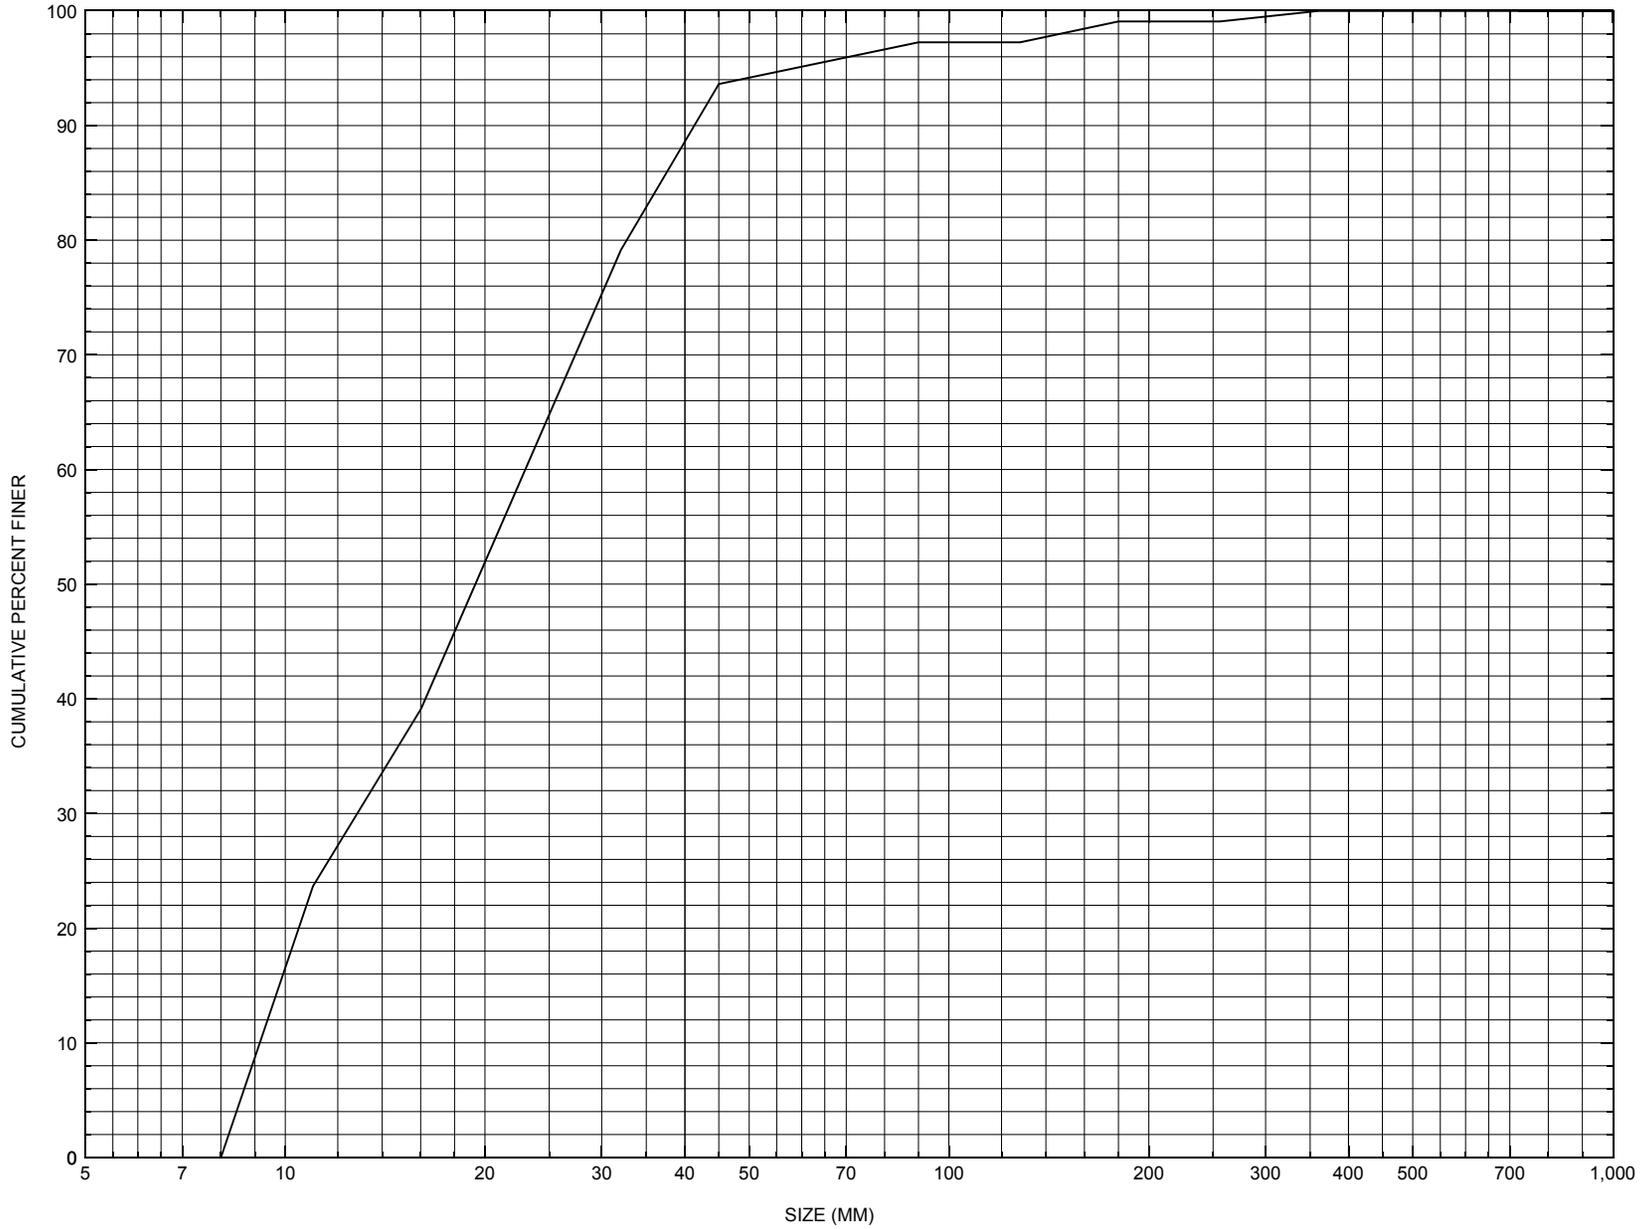
Appendix C. Bed material particle-size distribution for a pebble count in the channel approach of structure JERITH00030013, in Jericho, Vermont.
