LEVEL II SCOUR ANALYSIS FOR  
BRIDGE 59 (STRATH00030059) on  
TOWN HIGHWAY 3, crossing  
ABBOTT BROOK,  
STRAFFORD, VERMONT

Open-File Report 98-261

U.S. Geological Survey  
Open-File Report 98-261

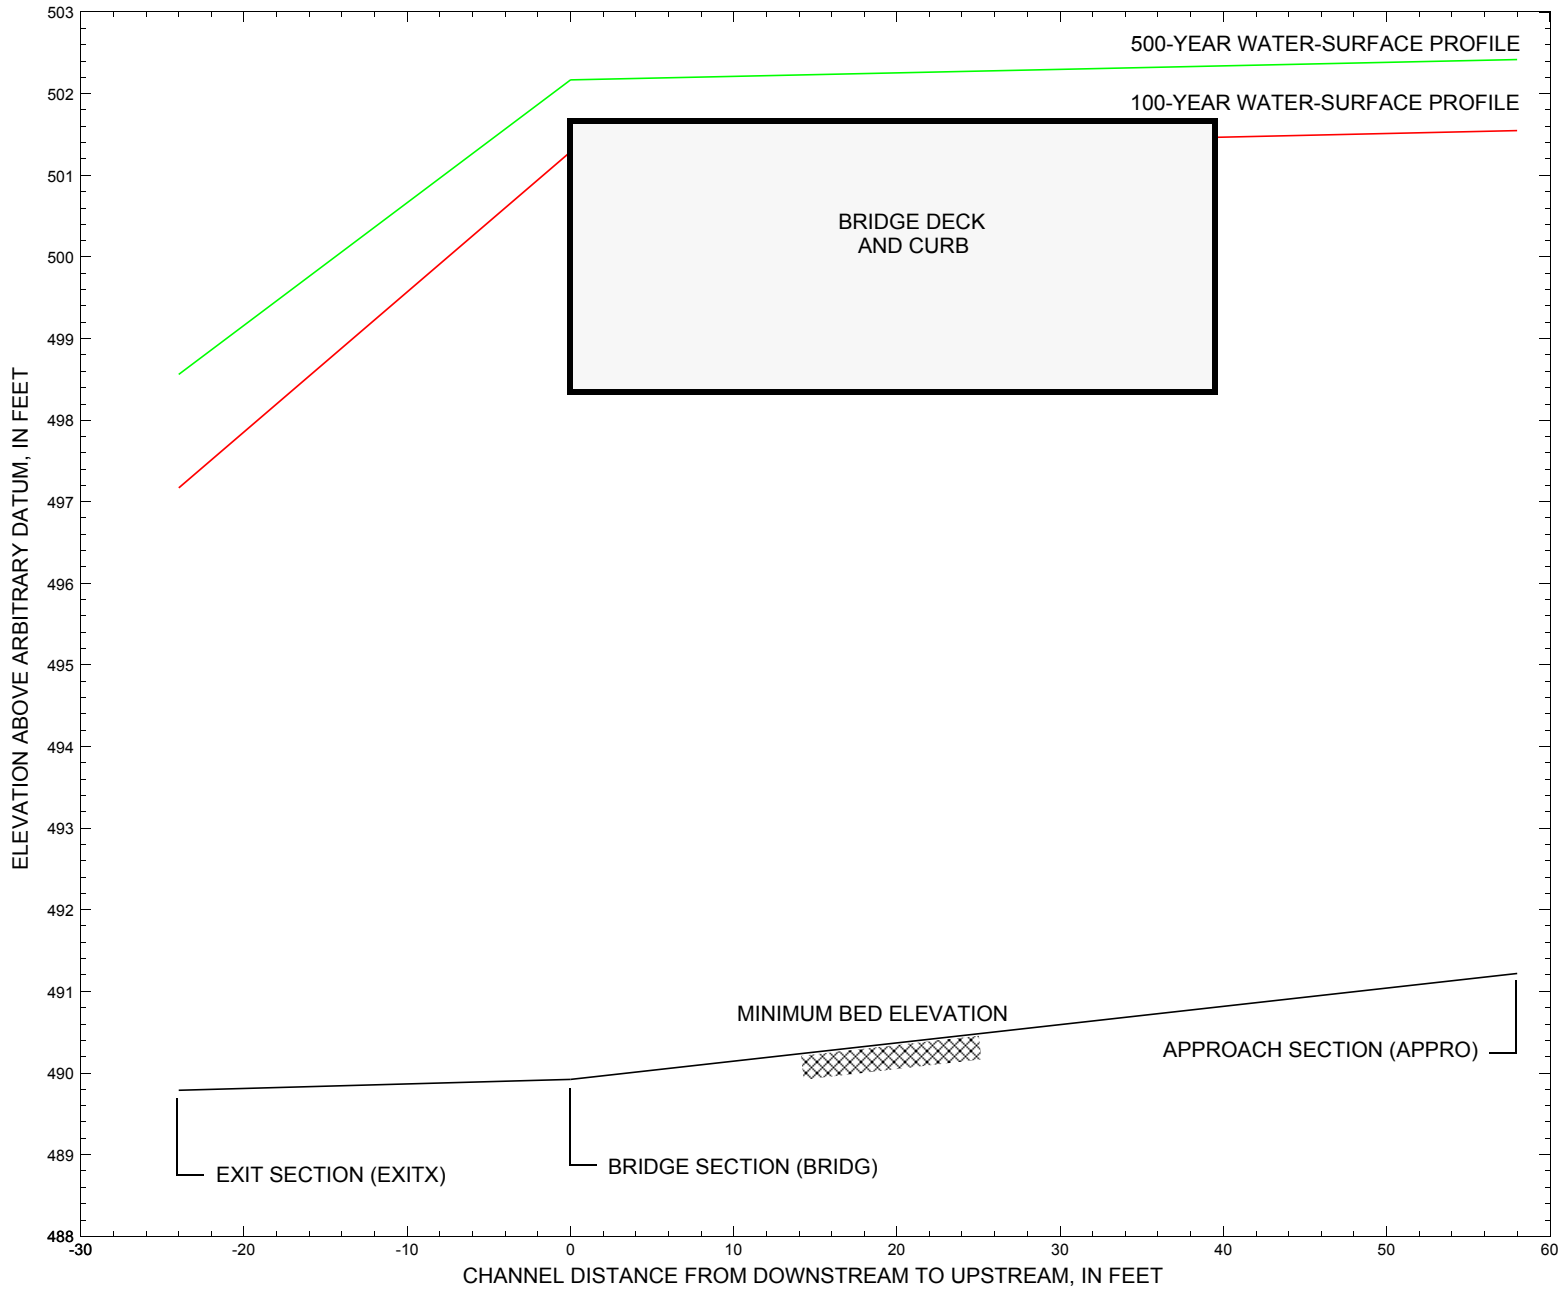
Figure 7. Water-surface profiles for the 100- and 500-year discharges at structure STRATH00030059 on Town Highway 3, crossing Abbott Brook, Strafford, Vermont.

Hydraulic analyses of the reach were done by use of the Federal Highway Administration's WSPRO step-backwater computer program (Shearman and others, 1986, and Shearman, 1990). The analyses reported herein reflect conditions existing at the site at the time of the study. Furthermore, in the development of the model it was necessary to assume no accumulation of debris or ice at the site. Results of the hydraulic model are presented in the Bridge Hydraulic Summary, appendix B, and figure 7.

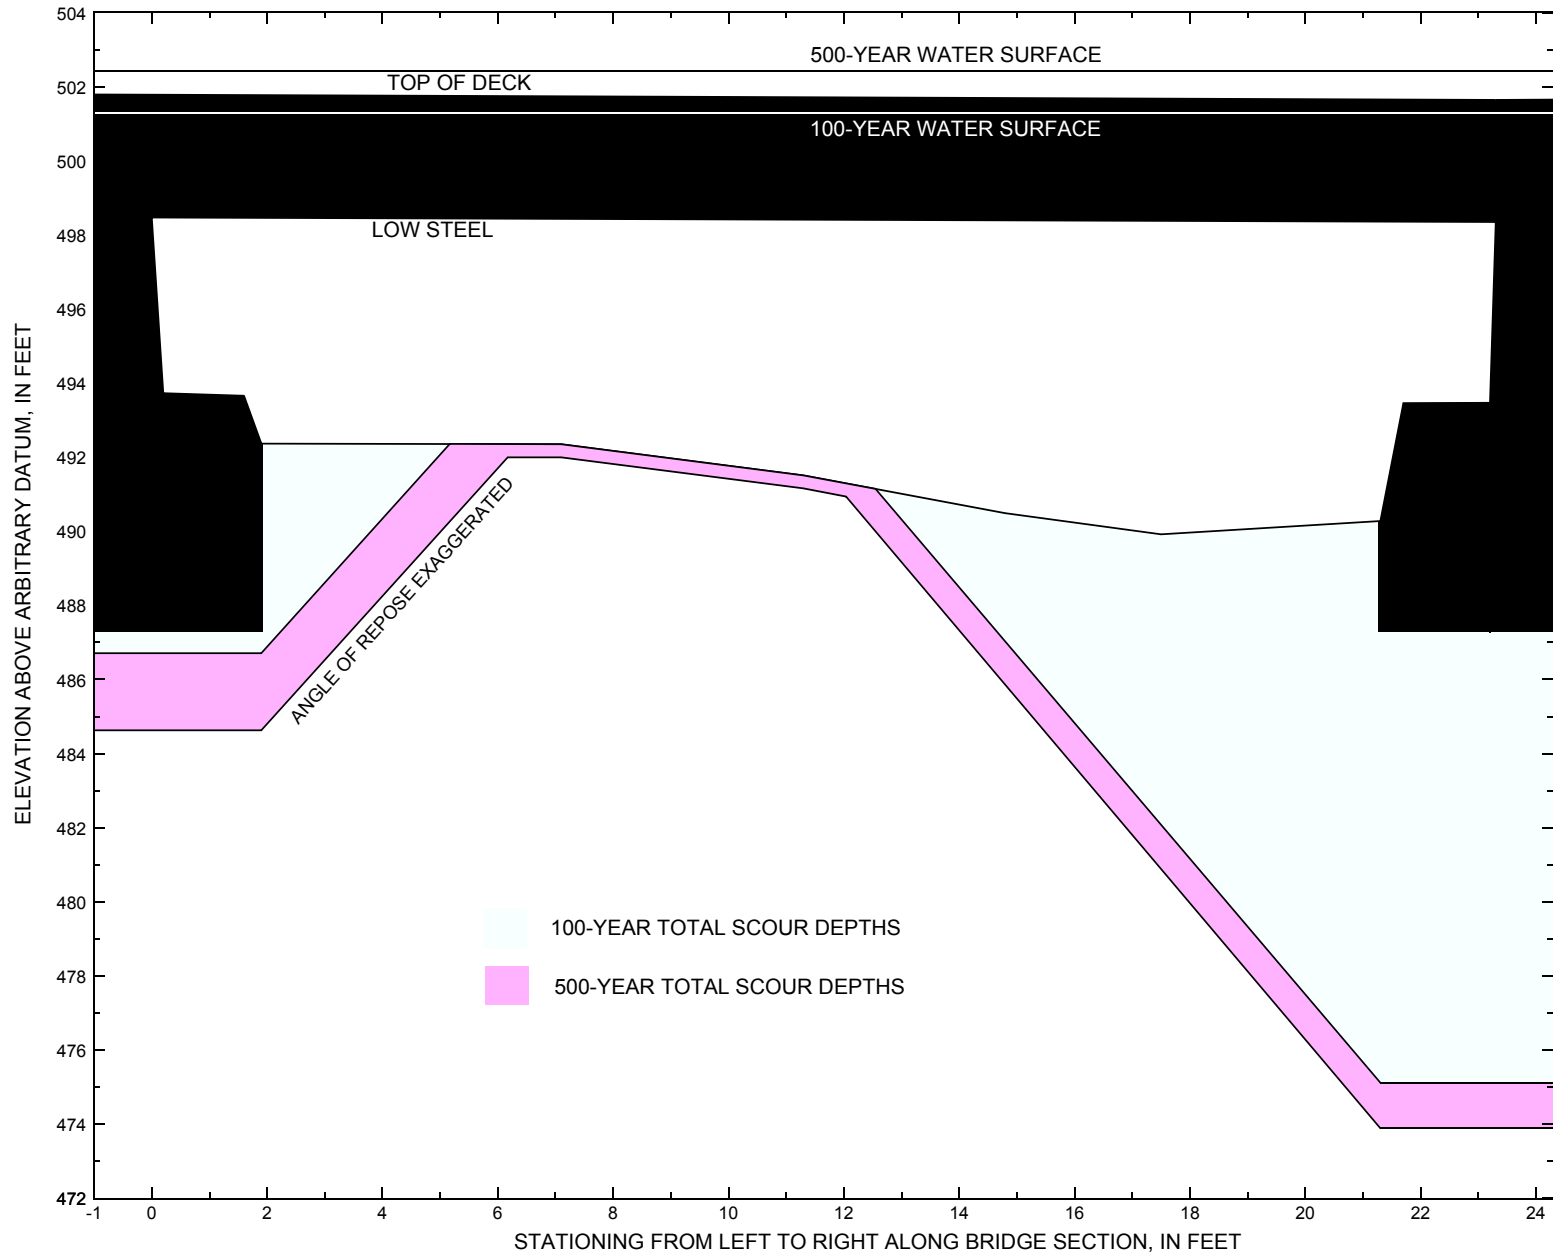
Figure 8. Scour elevations for the 100- and 500-year discharges at structure STRATH00030059 on Town Highway 3, crossing Abbott Brook, Strafford, Vermont.

Scour depths were computed using the general guidelines described in Hydraulic Engineering Circular 18 (Richardson and Davis, 1995). Scour depths were calculated assuming an infinite depth of erosive material and a homogeneous particle-size distribution. The results of the scour analyses for the 100- and 500-year discharges are presented in tables 1 and 2 and the scour depths are shown graphically in figure 8.

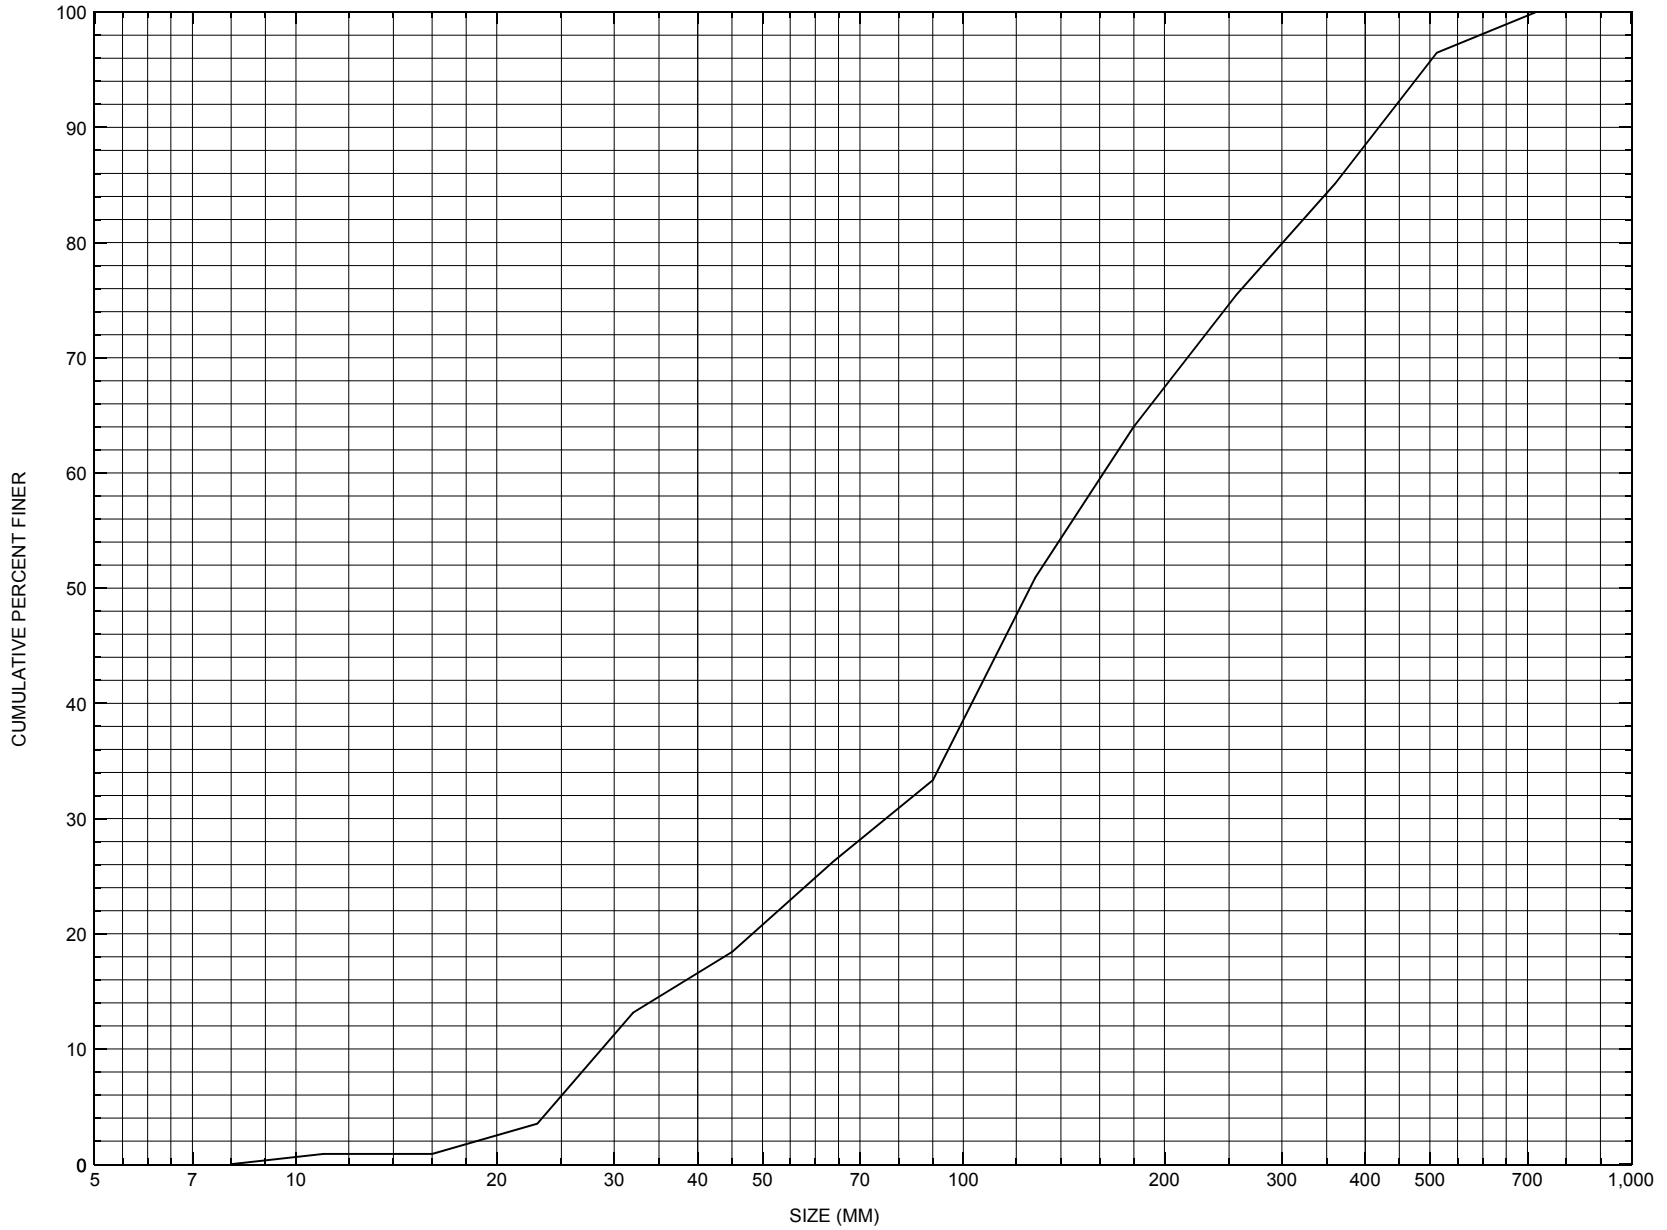
Appendix C. Bed material particle-size distribution for a pebble count in the channel approach of structure STRATH00030059, in Strafford, Vermont.
