LEVEL II SCOUR ANALYSIS FOR
BRIDGE 28 (ROCHTH00370028) on
TOWN HIGHWAY 37, crossing
BRANDON BROOK,
ROCHESTER, VERMONT

Open-File Report 98-273

Prepared in cooperation with
VERMONT AGENCY OF TRANSPORTATION
and
FEDERAL HIGHWAY ADMINISTRATION

By EMILY C. WILD and MATTHEW A. WEBER

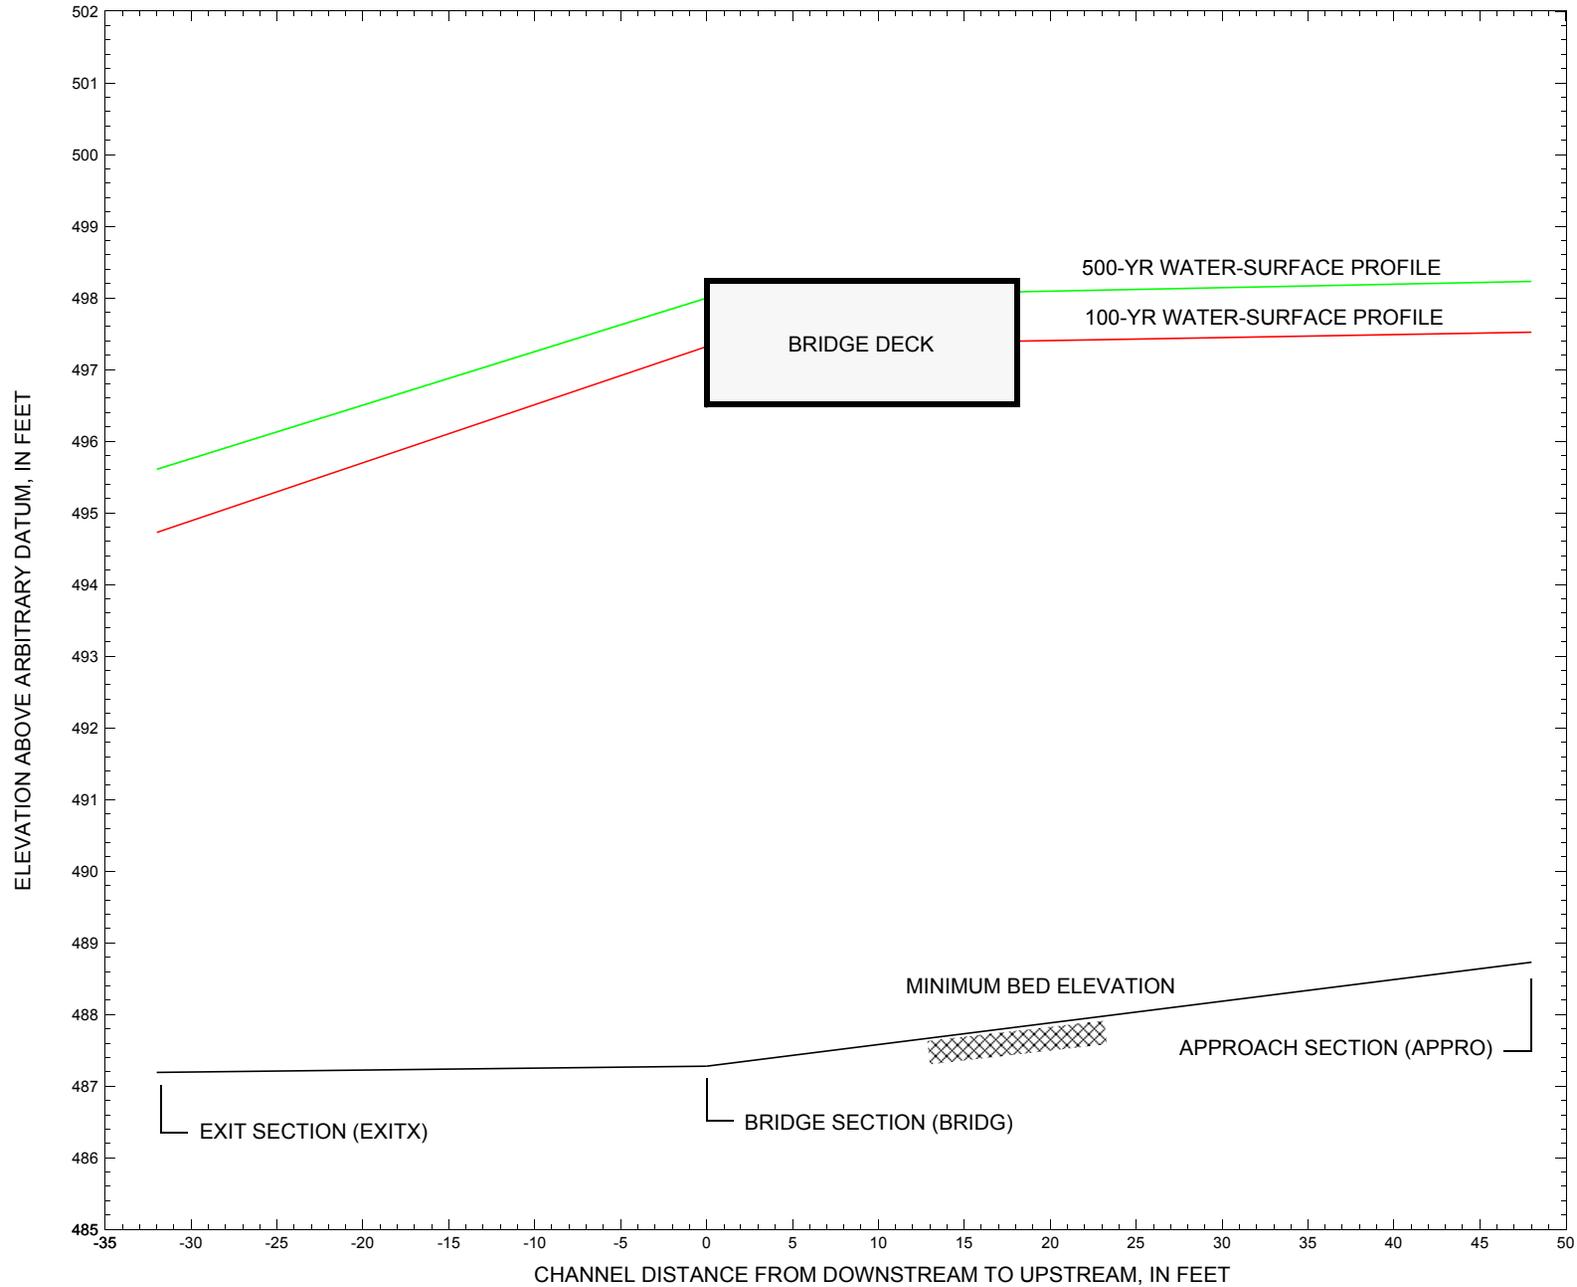
Figure 7. Water-surface profiles for the 100- and 500-yr discharges at structure ROCHTH00370028 on Town Highway 37, crossing Brandon Brook, Rochester, Vermont.

Hydraulic analyses of the reach were done by use of the Federal Highway Administration's WSPRO step-backwater computer program (Shearman and others, 1986, and Shearman, 1990). The analyses reported herein reflect conditions existing at the site at the time of the study. Furthermore, in the development of the model it was necessary to assume no accumulation of debris or ice at the site. Results of the hydraulic model are presented in the Bridge Hydraulic Summary, appendix B, and figure 7.

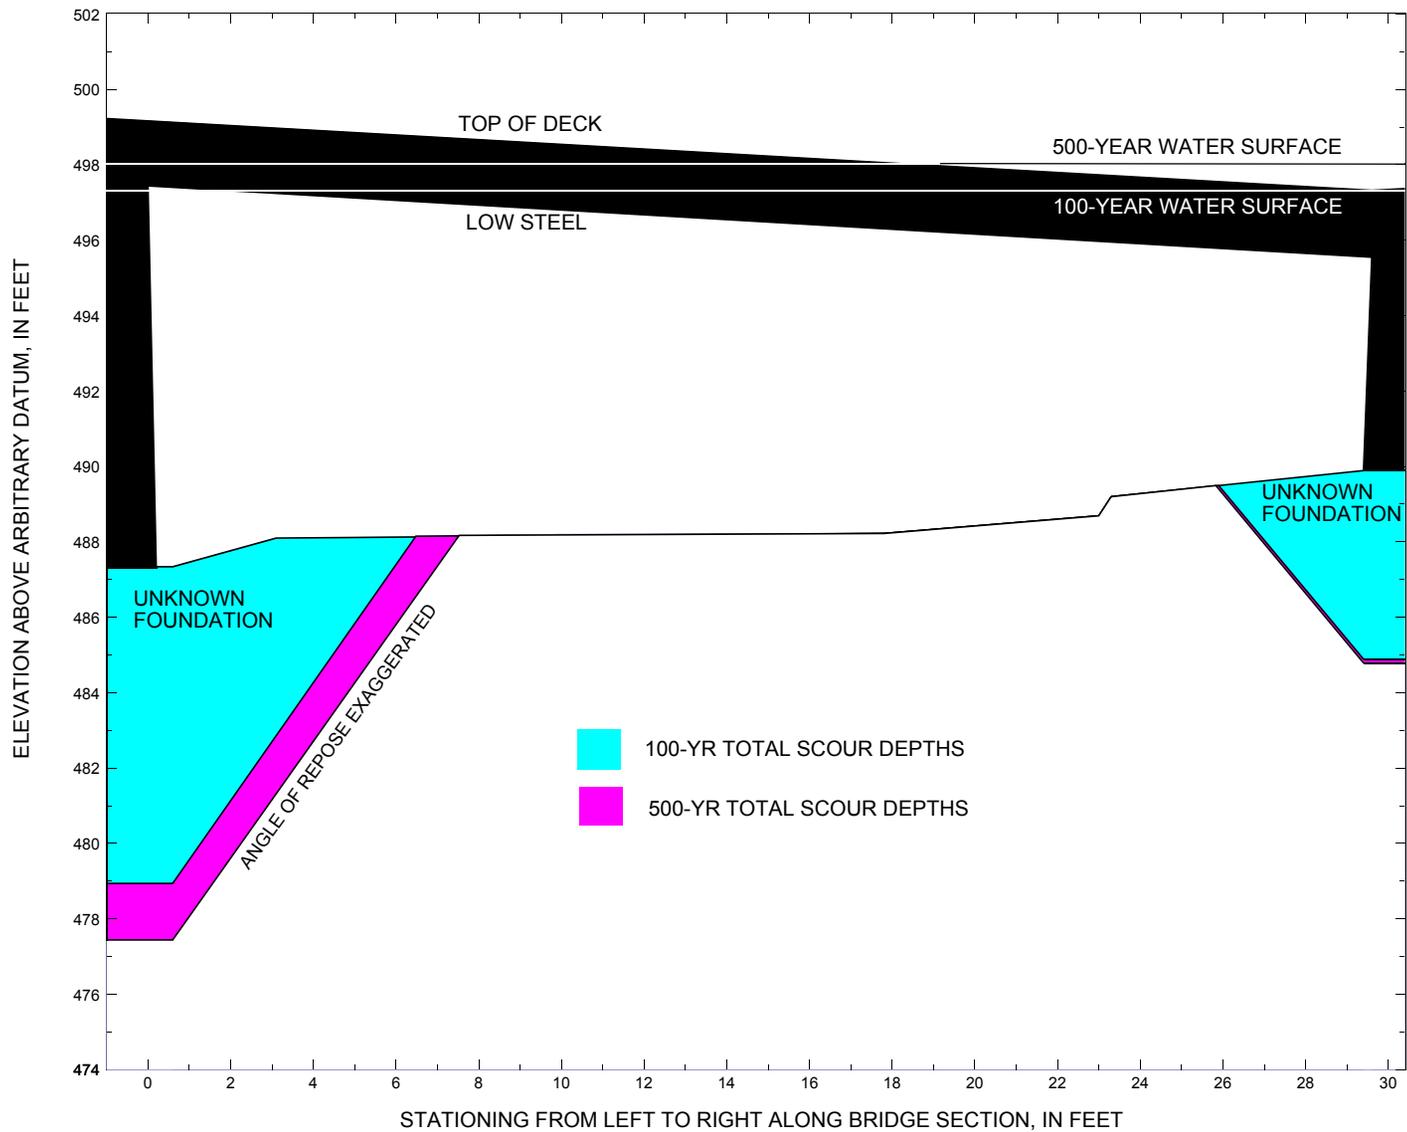
Figure 8. Scour elevations for the 100-yr and 500-yr discharges at structure ROCHTH00370028 on Town Highway 37, crossing Brandon Brook, Rochester, Vermont.

Scour depths were computed using the general guidelines described in Hydraulic Engineering Circular 18 (Richardson and Davis, 1995). Scour depths were calculated assuming an infinite depth of erosive material and a homogeneous particle-size distribution. The results of the scour analyses for the 100- and 500-year discharges are presented in tables 1 and 2 and the scour depths are shown graphically in figure 8.

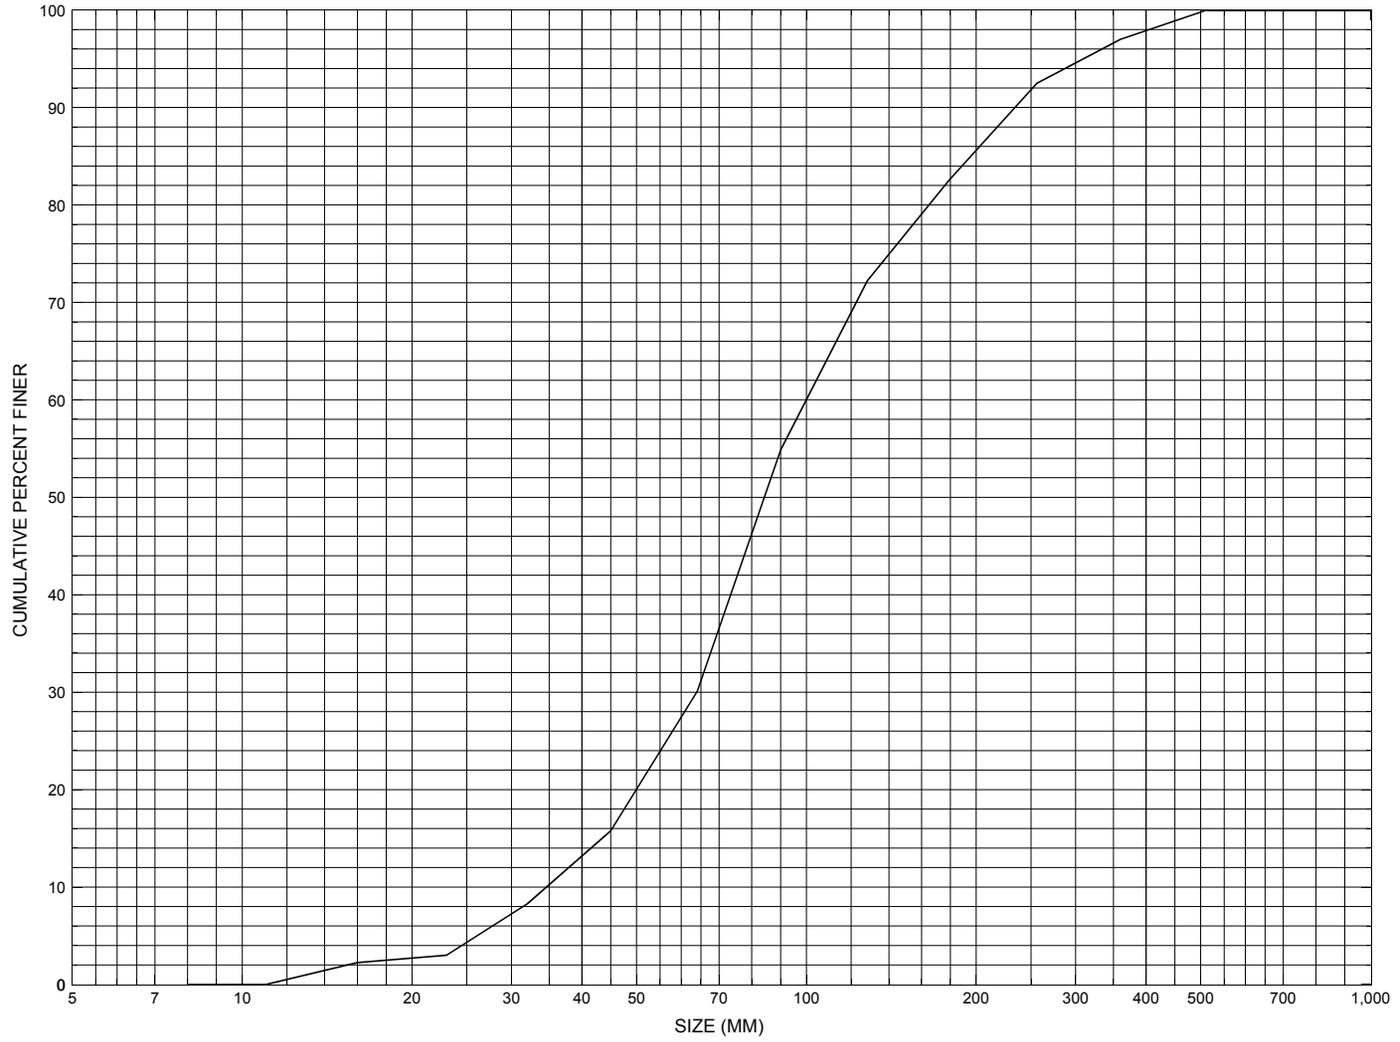
Appendix C. Bed material particle-size distribution for a pebble count in the channel approach of structure ROCHTH00370028, in Rochester, Vermont.
