# LEVEL II SCOUR ANALYSIS FOR BRIDGE 28 (STRATH00020028) on TOWN HIGHWAY 2, crossing the WEST BRANCH OMPOMPANOOSUC RIVER, STRAFFORD, VERMONT

Open-File Report 98-293

By EMILY C. WILD

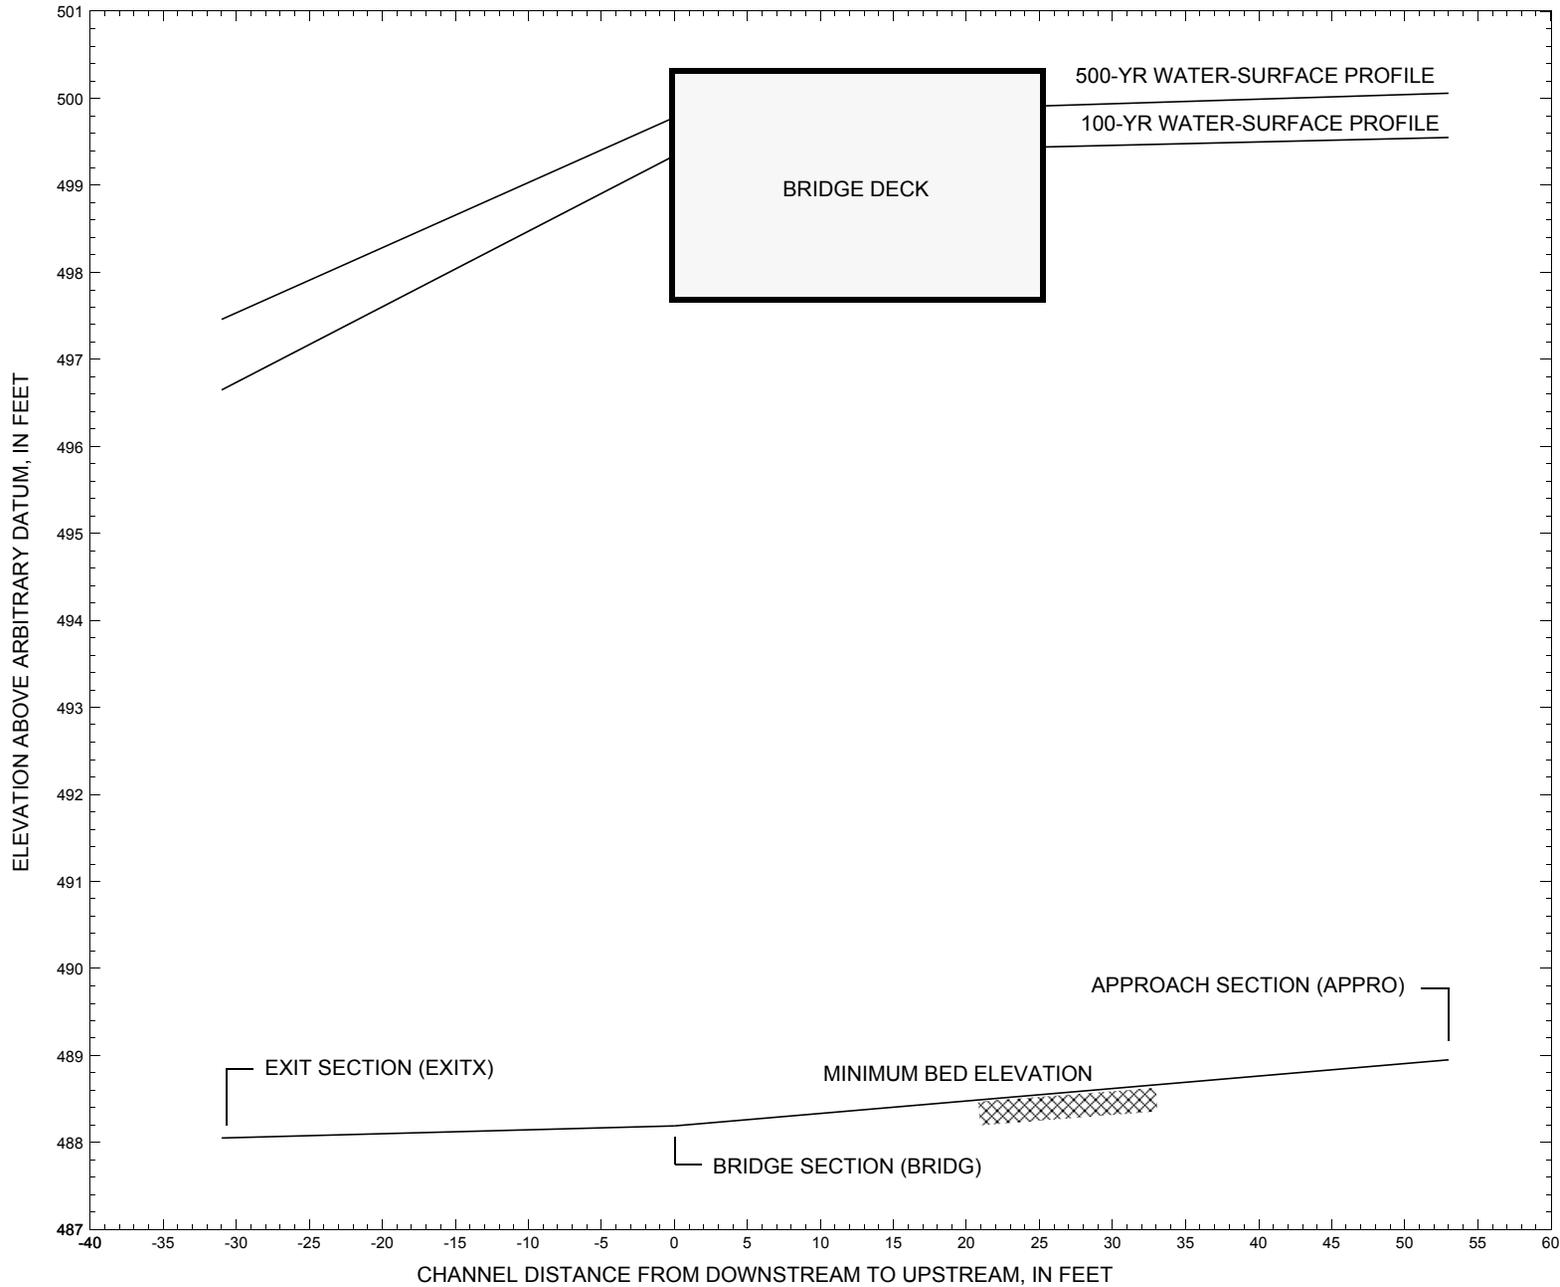
Figure 7. Water-surface profiles for the 100- and 500-year discharges at structure STRATH00020028 on Town Highway 2, crossing the West Branch Ompompanoosuc River, Strafford, Vermont.

Hydraulic analyses of the reach were done by use of the Federal Highway Administration's WSPRO step-backwater computer program (Shearman and others, 1986, and Shearman, 1990). The analyses reported herein reflect conditions existing at the site at the time of the study. Furthermore, in the development of the model it was necessary to assume no accumulation of debris or ice at the site. Although flow approaches this site at an angle greater than the opening-skew-to-roadway, flow was assumed to align with the abutments in the bridge. Results of the hydraulic model are presented in the Bridge Hydraulic Summary, appendix B, and figure 7.

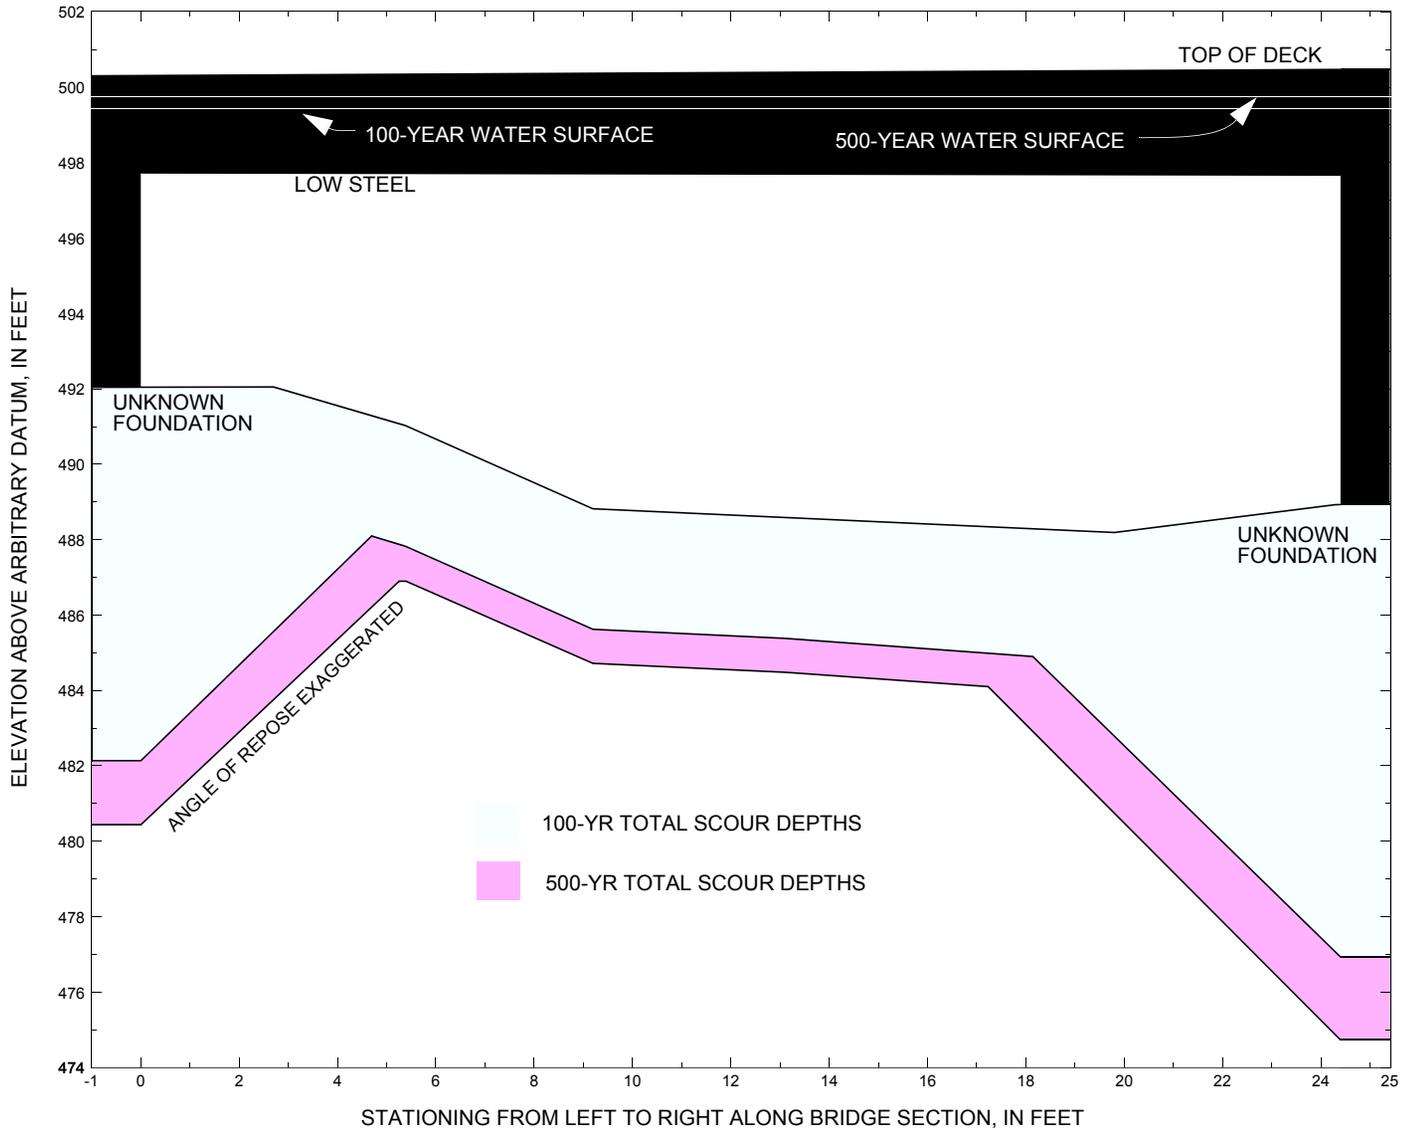
Figure 8. Scour elevations for the 100- and 500-year discharges at structure STRATH00020028 on Town Highway 2, crossing the West Branch Omppanoosuc River, Strafford, Vermont.

Scour depths were computed using the general guidelines described in Hydraulic Engineering Circular 18 (Richardson and Davis, 1995). Scour depths were calculated assuming an infinite depth of erosive material and a homogeneous particle-size distribution. The results of the scour analyses for the 100- and 500-year discharges are presented in tables 1 and 2 and the scour depths are shown graphically in figure 8.

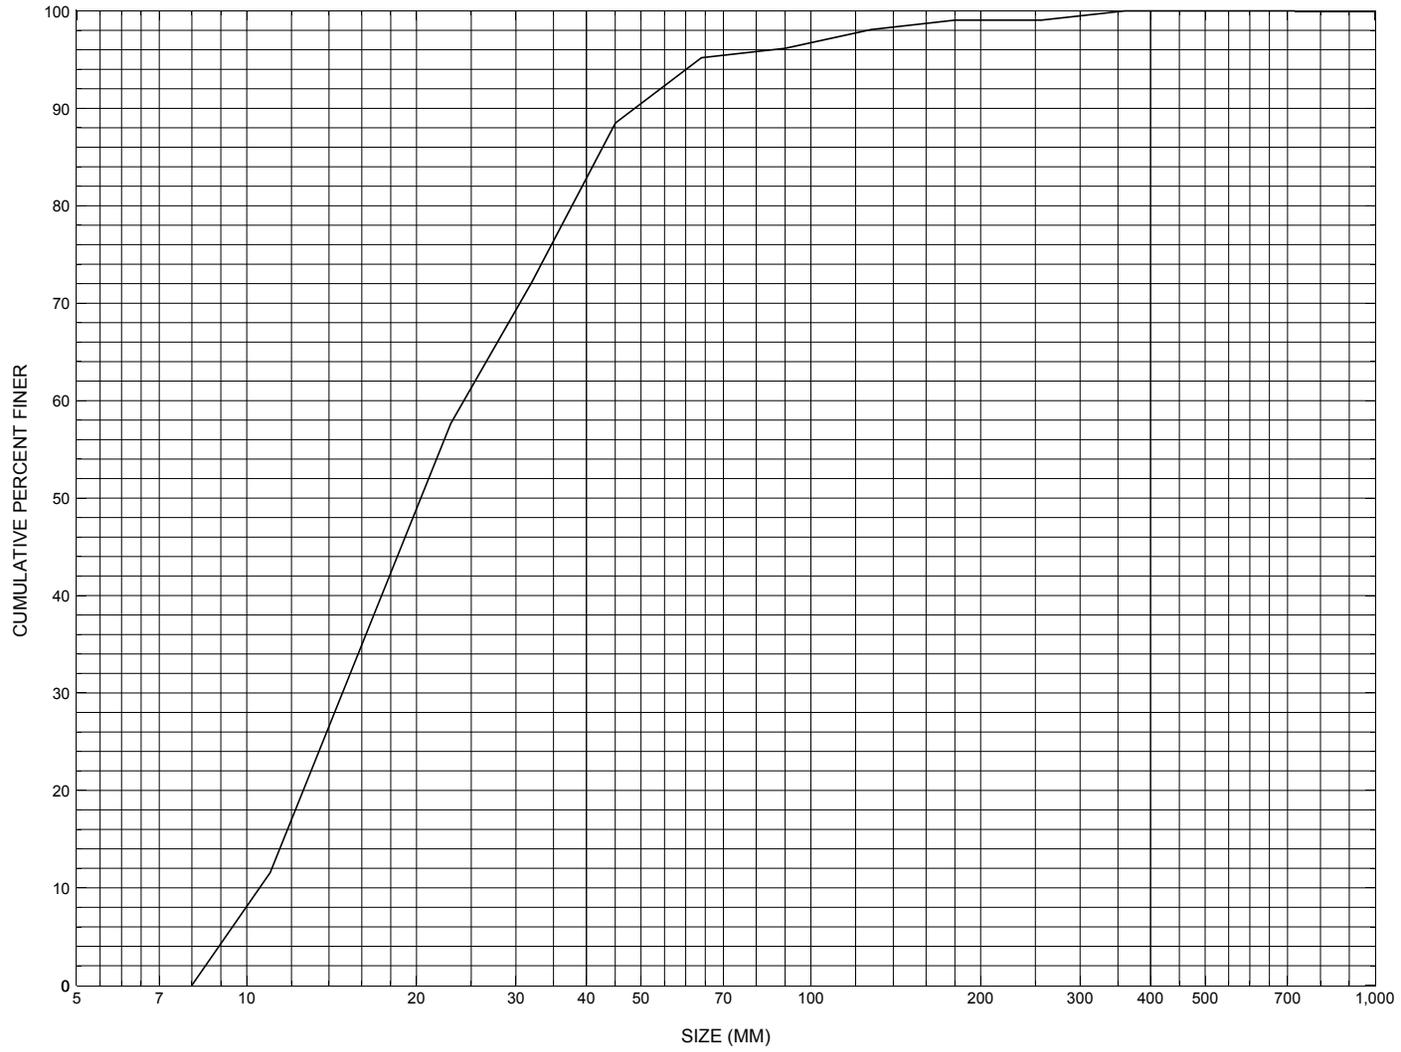
Appendix C. Bed material particle-size distribution for a pebble count in the channel approach of structure STRATH00020028, in Strafford, Vermont.
