# LEVEL II SCOUR ANALYSIS FOR BRIDGE 27 (READTH00380027) on TOWN HIGHWAY 38, crossing the NORTH BRANCH BLACK RIVER, READING, VERMONT

Open-File Report 98-379

Prepared in cooperation with  
VERMONT AGENCY OF TRANSPORTATION  
and  
FEDERAL HIGHWAY ADMINISTRATION

By MICHAEL A. IVANOFF AND MATTHEW A. WEBER

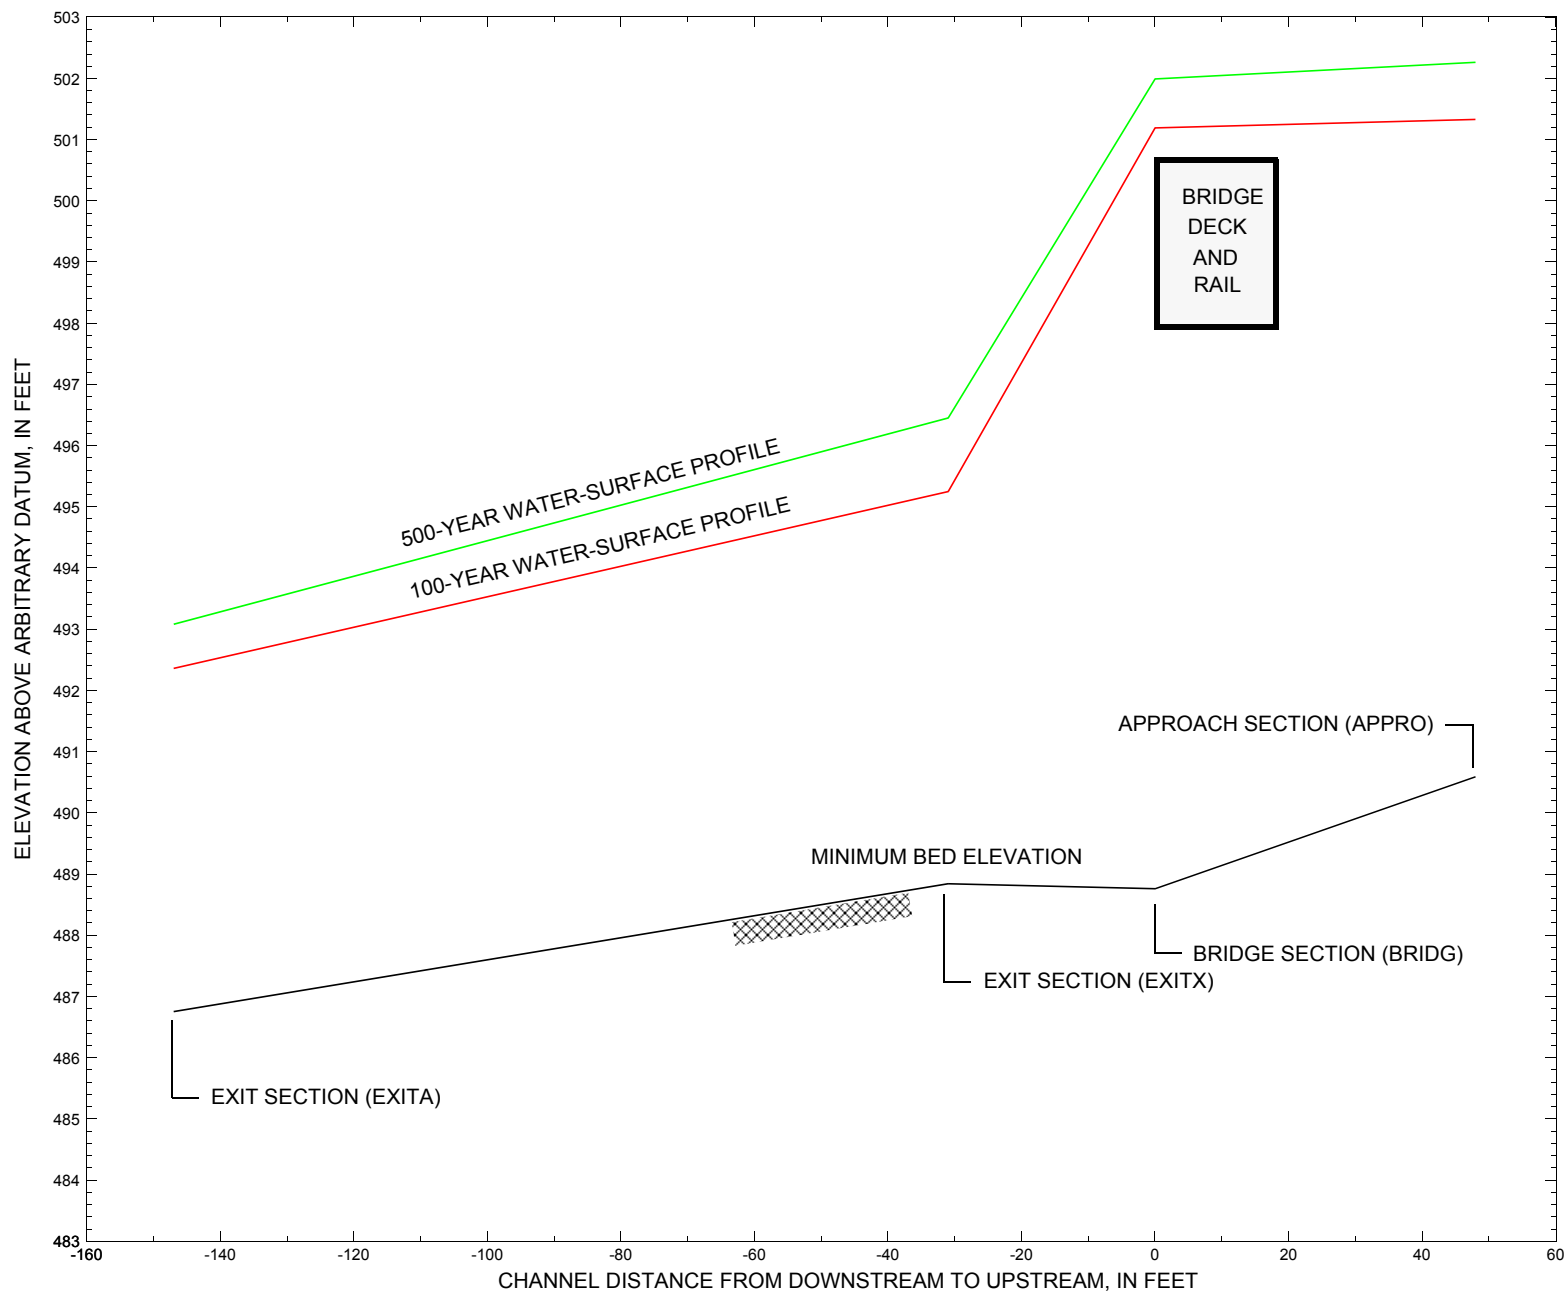
Figure 7. Water-surface profiles for the 100- and 500-year discharges at structure READTH00380027 on Town Highway 38, crossing the North Branch Black River, Reading, Vermont.

Hydraulic analyses of the reach were done by use of the Federal Highway Administration's WSPRO step-backwater computer program (Shearman and others, 1986, and Shearman, 1990). The analyses reported herein reflect conditions existing at the site at the time of the study. Furthermore, in the development of the model it was necessary to assume no accumulation of debris or ice at the site. Results of the hydraulic model are presented in the Bridge Hydraulic Summary, appendix B, and figure 7.

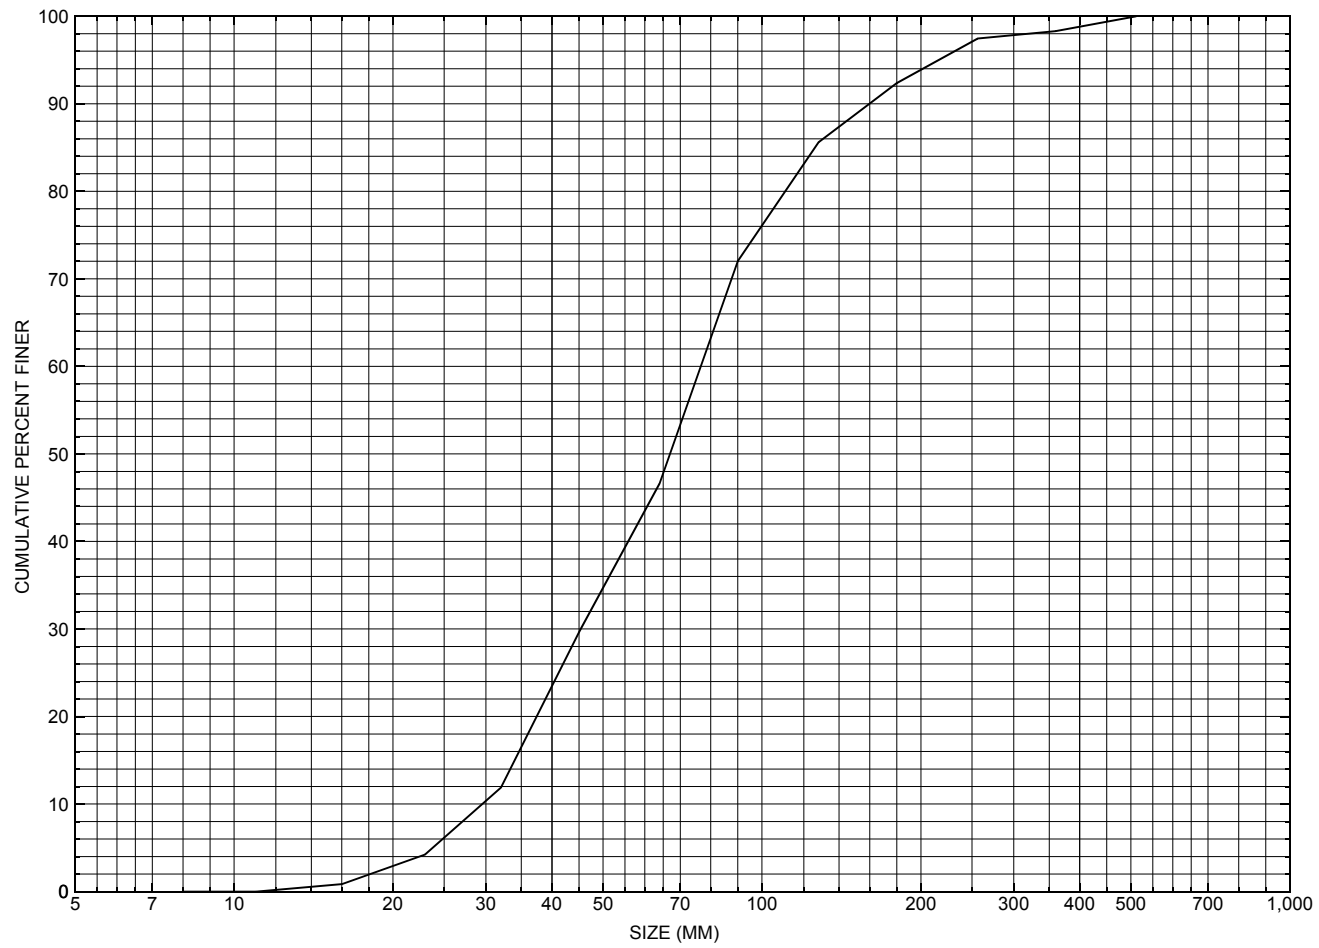
Appendix C. Bed material particle-size distribution for a pebble count in the channel approach of structure READTH00380027, in Reading, Vermont.
