LEVEL II SCOUR ANALYSIS FOR BRIDGE 13 (MNTPTH00CU0013) on CUMMINGS STREET, crossing the NORTH BRANCH WINOOSKI RIVER, MONTPELIER, VERMONT

Open-File Report 98-550

Prepared in cooperation with
VERMONT AGENCY OF TRANSPORTATION
and
FEDERAL HIGHWAY ADMINISTRATION

U.S. Department of the Interior
U.S. Geological Survey

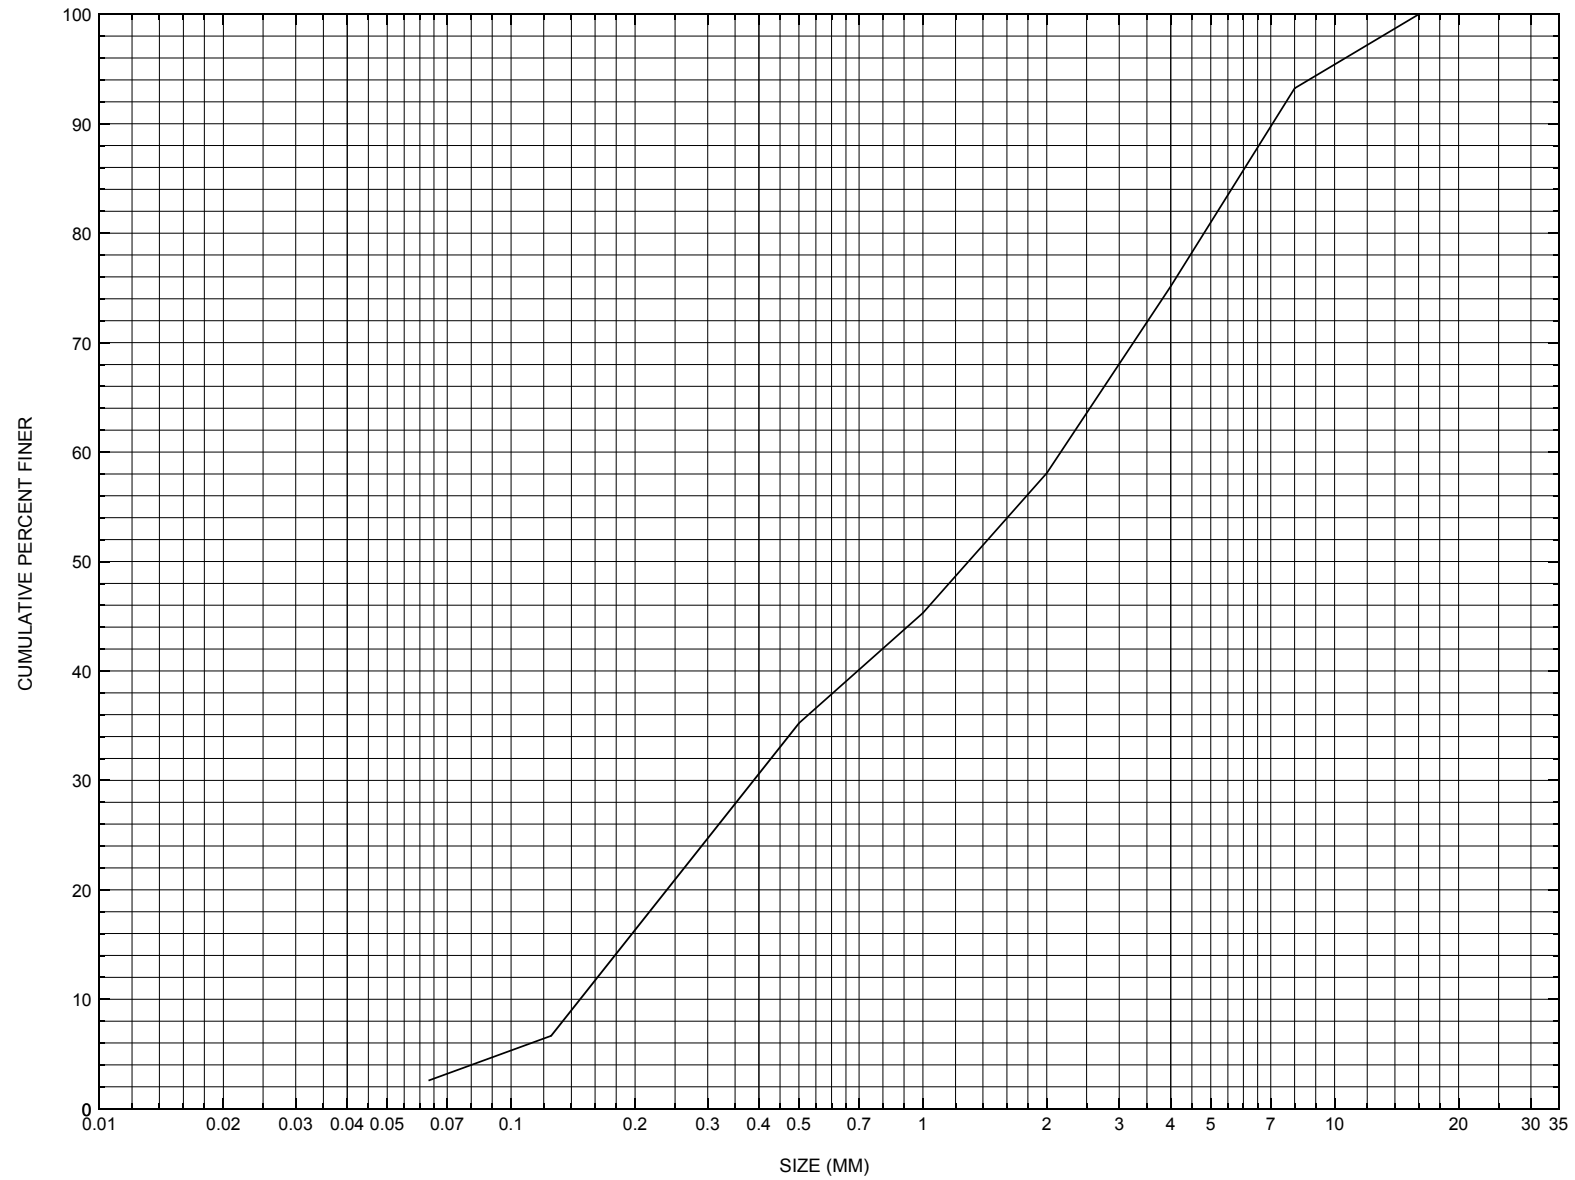
Appendix C. Bed material particle-size distribution for a sieve analysis of a sample from the channel approach of structure MNTPTH00CU0013, in Montpelier, Vermont.
