LEVEL II SCOUR ANALYSIS FOR
BRIDGE 34 (WWINTH00370034) on
TOWN HIGHWAY 37, crossing
MILL BROOK,
WEST WINDSOR, VERMONT

Open-File Report 98-570

Prepared in cooperation with
VERMONT AGENCY OF TRANSPORTATION
and
FEDERAL HIGHWAY ADMINISTRATION

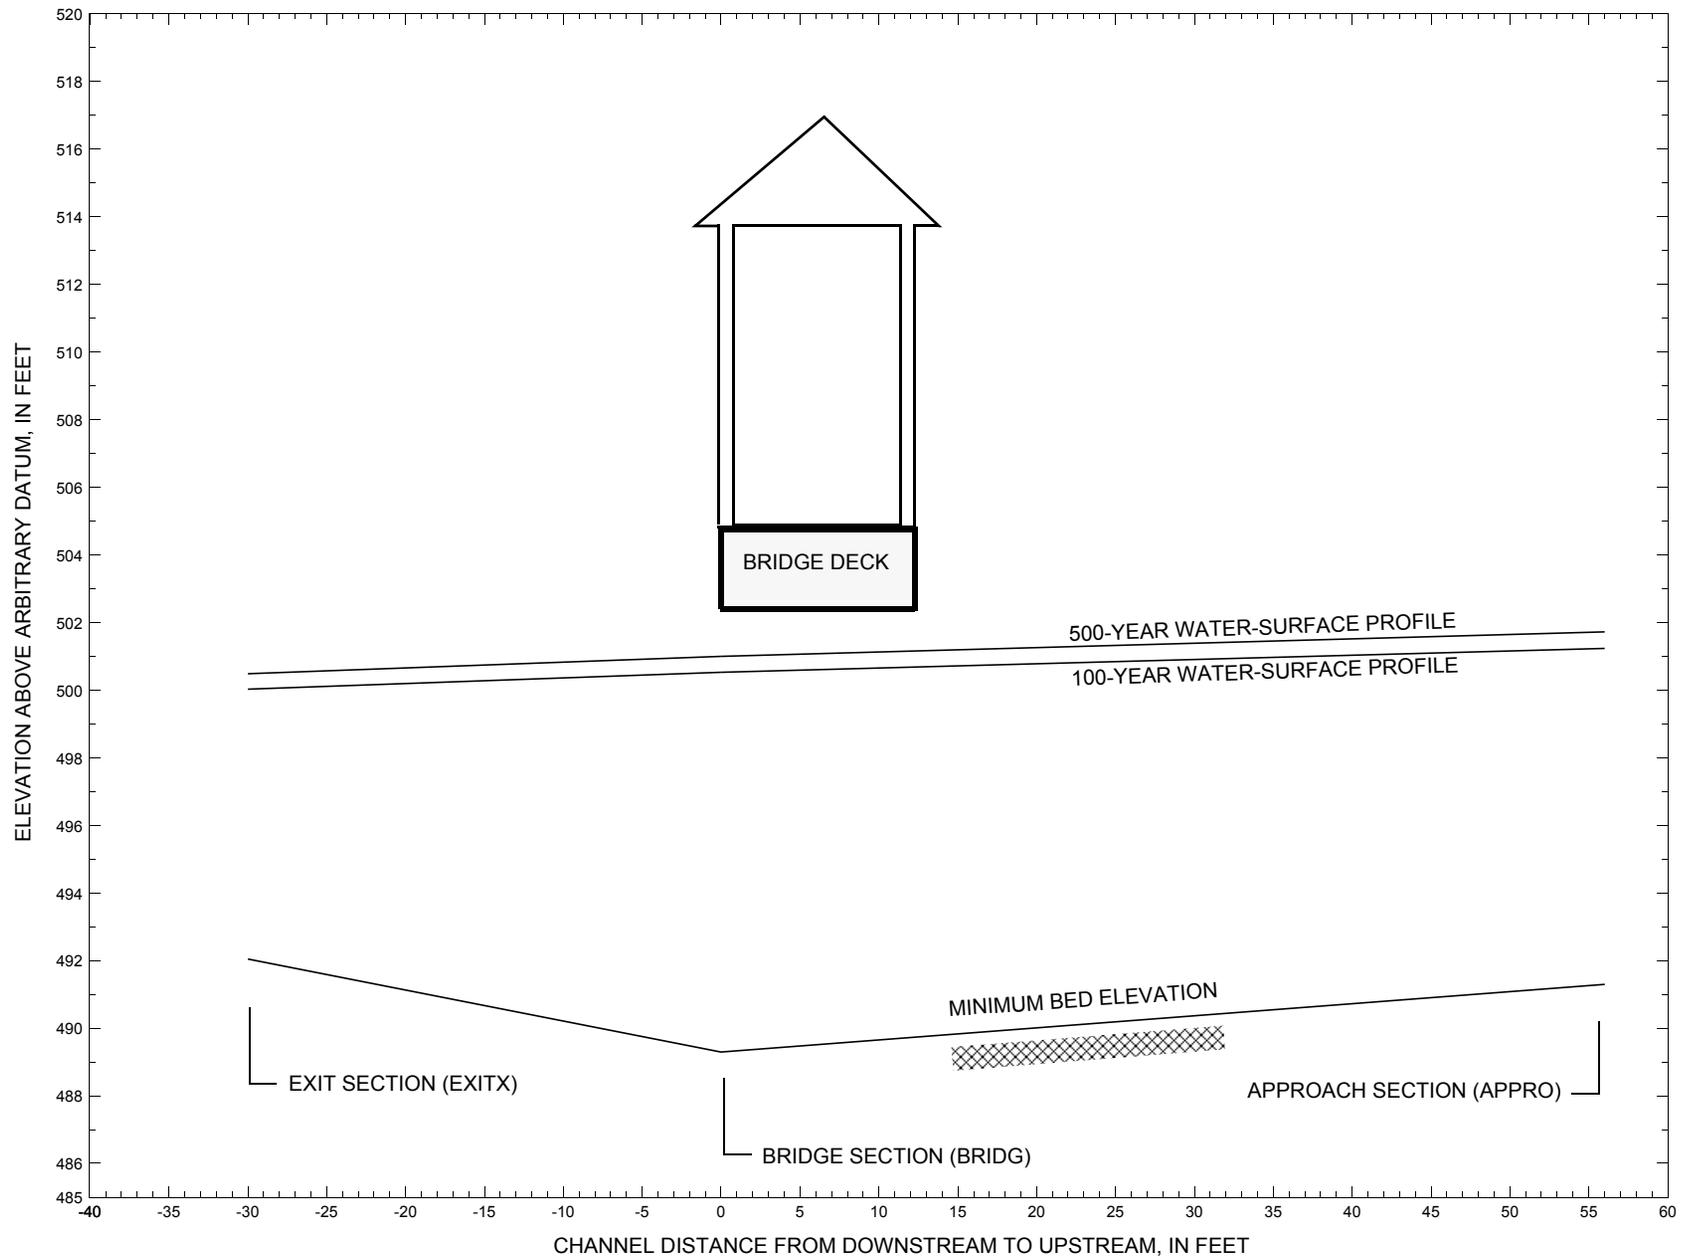
Figure 7. Water-surface profiles for the 100- and 500-year discharges at structure WWINTH00370034 on Town Highway 37, crossing Mill Brook, West Windsor, Vermont.

Hydraulic analyses of the reach were done by use of the Federal Highway Administration's WSPRO step-backwater computer program (Shearman and others, 1986, and Shearman, 1990). The analyses reported herein reflect conditions existing at the site at the time of the study. Furthermore, in the development of the model it was necessary to assume no accumulation of debris or ice at the site. Results of the hydraulic model are presented in the Bridge Hydraulic Summary, appendix B, and figure 7.

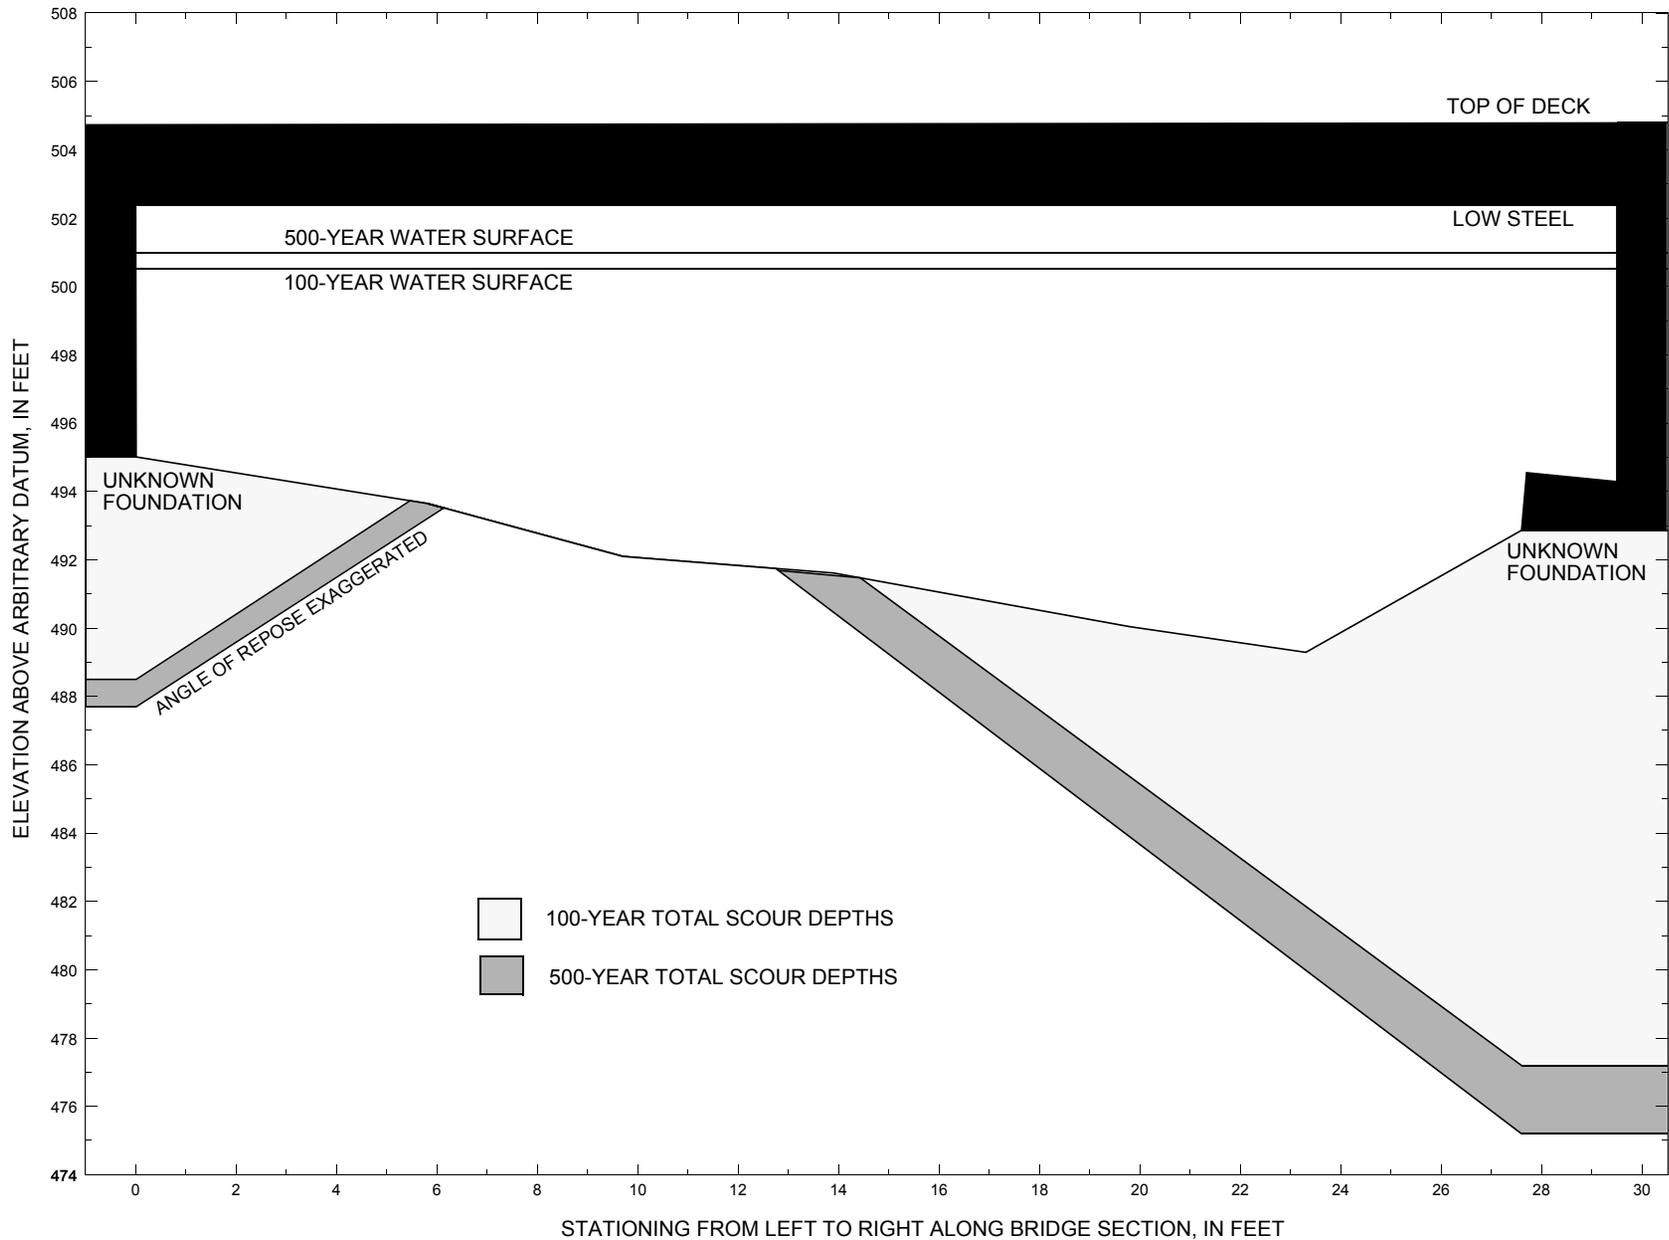
Figure 8. Scour elevations for the 100- and 500-year discharges at structure WWINTH00370034 on Town Highway 37, crossing Mill Brook, West Windsor, Vermont.

Scour depths were computed using the general guidelines described in Hydraulic Engineering Circular 18 (Richardson and Davis, 1995). Scour depths were calculated assuming an infinite depth of erosive material and a homogeneous particle-size distribution. The results of the scour analyses for the 100- and 500-year discharges are presented in tables 1 and 2 and the scour depths are shown graphically in figure 8.

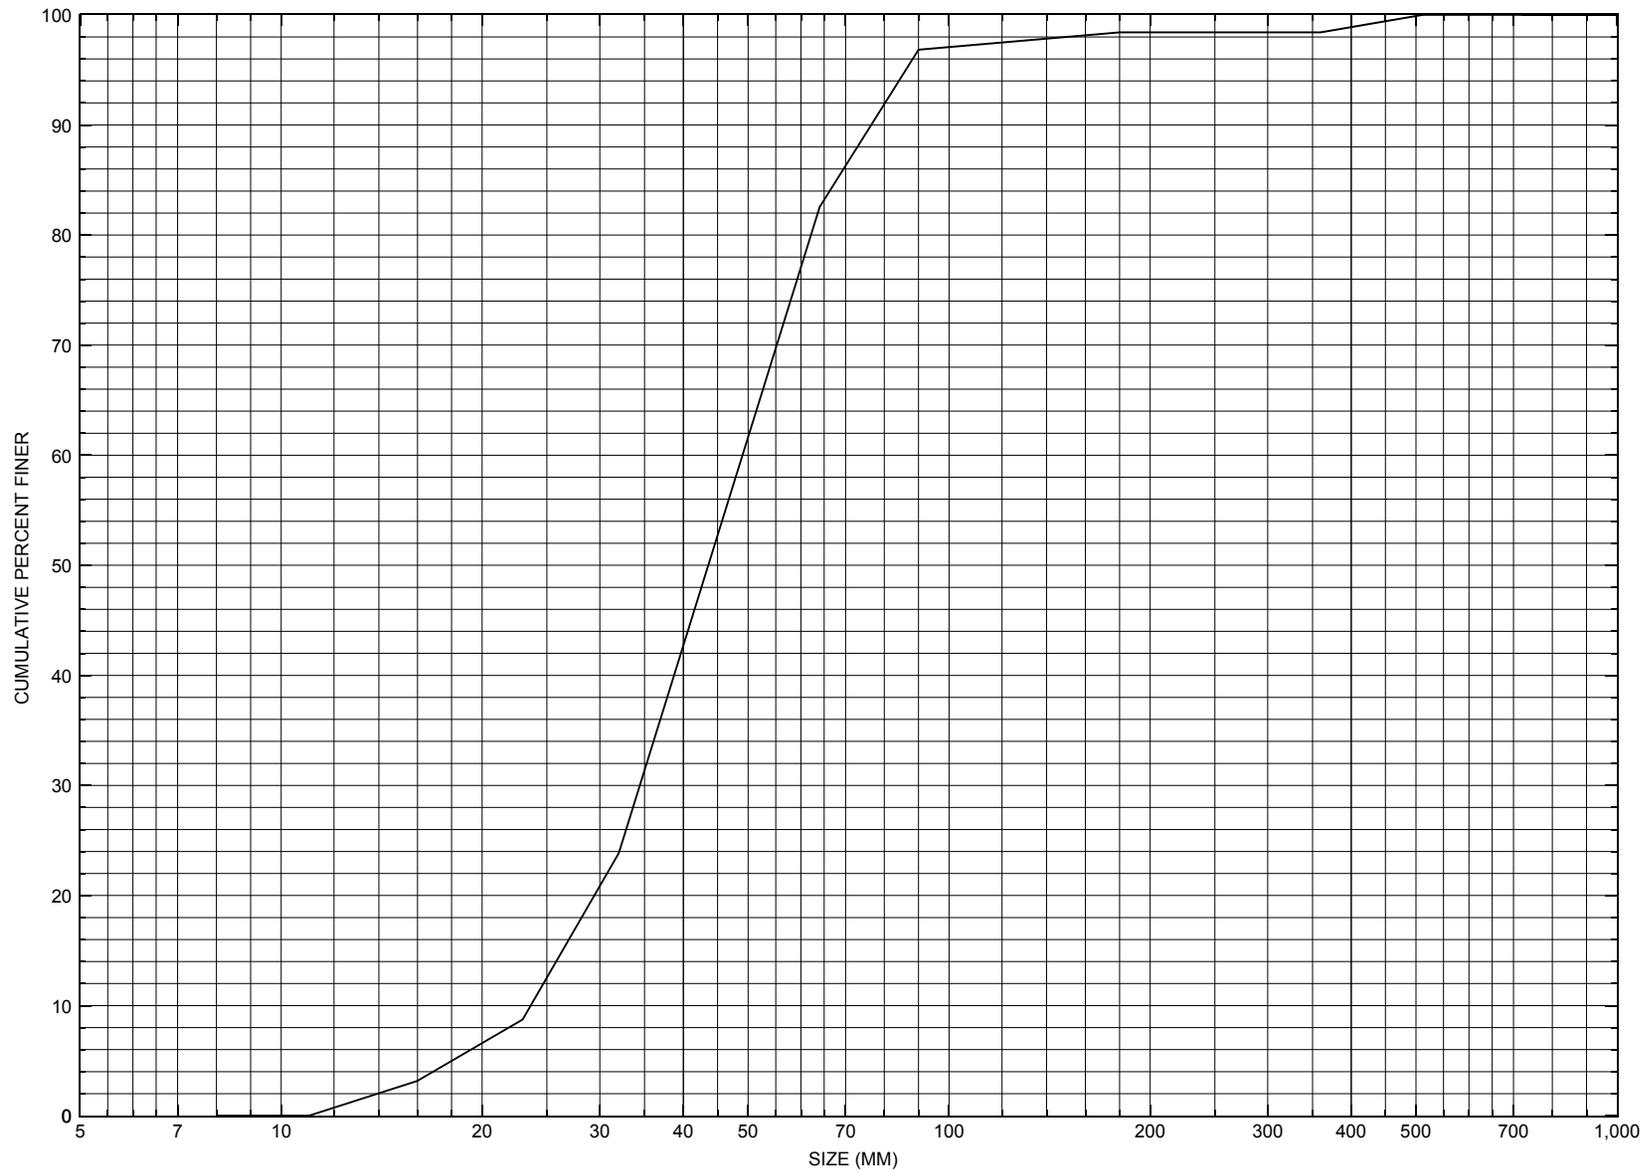
Appendix C. Bed material particle-size distribution for a pebble count in the channel approach of structure WWINTH00370034, in West Windsor, Vermont.
