LEVEL II SCOUR ANALYSIS FOR
BRIDGE 42 (BAKETH00060042) on
TOWN HIGHWAY 6, crossing
THE BRANCH,
BAKERSFIELD, VERMONT

Open-File Report 98-585

By ERICK M. BOEHMLER AND JAMES R. DEGNAN

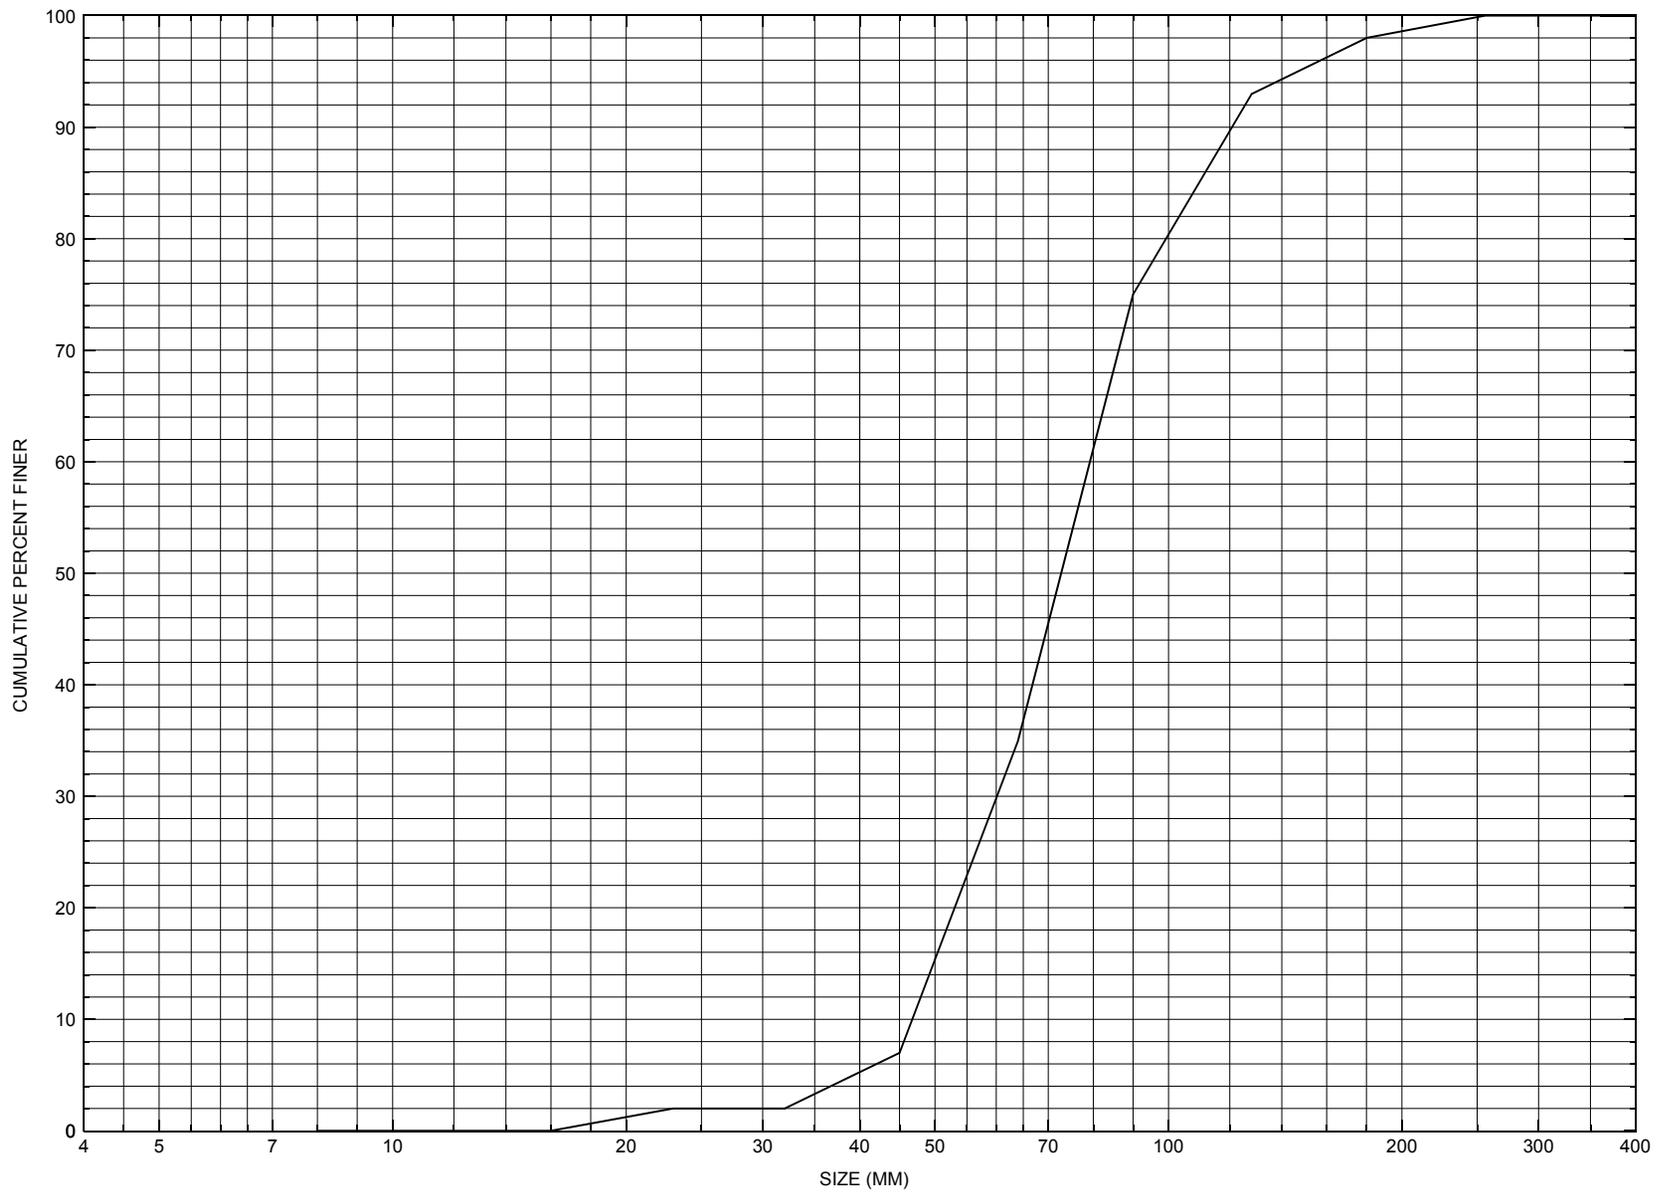
Appendix C. Bed material particle-size distribution for a pebble count in the channel approach of structure BAKETH00060042, in Bakersfield, Vermont.
