U.S. DEPARTMENT OF THE INTERIOR
U.S. GEOLOGICAL SURVEY

EXPERIMENTAL TESTING OF FLEXIBLE BARRIERS FOR CONTAINMENT OF DEBRIS FLOWS

OPEN-FILE REPORT 99-205

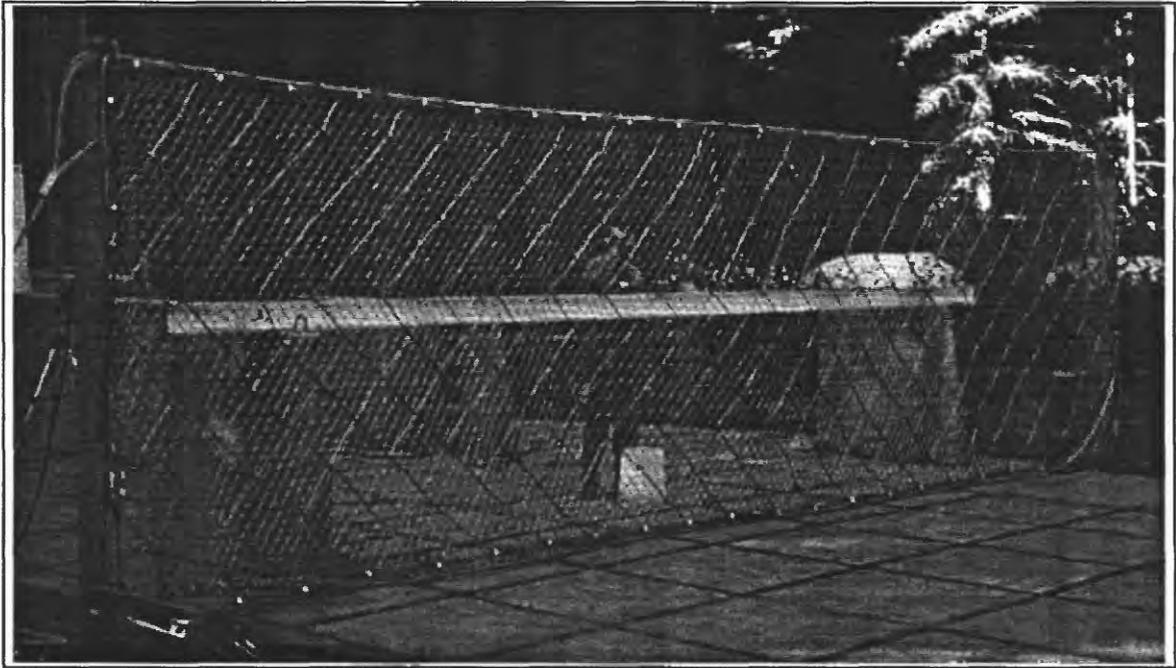
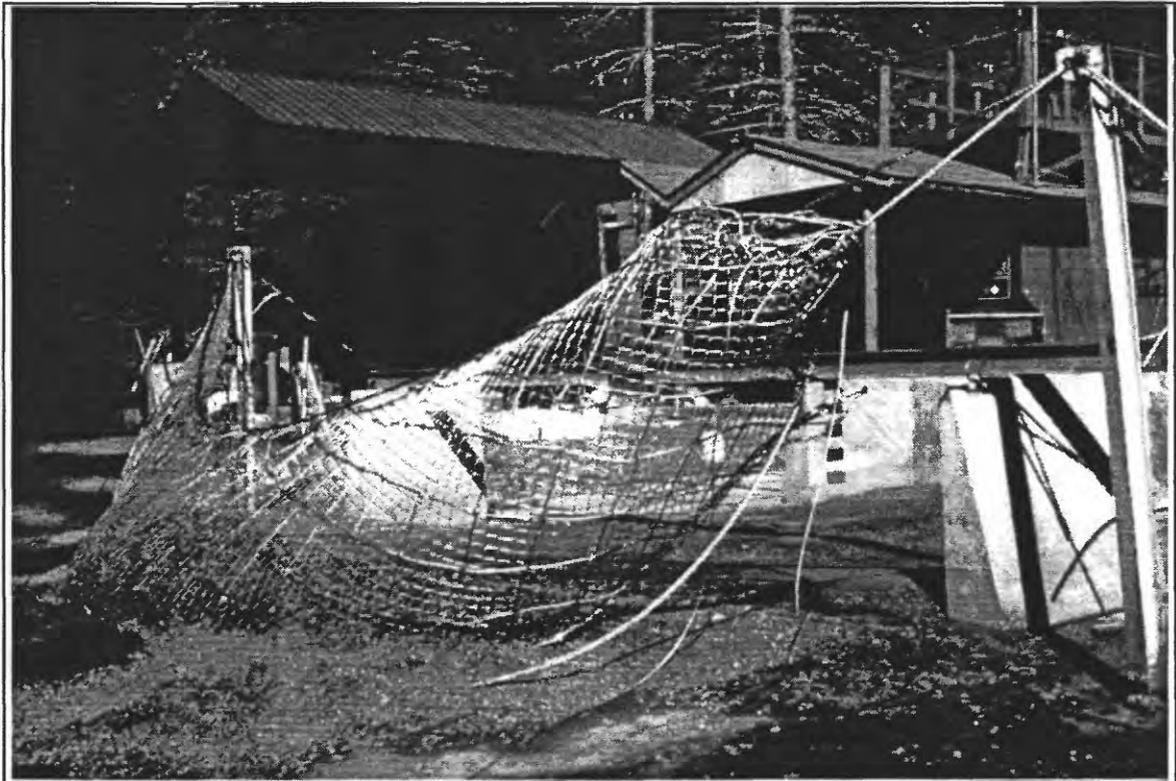
Figure 2. Barrier 1 (test 1).

Figure 3. Post-flow condition of barrier 1 (test 1).

The first barrier system (test 1) employed 30 cm by 30 cm wire rope netting overlaid with a 5.1 cm chain link liner to reduce the size of the largest clear opening. The net panel was supported by 1.9 cm diameter perimeter and anchor cables and two vertical W 4 x 13 structural steel columns rigidly fixed to concrete anchor pads. W 4 x 13 is the American Institute for Steel Construction (AISC) designation for a wide-flange section having a nominal depth of 4 inches and a weight of 13 pounds/lineal foot. Photographs taken before and after the debris flow are included as figures 2 and 3.

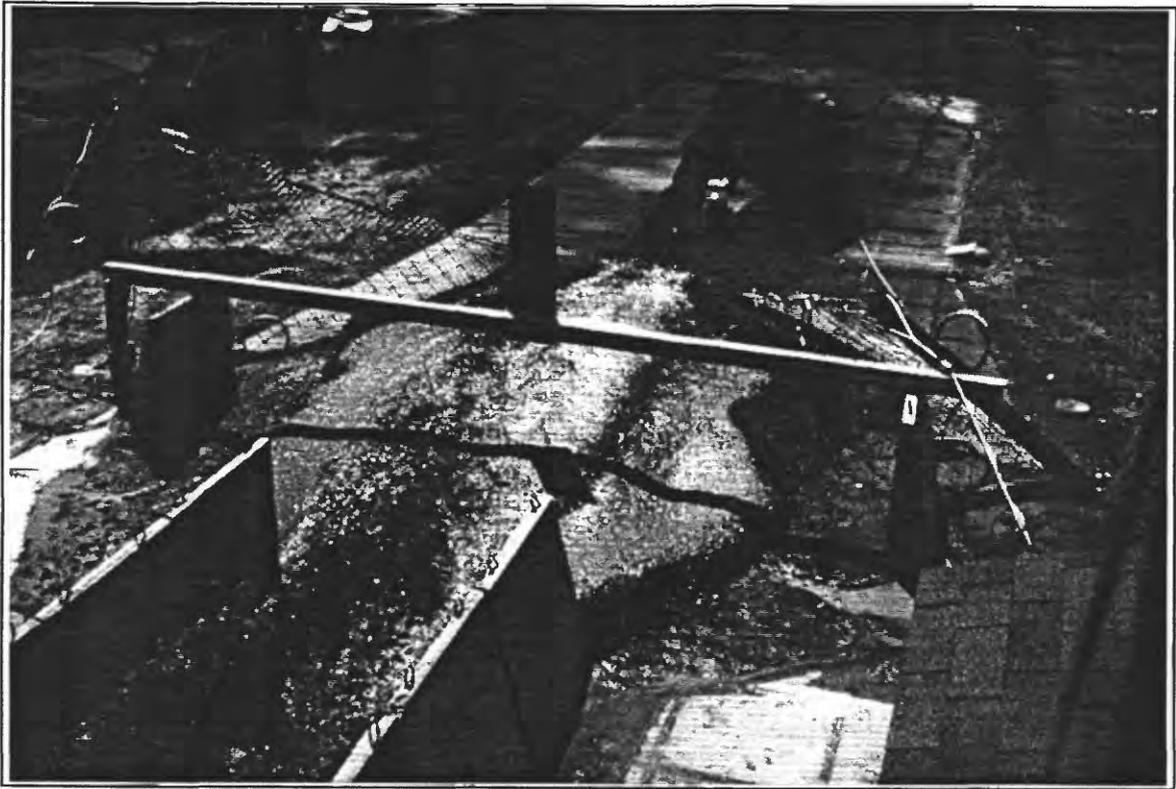
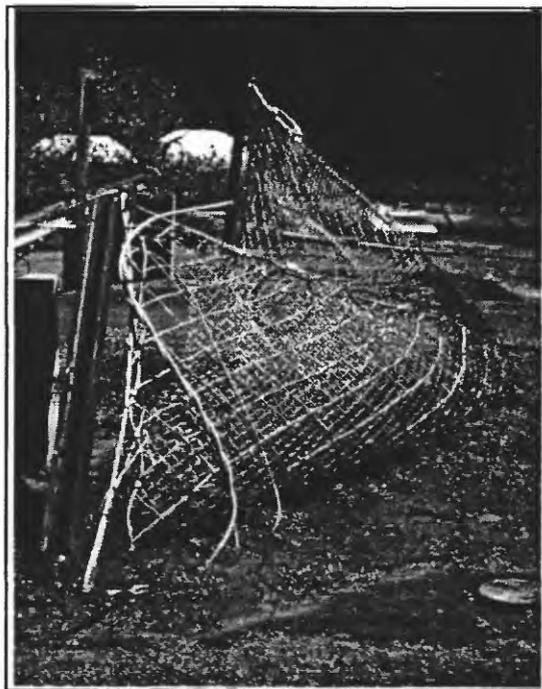
Figure 4. Maximum run-up on barrier 2 (test 2).

Figure 5. Post-flow condition of barrier 2 (test 2).

Figure 6. Collapse of right column and overtopping of barrier 2 (test 3).

Figure 7. Post-flow profile view of barrier 2 (test 3).

The second barrier system (tests 2 and 3) employed 20 cm by 20 cm wire rope netting overlaid with a 5 cm chain link liner. An additional chicken wire liner was attached to the middle third of the net to further reduce the size of the largest clear opening. The net panel was supported by 1.9 cm diameter perimeter and anchor cables and hinged-base steel columns. The barrier was subjected to two consecutive debris flows. Photographs taken during and after the debris flow are included as figures 4-7.

column failure and collapsed during the flow. The second barrier system performed well during the initial debris flow (test 2) but experienced an anchor cable connection failure and partially collapsed during the subsequent debris flow (test 3). The last two barrier systems incorporated both chain link and chicken wire (tests 4 and 5) or silt screen (test 6) net panel liners. As shown in table 2, each barrier stopped and contained most of the flowing debris. Essentially full containment was realized in test 6, where less than 0.05 percent of the sediment passed beneath or through the net.

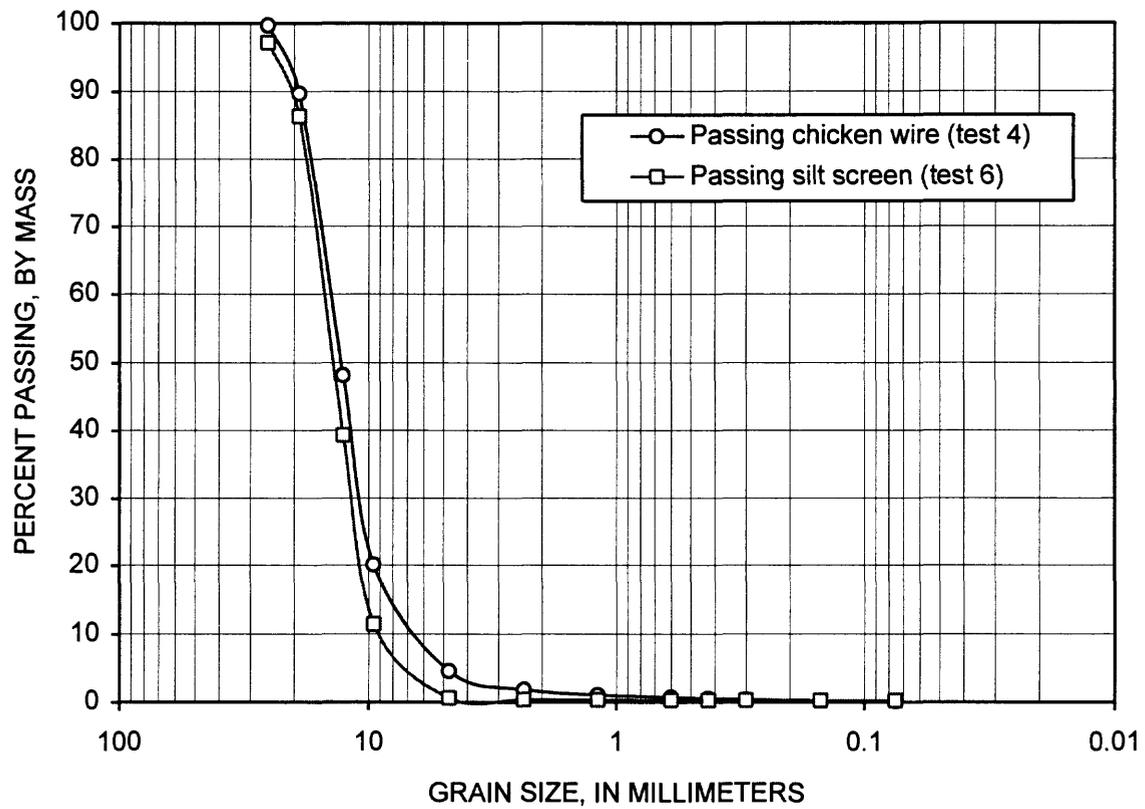
Figure 15. Comparison of gradations of retained and passing debris (test 2).

Figure 16. Comparison of gradations of retained and passing debris (test 4).

Figure 17. Comparison of gradations of retained and passing debris (test 6).

Figure 18. Comparison of debris passing the chicken wire (test 4) and silt screen (test 6) net liners.

Laboratory sieve analyses were done to determine the gradation characteristics of sediment samples recovered at the conclusion of each debris flow. The dry mass of these samples ranged from 2.6 to 17.0 kg (kilograms). Grain size distribution curves of the passed and retained materials are compared in figures 15-18. In tests 4 and 6, the passed material consisted almost entirely of gravel-sized particles (fig. 16 and 17). As expected, somewhat more sand passed through the chicken wire than the finer-mesh silt screen (fig. 18). Photographs reveal that a very diffuse spray of gravel always precedes the first wave of flowing debris. It is this diffuse spray (and only this spray) that passed beneath and through the net. Most of the passed material came to rest very quickly. In test 6, for example, only 12.5 percent of the passed material (0.006 percent of the initial volume) flowed more than 3 m beyond the net (fig. 19).
