Survey of Lake Ontario Bottom Sediment off Rochester, New York, to Define the Extent of Jettisoned World War II Matériel and its Potential for Sediment Contamination

Open File Report 99-237

Prepared in cooperation with the
New York State Department of
Environmental Conservation

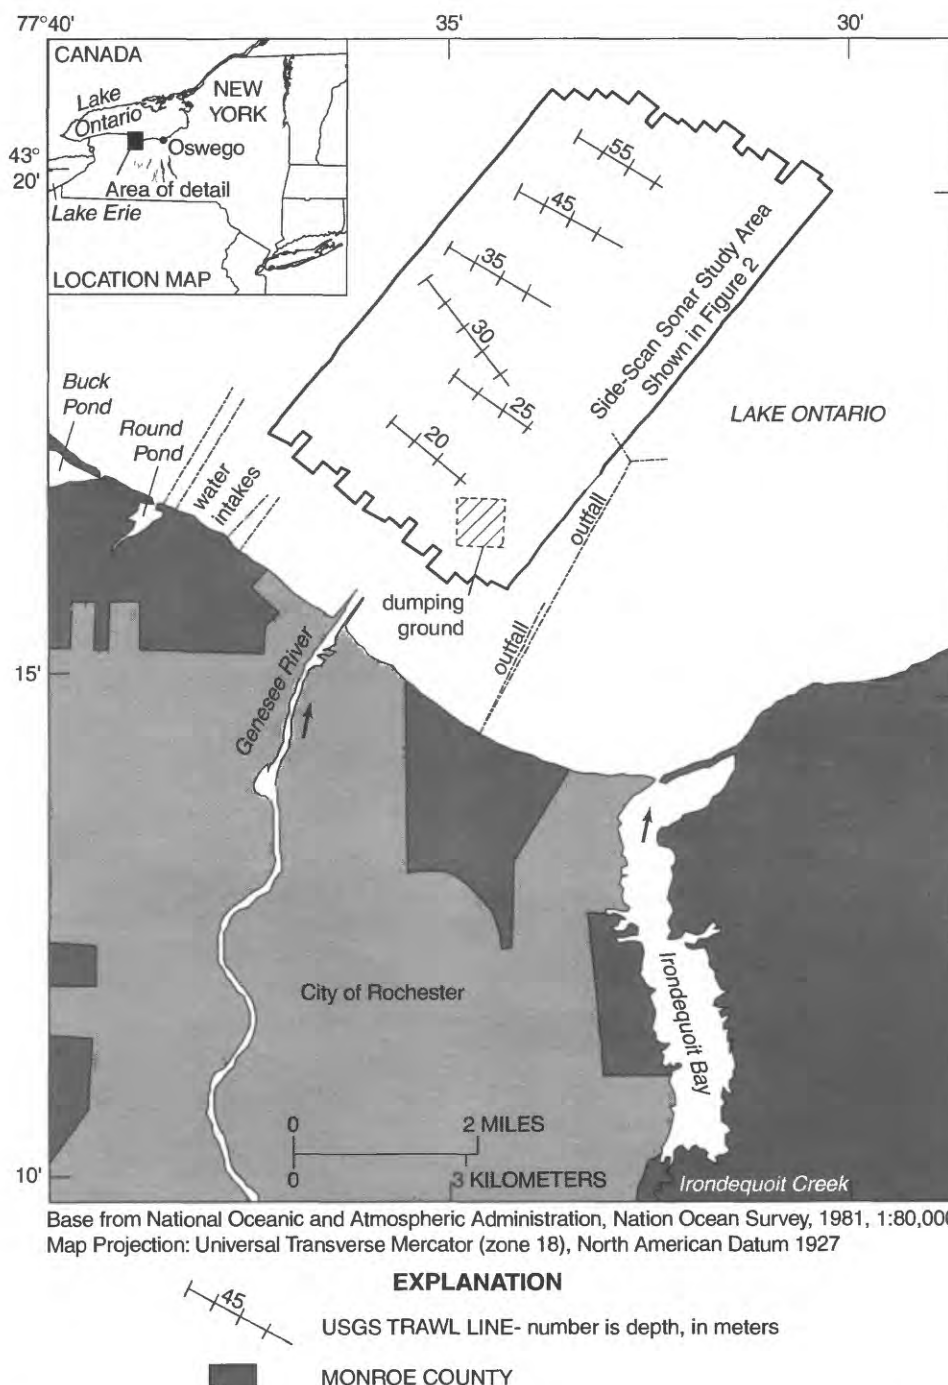
Figure 1. Map showing location of side-scan SONAR and remote-operated-vehicle (ROV) underwater video survey area in Lake Ontario, north of Rochester, N.Y., and locations of U.S. Geological Survey (USGS) trawl survey.

The recovered debris was routinely thrown overboard until the recovery of the mercury capsules in 1993, whereupon the NYSDEC was notified. (See appendix.) Representative samples of the military debris found in the trawl nets were saved from 1994 through 1996 and temporarily stored at LOBS. In 1996, the NYSDEC obtained funds from Region II of the U.S. Environmental Protection Agency to delineate the extent of the debris on the lake bottom and to evaluate its potential to contaminate the bottom sediment with mercury and (or) other heavy metals. The NYSDEC in 1997 began a study in cooperation with the U.S. Geological Survey (USGS) to conduct a preliminary assessment of the 17-mi² lake-bottom area in which debris had been found (fig. 1) to locate debris piles or fields.

The lake area historically surveyed for fish by the LOBS in the Rochester offshore area is about 2 mi north-northeast of the mouth of the Genesee River, near Rochester (fig. 1). Bottom-trawl tows have been conducted in this area from mid-April through mid-May, in June, from mid-July through mid-August, and

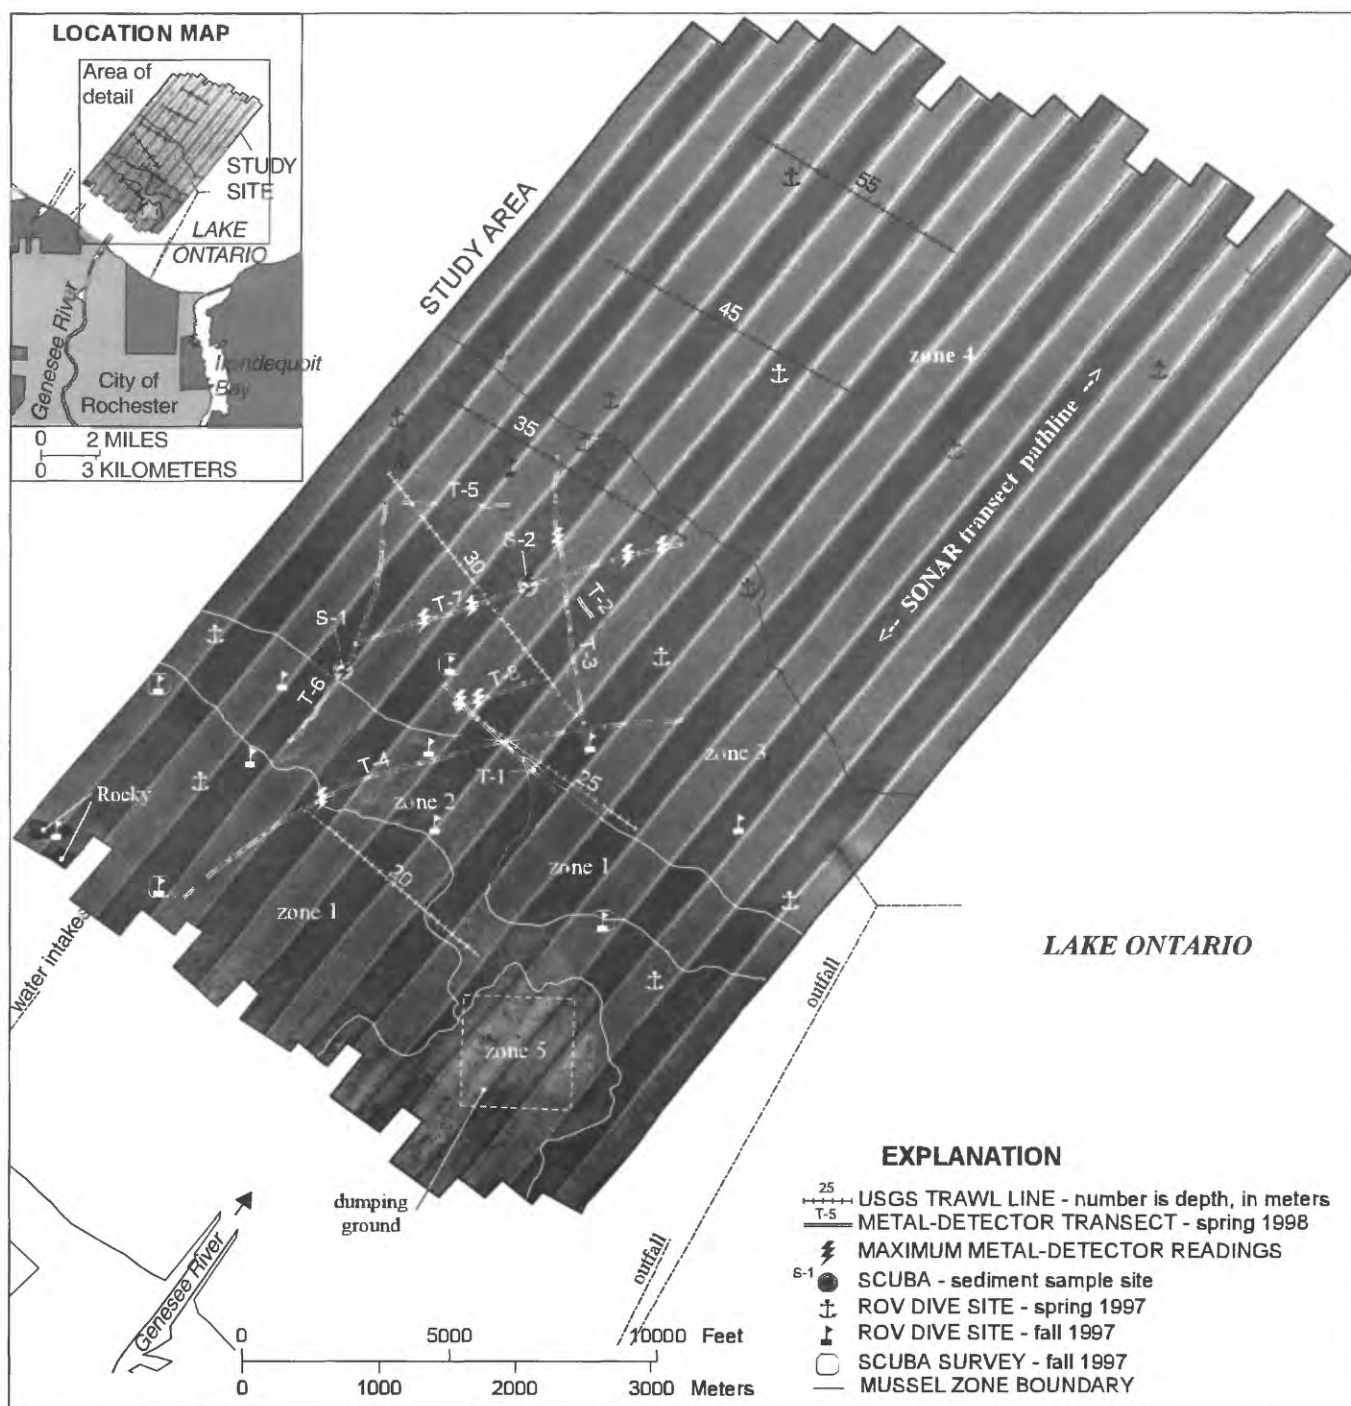
Figure 2. Side-scan SONAR mosaic showing reflectance patterns from surficial substrate, locations of metal-detector surveys and of maximum readings, ROV underwater video surveys, and SCUBA sediment-sampling sites in Lake Ontario, north of Rochester, N.Y.

On May 24, 1997, the USGS Great Lakes Science Center (GLSC), Ann Arbor, Mich. began SSS and ROV underwater video reconnaissance surveys of the 17-mi² study site (figs. 1, 2) from the research vessel *Kaho*. The surveys were completed by May 29, 1997. Data collection included (1) SSS mapping (100-kHz frequency) of the 17-mi² study area at 1:4,000-scale, and detailed SSS mapping (100- and 500-kHz frequency) at 1:1,000-scale, of three selected sites

Examination of the 1:4,000-scale SSS images from the mussel patches within the mapped area (figs. 2 and 5-8) indicated five zones of differing reflectance intensity and pattern, as follows;

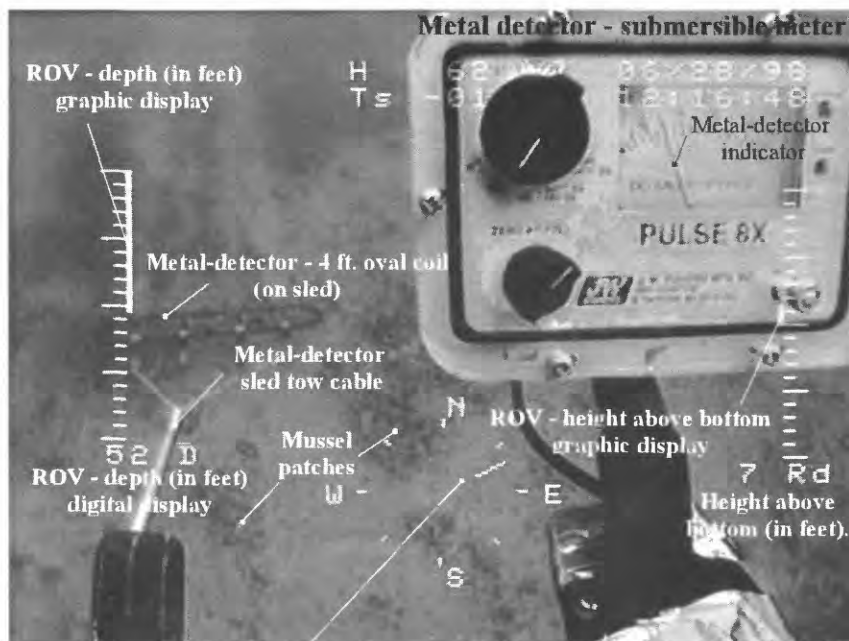
Compass needle graphic, indicating northeast heading
(Direction of view only - ROV is being pulled backwards in a southwest heading.)

Figure 3. Example of ROV image showing towable metal detector used to locate magnetic anomalies in Lake Ontario, north of Rochester, N.Y.

The new sled-mounted metal detector was attached directly to the ROV such that the sled, which was towed along the bottom, and a submersible meter attached to the detector, were in constant view on the video monitor (fig. 3) onboard the *Kaho*. The combined apparatus was pulled along the bottom following the *Kaho*'s drift through the study area (fig. 2). A mapping-grade differential GPS was used to track the vessel's drift for each transect, and subsequent transects were oriented to maximize coverage within the area accessible by SCUBA (depths of 100 ft or less). As the coil passed over or near a metallic object, the meter's needle would fluctuate, and at that moment the GPS position was noted so that the location of the magnetic response indicated by the needle deflection could be relocated later. With the coil and the surrounding substrate in the ROV's video-camera view, the video image would indicate whether the object was visible on the lake bottom (fig. 3). Upon completion of the drift transects, the video tapes were reviewed, and two sites were chosen for sampling on the basis of detector response and the physical characteristics (mounds and depressions) of each area.

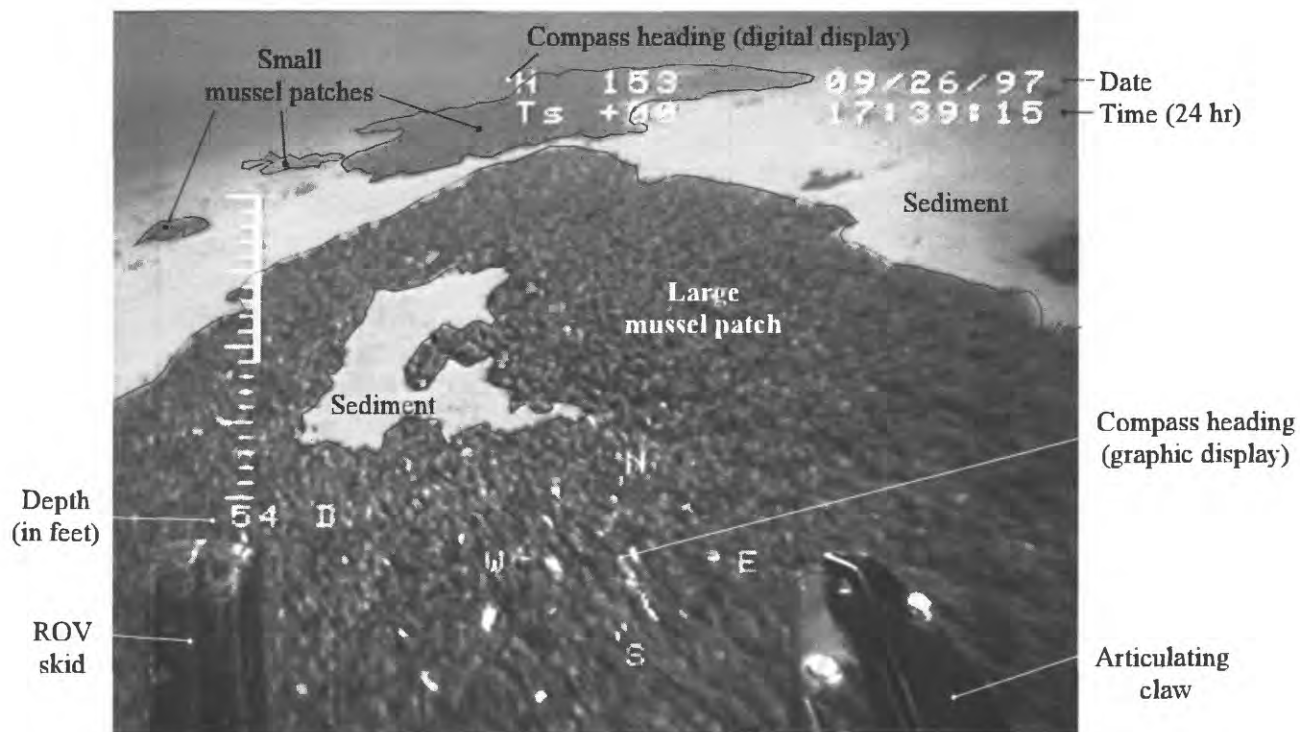
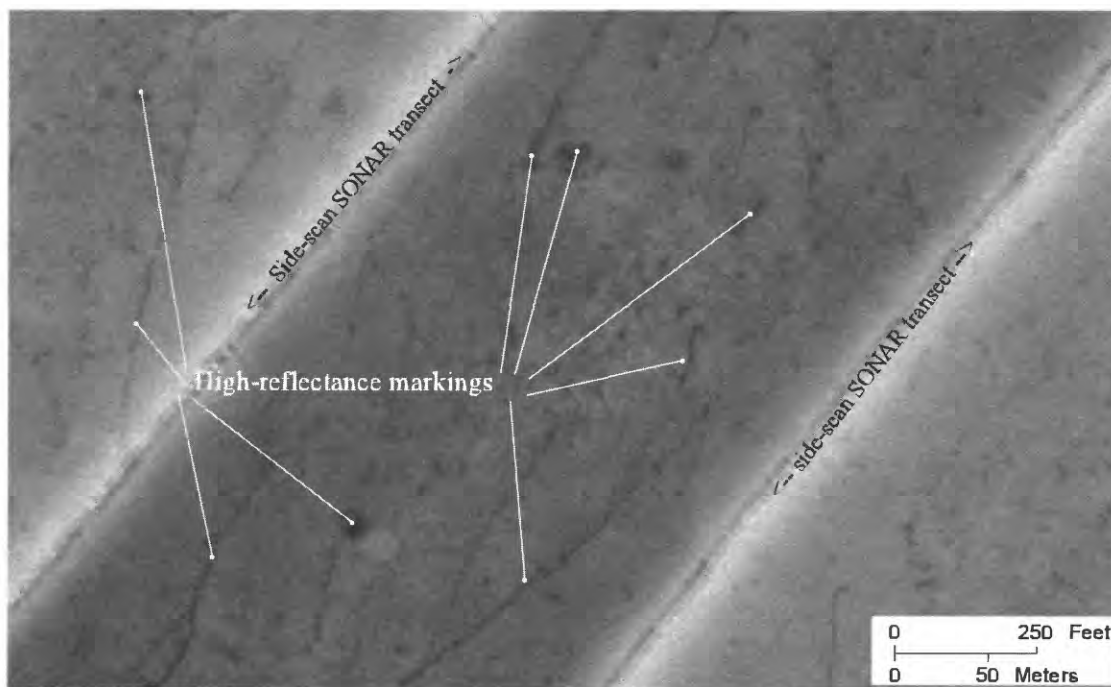
A. ROV video image.

B. Side-scan SONAR image

Figure 4. Sample ROV video image (fall 1997) showing bed of mussels observed during initial ground-truthing dives to inspect high-reflectance targets recorded on spring, 1997 side-scan SONAR survey in Lake Ontario, north of Rochester, N.Y.

Preliminary examination of the 1:4,000-scale SSS images from May 1997 showed many potential targets (high SONAR reflectance areas) that appear on the SONAR record as dark "patches," of which 15 were chosen for the initial, (June 1997) ROV underwater-video surveys. Analysis of the underwater video indicated that all targets were large patches of mussels (fig. 4). The mat of mussel shells forms an acoustic reflective surface that contrasts with the surrounding soft sand, silt, and clay substrate and, when displayed as a SONAR image, appears similar to the image expected from a small pile of debris. This is consistent with findings by the GLSC in Lake Erie, where similar patterns of mussel encrustation of soft substrates have been observed (Berkman and others, 1998). The ROV

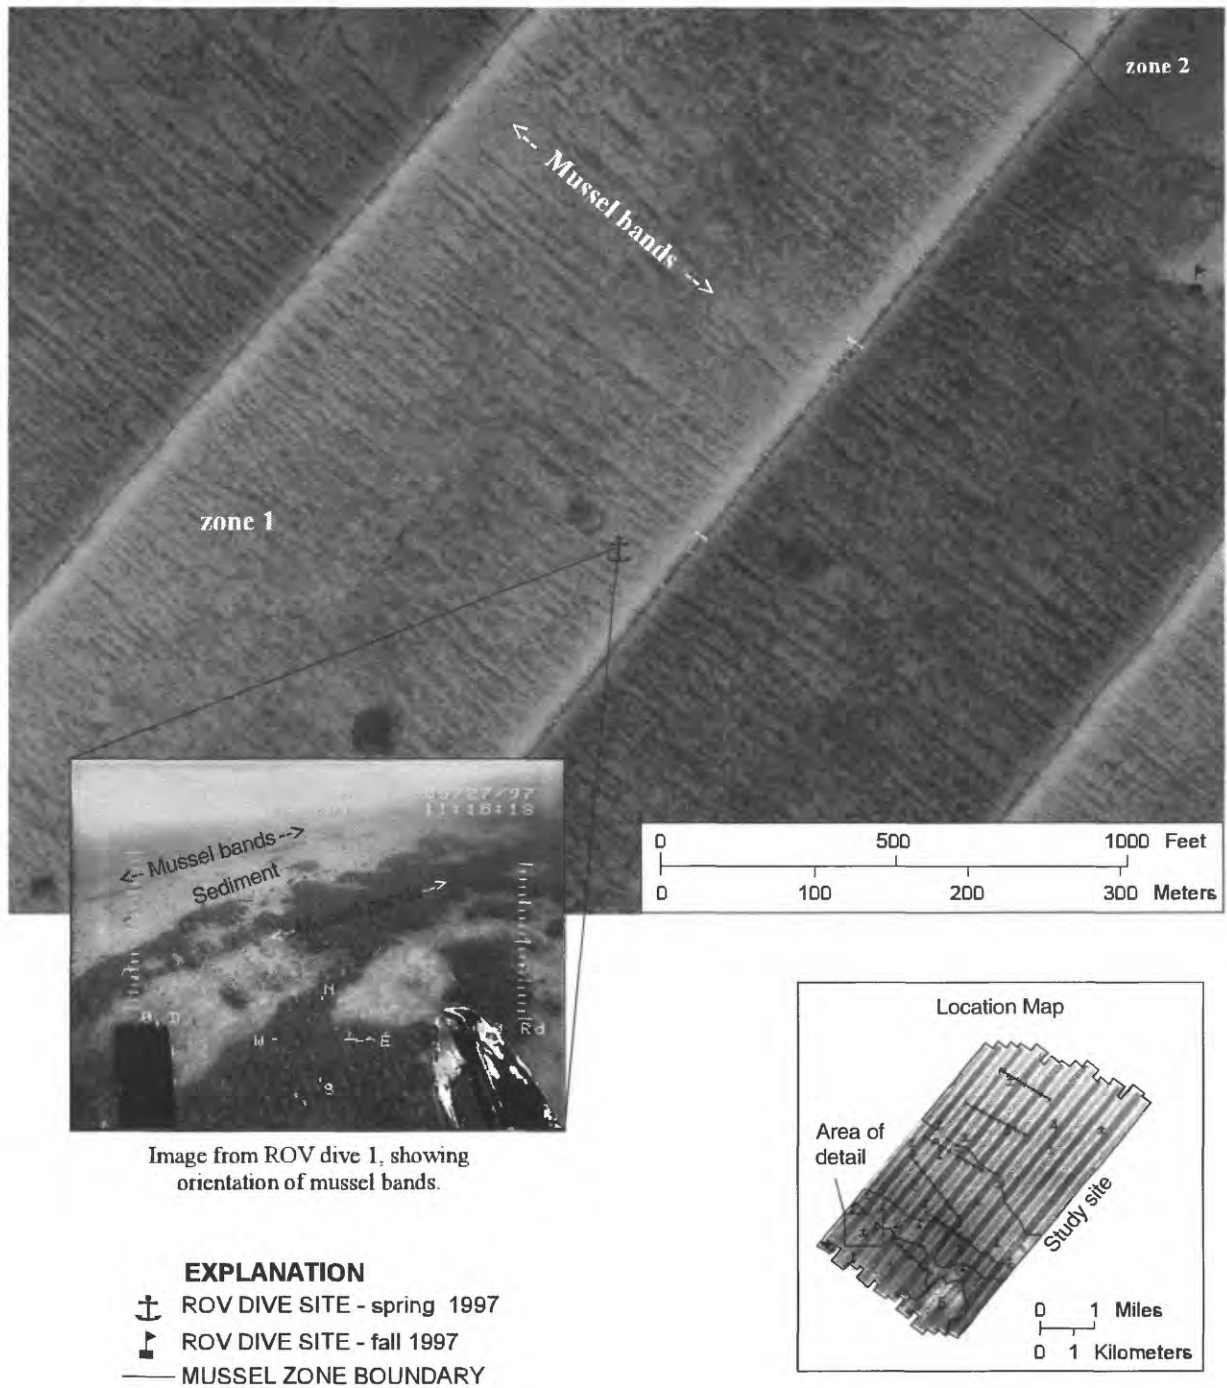
Zone 1 is closest to shore, and depths are less than 65 ft. Mussel patches are in the form of "bands" on the sediment surface (fig. 5); the underlying sediment appears to be mostly sand and silt. These bands appear similar to large sand ripples and average about 15 ft in width. Zone 1 is mostly within the west-southwest corner of the study area but is separated into two parts by an area that roughly coincides with the dredge-spoil-disposal area for sediment dredged from the Genesee River (fig. 1) and by part of Zone 2 (fig. 2). Zone 1 encompasses about 15 percent of the 17-mi² study area. The ROV video from Zone 1 indicates that more than 80 percent of the sediment is encrusted with mussels.

Figure 5. Close-up view of side-scan SONAR mosaic image showing mussel "bands", locations of ROV dive sites in zone 1, and image from ROV dive 1 (spring 1997), showing mussel band in the Lake Ontario study area, north of Rochester, N.Y.

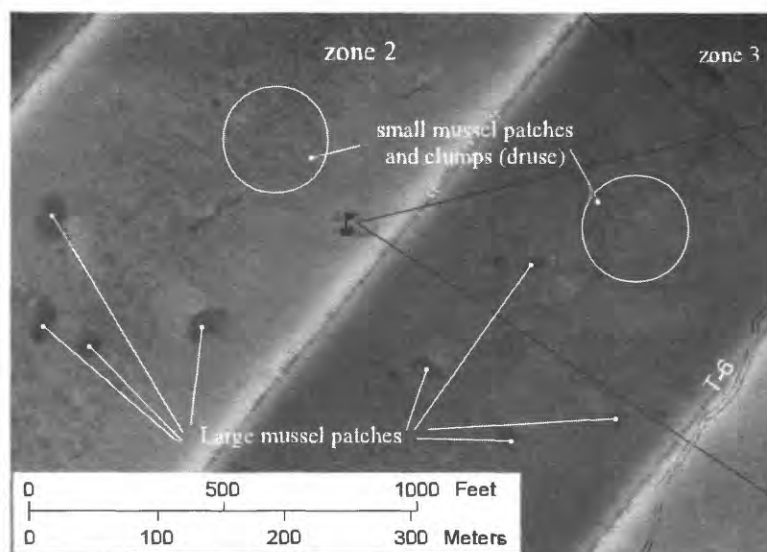
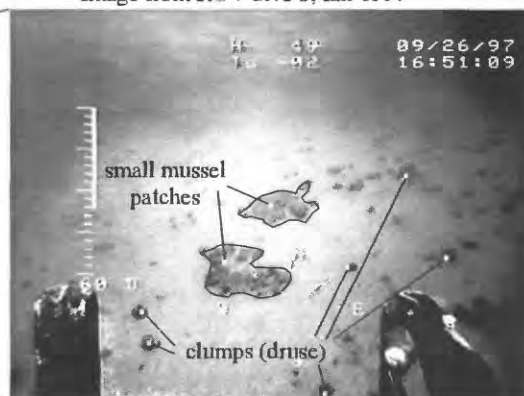
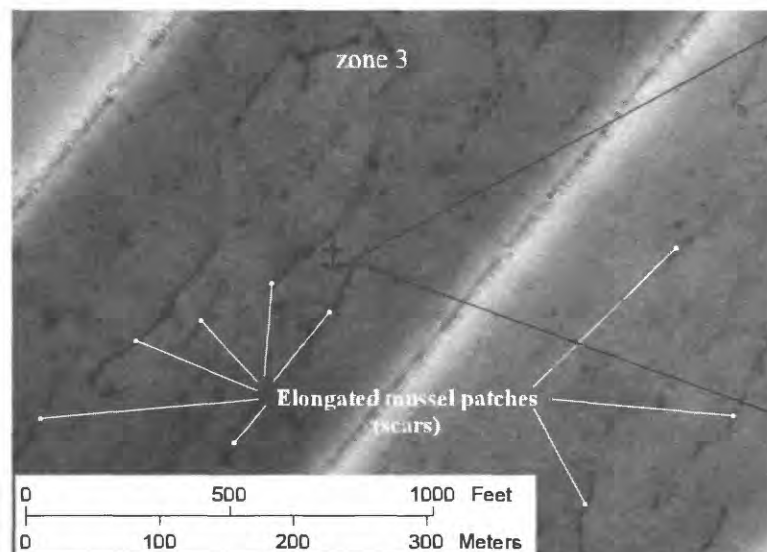
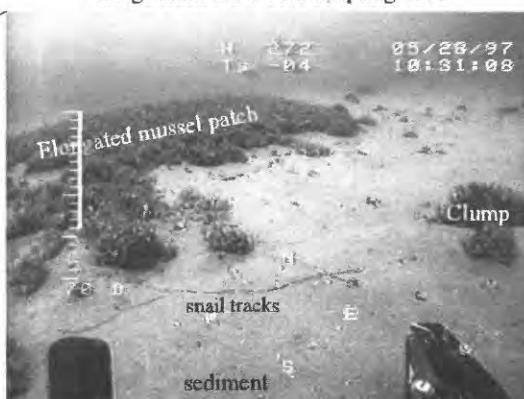
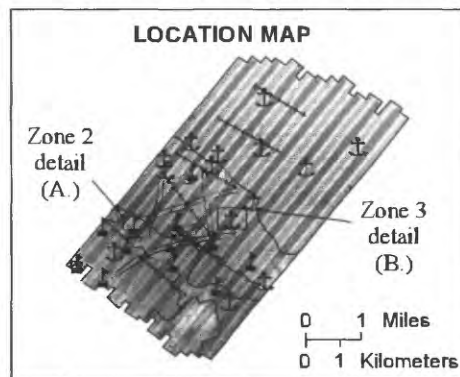
Zones 2 and 3 occupy the middle third of the survey area and contain a random distribution of mussel “patches” (fig. 6A) and linear “scars” (fig. 6B). The “patches” (Zone 2) range from 6 to 30 ft in diameter, and the linear “scars” (Zone 3) can exceed 300 ft in length. The sediment in this zone shows a considerable number of furrows that generally run parallel to shore. These furrows may have been caused by the trawl-net “doors” that drag along the bottom and keep the mouth of the net open during the fish-survey tows. Estimated water depth in zones 2 and 3 ranges from 65 ft to 130 ft. ROV video images indicate that mussels cover more than 50 percent of the lake bottom in Zone 2, which is closer to shore than Zone 3, the “scarred” zone, in which mussel coverage was around 25 percent. The linear furrows initially seemed to hold the highest probability for detection of debris, but the ROV surveys found only mussel encrustation.

A. zone 2

Image from ROV dive 5, fall 1997

Small patches in this image are about 1-2 feet in diameter. Clumps are about 2-6 inches in diameter.

B. zone 3

Image from ROV dive 9, spring 1997

Image shows the trailing edge of an elongated patch that is about 2-3 feet wide, and stretches (beyond the view) for about 100 feet. A small clump (about 3 inches in diameter) can be seen on the right side of the image.

Figure 6. Close-up view of side-scan SONAR mosaic images showing mussel settlement in random distribution ("patches") in zone 2, and in linear features ("scars") in zone 3, and ROV dive images: A. Mussel "patches" in zone 2, fall 1997. B. Mussel "scars" in zone 3, spring 1997, in Lake Ontario study area, north of Rochester, N.Y.

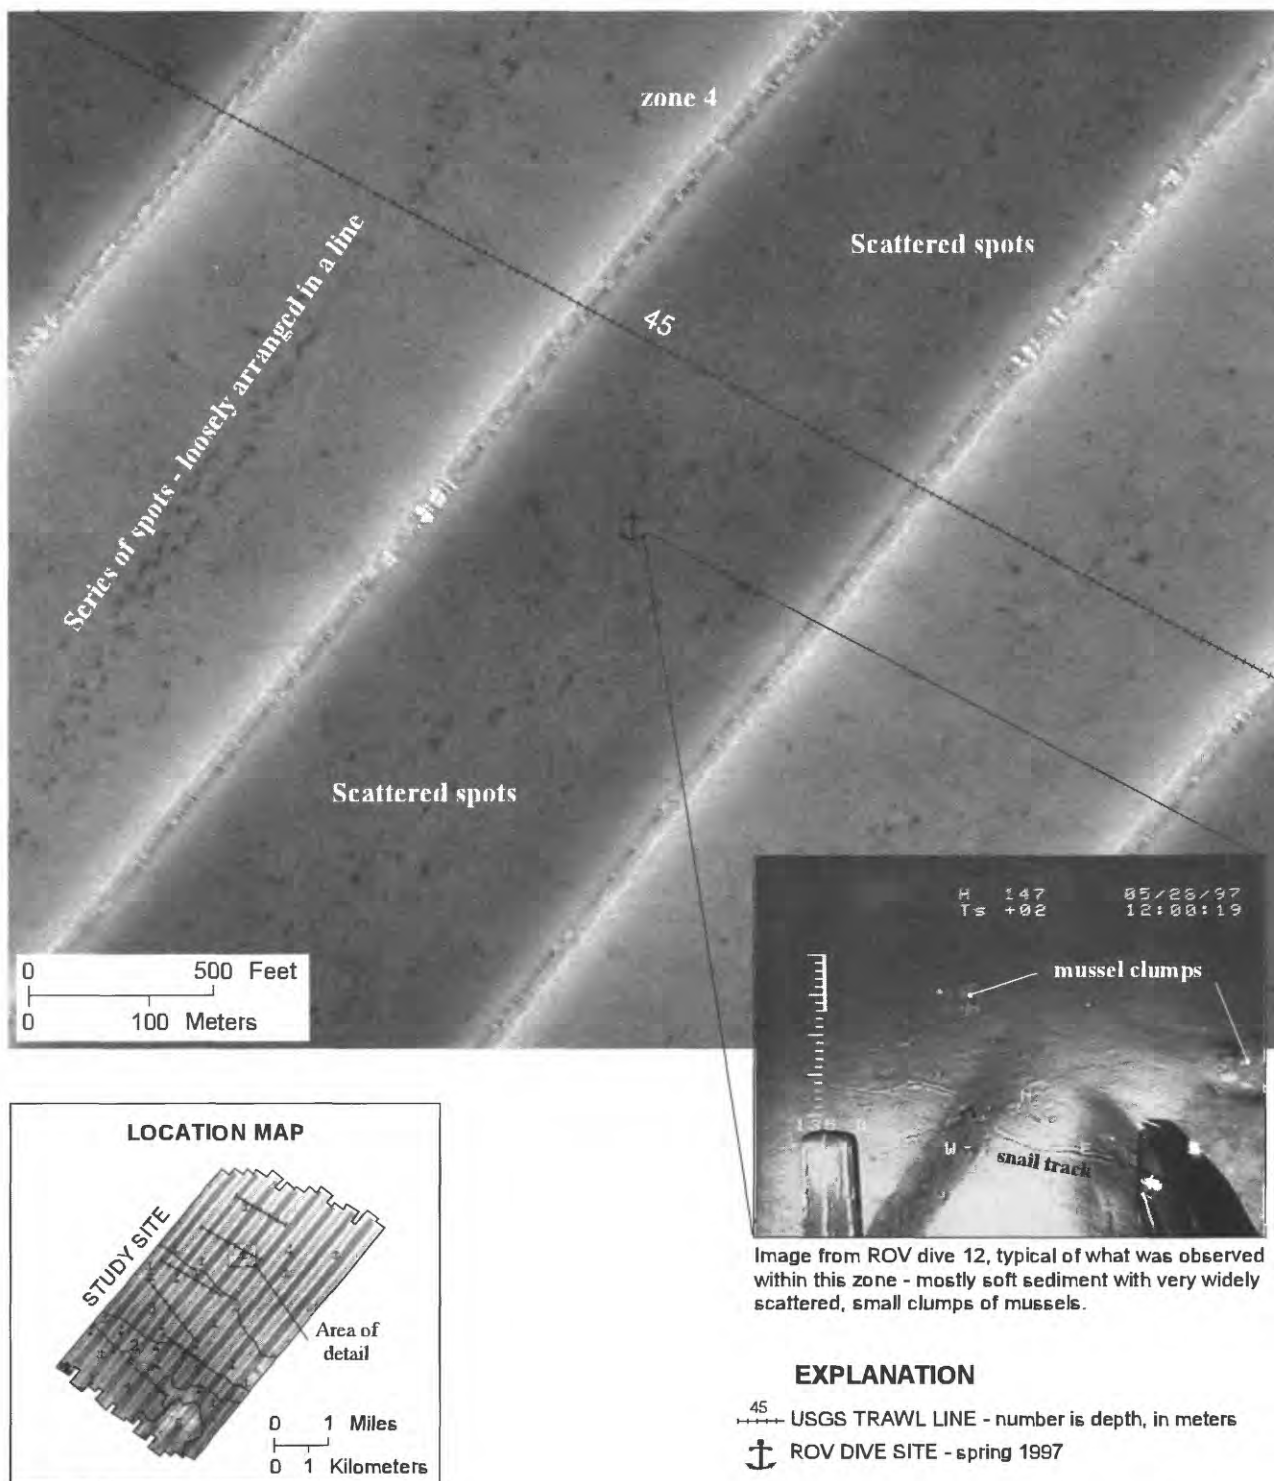
Zone 4 is the area farthest from shore and occupies the deepest parts of the surveyed area (fig. 7). This zone is characterized by relatively little acoustic reflectance on the SONAR records, except for several scattered, small spots no greater than 10 ft in diameter that together occupy no more than 5 percent of the zone. The great depths (130 to 200 ft) and the small size of the echoes made these spots difficult to identify with the ROV, but the ROV images confirmed that the sediment was soft (probably clay with some silt) and contained a few widely scattered, fist-sized clumps of mussels. The small spots observed on the SSS records could be slight depressions, which can deflect some of the acoustic signal. Analysis of the data from the seven ROV dives in Zone 4 indicated that the spots on the SSS image were either natural, dimple-like depressions in the lake bottom or small mussel “druses” (fist-sized clumps of interconnected mussels); the larger mats or patches are essentially thousands of loosely connected druses.

Figure 7. Close-up view of side-scan SONAR mosaic image showing widely scattered and small reflectance patterns typical for zone 4, and image from ROV dive 12 (spring 1997) in the Lake Ontario study area, north of Rochester, N.Y.

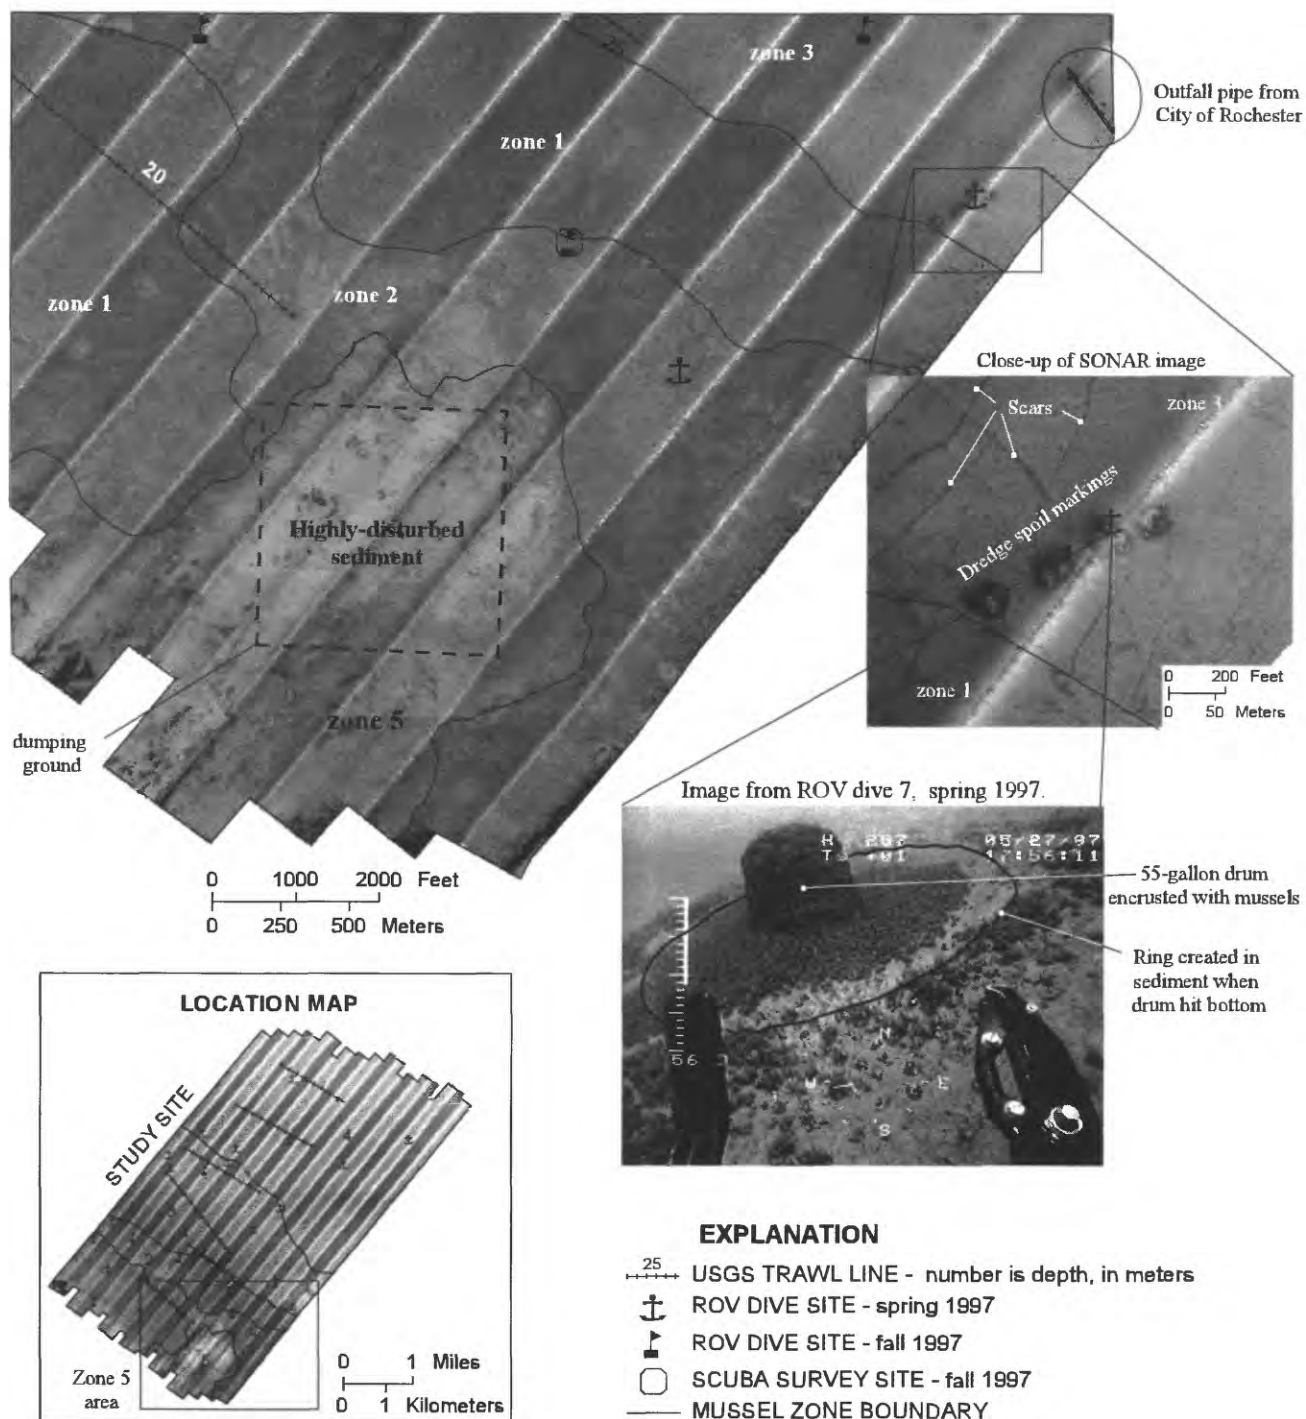
Zone 5 is in the southeastern corner of the surveyed area and contains a substrate that roughly coincides with the dredge-spoil dumping grounds identified on lake charts. This area receives sediment dredged from the Genesee River. The dredged spoil

appears clearly on the SSS records as a doughnut-shaped rings 30 to 75 ft in diameter, in which the main dredge material forms the center, and the displaced sediment forms the ring (fig. 8). The disturbed nature of this area prevents recognition of World War II matériel amid the deposited dredged material. An assessment of one dredge pile by the ROV to confirm the SSS echoes indicated much disturbed sediment and some manmade debris, including, in this case, a mussel-encrusted 55-gal drum (fig 8).

Figure 8. Close-up views of side-scan SONAR mosaic image showing highly-disturbed sediment within zone 5 area and identified as "dumping ground" in figure 1, enlarged view of SONAR image showing reflectance patterns from individual dredge-spoil dumping, and image of ROV dive 7 (spring 1997) showing a mussel-encrusted 55-gallon drum in the Lake Ontario study area north of Rochester, N.Y.

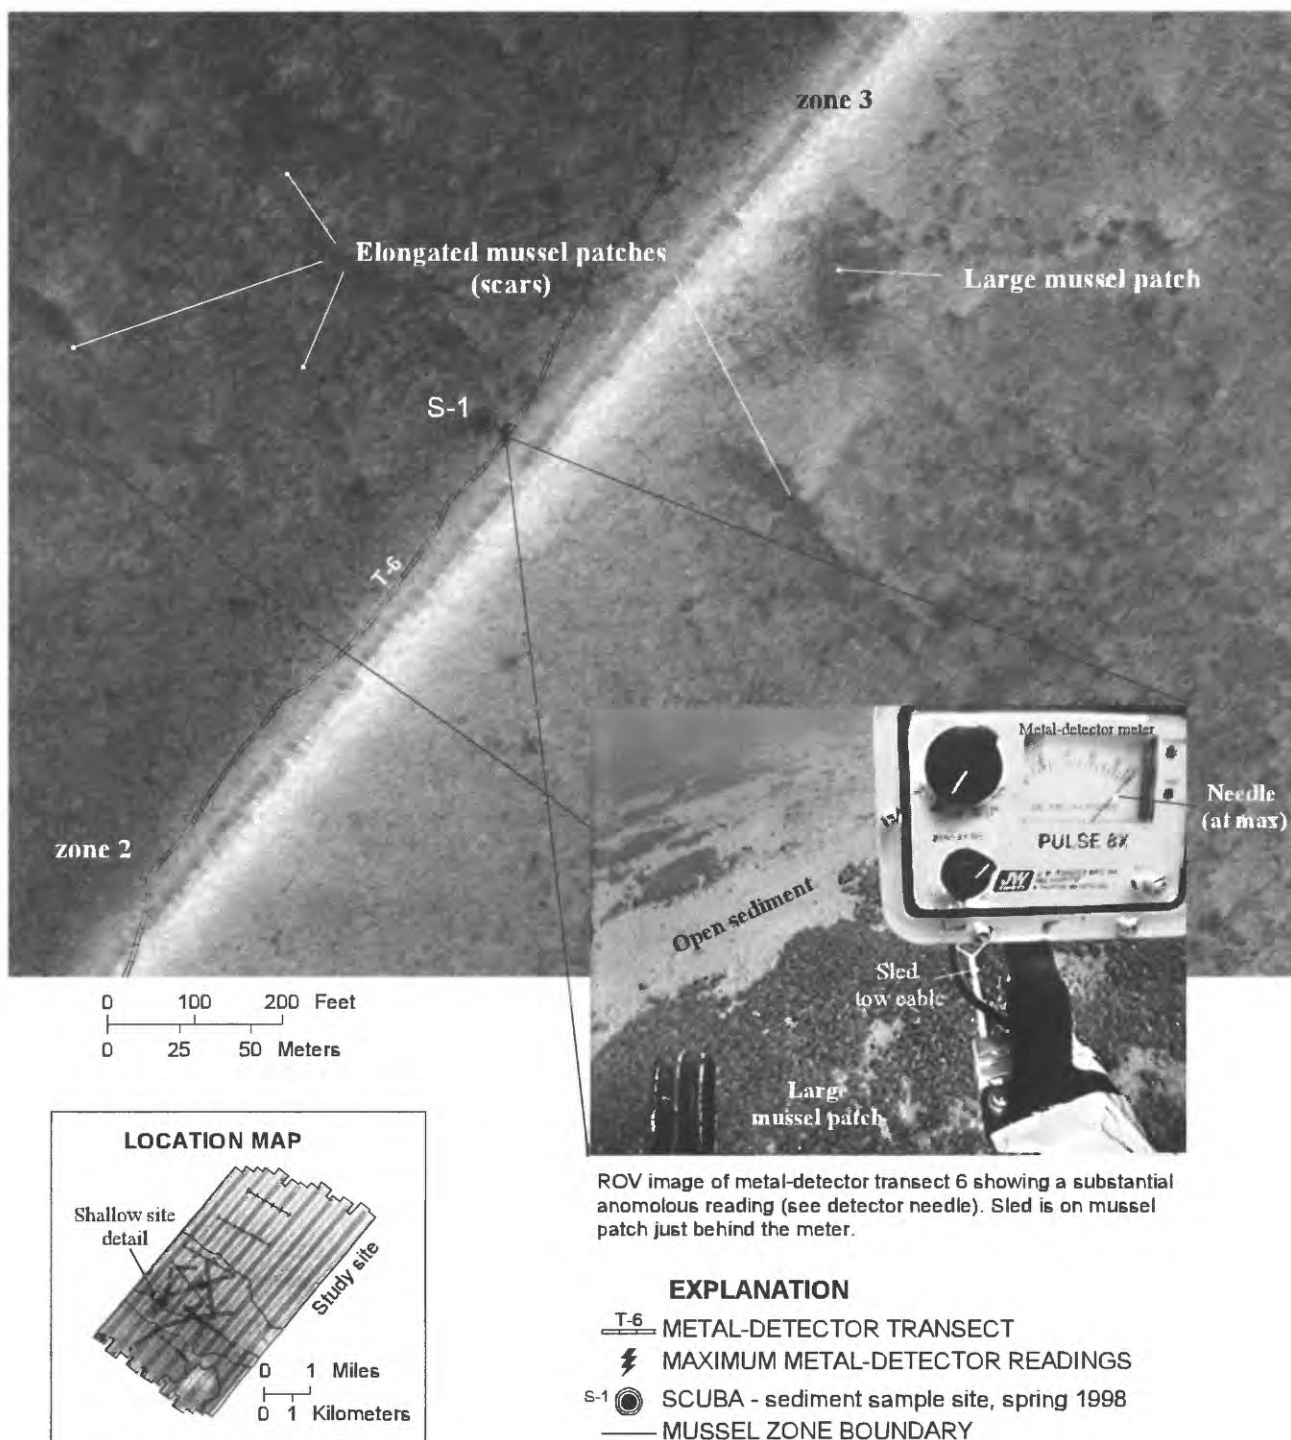
Figure 9. Close-up view of side-scan SONAR mosaic image showing location of shallow sediment-sampling site (zone 3) north of Rochester, N.Y., that was sampled June 29, 1998, for mercury and other metals, and ROV image of sampling site

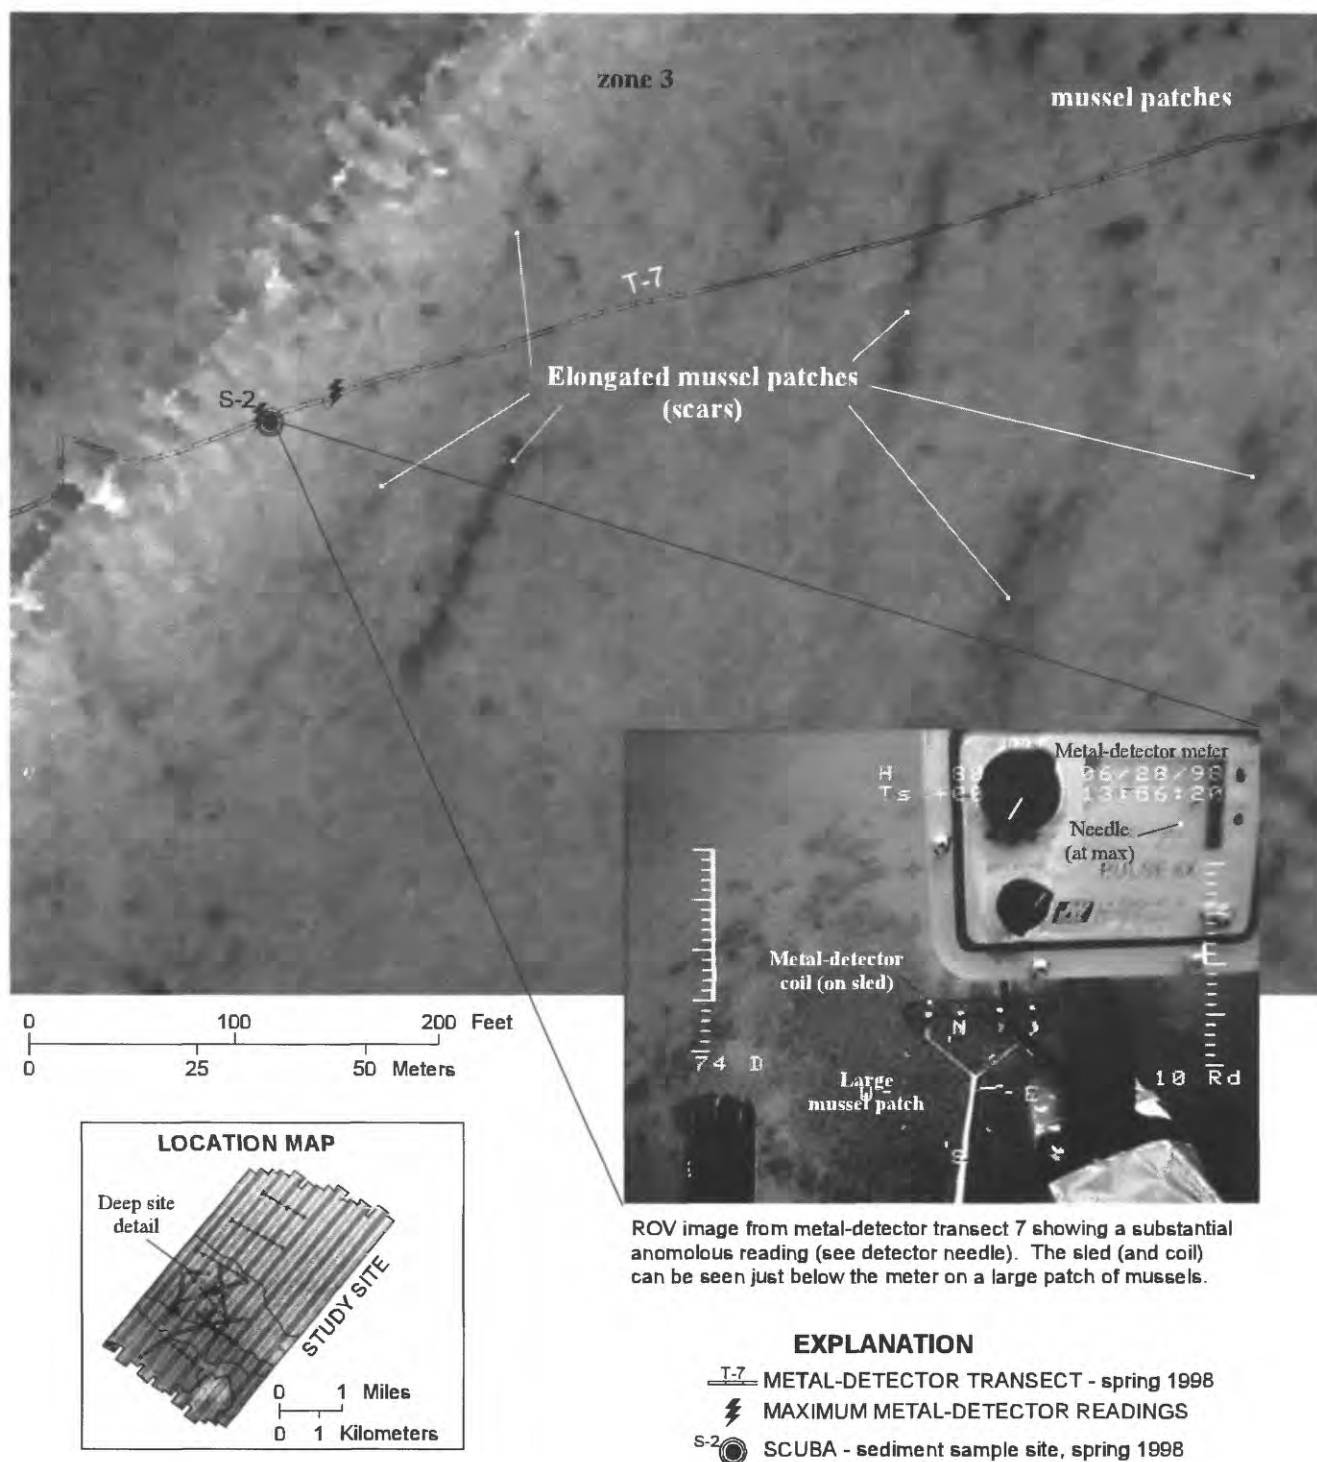
Figure 10. Close-up view of side-scan SONAR mosaic image showing location of deep sediment-sampling site (zone 3) north of Rochester, N.Y., that was sampled June 29, 1998, for mercury and other metals, and ROV image of sampling site.

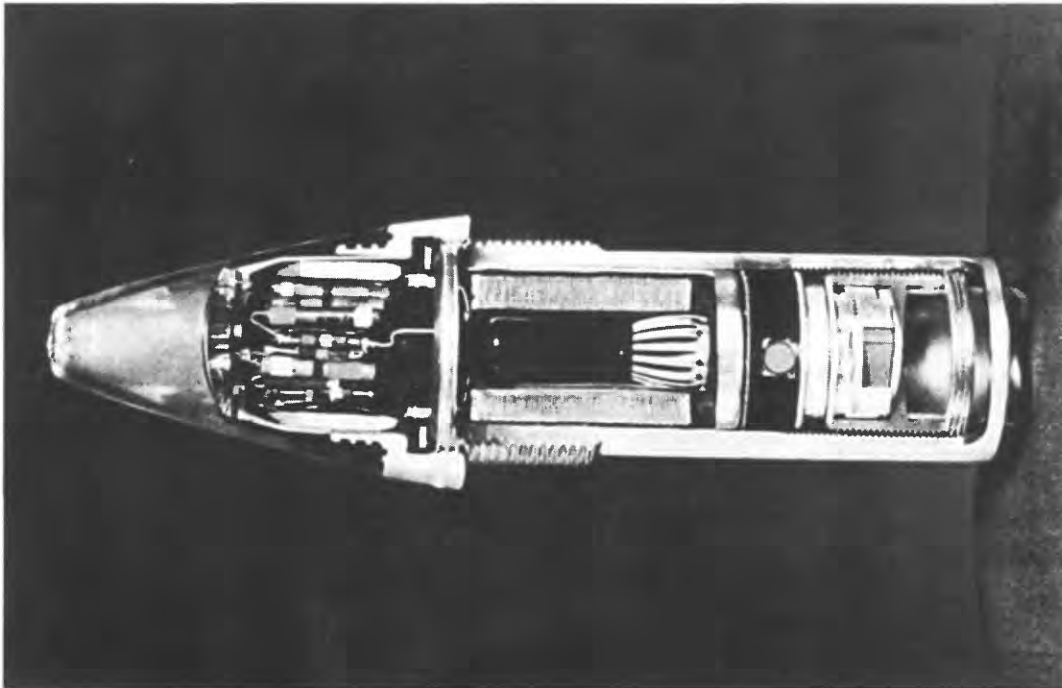
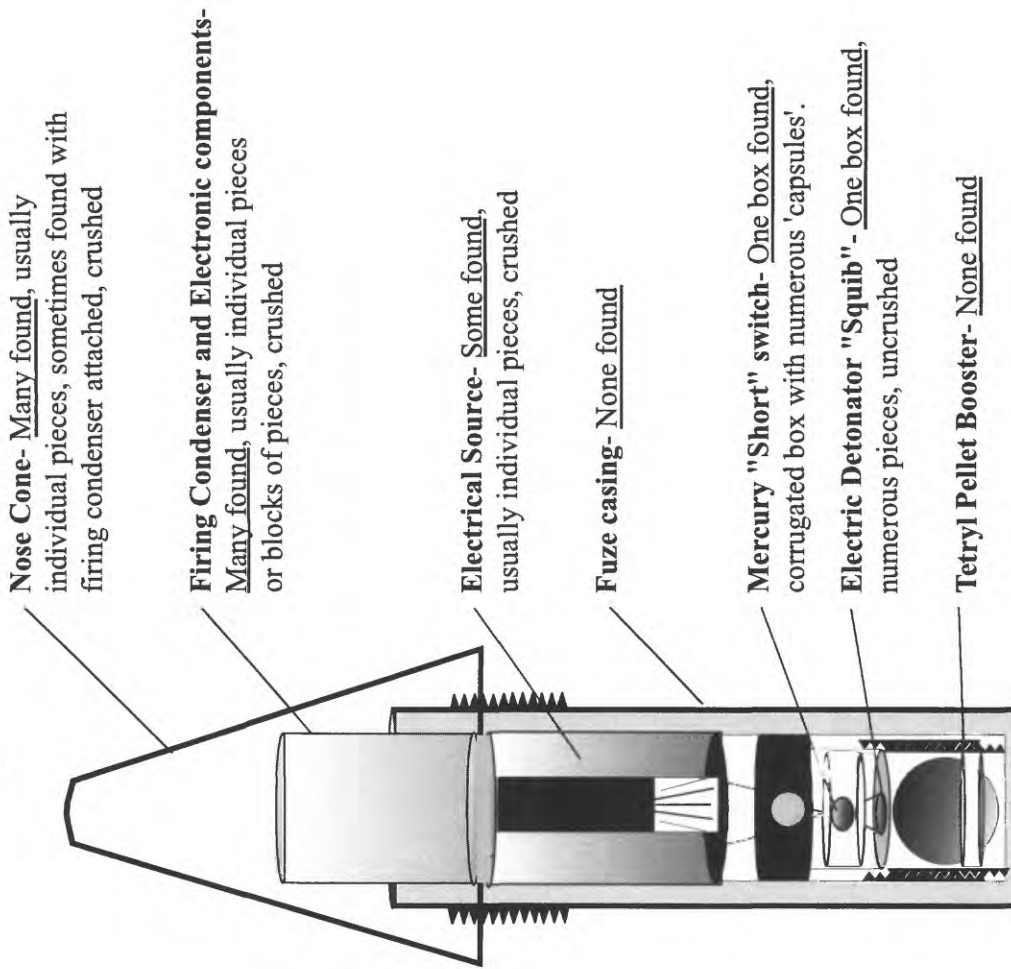
A. Mark 45 Fuze

B. Fuze Diagram

Figure A-1. Proximity fuze of the type found by Lake Ontario Biological Station during fish trawls, 1974-96: A. Interior view of fuze. (with permission of Eastman-Kodak). B. Diagram showing major components of fuze, frequency of detection off Rochester, and condition of parts found.

The most common type of material found in the past 20 years of lake-bottom surveys has been the nose cones of shell detonators (proximity fuzes); an inventory is given in Table A1, and a photograph and schematic diagram of a proximity fuze is given in figures A-1-A and A-1-B, respectively. All nose cones are crushed, but are about 2 in. in diameter, by about 3.5 in. long, and appear to have two sections—a lower cylindrical section and an upper cone section.

The fuze is simply a specialized radio set. There is a battery whose electrical energy is released by a setback, the shock of the firing of a gun. The battery furnished three different voltages: one for the filaments of the vacuum tubes, one for the plates, and one for the grids. One of the tubes is an oscillator. In the nose of the fuze is a metallic cap, which together with the rest of the shell acts like a dipole. The oscillator tube thus has an antenna and emits a high-frequency radio wave in particular directions from the shell. This continuous radio wave surrounds the moving shell, and when the shell passes close to a target, the latter reflects a small amount of radio wave energy back to the fuze where it is detected by the same tube as sent out the wave in the first place. The plate voltage is "modulated" by the reflected wave, which is at a slightly different frequency than the outgoing wave due to the relative motion of the shell and target. Thus, a beat note is set up and the plate voltage varies in frequency within the audio range of a few, to a few thousand cycles per second. This audio frequency voltage variation is then passed through a three tube amplifier. When the period of the audio frequency wave and also its amplitude or intensity are

exactly right, a thyratron tube, serving as a switch, is discharged. It completes a circuit that releases an electrical charge, which meanwhile has been stored in a condenser. The surge of electricity goes through a tiny wire in an electric squib (detonator), much like a dynamite cap. The wire gets hot and the explosive in the squib goes off. This tiny explosion sets off...[another] sensitive explosive...at the bottom of the fuze. This explosion sets off the explosive loading of the shell and it bursts the steel shell body into hundreds of high velocity fragments.

Background information and examination of retrieved proximity fuzes indicated that nearly all debris recovered by the *Kaho*, other than the box of mercury components and the box of detonators (squibs) referred to in figure A-1-B, were merely the upper ends of proximity fuzes; that is, the nose cone and the condenser. Nearly all of the recovered components were crushed. Crushing was apparently a required means of destroying defective components (every component was tested and required to meet strict quality-assurance standards during the manufacturing process); crushing also was a means of preventing any of the components from reaching enemy hands during the war; as indicated by Baldwin (1980, p. 111).
