DEPARTMENT OF THE INTERIOR  
U. S. GEOLOGICAL SURVEY

SUBSURFACE CHARACTERIZATION OF SELECTED WATER BODIES  
IN THE ST. JOHNS RIVER WATER MANAGEMENT DISTRICT, NORTHEAST FLORIDA

Jack L. Kindinger<sup>1</sup>, Jeffrey B. Davis<sup>2</sup>, and James G. Flocks<sup>1</sup>  
2000

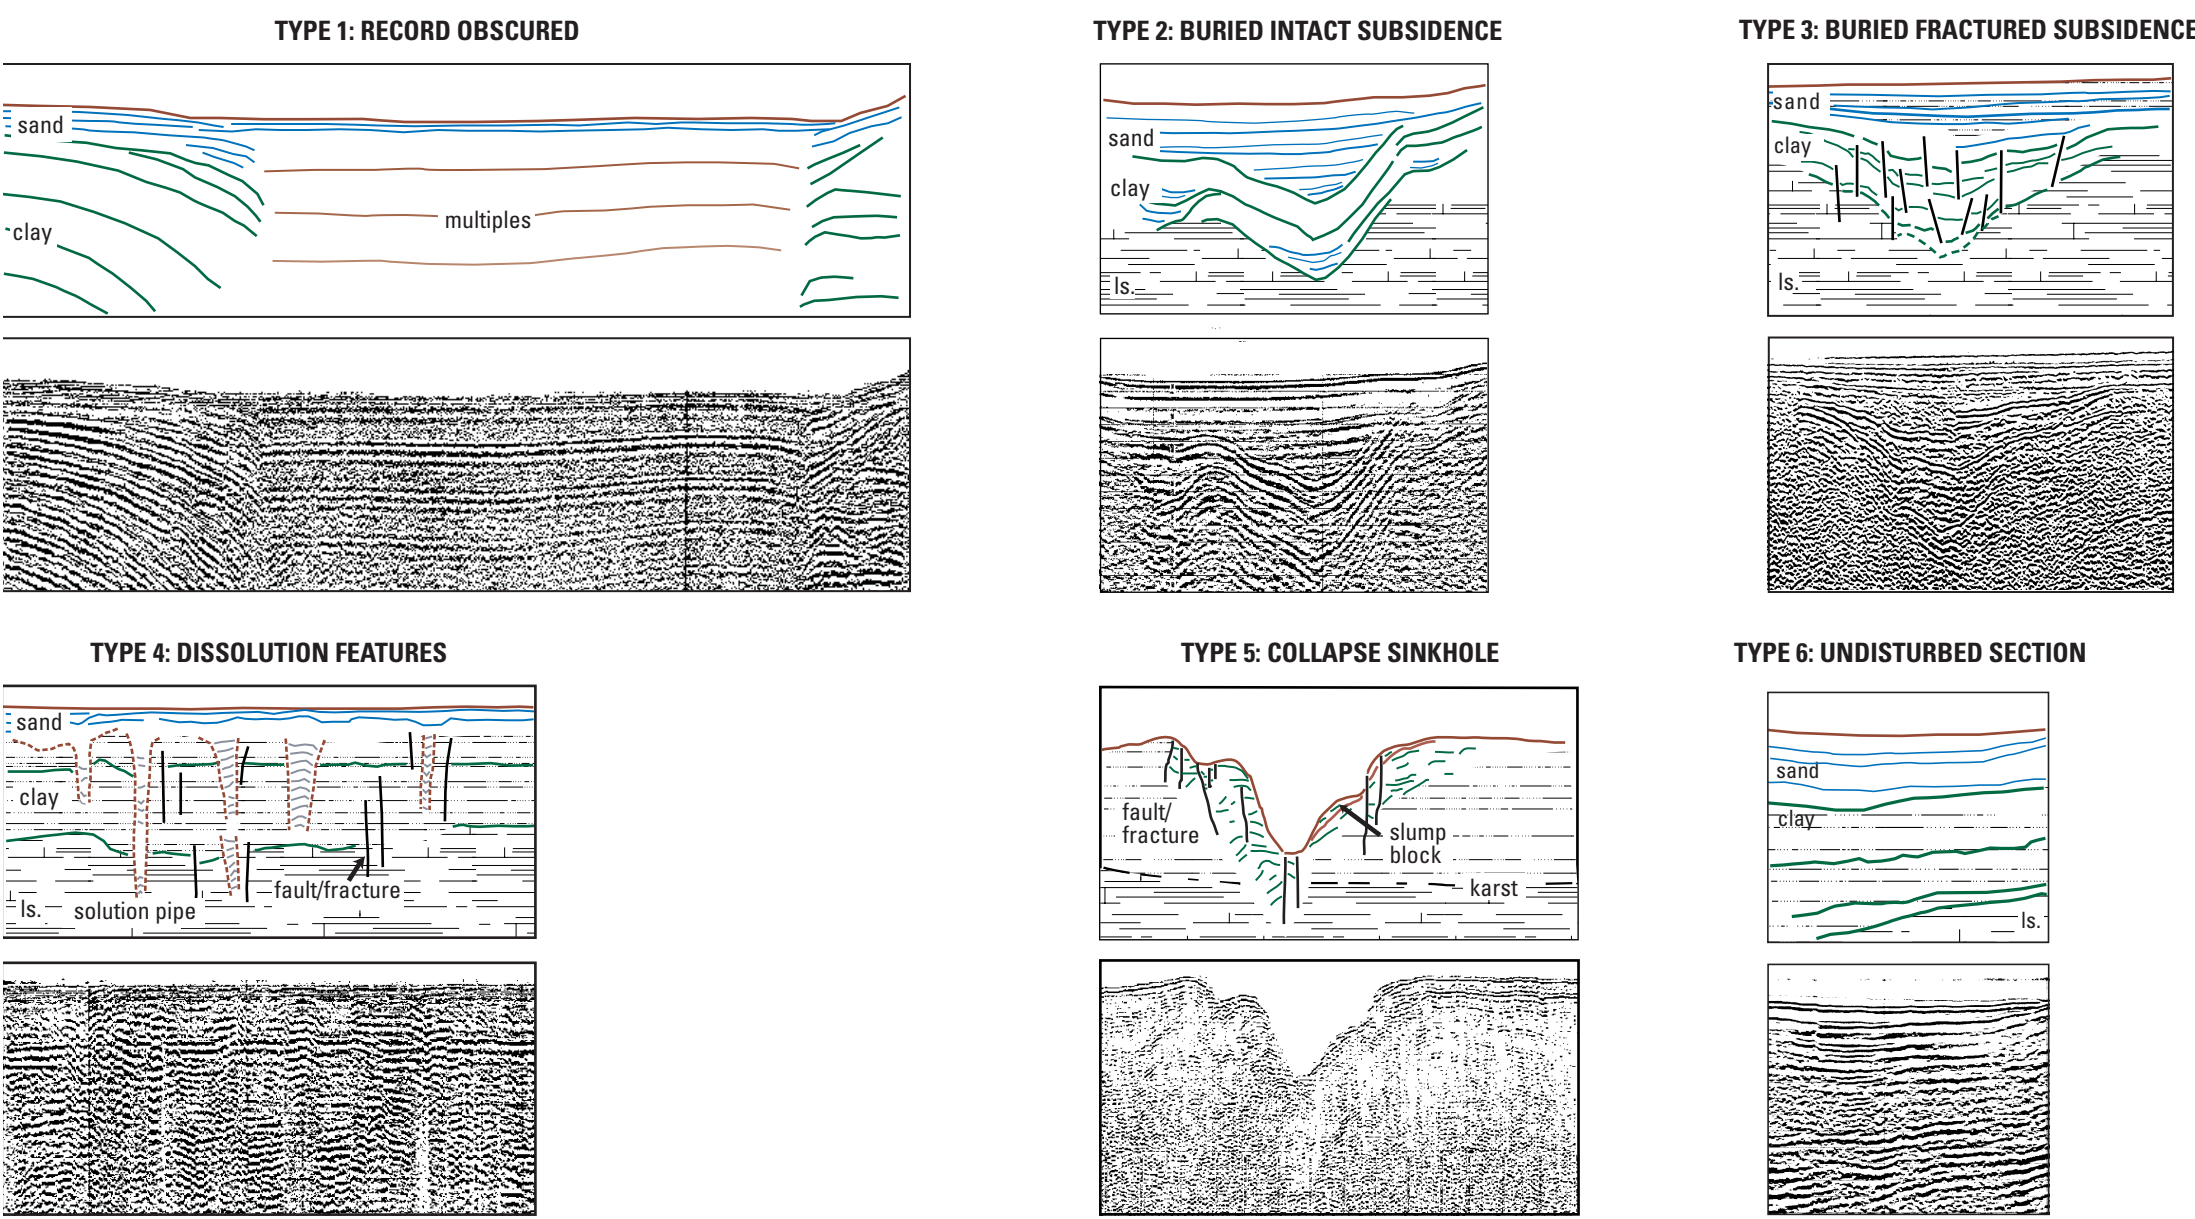
**Figure 16.** Seismic profiles with line drawing interpretations of six types of features described from the lakes of northeastern Florida.

When the record is not obscured, a number of patterns have been identified that relate to karst features. Types 2 and 3 (Fig. 16) represent depressions that have been subsequently filled to the present lake bottom. The fill is represented by horizontal reflectors that may onlap the depression or completely cover the subsided area. Evidence of stress fractures, slumping, faulting, or dissolution fractures around the depression (Type 3) differentiate the two dolines and may indicate more rapid or continuous subsidence, or a more competent overburden. These breaches within the depression may provide a significant hydraulic connection between surface waters and the underlying aquifer. Most of the sinkholes detected using HRSP are of the buried base-level type (Fig. 13, Sinkhole Evolution sheet) and should be a common occurrence beneath dry land as well. Only when these features develop a transitional phase (Fig. 13.), reactivate and cause a surface subsidence or collapse, do they become evident at the surface.

Other common features are high-frequency or chaotic reflections interspersed between horizontal reflections (Type 4). These reflectors indicate a disturbance within a relatively intact stratigraphic sequence and may represent solution pipes or fractures through the overburden. The features may connect to dissolution systems in the underlying limestone and could represent direct hydraulic connection through the semi-confining layer to the underlying aquifer. The disturbed reflections indicate areas of potential subsidence or collapse. These features have a high potential for reactivation since the plugs that fill solution pipes may dislodge during periods of major rainfall variations. There are many examples of this from Marion County (Cain and Hornstine, 1991). Solution pipes and related features commonly occur in areas where cohesive overburden is moderate to thin. Dissolution is focused and material directly over the cavity is washed into the void during the piping process. Type 4 features are widespread throughout the lakes surveyed, they occur in all phases of karst development and are commonly associated with poljes.

The Type 5 feature represents the classic collapse sinkhole, with steep walls that show evidence of slumping and active development along the periphery of the collapse. Freshwater plumes have been imaged emerging from similar collapse features found in marine environments (e. g. Crescent Beach Spring). In seismic profiles, areas of negligible acoustic return below the collapse have been postulated to represent subterranean cavities. These active phase collapse sinkholes are typically evident at the surface without imaging and occur in areas of minimal overburden. They also indicate areas of internal drainage or discharge depending on the location of the potentiometric surface of the Floridan aquifer.

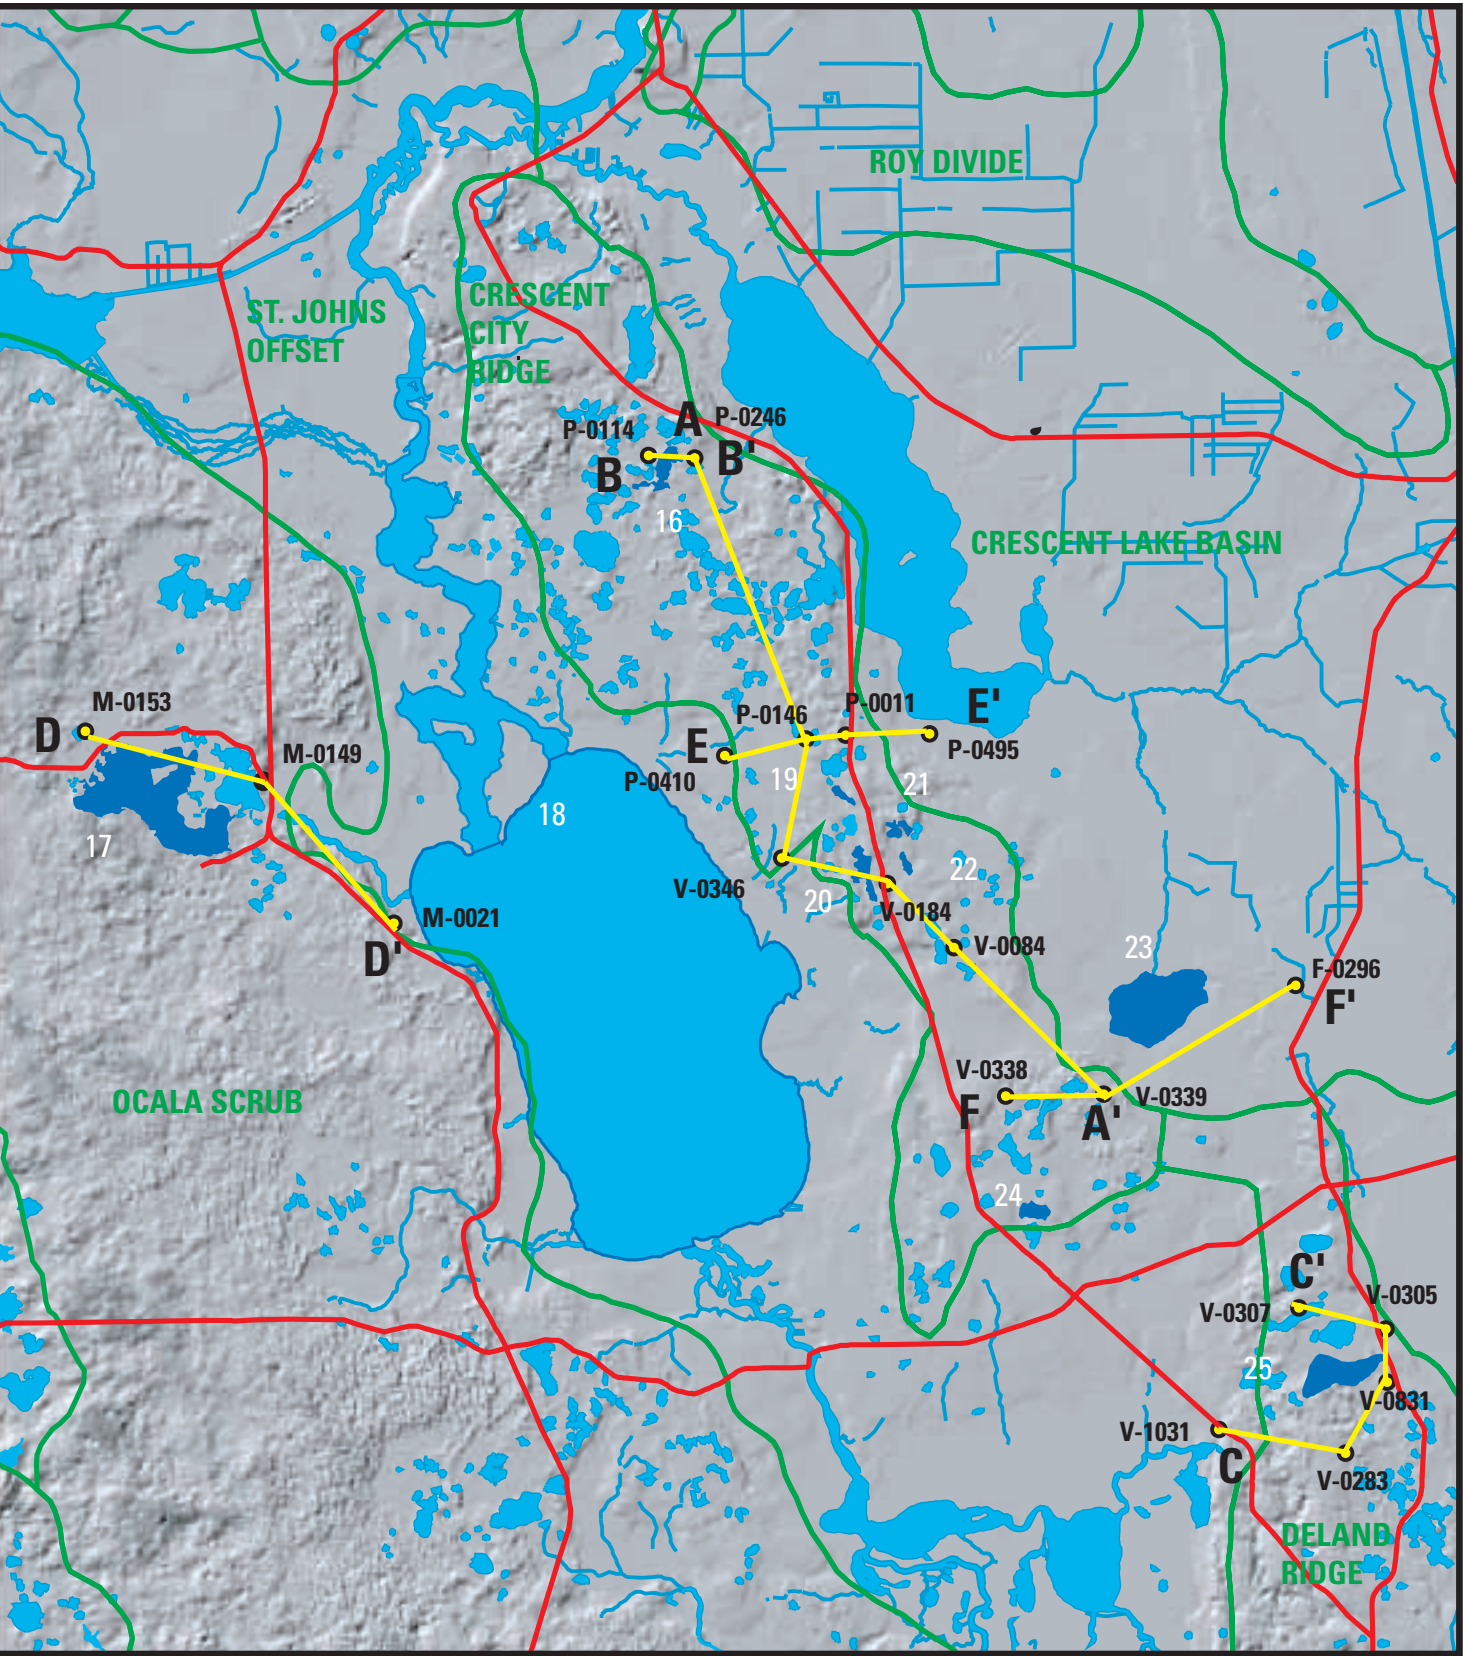
Location of survey area right (red square). Shaded relief map below showing physiographic regions, and location of wells and gamma log cross-section. Gamma Log cross-sections (left) show geologic contacts for correlation to seismic sections.

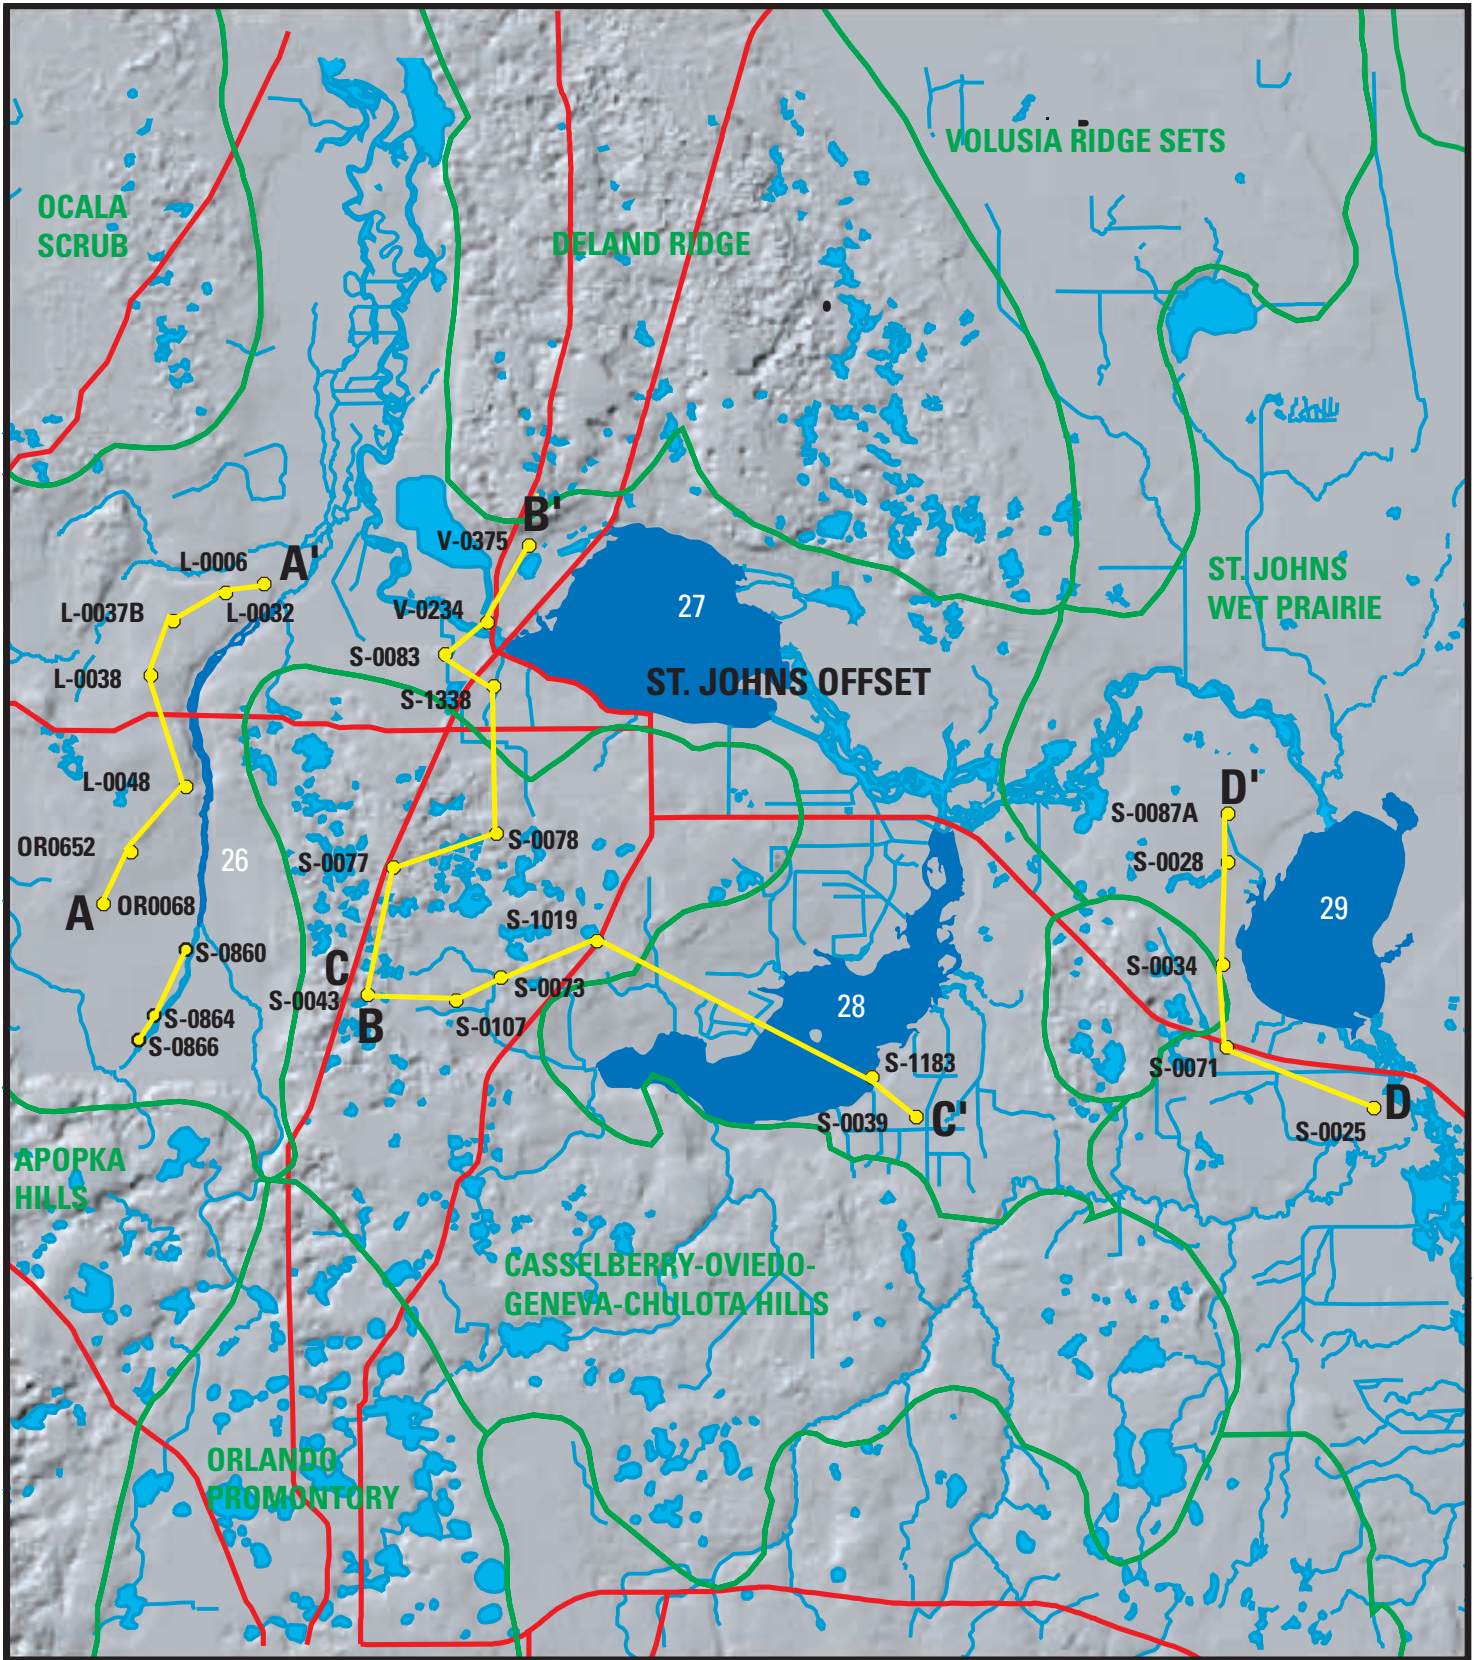
Location of survey area right (red square). Shaded relief map below showing physiographic regions, and location of wells and gamma log cross-section. Gamma Log cross-sections (left) show geologic contacts for correlation to seismic sections.
