1998 Survey

6b. Backscatter Intensity, Topography and Sediment Texture

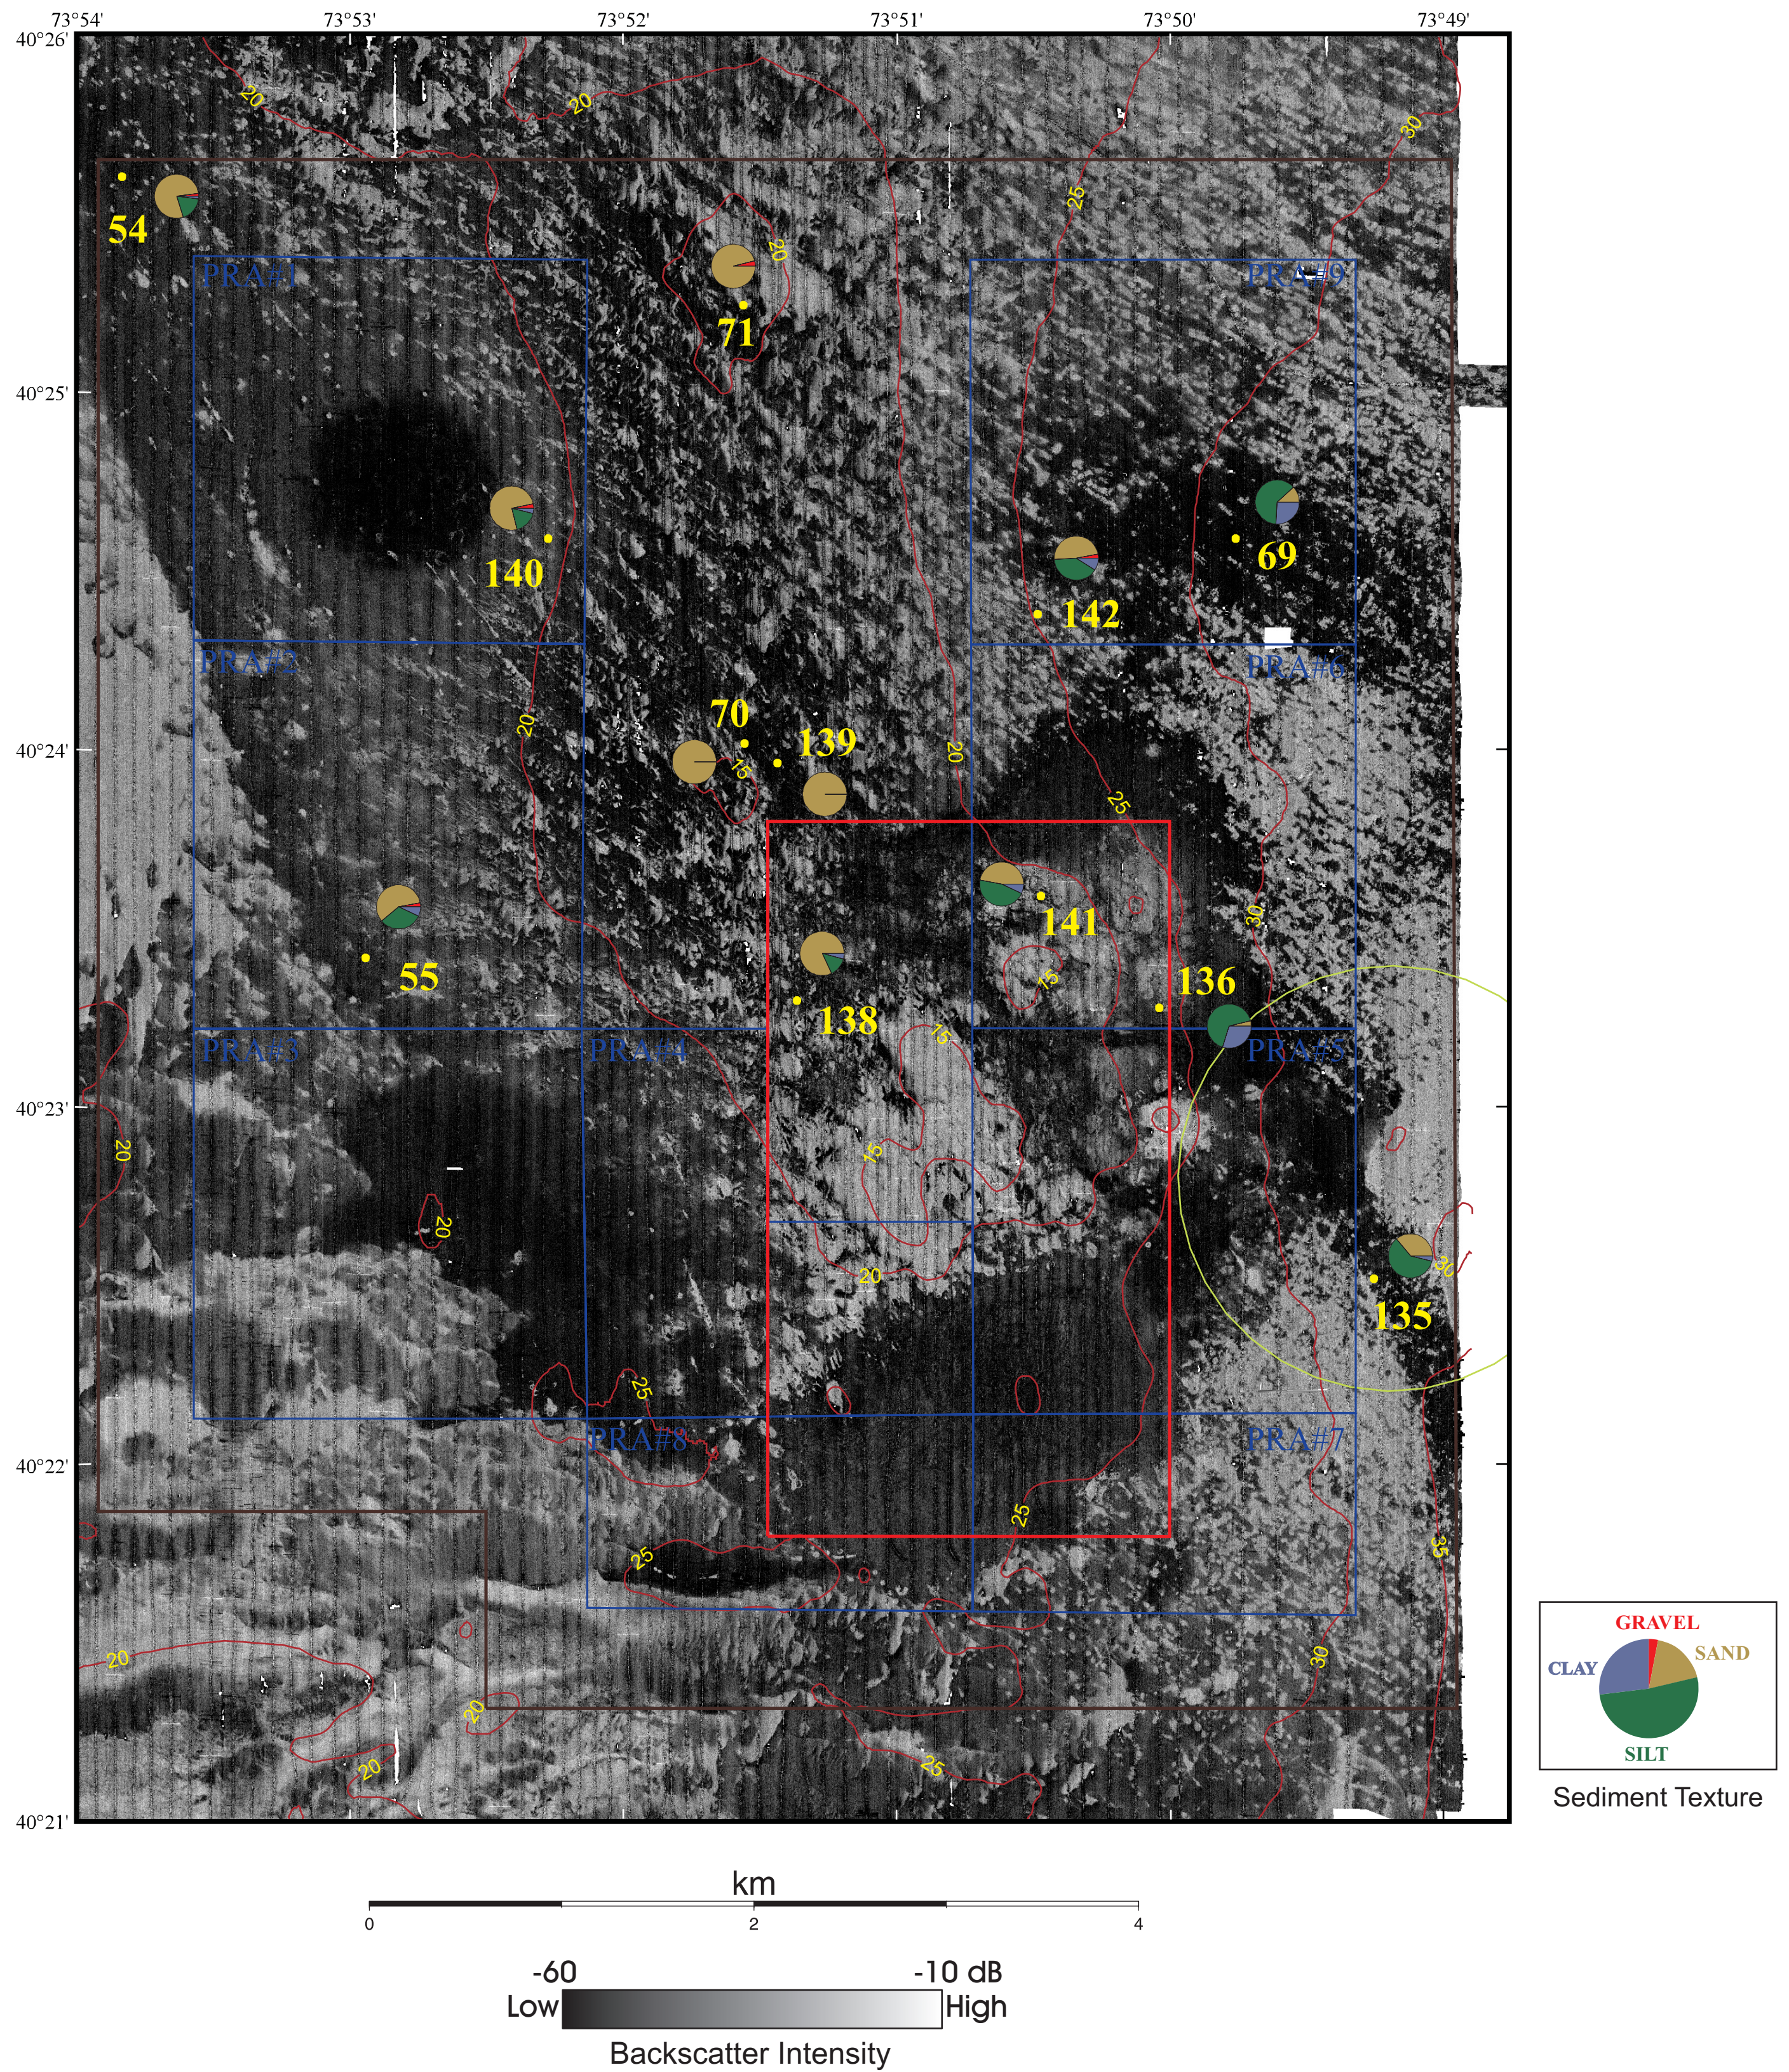
Figure 6b. Backscatter intensity and depth contours displayed at 5 m intervals for the 1998 survey. Pie diagrams for the sediment texture (see Table 3) for samples obtained in 1998 are superimposed. The boundaries of the Historic Area Remediation Site (brown), the Primary Remediation Area (divided into 9 cells outlined in blue), the Mud Dump Site (red), the no-discharge zone (black), and the Cellar Dirt Disposal Site (green) are also shown. White areas are areas of no data. Principal changes between 1996 and 1998 are the placement of new dredged material in the eastern part of the HARS, capping in the southern part (see circular feature centered near 40°22.25' N. and 73°50.45' W.), and remediation in PRA#1. The remediation in PRA#1 appears as circular area of low-backscatter intensity material. See the Maps section of the text for a description of the how these images were created from the multibeam data.
