This map is one of seven showing areas in Nicaragua impacted by debris flows and other landslides triggered in response to the torrential rainfall that accompanied Hurricane Mitch in October of 1998. The maps provide a record of landslide activity over areas of diverse geology, geomorphology, microclimates, and vegetation. When combined with information on the physical properties of hillslope-mantling materials, hillslope form and gradient, and rainfall characteristics, the inventories provide a foundation for evaluating the susceptibility of other similar areas to landsliding.

MAP OF LANDSLIDES AND RELATED DOWNCHANNEL EFFECTS TRIGGERED BY HURRICANE MITCH IN PART OF CINCO PIÑOS (2855 IV) QUADRANGLE, NICARAGUA

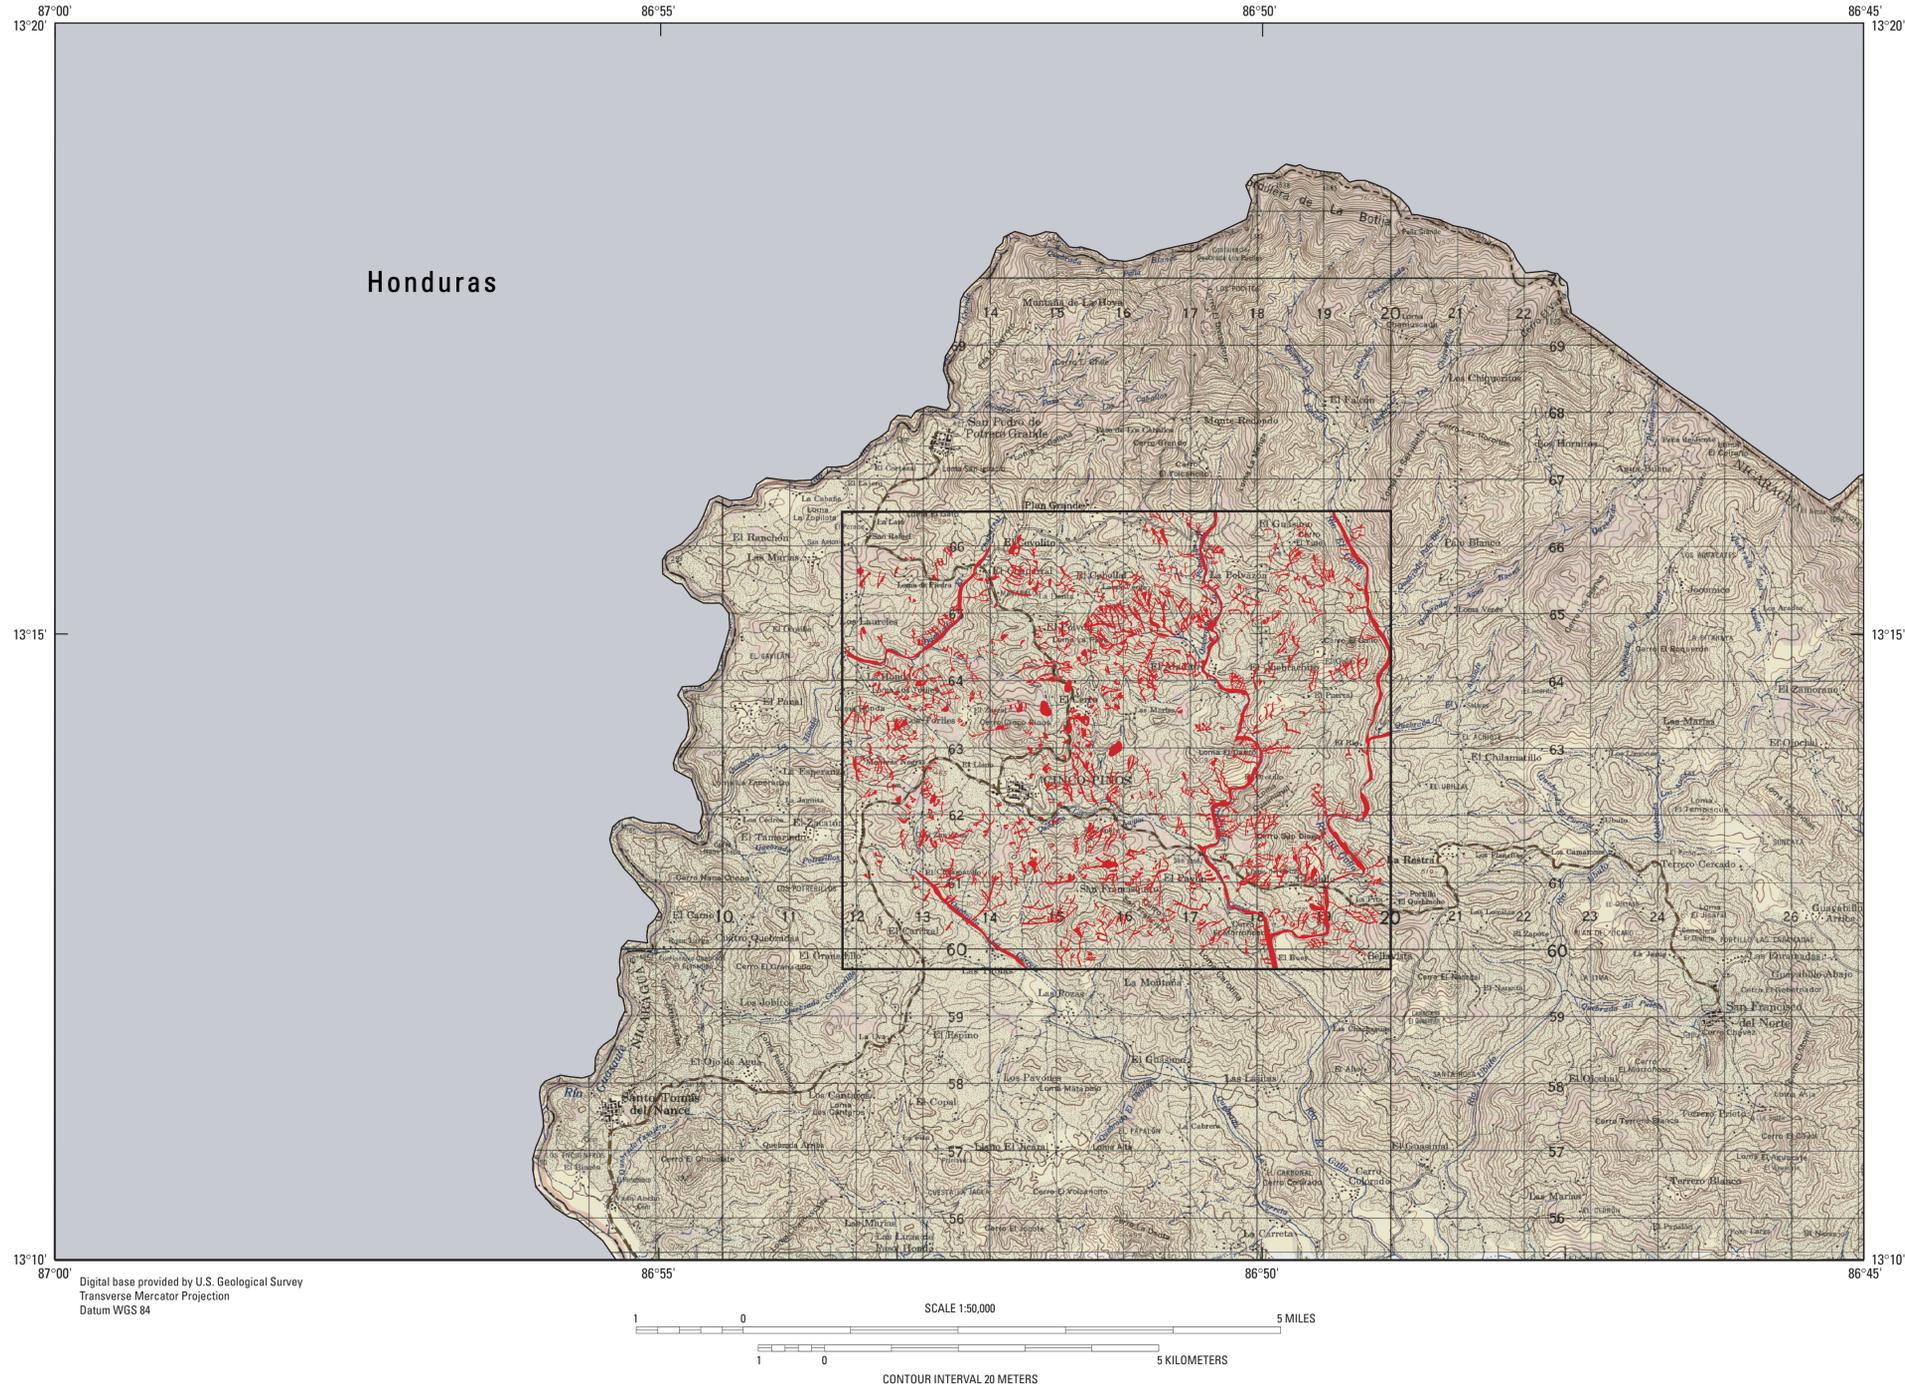
Area impacted by landslides and related downslope effects mapped from aerial photography. Effects include deposition and erosion in downslope channels and on alluvial fans

Extent of aerial photography coverage

Aerial photographs taken between 4 and 19 December 1998 were used to map the landslides shown on this plate. The aerial photographs were taken under the Open Skies program of the Defense Threat Reduction Agency (<http://mitchnts1.cr.usgs.gov/data/aerial.html>). Photographs at 1:60,000 scale were available for all seven study areas, and 1:30,000-scale photographs were also available for portions of the Matagalpa and the Jinotega/San Rafael del Norte study areas. Digital Raster Graphics (DRG) scanned images of 1:50,000-scale quadrangles projected to Transverse Mercator were used as base maps for mapping the landslides. Landslides and related effects in and adjacent to downstream drainages were mapped by first identifying them on the aerial photographs using a mirror stereoscope. The area visible on the aerial photographs impacted by the landslides was manually plotted by inspection onto the base maps. In some cases, the base maps were enlarged to 1:25,000 scale to facilitate mapping. Locations of landslides mapped using this procedure are estimated to be accurate to within 200 m.

Following field verification, the area impacted by the landslides was digitized manually, and the data were then digitally registered to the DRG base map in Arc/Info. The initiation location of each landslide was also digitized. Final maps are presented at 1:50,000 scale.

The small scale of the aerial photographs precludes identification of locations of transitions between debris-flow source areas and debris-flow paths, and transitions between debris-flow and streamflow processes. For this reason, we mapped debris flows as extending from the source areas to the farthest point down channel that appeared to have been affected by flow processes, whether streamflow or debris flow. Also, because of the small scale of the aerial photographs used for this mapping, it is possible to discern between debris flows and slow-moving earth flows, but not between different types of landslides that mobilized into debris flows. If a landslide feature was only partially obscured by trees or shadows, we mapped only what was visible. Finally, the area impacted by each landslide was mapped by filling in a colored polygon that best represented its shape and size. Because each feature is represented by a line at least the width of one pencil lead, the size of very small features may be somewhat exaggerated.
