# CHANGES IN RIPARIAN VEGETATION IN THE SOUTHWESTERN UNITED STATES: Historical Changes Along the Mojave River, California

## USGS GROUND WATER RESOURCES PROGRAM

U.S. GEOLOGICAL SURVEY OPEN-FILE REPORT OF 01-245, 2001

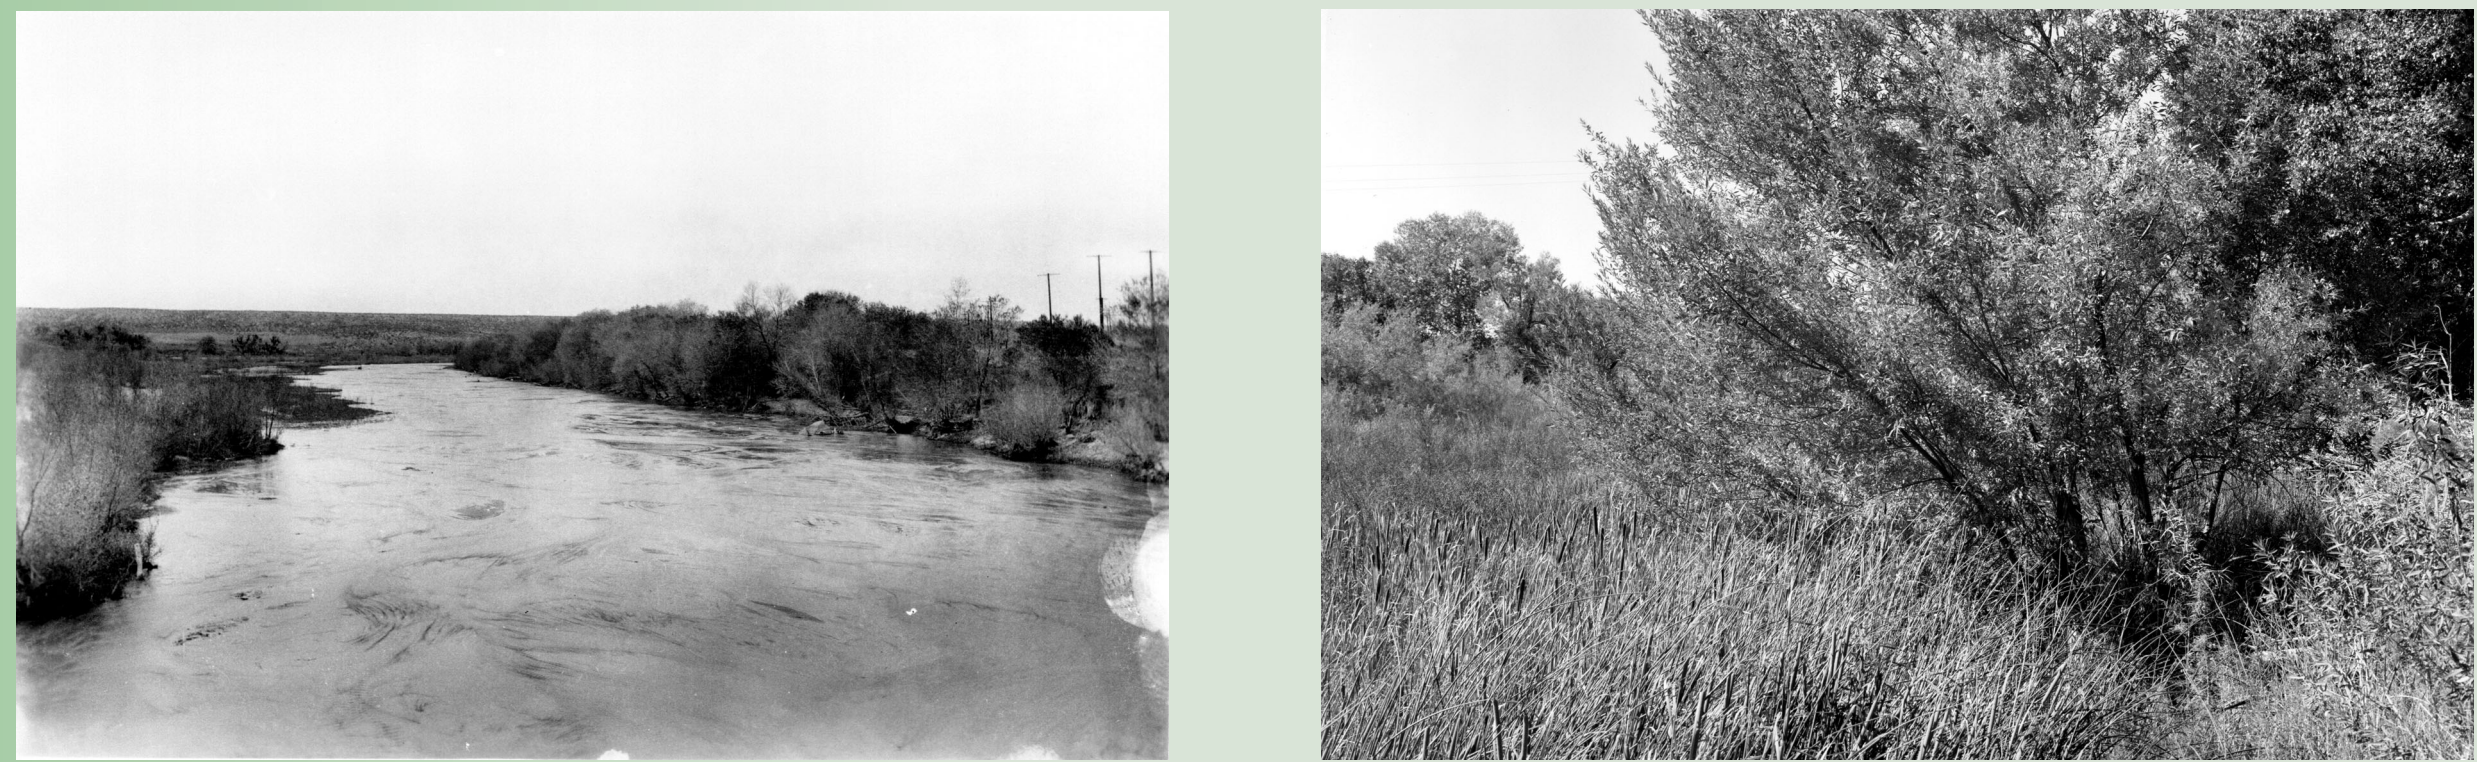
(1917). Thompson took this downstream view of the Mojave River from the deck of a highway bridge. Most of the trees appear to be Goodding willows, leafless in the winter season, and cottonwoods appear at several places, particularly on river right (right side). The channel is unconfined by bedrock here and is very wide, possibly in response to recent floods (David Thompson 443, USGS Photo Library).

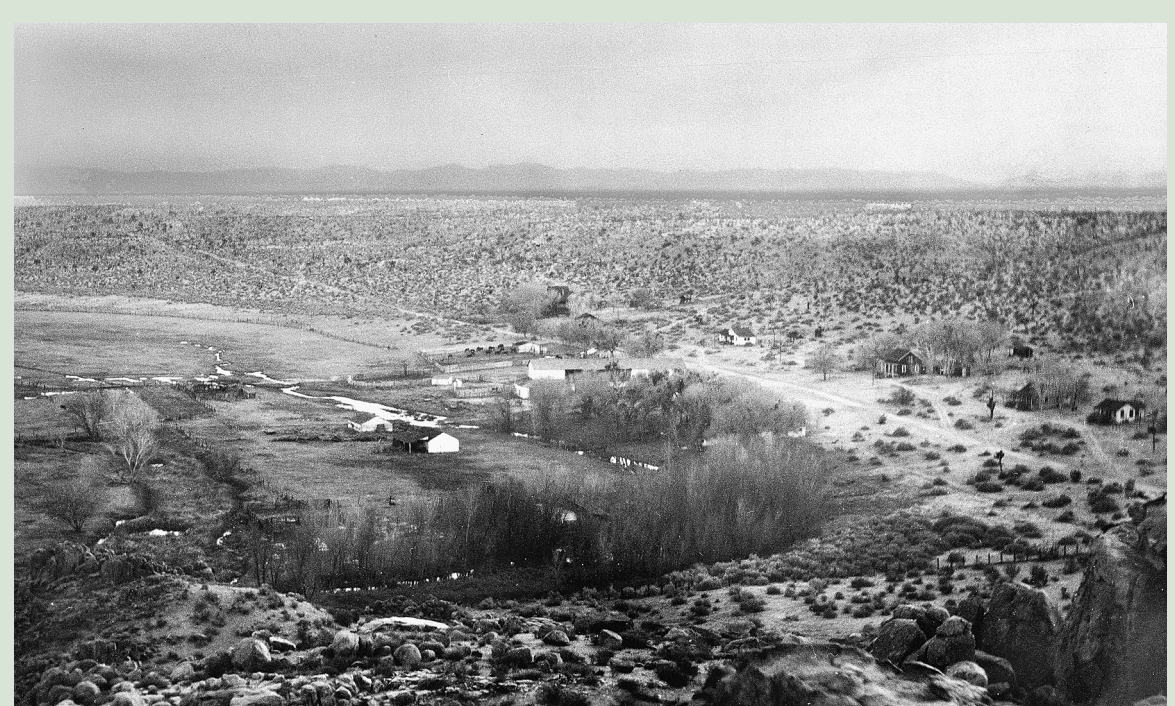
(1917). Thompson photographed this upstream view of the Mojave River at the Upper Narrows as part of a 360° panorama. The leafless trees indicate the season is winter. The band of trees nearest the photograph appear to be mostly Goodding willows, but scattered cottonwoods are also in the view (David Thompson 445, USGS Photo Library).

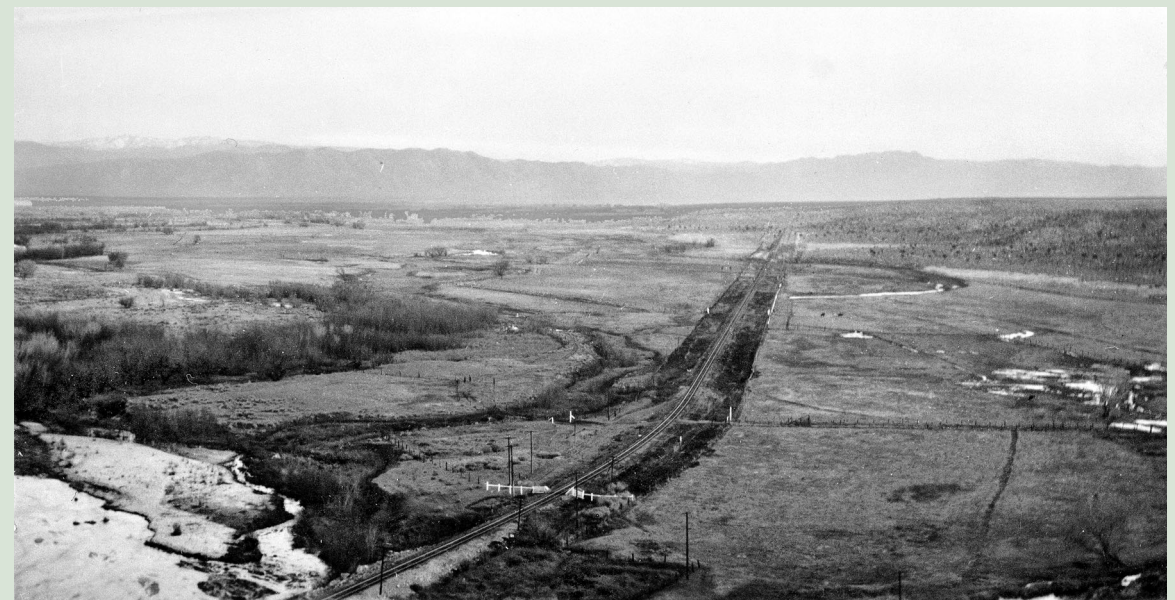
(1917). This view, a pan to the left from the previous view, shows the main railroad line from Los Angeles to Salt Lake City as it passes out of the Mojave Desert into Cajon Pass and the Los Angeles basin. This single-track line is built on a berm that forces most surface water moving down the Mojave River to the left (east), although ground-water seepage appears in pools on the right. At left, the river floodplain has scattered Goodding willows. At right center, the railroad berm truncates a meander of the river, which now appears to be a disconnected slough with scattered trees along its banks (David Thompson 446, USGS Photo Library).

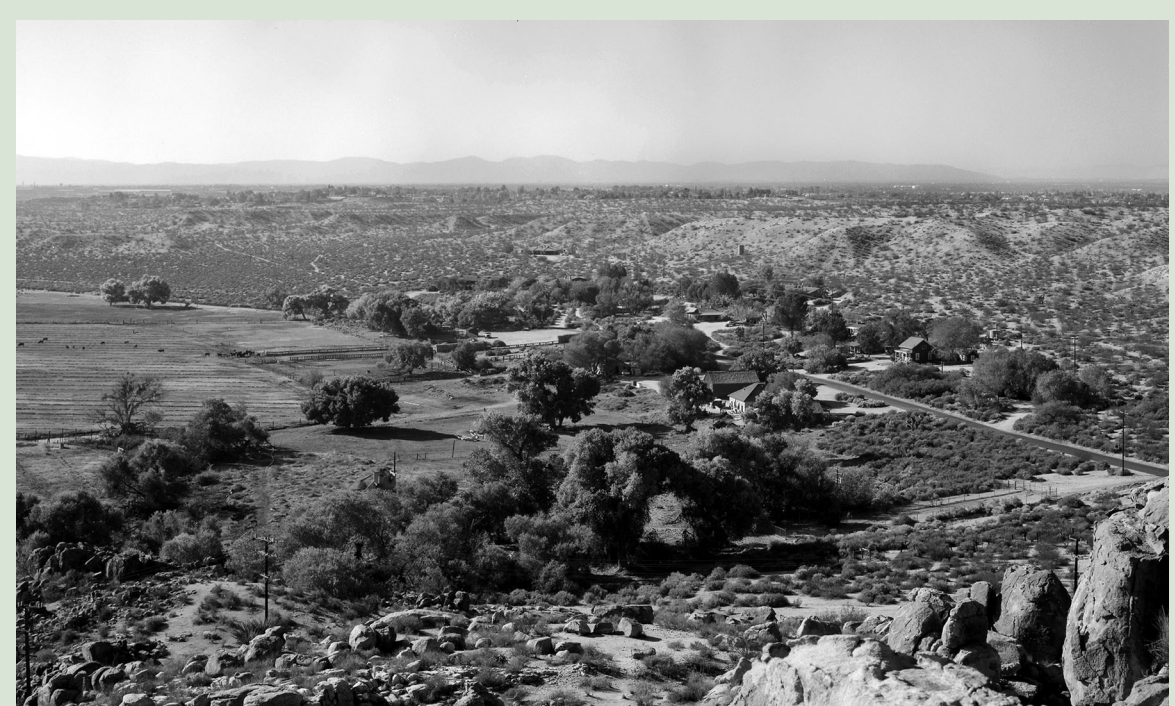
(October 24, 2000). Until recently, the ranch shown in the center of this view remained in the same family that owned the property in 1917. Most of the has been grazed continuously, but likely at varying intensities, since 1917. Irrigation canals and water sources remain in approximately the same places, indicating that ground-water levels likely have not fluctuated significantly. Cottonwoods now dominate the trees in the view, and scattered Goodding willows are still present (Dominic Oldershaw, Stake 2110a).

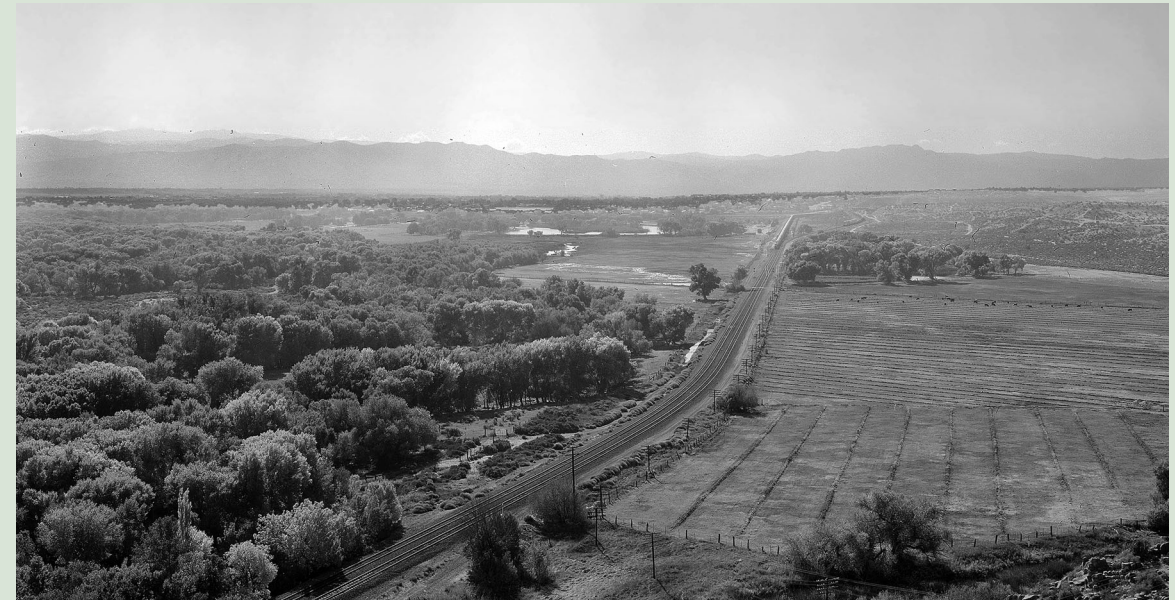
(October 24, 2000). Most of the land to the left (east) of the railroad is now in the Mojave Narrows Regional Park. Most of the trees visible are cottonwoods, although Goodding willows are still present. The fields in the right foreground are alfalfa, and cattle are grazing in the middle distance in front of a line of cottonwoods growing along the slough (Dominic Oldershaw, Stake 2110f).

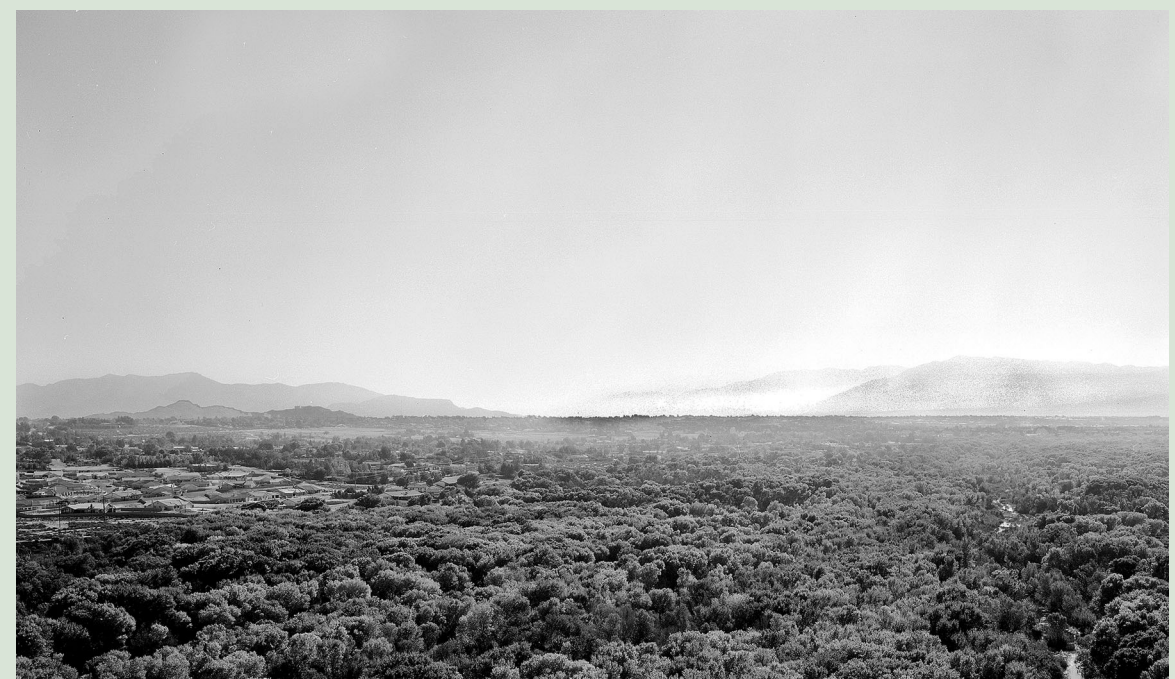
(October 24, 2000). Most of the riparian forest shown in this view is in the Mojave Narrows Regional Park. The channel of the Mojave River has decreased to a more fraction of its former width, in part because of regulation by dams upstream and the influence of the riparian vegetation. The trees present are mostly cottonwoods, but very large Goodding willows and other species are also present. The white haze in the background is smog over Cajon Pass (Dominic Oldershaw, Stake 2110e).

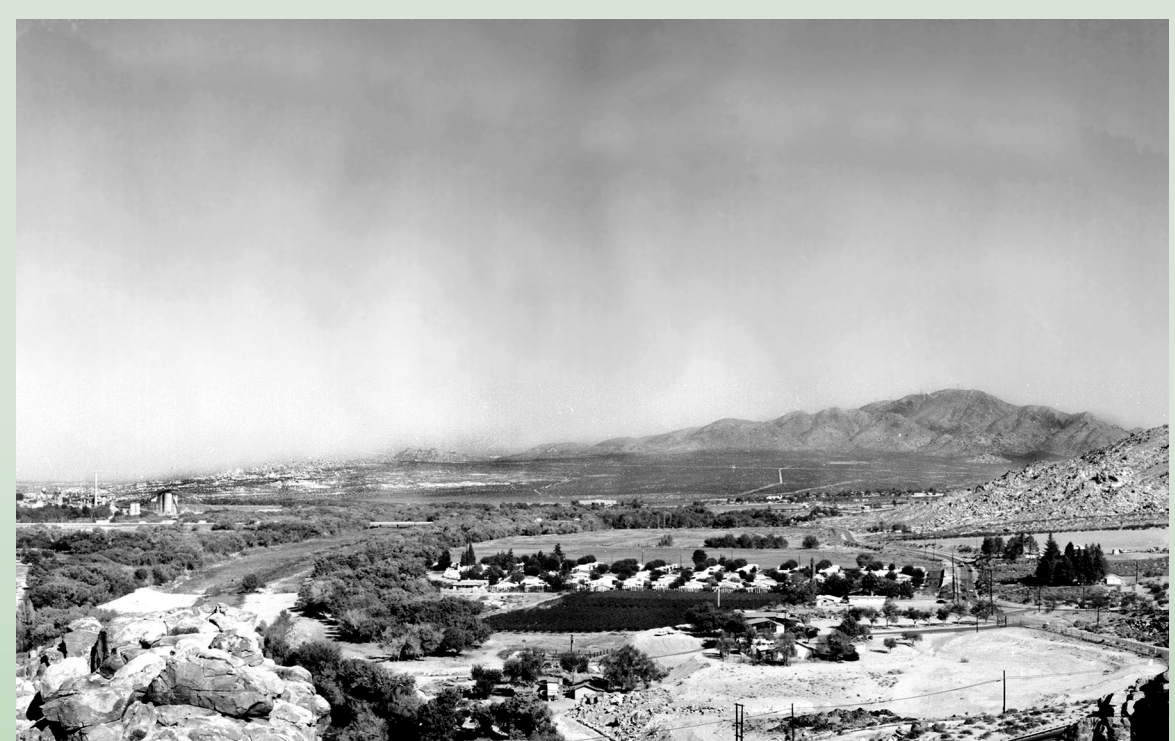
(October 24, 2000). Development associated with downtown Victorville has changed the land use away from ranching, and no grazing occurs here. The perennial flow creates ideal conditions for the growth of riparian vegetation. The width of the channel has decreased by about two thirds, and the floodplain has been replaced by willows. Although this photo is of mesquite-covered dunes with a few thorn bushes, tamarisk is the dominant woody species. Cottonwood trees now dominate the river on both sides (Dominic Oldershaw, Stake 2110c).

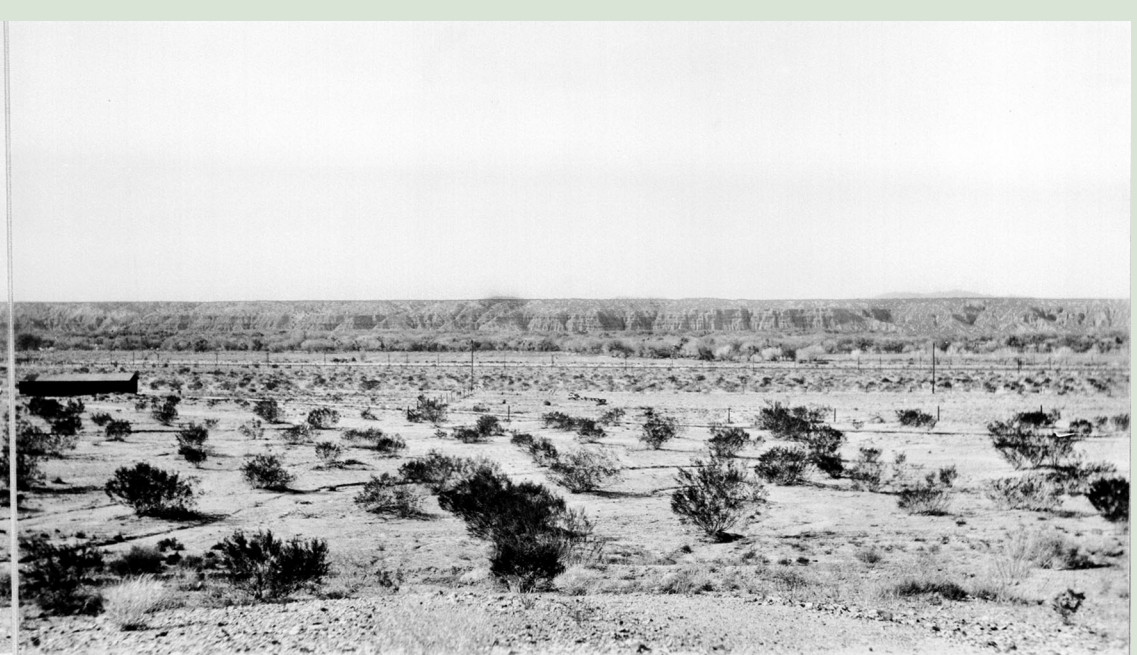
(1919). This view, from the east side of the Mojave River valley looking west, shows the Mojave River in the distance with low bluffs of fine-grained river and lake deposits on the skyline. The river is lined with trees that are likely a mixture of cottonwoods (taller, darker trees) and Goodding willows (lower, lighter trees). Both old Route 66 and the railroad cross the midground. The vegetation in the foreground is mostly creosote bush (*Larrea tridentata*) (David Thompson 441, USGS Photo Library).

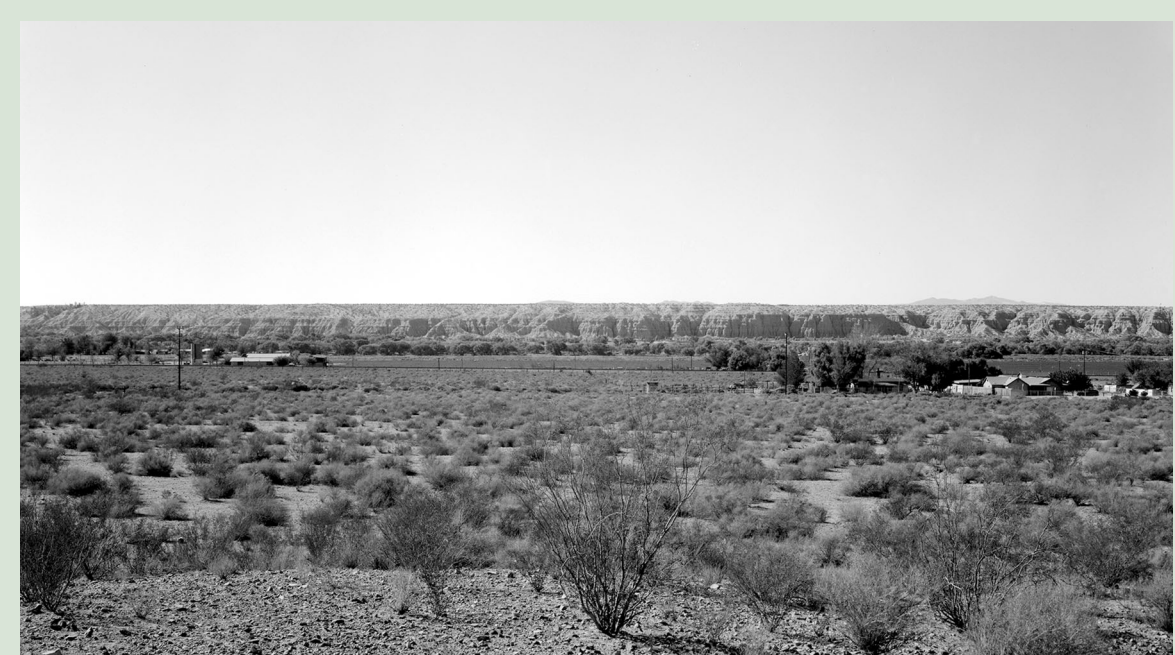
(October 24, 2000). The trees along the river have increased in size and number despite ground-water pumping in the vicinity. Cottonwood is now the most obvious species from this distance. The number of creosote bushes and other small shrubs in the foreground has greatly increased (Dominic Oldershaw, Stake 2114a).

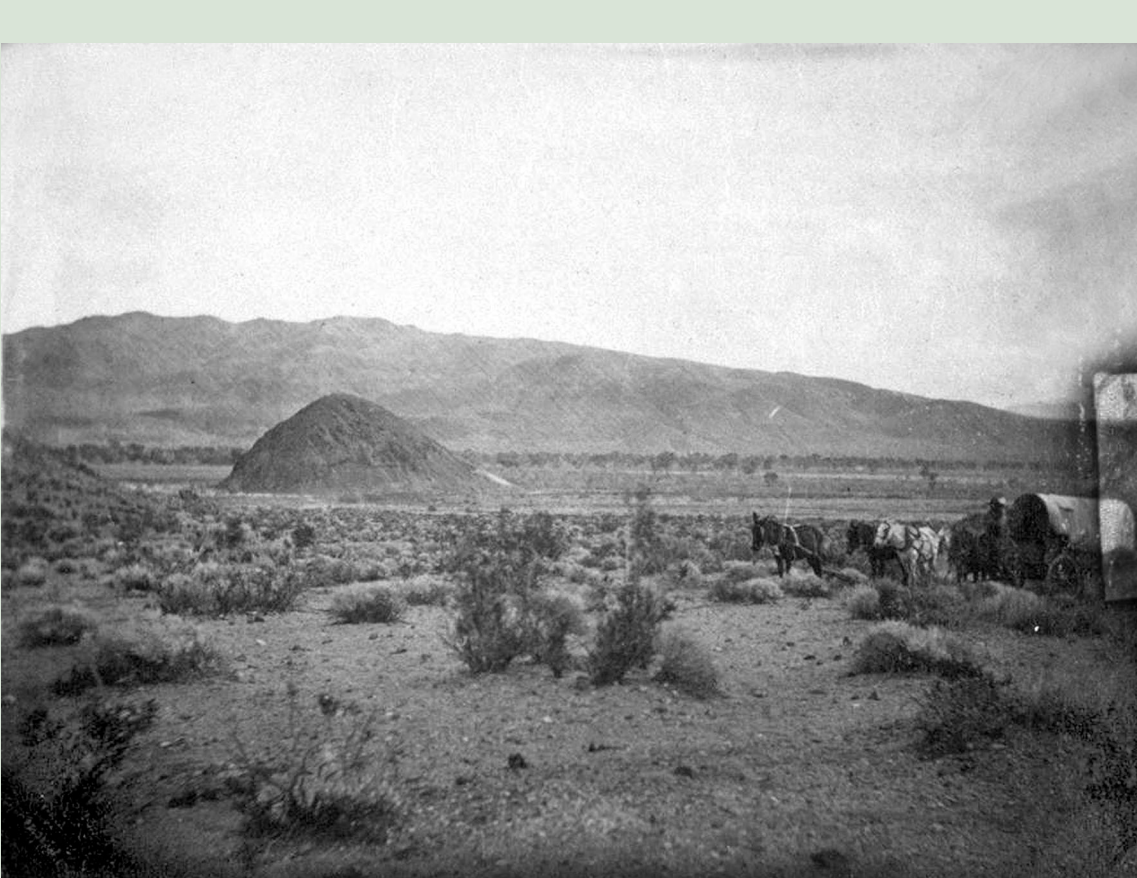
(1863). The California Geological Survey party of 1863, en route from San Bernardino to the Colorado River, paused at the future site of Barstow along the Mojave Road. The party called the low hill at left center OSugarloaf. The foreground plants are creosote bush and cattle spinach (*Atriplex polycarpa*). In the distance, trees line the channel of the Mojave River. Their stature suggests they likely are mostly Goodding willow, although a positive identification is impossible (Richard D'Heureuse 1905.16894NA, courtesy of the Bancroft Library).

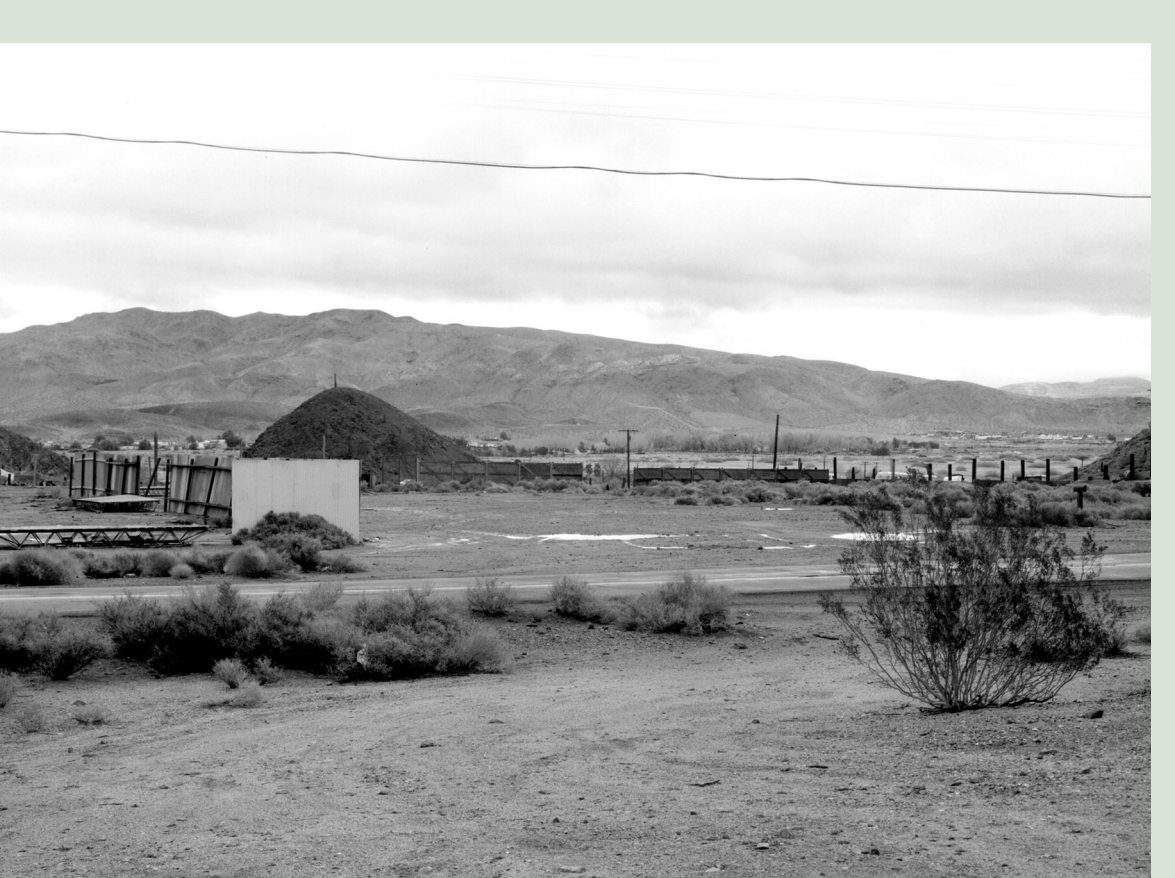
(February 26, 2001). The camera station is on the edge of a railroad cut (behind the view) east of downtown Barstow, and vegetation and topography in the foreground and midground have been disturbed. Because of ground-water pumping, almost the entire native riparian system in this area has been obliterated with the exception of mesquite hummocks on the north side of the river. The trees in the distance are a mixture of cottonwoods and non-native species, planted within a subdivision and irrigated (Dominic Oldershaw, Stake 2225).

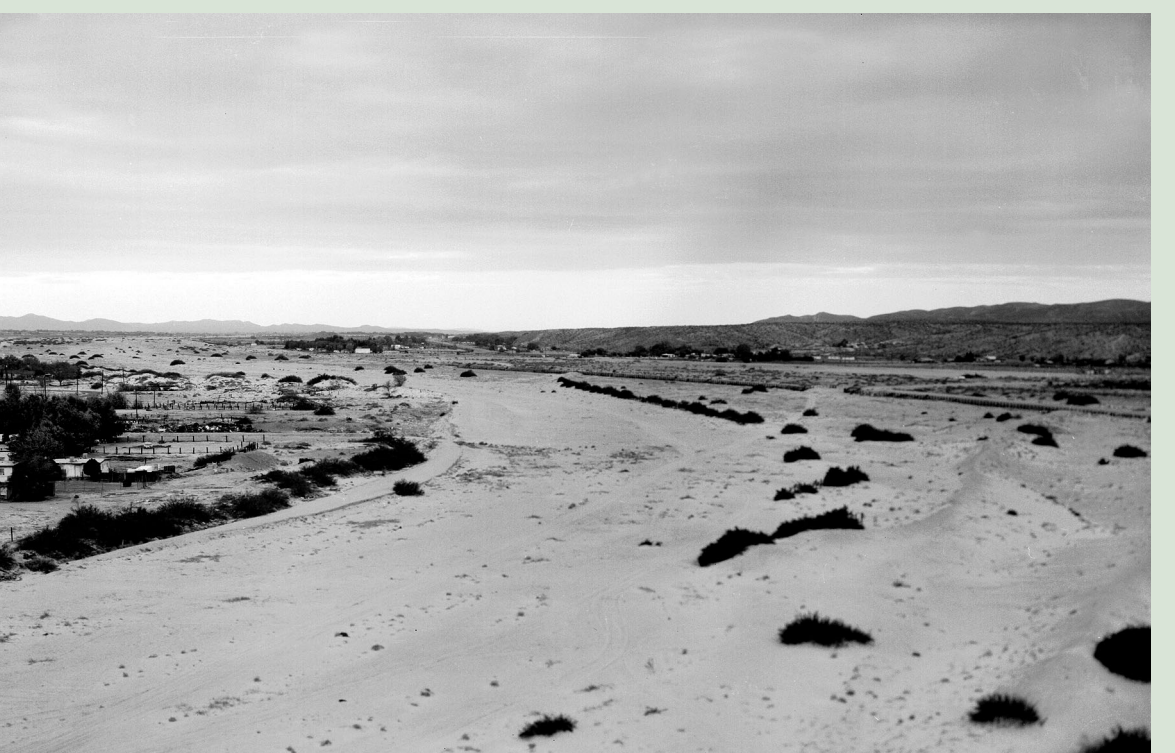
(October 22, 2000). Nearly all the native riparian plants in the previous view are dead, victims of ground-water overdraft in the reach upstream from Barstow. The low, hemispheric shrubs in the foreground are tamarisk, which accumulated pollen sand entrained from the open river bed and deposited around the trees. The vegetation at left is planted and irrigated, and most of the trees are non-native Athel tamarisk (*Tamarix aphylla*) (Dominic Oldershaw, Stake 2106b).

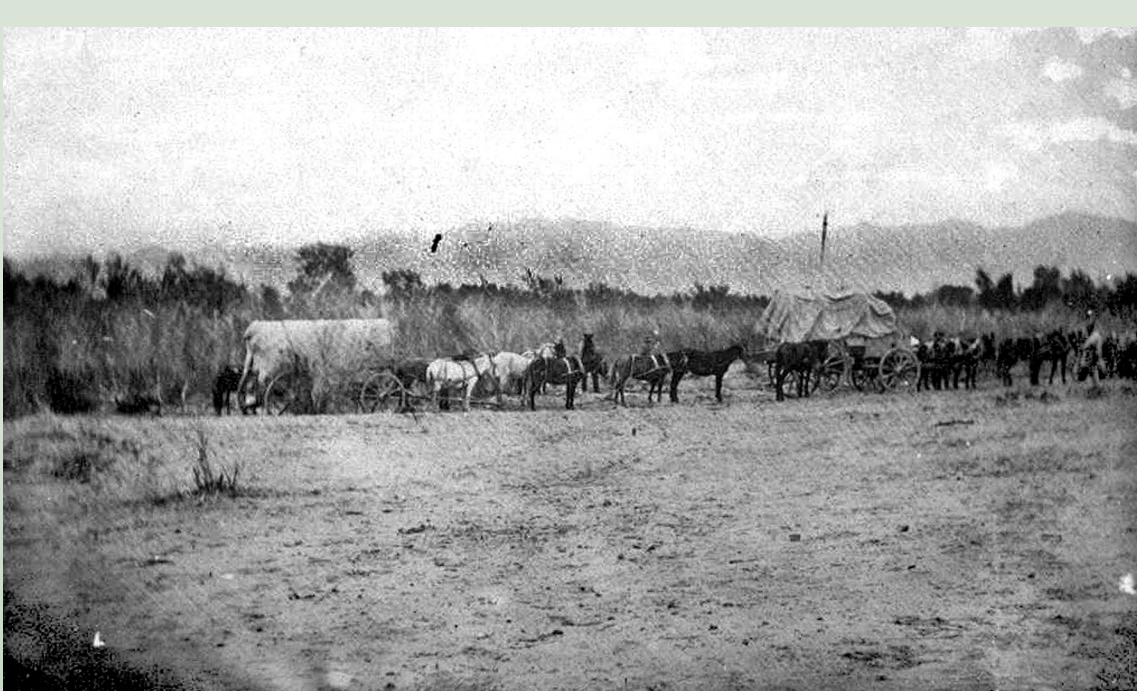
(1863). In 1863, the Mojave Road and the Spanish Trail met at the Mojave River east of Barstow, near the current site of Yermo. This photograph shows that the Mojave River was lined with short trees, probably Goodding willows. These trees suggest that reliable surface water once was present here (Richard D'Heureuse 1905.16894NA, courtesy of the Bancroft Library).

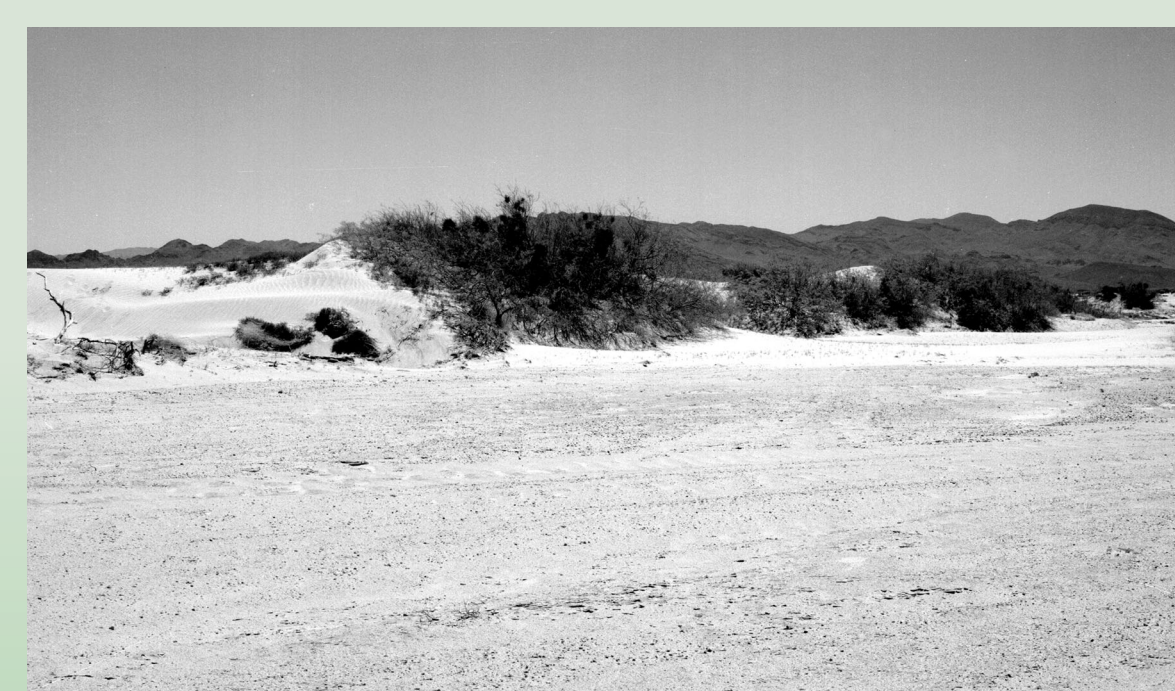
(April 25, 2001). During the last 138 years, hummocks with tamarisk, mesquite, desert willow (*Chilopsis linearis*), and California scale broom (*Lepidospartum squamatum*) have replaced the willows. Although this photo is of mesquite-covered dunes with a few thorn bushes, tamarisk is the dominant woody shrub along this stretch of the Mojave River bed (Dominic Oldershaw, Stake 4085).

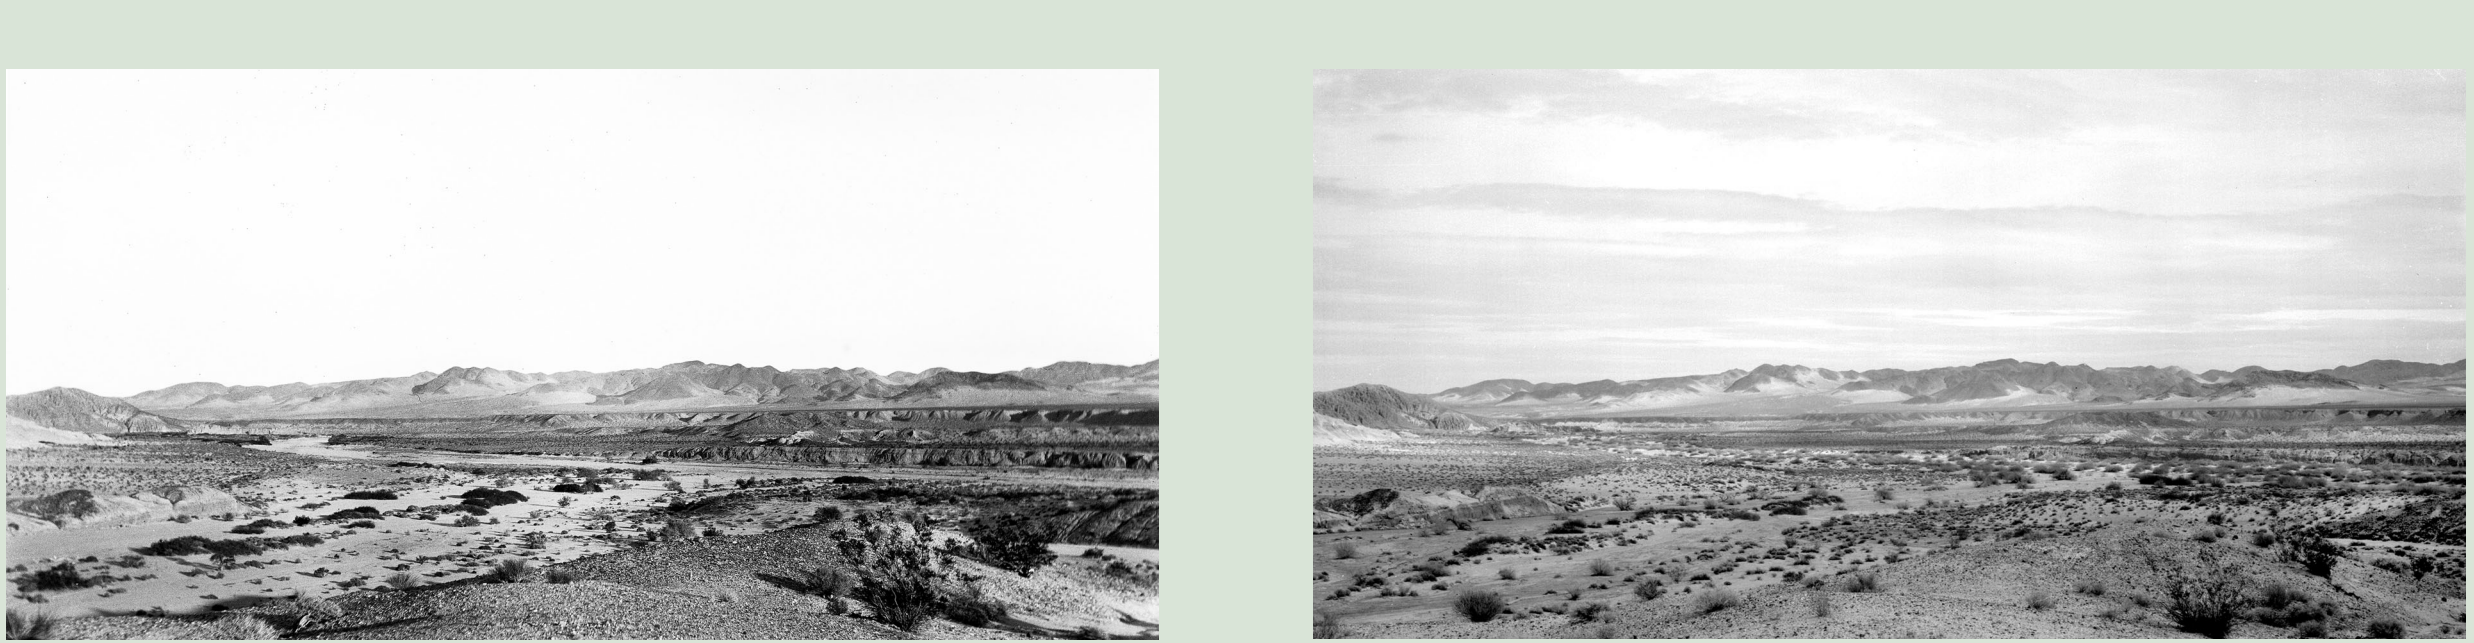
(1919). Manix Wash flows south into the Mojave River near the northern edge of the Cady Mountains. This view shows Manix Wash in the foreground and its confluence with the Mojave River (midground). Mesquite covers the dune hummocks in the wash. The Mojave River bed appears almost devoid of trees and shrubs in this view. Thompson also took photos a few hundred yards upstream (to the right). The upstream photos show patches of scattered trees, probably Goodding willows and cottonwoods (David Thompson 322, USGS Photo Library).

(March 2, 2001). The Manix Wash now has more shrubs, including many of the same mesquite hummocks present in 1919. Many of the other large shrubs and trees in the wash, tamarisk and desert willow, were uncommon in the early photo or not evident. No mesquite occurs beyond the confluence of the wash and Mojave River bed (midground). The Mojave River bed is now densely populated by tamarisks growing on hummocks of sand to the exclusion of all other species of shrubs and trees. Small remnants of native vegetation, including mesquite, can be seen on a few dunes at the north edges of the river bed (Dominic Oldershaw, Stake 116a).

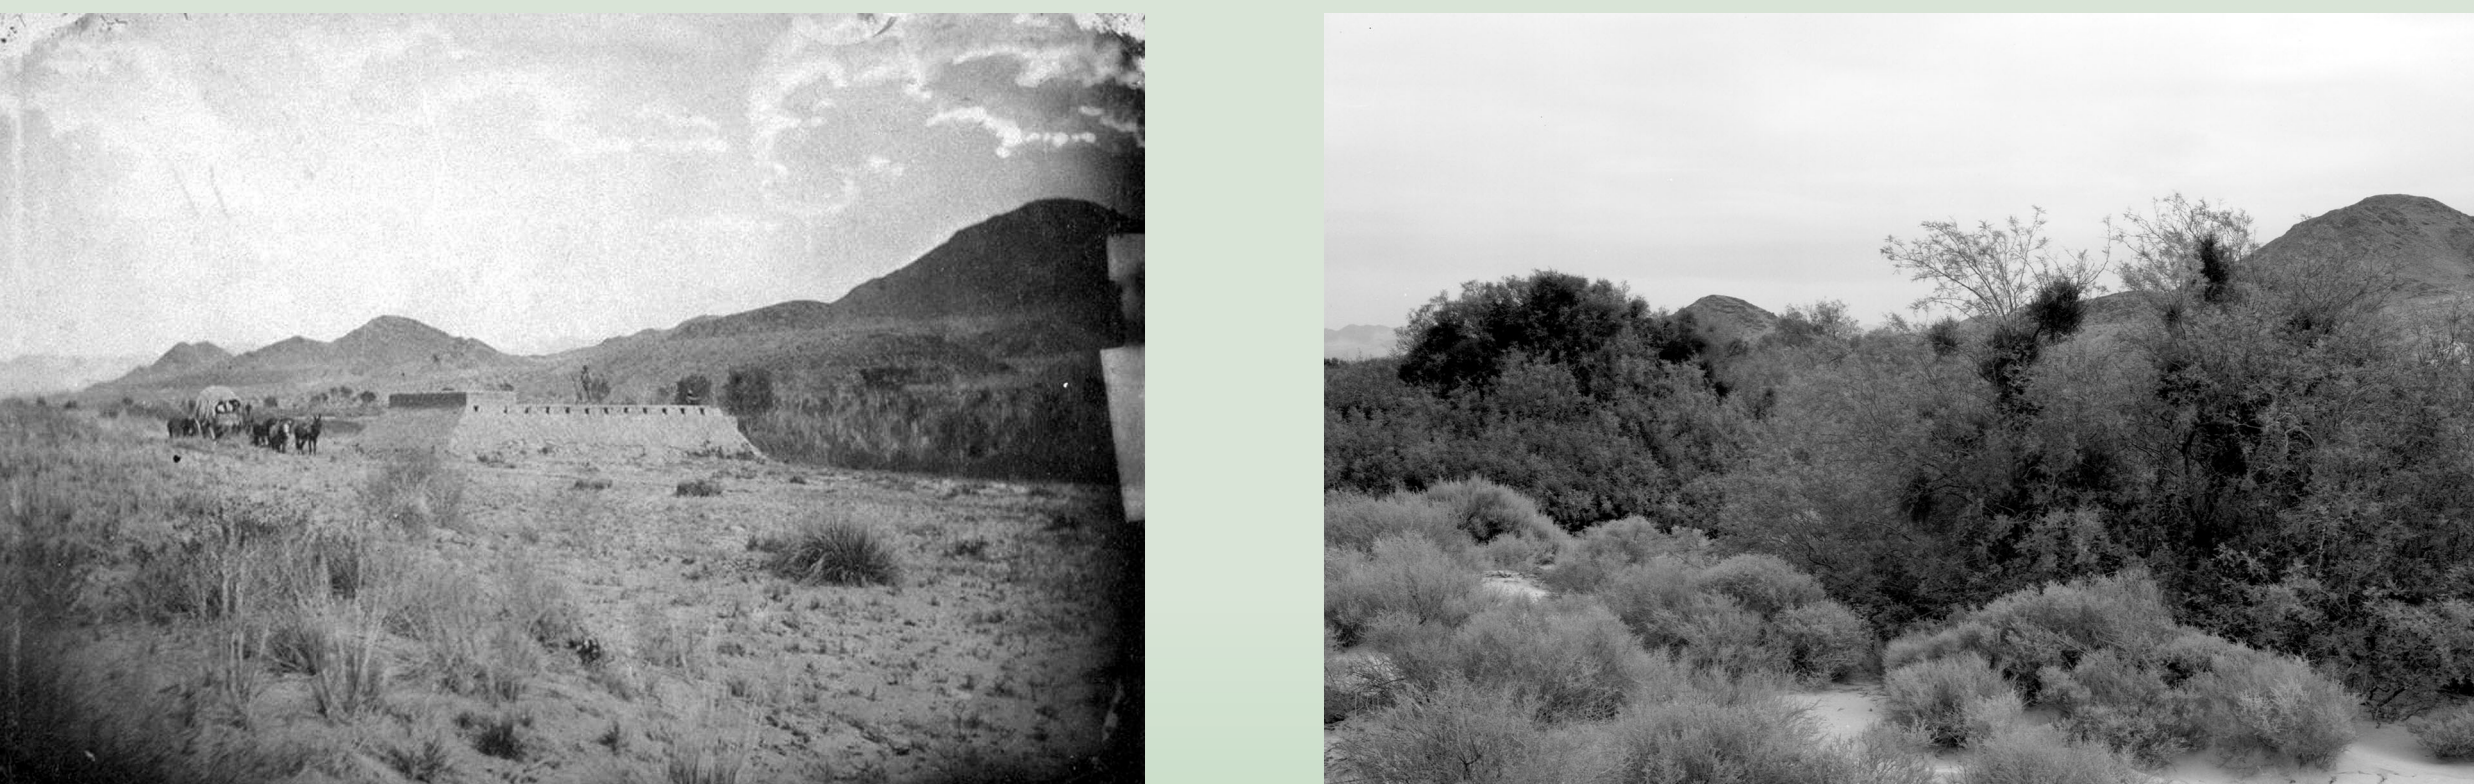
(1863). In the early 1860s, the U.S. Cavalry established several outposts at perennial water in the Mojave Desert for the protection of travellers along the Mojave Road, then known as the Government Road. The structure shown in this view is Camp Cady, on the north bank of the Mojave River northwest of the Cady Mountains. Behind and to the right of the fortification are riparian trees, which appear to be mesquite (plants just behind the fort), Goodding willows (both sides of fort), and coyote willow (right) (Richard D'Heureuse 1905-16894NA, courtesy of the Bancroft Library).

(October 23, 2000). Mesquite now blocks the view of the fort, which survives only in some broken foundations and a small commemorative sign. Mistletoe appears in some of these mesquite trees, which were very healthy at the time of this photograph. The foreground shrubs are cattle spinach. Cottonwood trees rise above some of the mesquite trees (Dominic Oldershaw, Stake 2107).

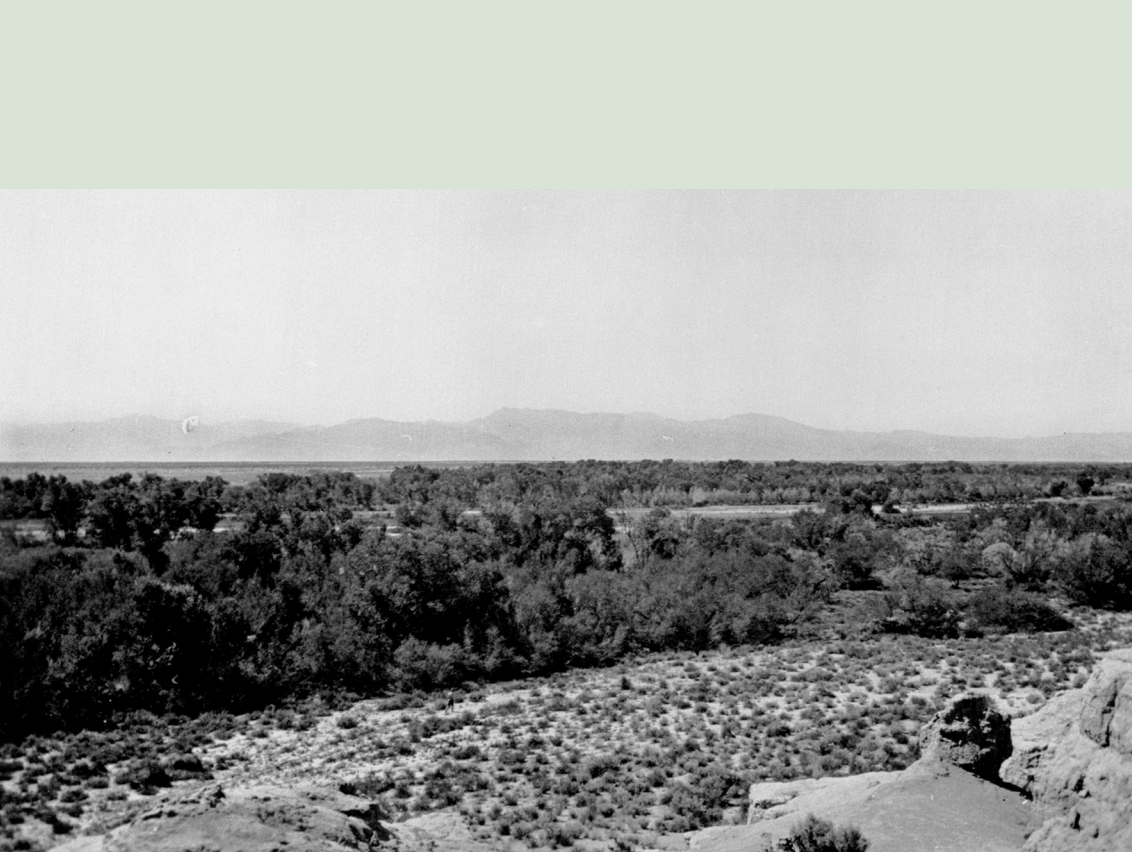
(1917). Downstream of Barstow, the Mojave River crosses a wide, sandy valley that, in 1917, had sand dunes and mesquite hummocks. Where the river approaches the northwest side of the Cady Mountains, its course apparently crosses a subsurface geological structure (either fault or geologic strata) that forces ground-water towards the surface. A zone of riparian vegetation consisting of mesquite, cottonwood, and Goodding willow was well established here in 1917. The channel of the Mojave River, which flows right to left across the center of this view, is relatively wide (David Thompson 15, USGS Photo Library).

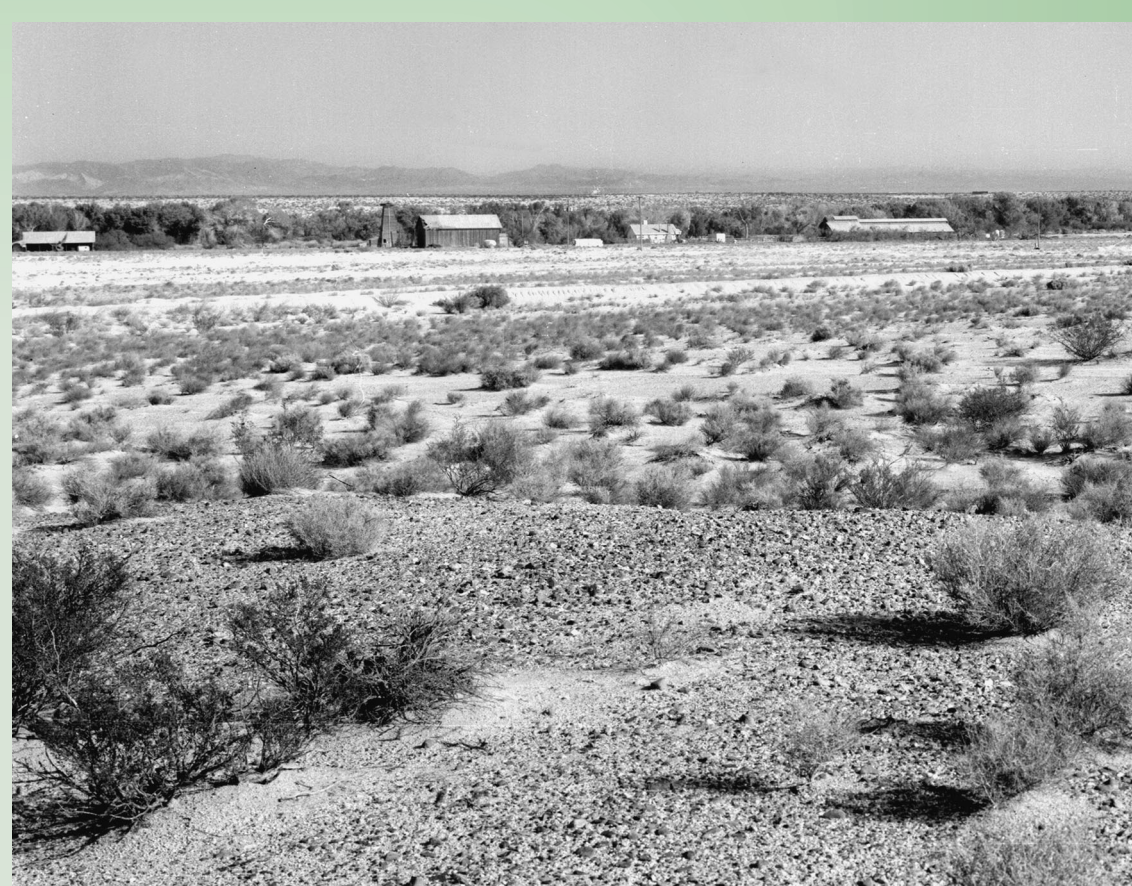
(October 25, 2000). Much of the midground vegetation was cleared for agriculture during private operation of Camp Cady Ranch. The ranch buildings and surrounding lands are now owned by the California Fish and Game Department, which ceased grazing and agriculture on the property shortly before this photograph was taken. The stature of the riparian community has increased as the cottonwoods have grown higher above the willows. Upstream and downstream from this reach, riparian vegetation is dying owing to ground-water pumping (Dominic Oldershaw, Stake 2115c).

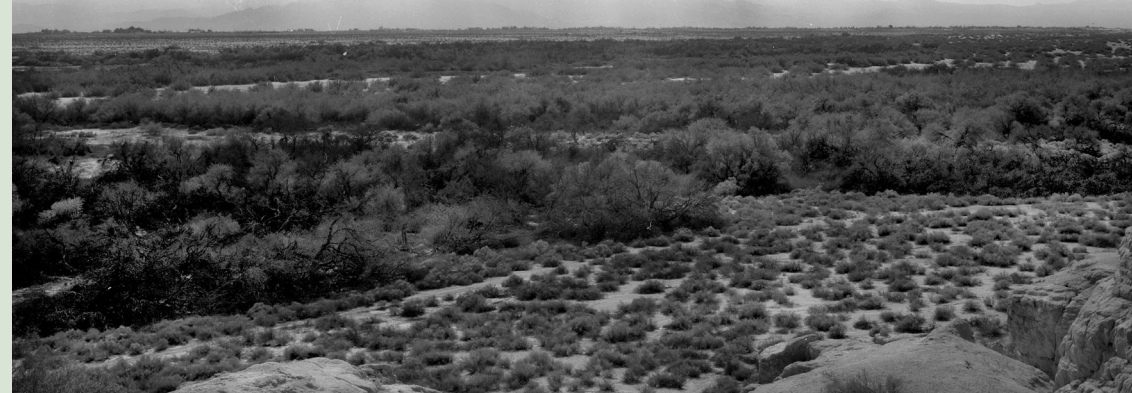
(October 25, 2000). This view across the upstream part of the Camp Cady Ranch shows a section where mortality of mesquite has been high owing to upstream ground-water pumping, much of it immediately upstream from the reach in this view, and tamarisk has increased considerably in the midground. At the time of this photograph, tamarisk removal was occurring in this reach. Despite the mortality, riparian vegetation increased during the middle of the 20th century before the dieback because the channel of the Mojave River is much narrower (Dominic Oldershaw, Stake 2117).

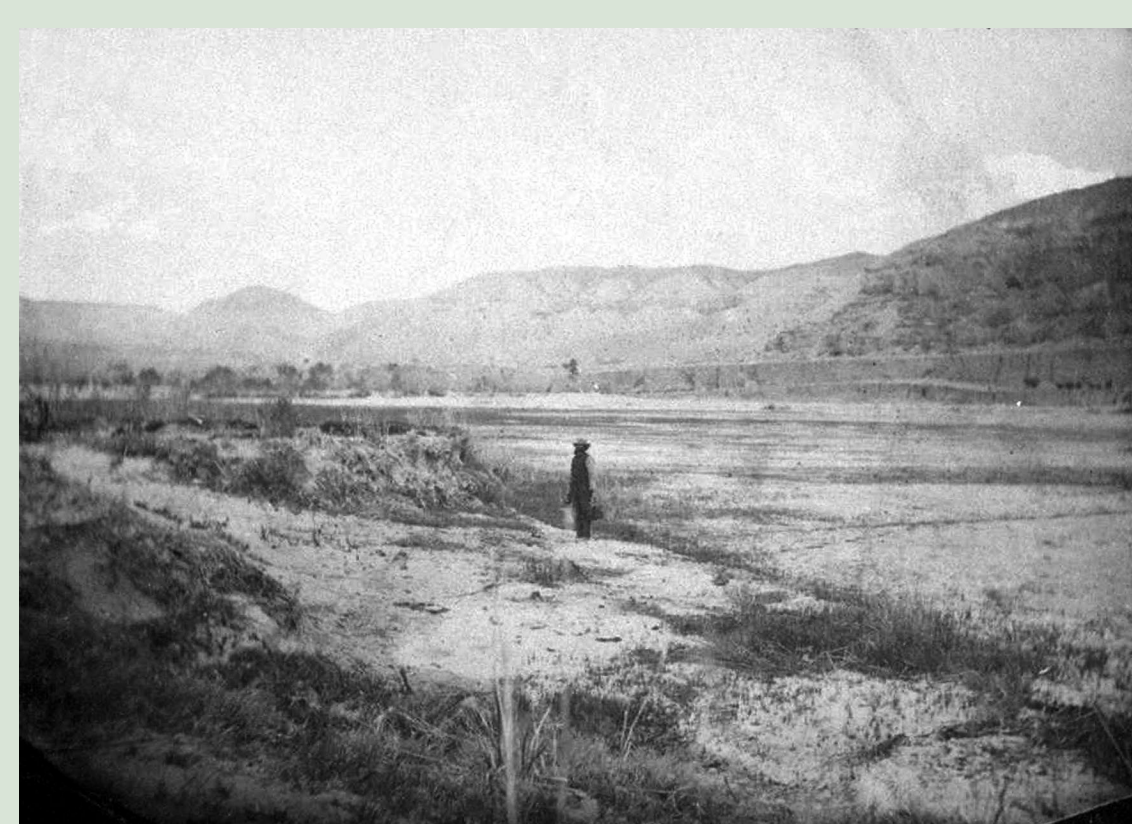
(March 1863). This downstream view of the Mojave River was taken at the head of Afton Canyon about a year after the 1862 flood. A wide, scoured channel with little riparian vegetation is present in the foreground, and larger trees of unknown species are in the middle distance. From this distance, it is impossible to determine whether these trees were cottonwoods or Goodding willows (Richard D'Heureuse 1905.16894NA, courtesy of the Bancroft Library).
