# CHANGES IN RIPARIAN VEGETATION IN THE SOUTHWESTERN UNITED STATES: Historical Changes Along the Mojave River, California

## USGS GROUND WATER RESOURCES PROGRAM

U.S. GEOLOGICAL SURVEY OPEN-FILE REPORT OF 01-245, 2001

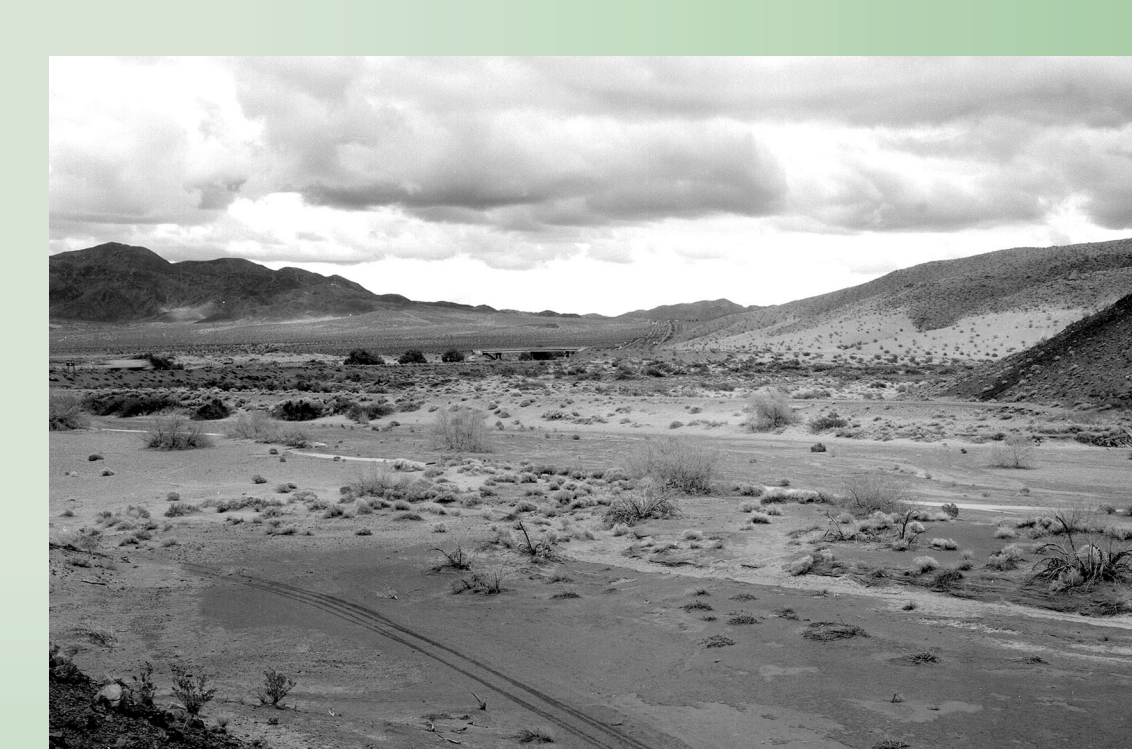
(February 26, 2001). In the intervening years, the dam in the foreground was breached, leaving a partial dike in the background. The large shrubs in the wash are desert willows, still alive but smaller and less robust than 82 years earlier. They are mixed with cattle spinach. In the background, the mesquites are gradually dying and being replaced by creosote bushes. One tamarisk is in the wash and several athel tamarisks are along Interstate 15 (Dominic Oldershaw, Stake 105).
