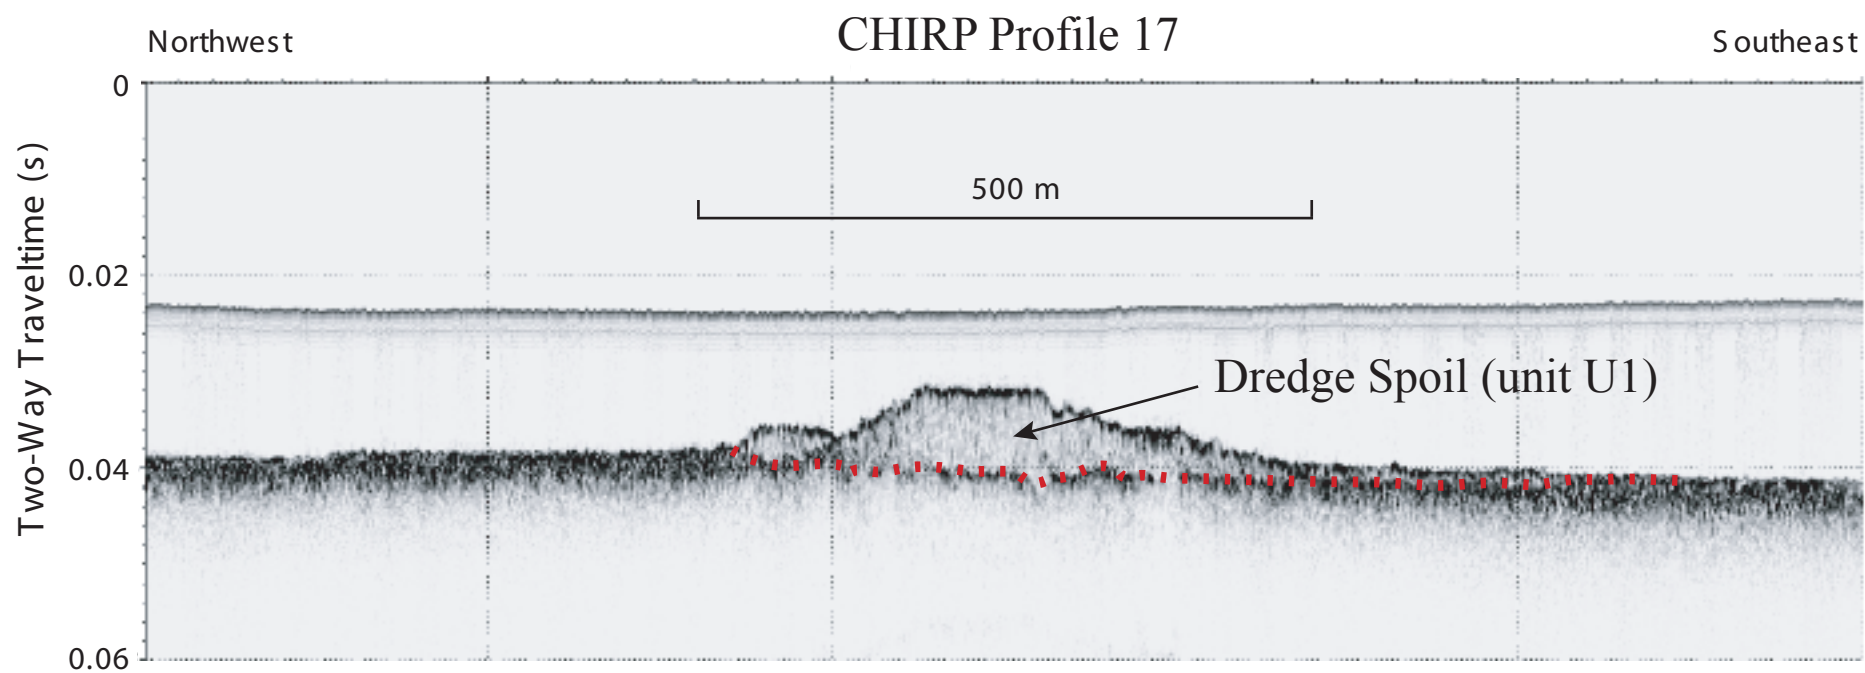
Figure 18. Seismic-reflection profile (cruise 98013) showing disposed dredged material (unit U1) in the Mud Dump Site. See Figure 2b for location.
