Debris Flows along the Interstate 70 Corridor, Floyd Hill to the Arapahoe Basin Ski Area, Central Colorado – A Field Trip Guidebook

by Jeffrey A. Coe, Jonathan W. Godt, and Alan J. Henceroth

Open-File Report 02-398

October 2002

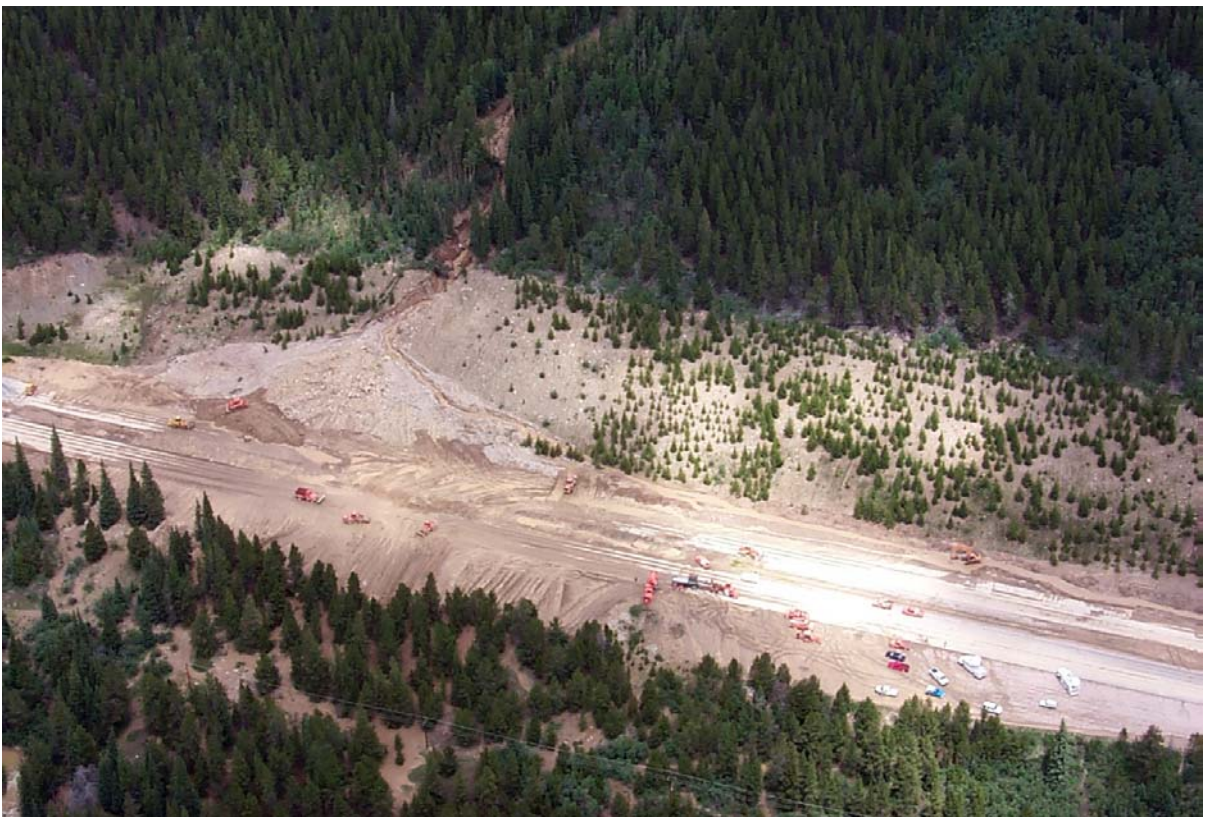
Cover: Debris-flow deposit on Interstate 70 about 2.1 miles west of the Bakerville exit (exit #221). Debris flow was triggered by an afternoon thunderstorm on July 28, 1999. The Interstate was closed about 25 hours while debris was cleared from the highway surface. See vehicles for scale. Photograph by Ed Harp on July 29, 1999.

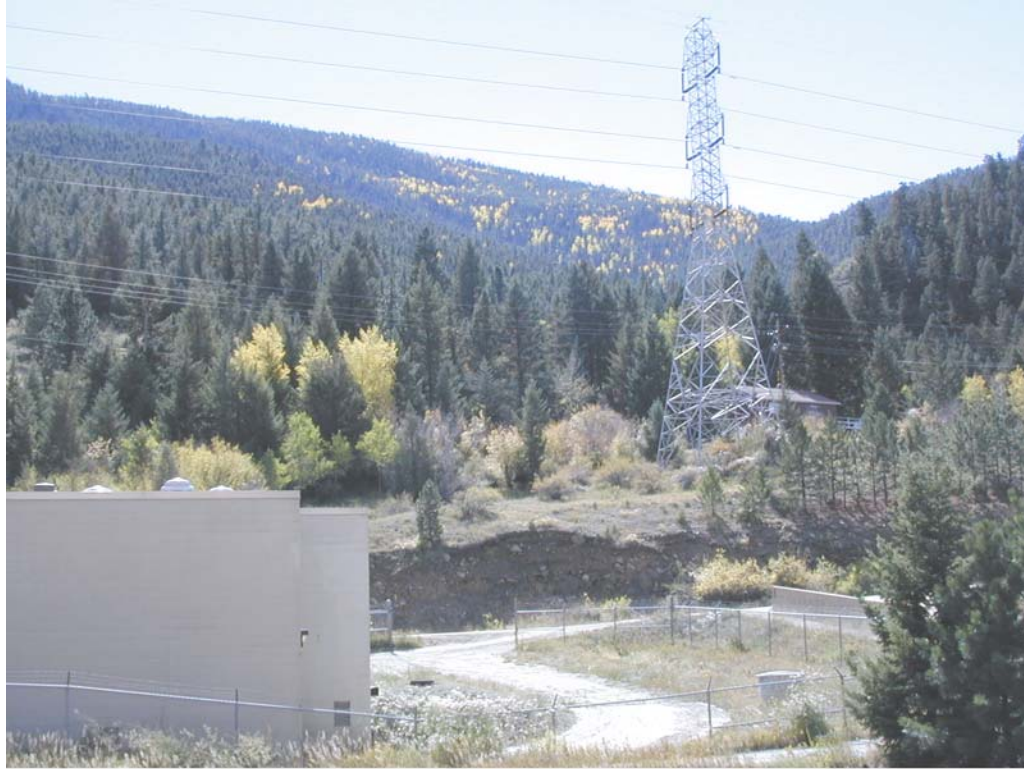
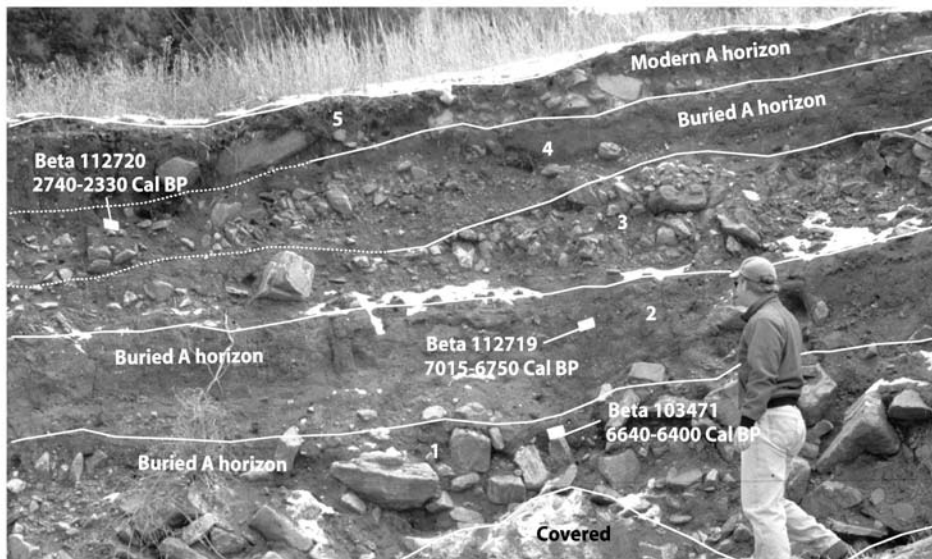
Figure 3. Drainage basin (A) and fan exposure (B) at the Aggregate Industries Plant (Stop 2). Radiocarbon dates are given as calibrated ages with a 2 standard deviation range.

The drainage-basin upslope from the fan is forested, and has moderate size and relief as indicated by a Melton's number of 0.44 (figs. 2 and 3). For tributary basins along Clear Creek, there is a negative correlation between Melton's number and the mean recurrence intervals of debris flows on fans (Coe and others, in press). That is, fans with the shortest mean recurrence intervals tend to be at basins with the highest Melton's numbers (small and steep basins). Also, in general, mean recurrence intervals between debris-flow events on fans at the mouths of vegetated basins (such as this one) are longer than those on fans at the mouths of sparsely-vegetated basins.

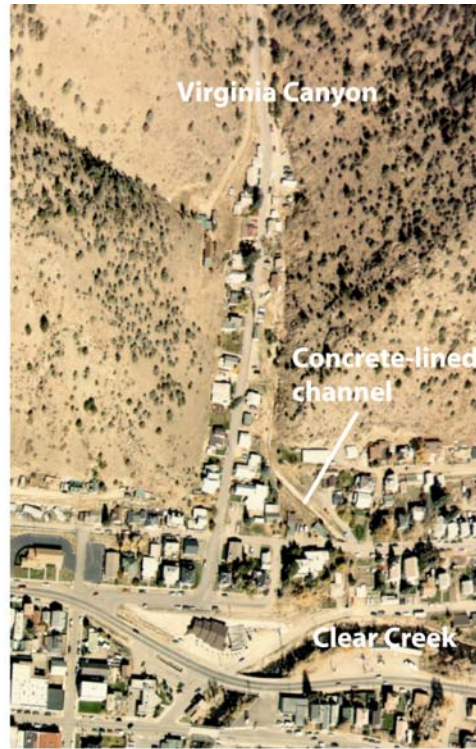
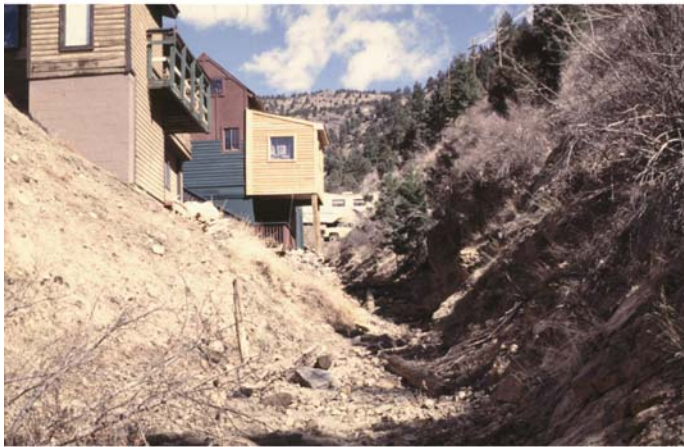
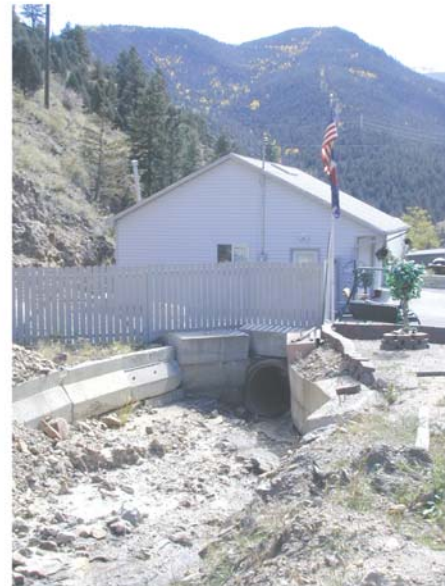
Figure 4. Drainage basin, fan, and structures at Virginia Canyon (Stop 3). A) Drainage basin. Photo taken in 1997. B) Aerial photograph of the mouth of the basin in Idaho Springs. Photo taken October 13, 1996. C) Houses along the west bank of the drainage channel. Photo taken in March, 1997. D) Garage built over the channel. Photo taken October 7, 2002.

The basin upslope from the fan is relatively large with moderate relief, as indicated by a Melton's number of 0.26 (figs. 2 and 4a). From our data, fans at the mouths of basins with Melton's numbers less than about 0.35 are dominated by flood events, whereas basins with Melton's numbers greater than about 0.35 are dominated by debris-flow events (fig. 2).

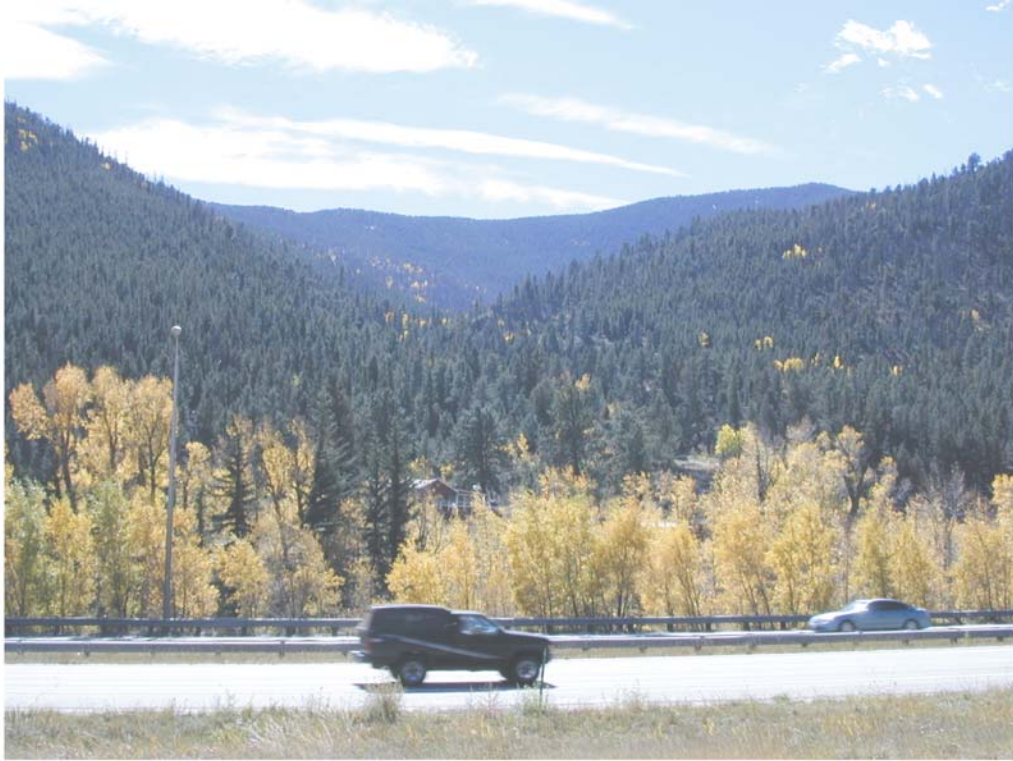
Figure 5. Drainage basin (A) and fan exposure (B) at Ohio Gulch (Stop 4). Basin photographed October 7, 2002. Fan photographed in 1997. Radiocarbon dates are given as calibrated ages with a 2 standard deviation range

The drainage-basin upslope from the fan is forested, and has moderate size and relief as indicated by a Melton's number of 0.50 (figs. 2 and 5). This basin has morphologic and vegetation characteristics that are very similar to those of the basin at Stop 2 (fig. 3). The recurrence interval of debris-flow events and estimated probability of future debris flows are also very similar.

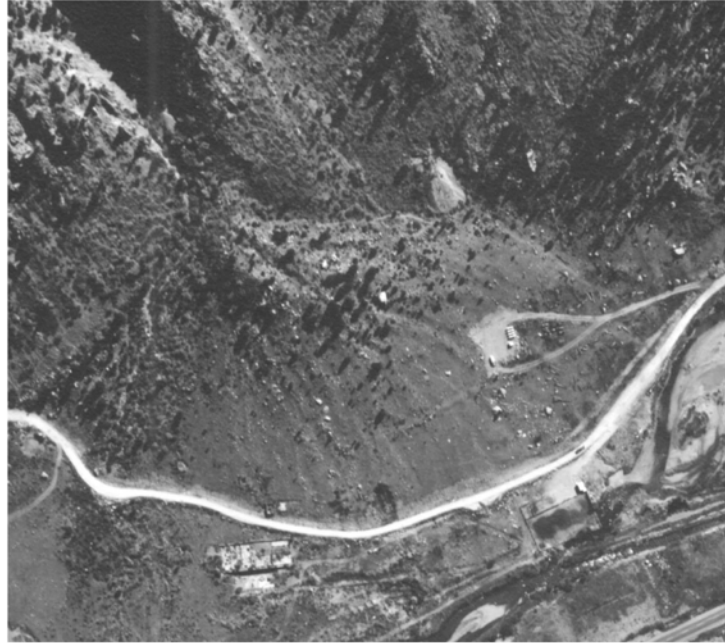
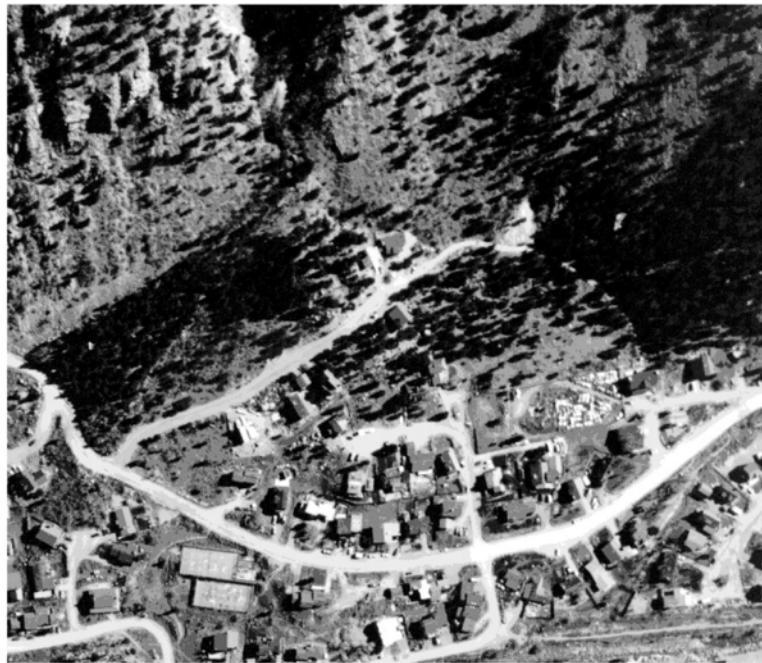
Figure 7. Aerial photograph showing residential development on a fan in Georgetown (fan is visible to the east from Stop 6). A) Photograph from 1961. B) Photograph from 1996. Distance covered by the width of the photos is about 0.5 km (~0.3 miles) on the ground.

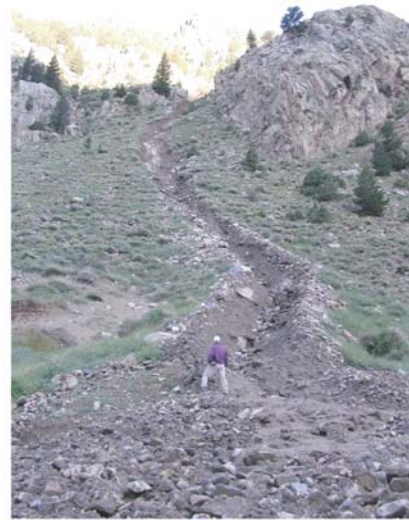
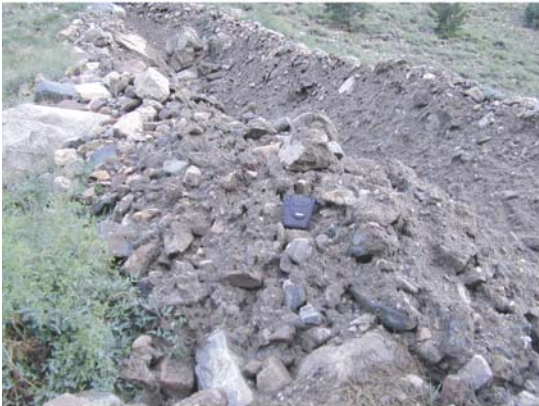
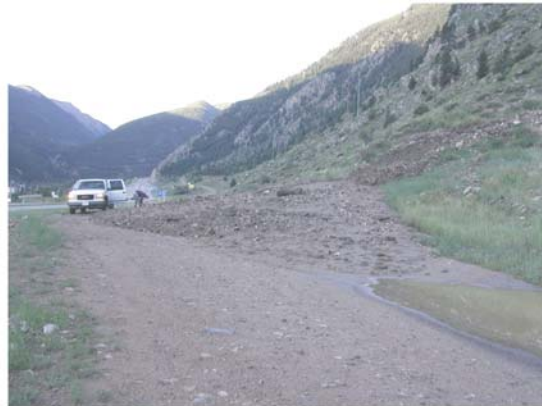
Figure 8. Drainage basin and July 13, 2001 debris-flow deposits at Stop 7. A) Drainage basin. Photograph taken August 30, 1996. B) Debris-flow channel. C) Matrix-supported debris-flow levee. See camera case for scale. D) Fan formed by deposit. Photos B,C, and D where taken July 14, 2001.

- 23.9 **STOP 7. Debris-flow channel with deposit from July 13, 2001 debris-flow event.** Latitude: N 39° 43' 31.9", Longitude: W 105° 41' 43.2", Elevation: 2,597 m (8,520 ft). The debris-flow that deposited this small fan has characteristics that are typical of debris flows in the area along the north side of I-70 between Empire and Georgetown. That is, it traveled a short distance (less than 1 km) and deposited a volume of material less than 1000 m³. The fan deposit is matrix supported, poorly sorted, and contains randomly oriented clasts (fig. 8). Grain-size analysis of a similar deposit (at the same location) that resulted from the July 28, 1999 storm (USGS, unpublished data) indicated that sand-sized material makes up most of the matrix (74 percent), followed by silt- (21 percent), and clay-sized material (5 percent). Unlike some of the other debris-flow channels in the area, this channel has matrix-supported levees that seemingly receive fresh material with each debris-flow event (for example, see fig. 8c).

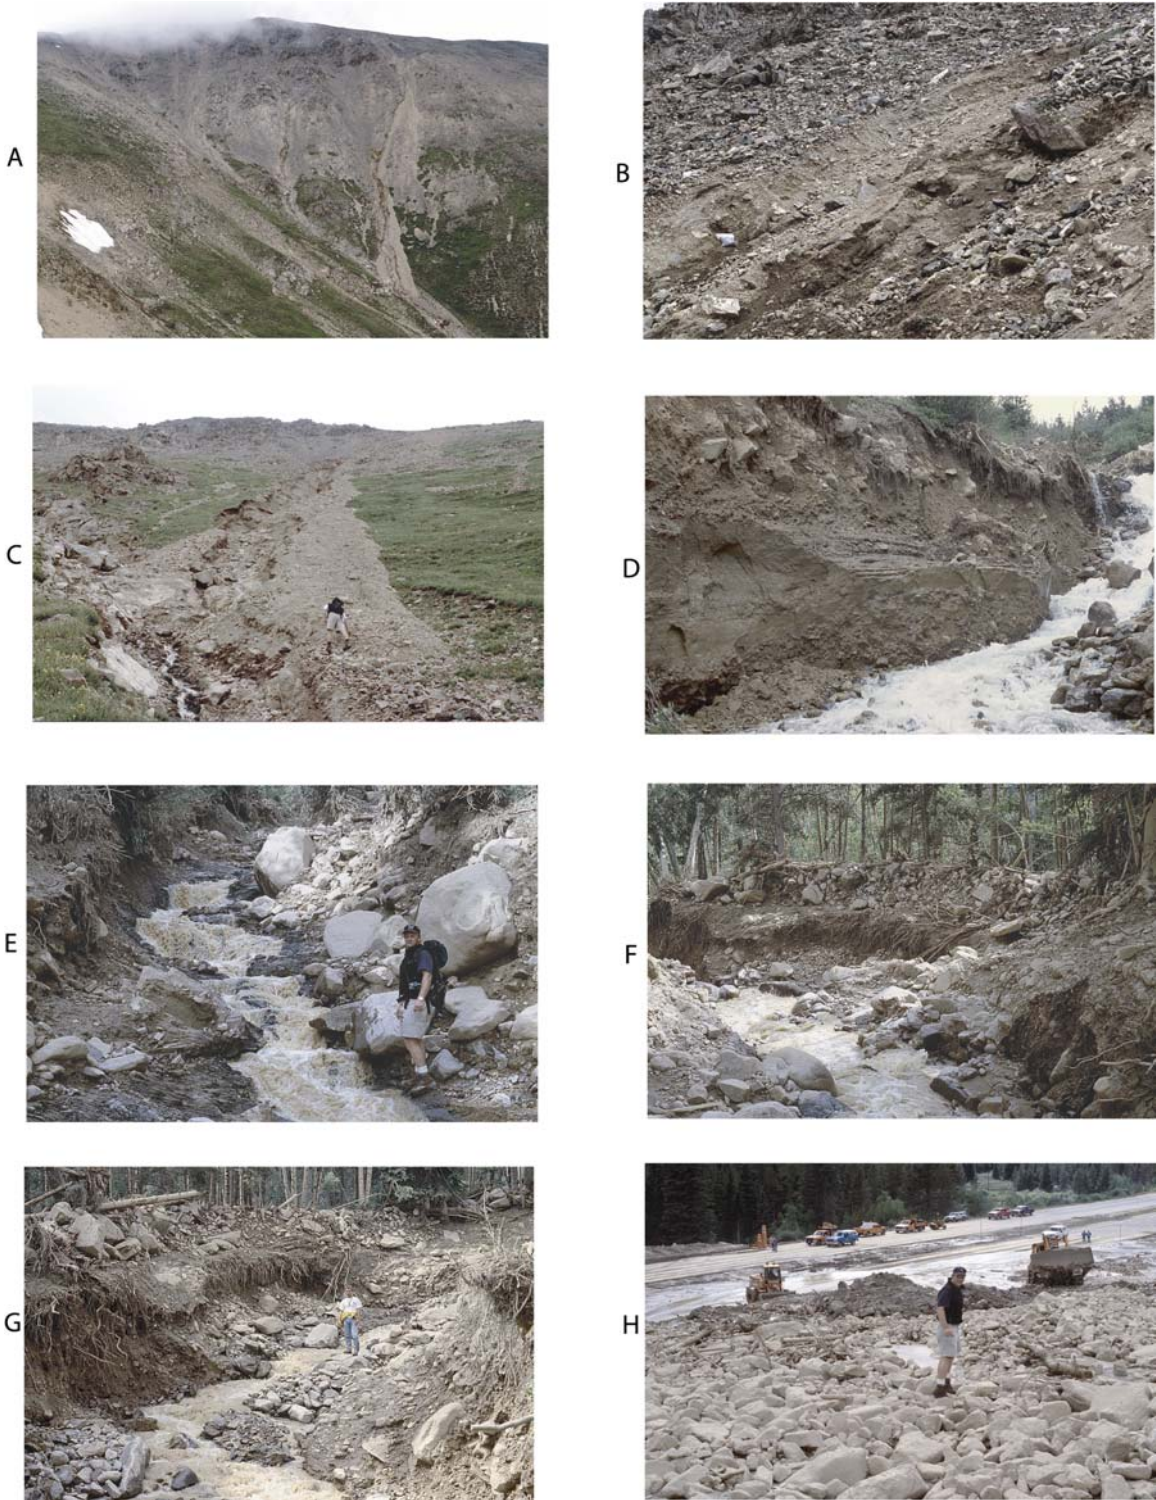
Figure 12. Photographs of Watrous Gulch taken after the July 28, 1999 debris-flow event. A) Rills in the source area. View to the east. Relief visible is about 610 m (2,000 ft). B) Head of the largest rill in the source area (see quart-sized sample bag at lower left for scale). View to the north. C) View upstream along the largest rill. See geologist for scale.

Figure 12 – continued. D) Deposits exposed by the July 1999 debris-flow event located about half way between the head of the largest rill and the fan. Channel is about 3 m deep. Matrix-supported boulder-rich deposit on top, sorted, stratified, silt-rich deposit at base. View to the northwest. E) Bedrock-lined channel exposed by the July 1999 debris flow. F) Matrix-supported levee deposits along a bend in the channel above the fan. View downstream to south. Channel depth (thalweg to top of levee) is about 4 m. G) Matrix-supported levee deposits along a bend in the channel above the fan. View upstream to north. H) Fan on I-70. Photos A through D taken on August 4, 1999. Photos E through H taken July 29, 1999.

On the south flank of Mount Parnassus the flows initiated as rills on steep, non-vegetated slopes above tree line (figs. 12a, b, and c). The matrix of colluvium at the head of the largest rill contained 84 percent sand-sized material, 8 percent silt-sized material, and 8 percent clay-sized material (Godt and Coe, in press). Clasts made up about 50 percent of the colluvium. As the debris flow(s) progressed downslope, it eroded material from the channel. Parts of the channel were incised several meters by the flow (figs. 12d, e, f, g). Material eroded from the channel included deposits of layered, sandy-silt (fig. 12d), as well as, matrix-supported deposits containing sub-angular to sub-rounded boulders (fig. 12d). The matrix of the flow became finer-grained as it progressed downslope. The matrix of the deposit on I-70 (fig. 12h) contained 69 percent sand-sized material, 24 percent silt-sized material, and 7 percent clay-sized material. Clasts made up about 70 percent of the deposit on I-70 and were larger and more rounded than those in the colluvium at the source area (compare fig. 12b with fig. 12h).

An analysis of superelevation of debris-flow levees (see Costa, 1984 for description of the method) at a bend in the channel of Watrous Gulch directly above I-70 (figs. 12f and 12g) indicated a velocity for the Watrous Gulch debris flow of 9.7 m/s. This compares favorably with video footage shot of the debris-flow from I-70 (Denver television station “News4” footage).

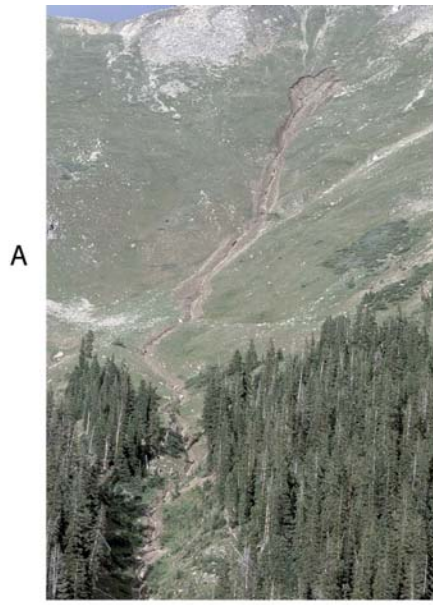
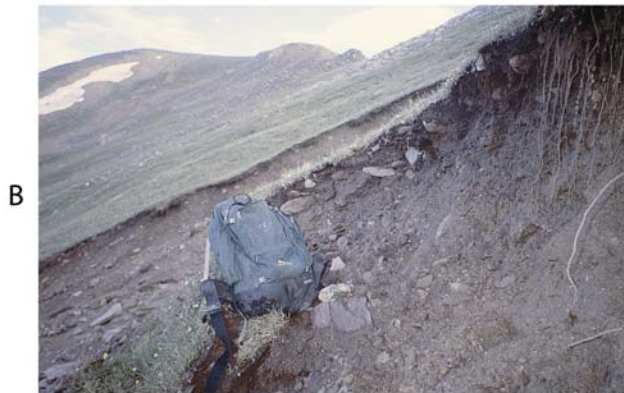
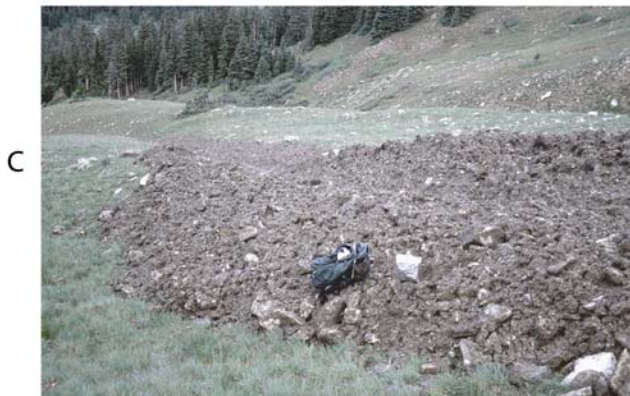
Figure 14. Debris flow mobilized from a landslide (soil-slip) on the west flank of Grizzly Peak near the Arapahoe Basin ski area. Eyewitness accounts indicate that the flow was mobilized on July 29, 1999, instead of July 28, 1999, as were most other debris flows that were triggered by the July 28 storm. A) Overall view of the flow. View to the east. B) Landslide head scarp. View to the north. C) Matrix-supported levee along the south edge of the debris-flow channel. All photos taken on August 10, 1999.

The soil-slip debris flow shown in figure 14 was reported by Mark Atkins of the Asphalt Paving Company to have failed on July 29, 1999, one day after the rainstorm. This observation suggests that the decrease in effective normal stress that caused the soil slip to fail may have resulted from slow, topographically forced convergence of flow, rather than the infiltration of rainfall. The position of the soil slip in a channel (fig. 14a) makes such a mechanism possible.

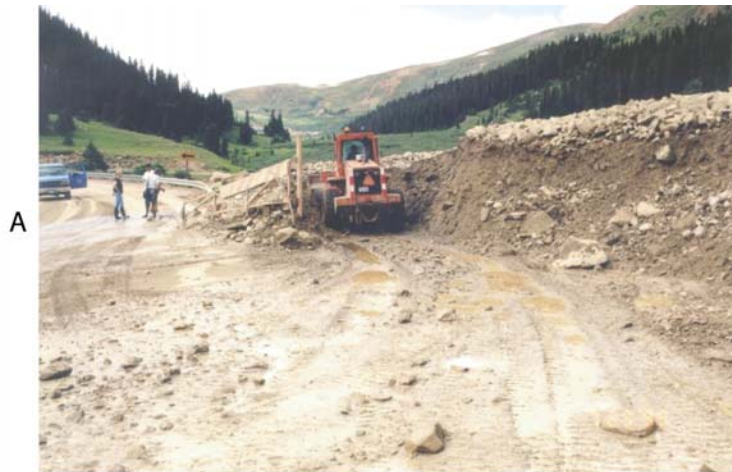
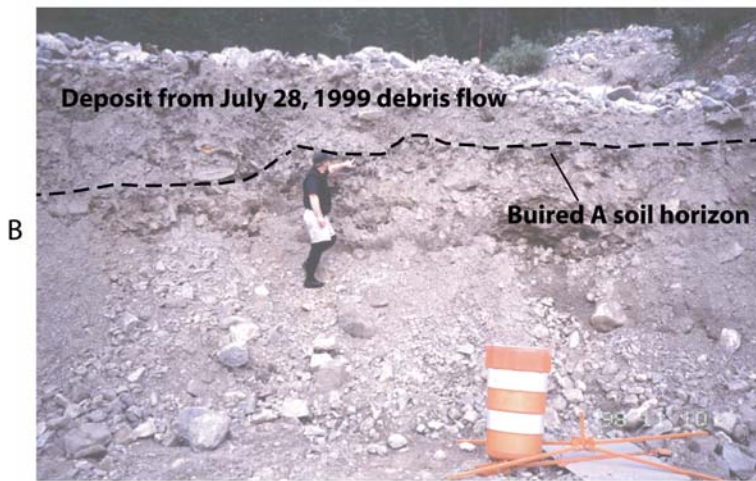
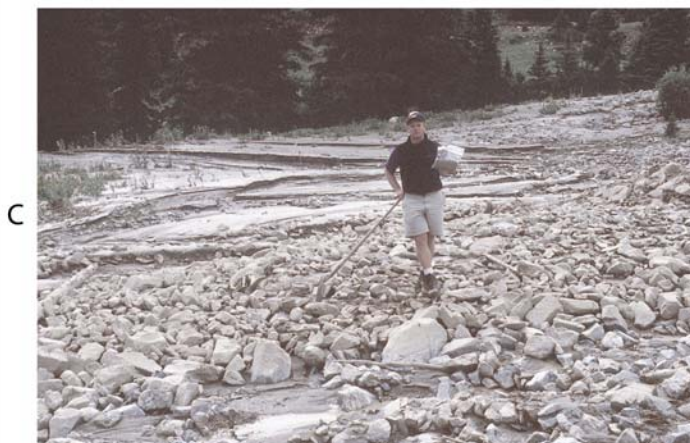
Figure 15. Deposits from July 28, 1999 debris flows near the Arapahoe Basin ski area. A) Deposit that closed U.S. Highway 6. Photograph by CDOT on July 28 or 29, 1999. View to the north. B) Soil horizon buried by July 1999 deposit (same deposit as shown in A but with view to the east). C) Deposit in the upper Arapahoe Basin parking lot. Photos in B and C taken July 29, 1999.
