# Fifty-Year Storm-Tide Flood-Inundation Maps for Santa Rosa de Aguán, Honduras

U.S. Geological Survey Open-File Report 02-258

By Mark C. Mastin and Theresa D. Olsen

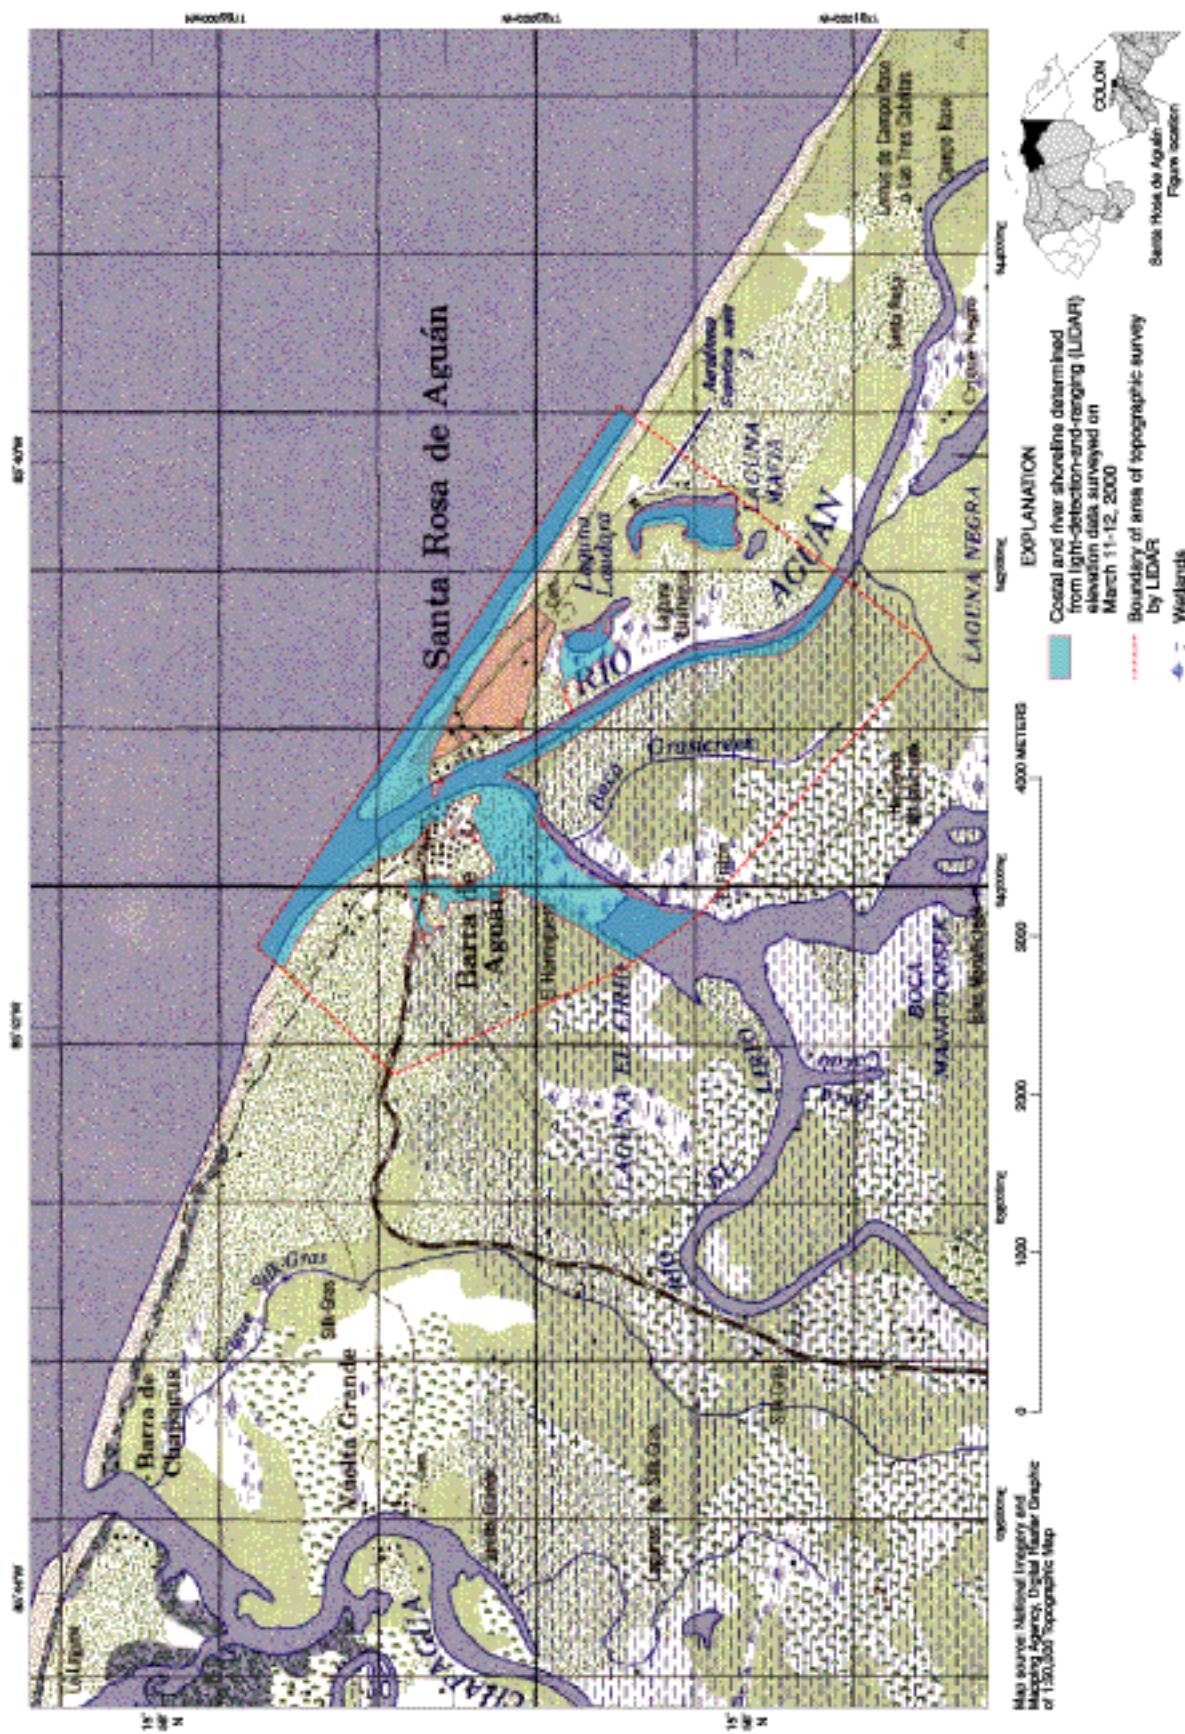
**Figure 1.** Location of study area and boundary of topographic survey at Santa Rosa de Aguán, Honduras.

The community of Santa Rosa de Aguán is situated on the Caribbean Sea at the mouth of Río Aguán ([figure 1](#)). Río Aguán flows from the south-southeast, splitting the residential area of the community into a left-bank area (looking downstream) and a right-bank area. The latter is accessible only by boat, with Río Aguán on its southwest side and the Caribbean Sea on its sandy north side ([figure 1](#)). Most of the study area consists of sandy deltaic deposits of Río Aguán. The propensity of the river to change course on its sandy delta was confirmed by Mr. Roberto Gutierrez during his three visits to Santa Rosa de Aguán between March 2000 and January 2001.

and 5 meters. There were no high-water-mark data from the Hurricane Mitch flood, however one resident of Santa Rosa de Aguán described waking to flood waters at chest-high level in his home. Except for the residential area and the sandy beaches along the Caribbean, lagoons and wetlands are the predominate land cover ([figure 1](#)).

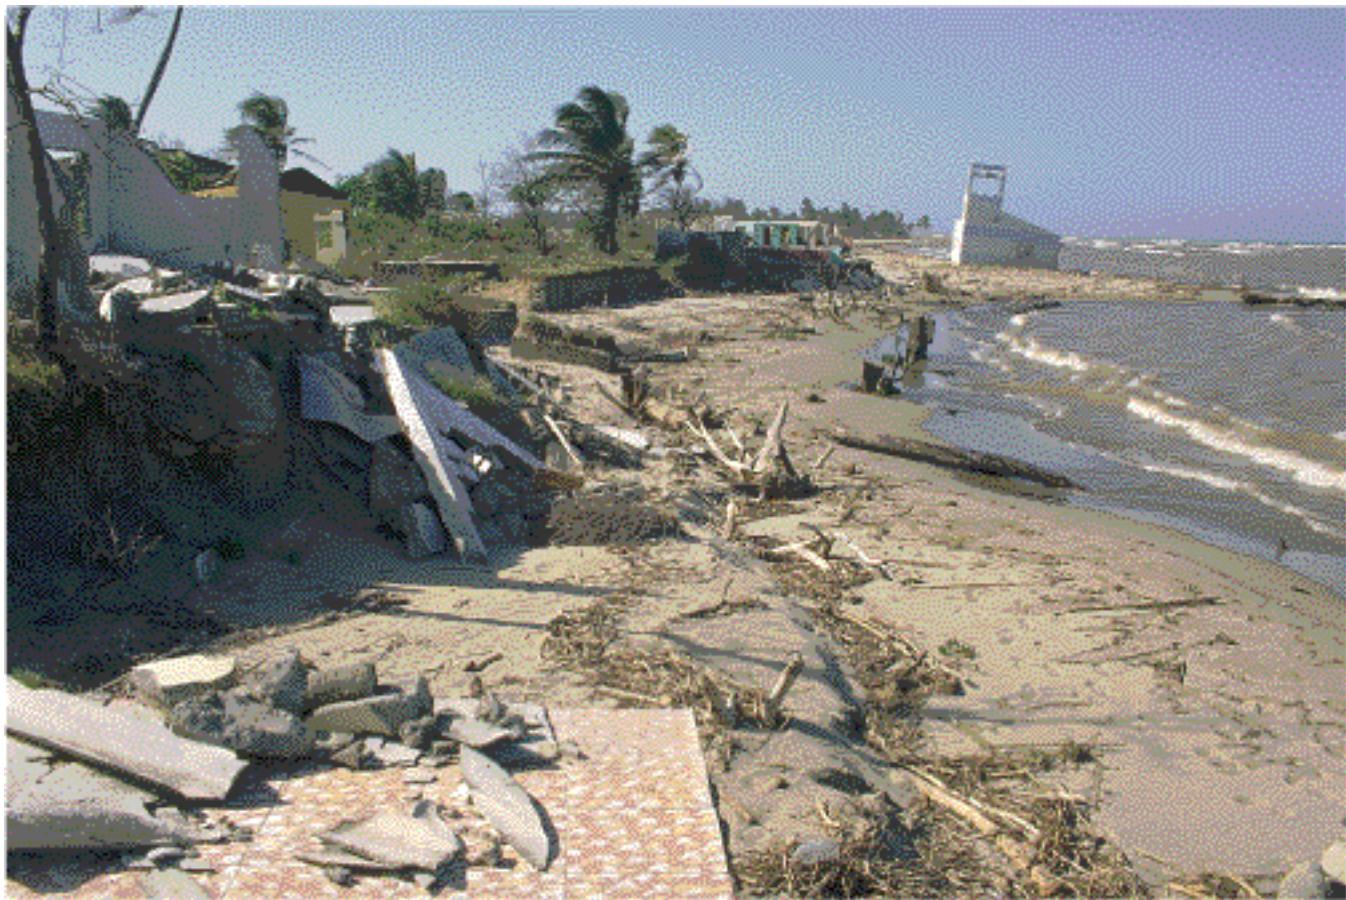
**Figure 5.** Houses destroyed by storm-surge wave action at Santa Rosa de Aguán, Honduras, during Hurricane Mitch.

Along with the flooding associated with the storm tide, wave action along the beach can be particularly destructive. Evidence of this destructive power from Hurricane Mitch was evident on the beaches in Santa Rosa de Aguán during a field visit ([figure 5](#)). Houses exposed to the wave action were destroyed. Foundations were moved and walls were knocked down. Houses on the landward side of topographic barriers to the open sea were flooded, but had much less structural damage.
