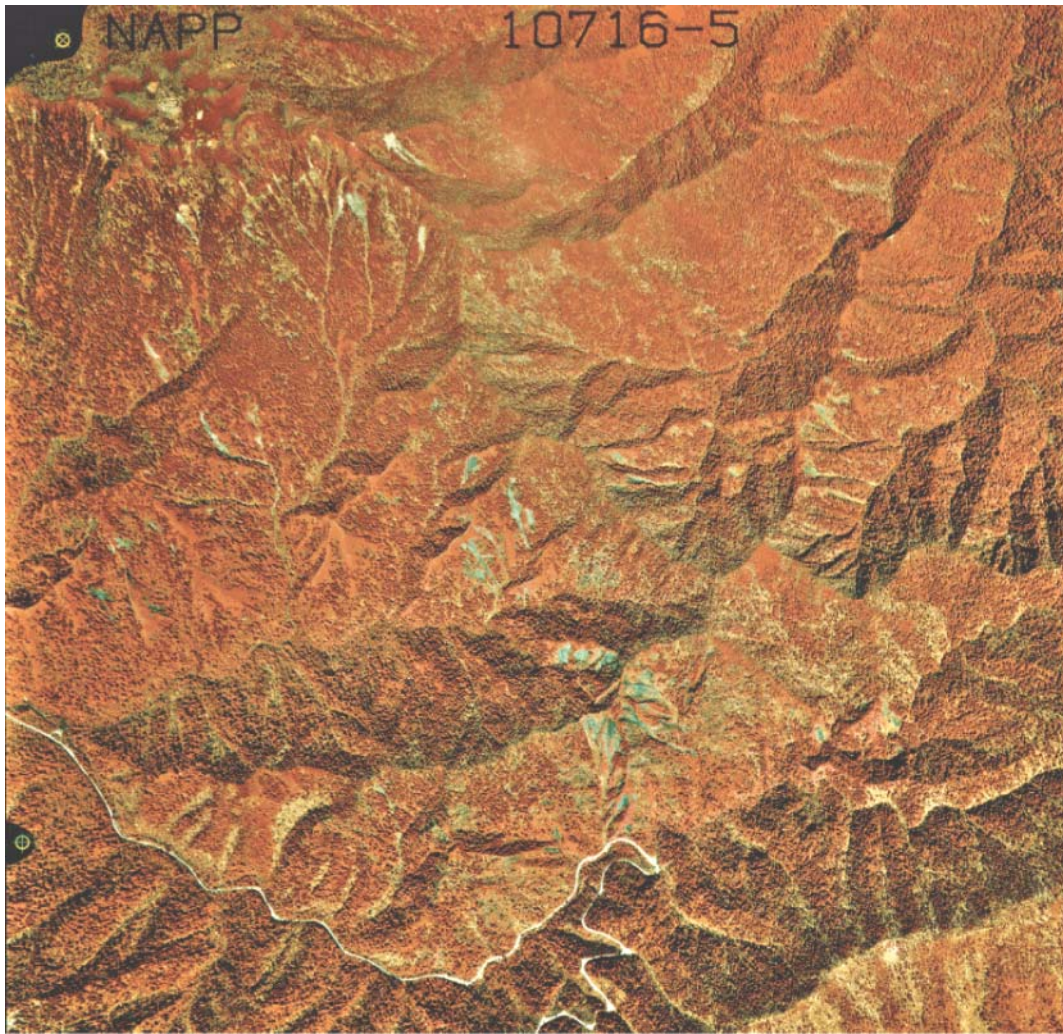
Fig. 33- Color-infrared aerial photograph showing vegetation-free scars (light-tone) of recent and historical debris flows. Route 411 is in the lower left (USGS NAPP 10716-5, acquired 4-02-1998).
