Fig. 38- Recent landslides are common in road cuts.

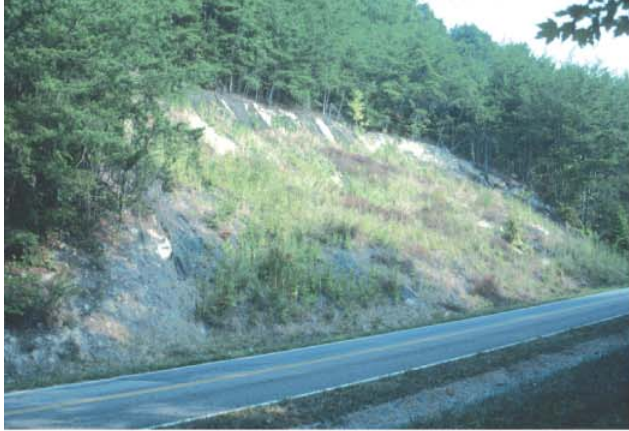
A) Landslide in quartzite regolith along the Foothills Parkway, east of Cosby.

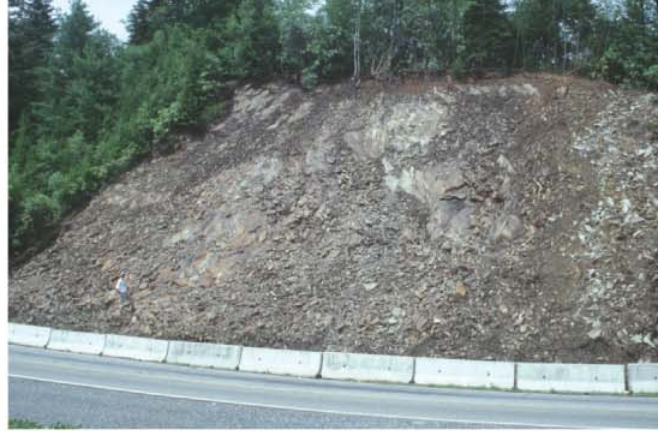
B) Landslide in slate of the Anakeesta Formation on Rt. 441, west of Newfound Gap.

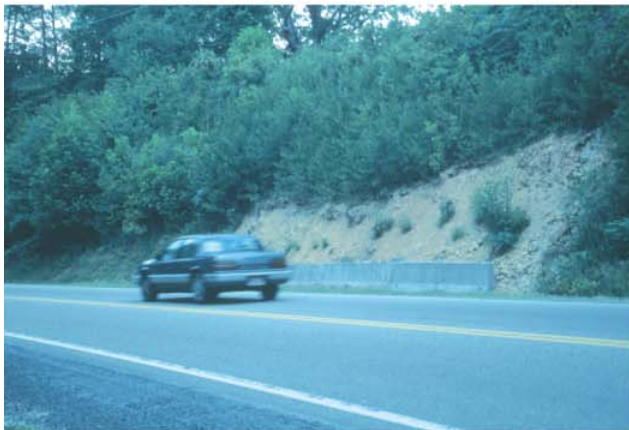
C) Landslide along Rt. 321, east of Gatlinburg in the Pigeon Siltstone.

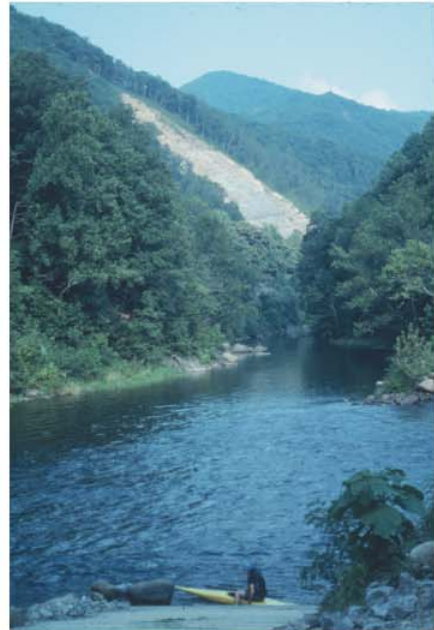
D) Landslide along I-40 near Waterville.
