Coastal Vulnerability Assessment of Cape Hatteras National Seashore (CAHA) to Sea-Level Rise

By Elizabeth A. Pendleton, E. Robert Thieler, and S. Jeffress Williams

Open-File Report 2004-1064

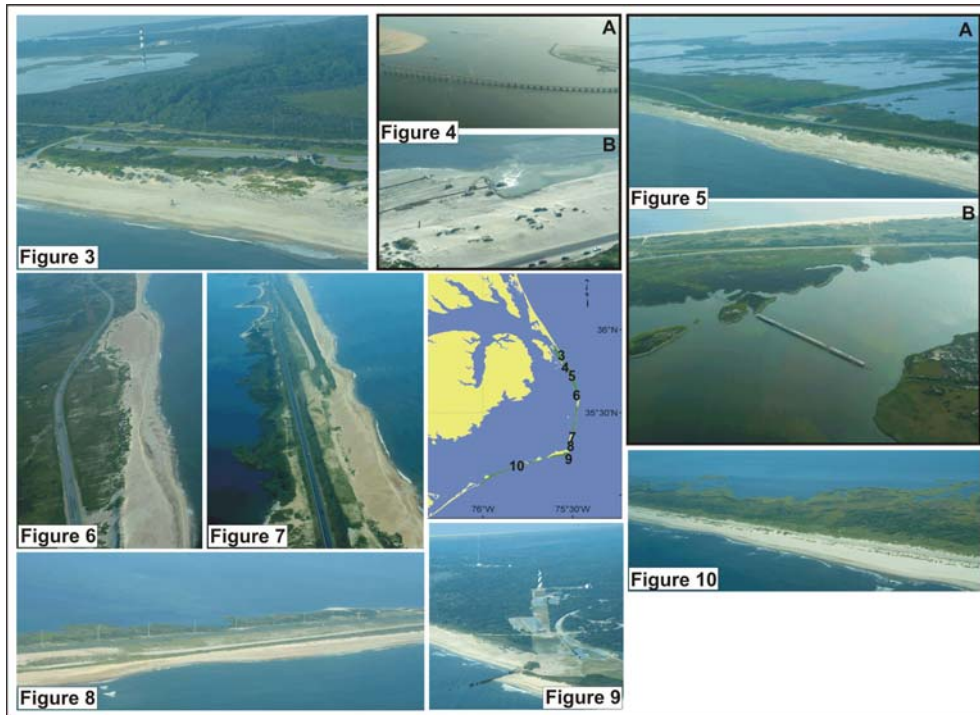
Figures 3-10. Photos taken along Cape Hatteras National Seashore in August 2003; the numbers on the inset location map correspond to the Figure numbers.

Figure 3. Coquina Beach with Bodie Island Lighthouse in the background. Coquina Beach is ranked as very high vulnerability based on geomorphology.

Figure 4. A) http://10.0.40.33/project-pages/glacier_studies/html/chapters.html. B) Sand dredged from Oregon Inlet is being pumped onto the beach within Pea Island NWR. Pea Island is ranked as a very high vulnerability area.

Figure 5. A) Vast wildlife habitat especially for shorebirds on the landward side of Pea Island NWR. B) The bridge that was constructed in the 1940's to bypass a breach that occurred across Pea Island during a hurricane.

Figure 6. Area just north of Rodanthe known as the S-curves. Road relocations caused by erosion hotspots have result in such turns in the road (very high vulnerability).

Figure 7. Road relocation between Avon and Buxton. The former location of the road is denoted by the break in vegetation. The barrier is so narrow that there is no room left to move the road landward (very high vulnerability).

Figure 8. Oblique view of the narrow part of the island shown in Figure 7. The NC Department of Transportation has planted dune-colonizing grass, which shows up in a gridded pattern (very high vulnerability).

Figure 9. The new location of Cape Hatteras Lighthouse. The old location was behind the groin in the foreground. The groin in the photo is one of three that were built to protect the lighthouse prior to its relocation in 1999-2000 (very high to high vulnerability).

Figure 10. Numerous overwashes have occurred on the eastern end of Ocracoke Island. Deposits from washover events are visible on the landward side of the island (very high vulnerability).

Figure 3. Coquina Beach with Bodie Island Lighthouse in the background. Coquina Beach is ranked as very high vulnerability based on geomorphology.

Figure 4. A) The Bonner Bridge crosses Oregon Inlet and connects Bodie Island to Pea Island National Wildlife Refuge (NWR). Dredging takes place frequently within Oregon Inlet to maintain a safe navigation channel. B) Sand dredged from Oregon Inlet is being pumped onto the beach within Pea Island NWR. Pea Island is ranked as a very high vulnerability area.

Figure 5. A) Vast wildlife habitat especially for shorebirds on the landward side of Pea Island NWR. B) The bridge that was constructed in the 1940's to bypass a breach that occurred across Pea Island during a hurricane.

Figure 6. Area just north of Rodanthe known as the S-curves. Road relocations caused by erosion hotspots have result in such turns in the road (very high vulnerability).

Figure 7. Road relocation between Avon and Buxton. The former location of the road is denoted by the break in vegetation. The barrier is so narrow that there is no room left to move the road landward (very high vulnerability).

Figure 8. Oblique view of the narrow part of the island shown in Figure 7. The NC Department of Transportation has planted dune-colonizing grass, which shows up in a gridded pattern (very high vulnerability).

Figure 9. The new location of Cape Hatteras Lighthouse. The old location was behind the groin in the foreground. The groin in the photo is one of three that were built to protect the lighthouse prior to its relocation in 1999-2000 (very high to high vulnerability).

Figure 10. Numerous overwashes have occurred on the eastern end of Ocracoke Island. Deposits from washover events are visible on the landward side of the island (very high vulnerability).

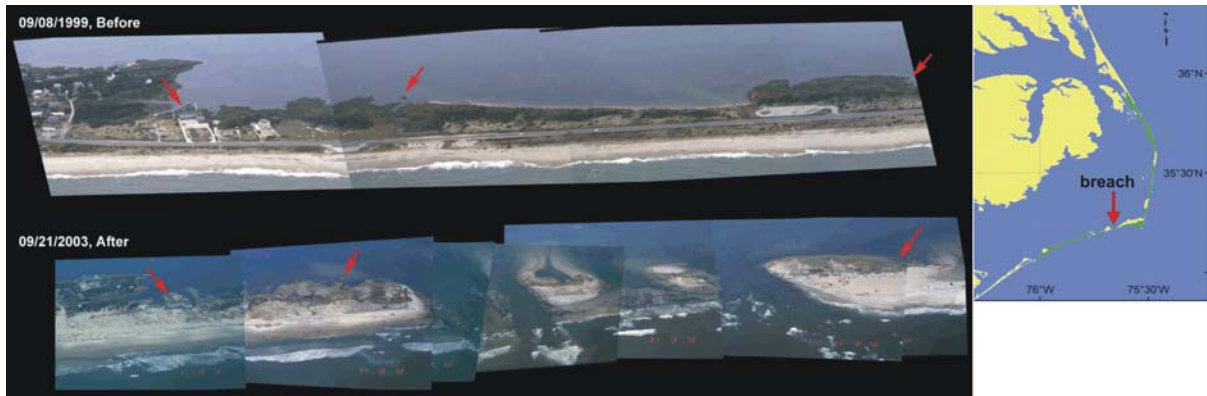
Figure 11: Photo from Hurricane Isabel impact study (USGS, 2003) showing the location of inlet formation between Frisco and Hatteras Village (<http://coastal.er.usgs.gov/hurricanes/isabel/>). The inlet was 600 meters wide with 3 distinct channels.

Figure 11: Photo from Hurricane Isabel impact study (USGS, 2003) showing the location of inlet formation between Frisco and Hatteras Village (<http://coastal.er.usgs.gov/hurricanes/Isabel/>). The inlet was 600 meters wide with 3 distinct channels.

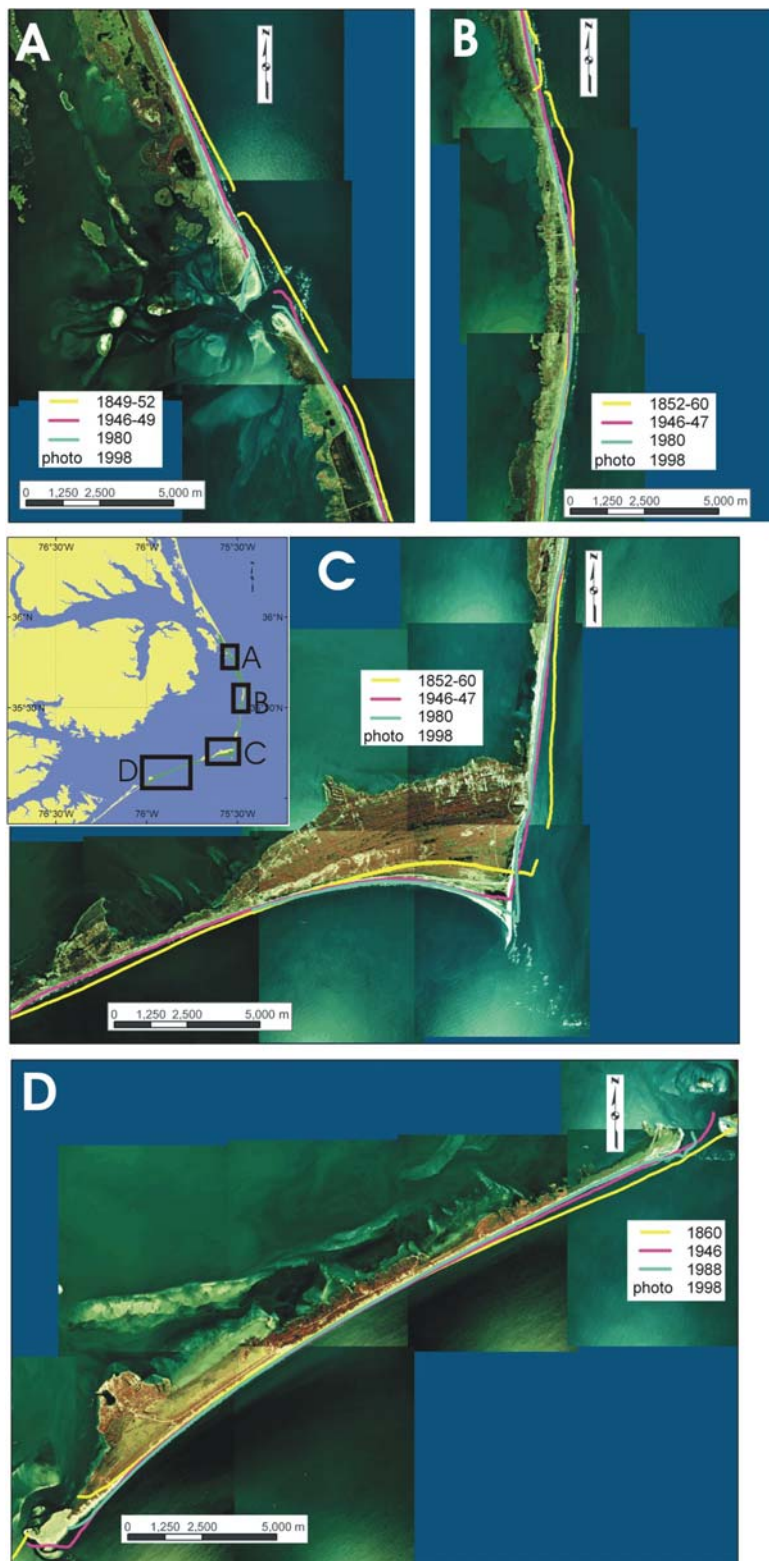
Figure 12: Historic shoreline positions for A) Bodie Island and Pea Island NWR near Oregon Inlett, B) Rodanthe, C) Cape Point, Buxton, Frisco, Hatteras Village and D) Ocracoke Island. The figure locations are shown on inset map.

and others, 2003). The rates for each transect within a 1-minute grid cell were averaged to determine the shoreline change value used here, with positive numbers indicating accretion and negative numbers indicating erosion. Shoreline change rates on Cape Hatteras range from greater than 2 m/yr of accretion (very low vulnerability) to greater than 2 m/yr of erosion (very high vulnerability) (Figure 12 A-D).

Figure 12: Historic shoreline positions for A) Bodie Island and Pea Island NWR near Oregon Inlet, B) Rodanthe, C) Cape Point, Buxton, Frisco, Hatteras Village and D) Ocracoke Island. The figure locations are shown on inset map.

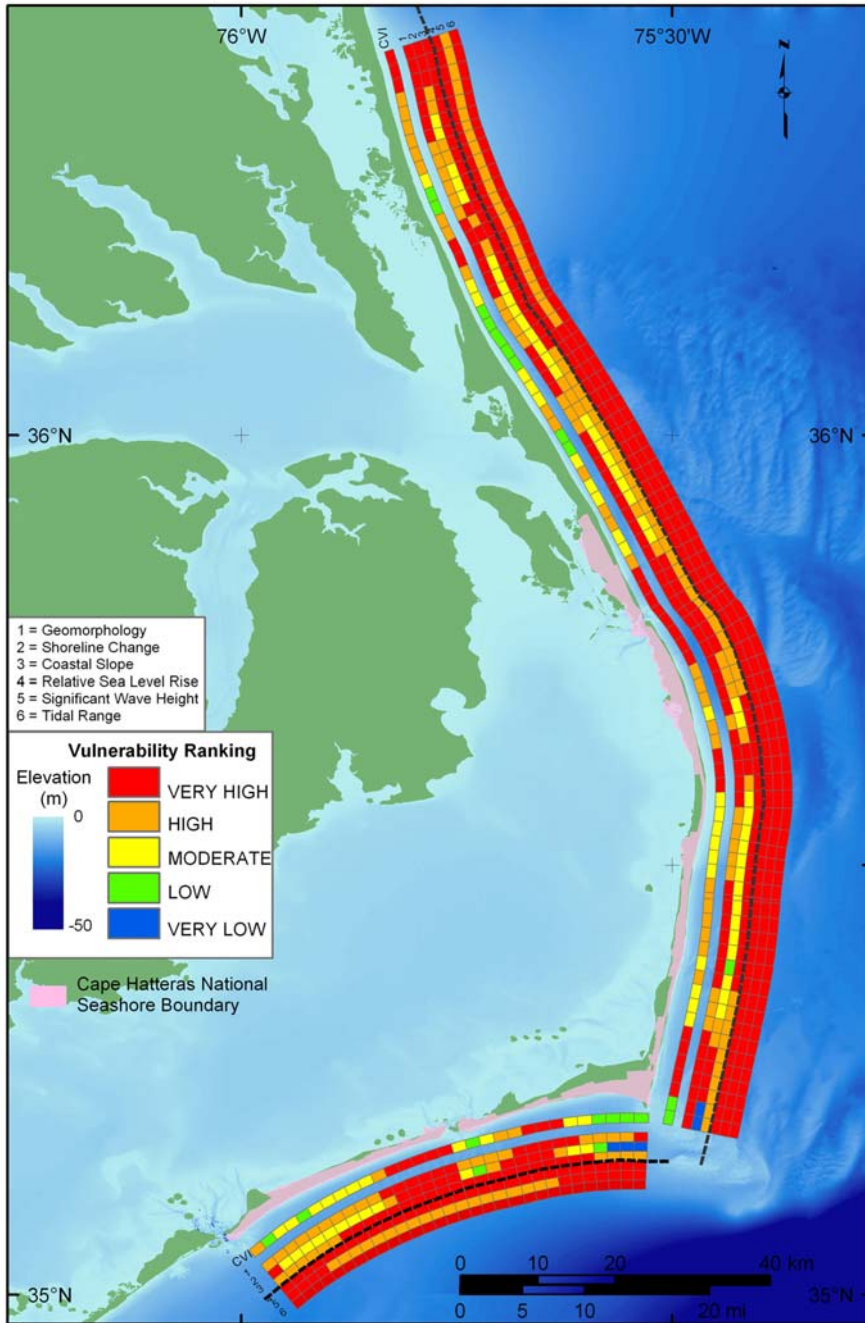
Figure 13. Shows a map of the CVI (vulnerability ranges) for Cape Hatteras National Seashore. The CVI scores are divided into low, moderate, high, and very high-vulnerability categories based on the quartile ranges and visual inspection of the data. CVI values below 13.9 are assigned to the low vulnerability category. Values from 13.91-15.7 are considered moderate vulnerability. High-vulnerability values lie between 15.71 and 18.6. CVI values above 18.6 are classified as very high vulnerability

Figure 14 shows a map of the CVI (vulnerability ranges) for Cape Hatteras National Seashore. The CVI scores are divided into low, moderate, high, and very high-vulnerability categories based on the quartile ranges and visual inspection of the data. CVI values below 32.0 are assigned to the low vulnerability category. Values from 32.0-36.0 are considered moderate vulnerability. High-vulnerability values lie between 36.01 and 42.0.

The data within the CVI show variability at different spatial scales (Figure 13). However, the ranked values for the physical process variables vary little over the extent of the shoreline. The value of the relative sea-level rise variable is constant at very high vulnerability for the entire study area. The significant wave height vulnerability is very high to high, and the tidal range is very high vulnerability.

The geologic variables show greater variability and thus have the most influence on the CVI value and ranges (Figure 13). Geomorphology in the park includes high vulnerability barrier island shoreline with dune ridges separated by very high vulnerability washover-dominated low areas. Vulnerability assessment based on historical shoreline change trends varies from very low to very high (Figure 12 A -D). Regional coastal slope is mostly in the very high vulnerability range with a few high vulnerability slope areas.

Figure 13. Relative Coastal Vulnerability for Cape Hatteras National Seashore. The innermost color bar is the relative coastal vulnerability index (CVI). The remaining color bars are separated into the geologic variables (1-3) and physical process variables (4 - 6). The very high vulnerability shoreline is located in low overwashed areas where rates of shoreline erosion are highest. The low vulnerability shoreline is around Cape Point where shoreline accretion is common.

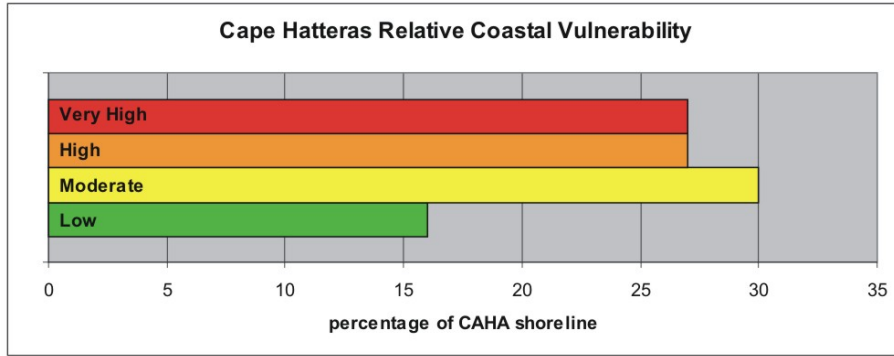
Figure 14. Shows a histogram of the percentage of CAHA shoreline in each vulnerability category. Over 115 km (70 miles) of shoreline is evaluated along the Cape Hatteras National Seashore. Of this total, 26 percent of the mapped shoreline is classified as being at very high vulnerability due to future sea-level rise. Another 24 percent is classified as high vulnerability, 26 percent as moderate vulnerability, and 24 percent as low vulnerability.

CVI values above 42.0 are classified as very high vulnerability. Figure 14 shows a histogram of the percentage of CAHA shoreline in each vulnerability category. Nearly 195 km (120 miles) of shoreline is evaluated along the Outer Banks. Of this total, 27 percent of the mapped shoreline is classified as being at very high vulnerability due to future sea-level rise. Another 27 percent is classified as high vulnerability, 30 percent as moderate vulnerability, and sixteen percent as low vulnerability.

Figure 14. Percentage of CAHA shoreline in each vulnerability category.
