# Surface- and Ground-Water Monitoring and Mapping of Selected Features at the Blue Ridge Parkway Mt. Pisgah Campground, Haywood County, North Carolina, 2002

U.S. Geological Survey Open-File Report 2004–1073

By Douglas G. Smith

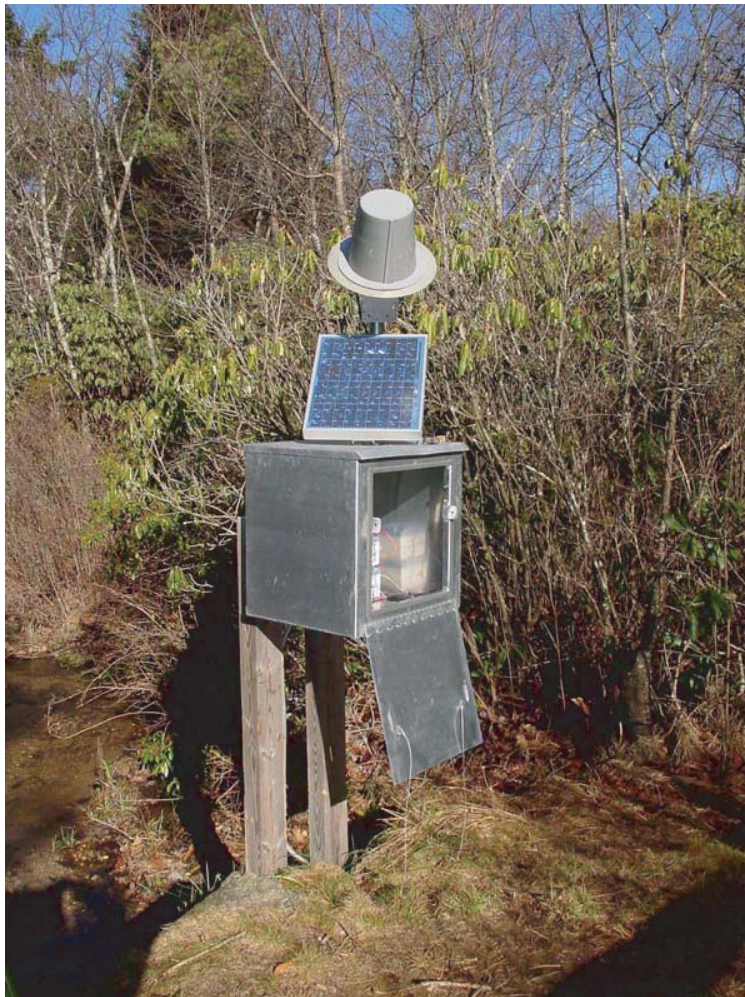
**Figure 5.** The U.S. Geological Survey gaging station that was built to monitor water levels in the stream flowing from the natural area in the center of the Mt. Pisgah campground.

A USGS streamgaging station was constructed at the downstream side of the culvert (fig. 5) to monitor stage fluctuations in the stream flowing from the natural area in the center of the campground. This stream site was identified as Unnamed Tributary to Pisgah Creek at Flat Laurel Gap, N.C., with USGS station number 0345638607. A steel enamel staff gage was installed in the stream at the downstream side of the culvert. Stage in the stream was monitored by a pressure transducer that was referenced to the staff gage and recorded by instrumentation housed in the gage shelter. Stage data were recorded at 15-minute intervals using an arbitrary gage datum. Recorded stage readings and the staff gage in the stream were set so that a stage of 0.00 ft in gage datum represented a corresponding water-surface elevation of 4,836.97 ft above mean sea level (referenced in this report to National Geodetic Vertical Datum of 1929 [NGVD29]). The mean sea level elevation of gage datum was determined by level surveys based on a nearby North Carolina Geodetic Survey benchmark (PI-1 1994).
