Hazard Analysis of Landslides Triggered by Typhoon Chata'an on July 2, 2002, in Chuuk State, Federated States of Micronesia

By Edwin L. Harp, Mark E. Reid, and John A. Michael

U.S. Geological Survey Open-File Report 2004-1348

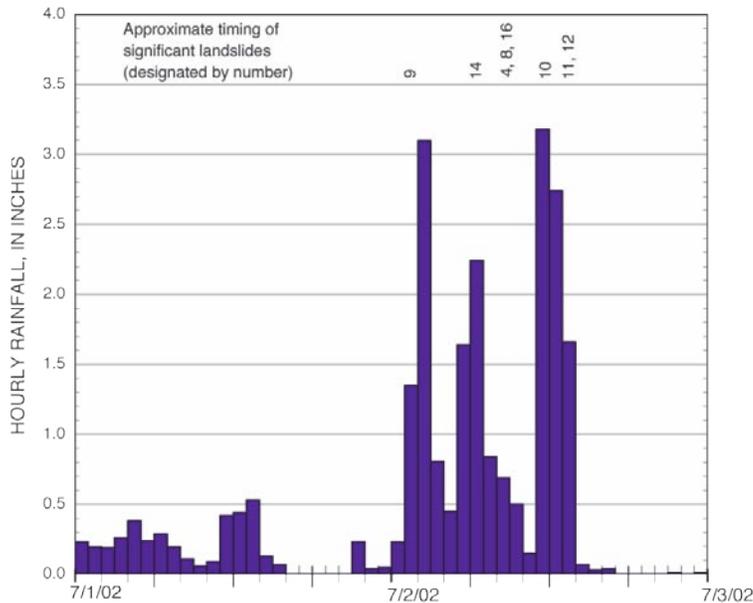
Figure 3. Bar graph of hourly rainfall from tropical storm Chata'an at Weno airport (WSO) station. Time of occurrence of significant landslides obtained from local residents. Table 2 contains more information about the significant landslides (by number).

According to local residents, most of the landslides occurred between 7 a.m. and 2 p.m. on July 2. At the airport on the island of Weno, 19.74 inches of rain fell on July 2, with several rain bursts having hourly intensities greater than 3 inches per hour (fig. 3). Although the timing and amounts of rainfall likely varied between islands, many of the landslides appear to have been triggered during or immediately following intense rain bursts (fig. 3). Residents experienced prolonged thunder and lightening during the storms, often during the time when landsliding occurred. Hundreds of people evacuated their homes in fear of future landsliding, and many remained evacuated more than a month later.

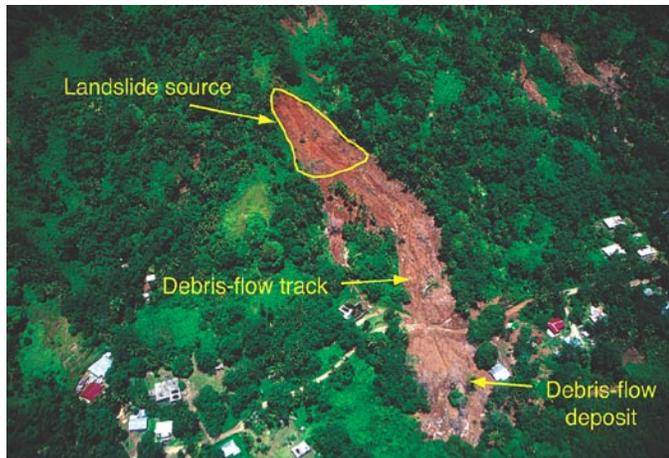
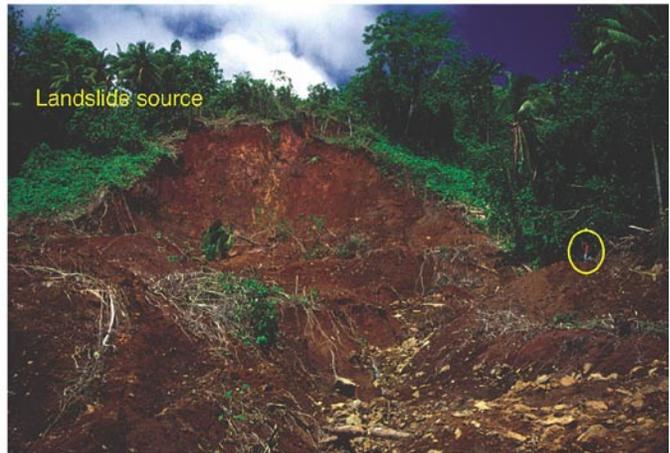
Figure 4. A. Oblique aerial photograph of Mwan slump/debris flow showing the location of the landslide source, debris-flow track, and debris-flow deposit. B. Landslide source (slump) for the Mwan debris flow. Yellow circle locates person for scale.

triggered by rainfall infiltrating into the ground, increasing ground-water pressures, and weakening the slopes. Most of the initial landslides occurred on slopes steeper than 20°. Many saturated or nearly saturated slumps then transformed into debris flows, raced down steep slopes, traveled across the coastal flats, and came to rest leaving thick deposits of saturated mud, boulders, and debris. Figure 4 shows a slump (landslide source), debris-flow track, and debris deposit at Mwan (no. 2, pl. 1) on the island of Weno.

This slump/debris flow occurred inland from the village of Mwan on the island of Weno (fig. 4) and resulted in one fatality. As with the Nepukos landslide, the Mwan landslide began as a slump in weathered volcanic rocks on a 35° slope and transformed into a rapidly moving debris flow. The flow traveled about 100 m downslope along a stream channel and buried a road and water well at the base of the slope. The debris flow also may have incorporated additional material from the stream channel. It then flowed onto flatter ground, destroyed a house, and stopped about 60 m downslope of the road. The initial slump, about 50 m high, had an approximate volume of 10,000 m³. Clay-, sand-, and boulder-rich landslide deposits remain along the sides of the stream channel and in the depositional area downslope of the buried road. Drainage channels have been eroded into remnants of the landslide debris in the slide scar. Two small incipient slumps remain adjacent to each side of the initial headscarp; they have volumes of about 1,000-2,000 m³ each. Both incipient slumps have undergone about 3 to 4 m of displacement. Future heavy rainfall may reactivate these incipient slumps; however, it is doubtful that they will cause additional damage in the short term. Any newly mobilized materials likely will be small and will be impeded by the rough, irregular slide surface.

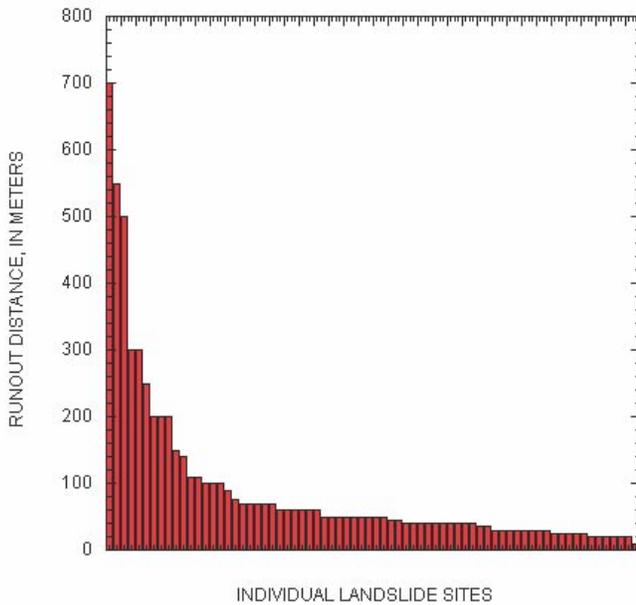
Figure 5. Bar graph showing horizontal runout distances of 72 individual debris flows triggered by tropical storm Chata'an. Distances were determined from the topographic base map used for Plate 1.

The distance debris flows travelled across gently sloping ground and the coastal flats was extremely important in causing damage to people and property during Chata'an. Most of the population of the volcanic islands reside on the flat coastal shorelines of the islands. The degree of damage wrought by landslides was linked directly to the runout length of debris flows that invaded these areas of highest population density. Runout distances depended on the volume of the source landslide and the slope steepness below the source areas; large initial volumes and steep slopes resulted in longer runouts. Using the landslide-inventory map (pl. 1), we measured and compiled runout distances for all debris flows that had significant runout. Runout was defined as the distance a debris flow traveled after it reached a distinctive break in slope below its source, identifiable on the topographic base of plate 1. For longer flows, part of this runout is across the coastal flats. Figure 5 shows a bar graph of the runout distances of 72 debris flows that had a flow path that could be measured. The range of runout distances varied from a low of 10 m to a maximum of about 700 m. The average runout distance was 89 m.

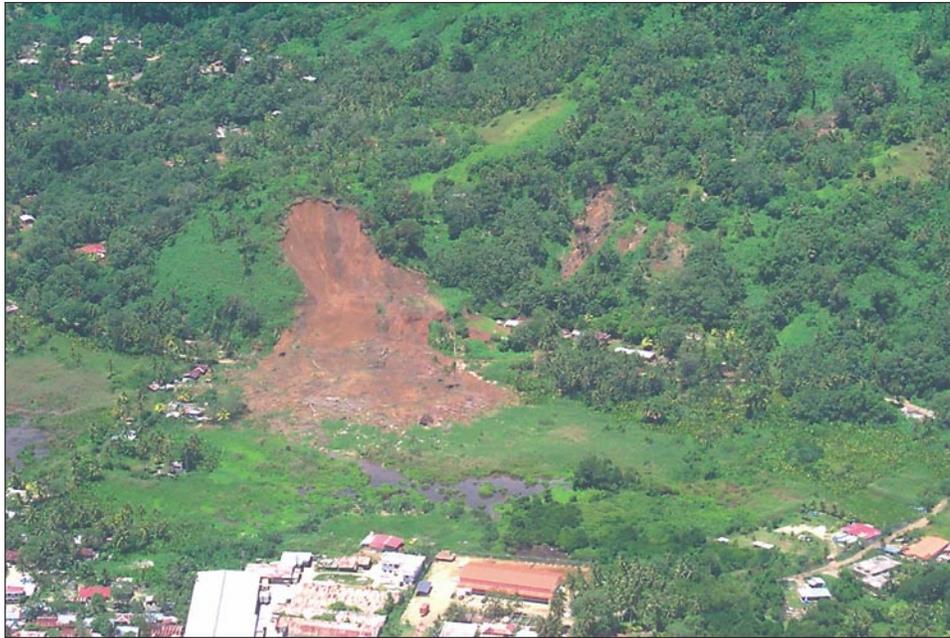
Figure 6. Oblique aerial photograph of Nepukos slump/debris flow on the island of Weno.

Above Nepukos village on the western side of Weno Island, Chata'an triggered a slump that transformed into a debris flow; this flow overran five houses, a road, and powerline at the base of the slope, caused three fatalities, and continued about 70 m out onto coastal flats and into mangrove swamps. The initial slump of about 20,000 m³ occurred on a knoll with a slope of about 35° at the end of a ridge (fig. 6). The headscarp of the slump was about 10 m high and 30 m wide at its base. The slump occurred in weathered, clay-rich volcanic rocks. The landslide scar and remaining debris are now well drained and eroded so that water emanating from the headscarp flows in a well-developed channel. Future rainfall could generate some smaller failures from the headscarp; however, such failures are not likely to travel beyond the immediate headscarp area.

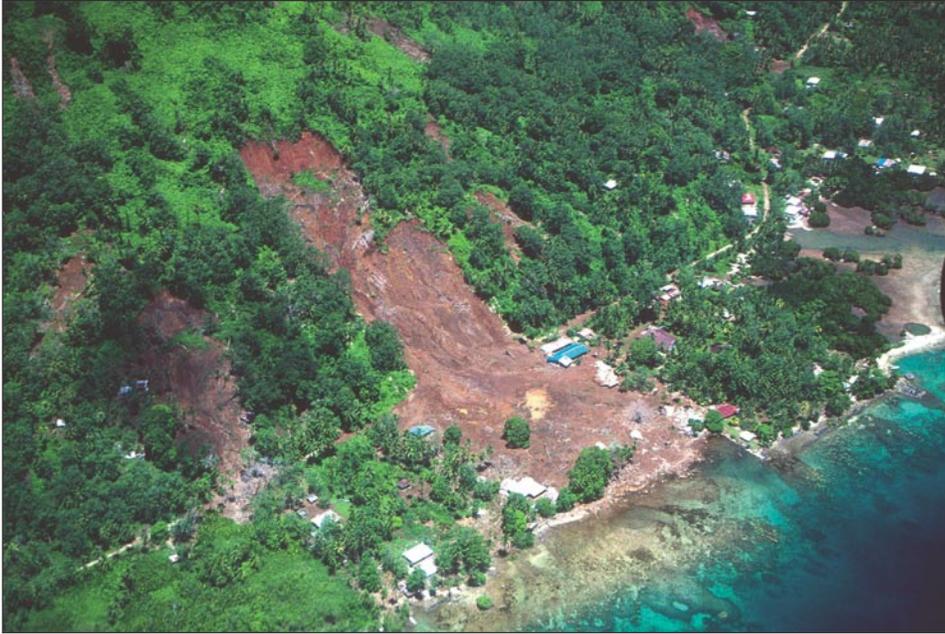
Figure 7. Oblique aerial view of Nechap slump/debris flow on the island of Tonoas.

One of the largest landslide disasters transpired in the village of Nechap on the island of Tonoas. Here, residents reported that debris flows caused 14 fatalities and destroyed 31 dwellings, a water-supply system, and powerlines (fig. 7). Concrete water tanks were transported more than 100 m out to the ocean's edge by the flows. The damaging landsliding began as two slumps in weathered volcanic rocks, with a combined volume of more than 100,000 m³. These slumps mobilized into rapid debris flows; deposits from these flows cover a road and extend across the flat coastal lowland for about 175 m and into the ocean (figs. 8 and 9). The lower slump of approximately 75,000 m³ has a slope width of about 90 m, a scarp height of 120 m, and an average thickness of 7 m. The upper slump mass has a width of about 70 m, a scarp height of 50 m, and a thickness of about 7 m. The upper slump mass initially impounded water draining from the landslide scarp and formed a rapidly moving slurry of soil and weathered rock (debris flow) as the impounded water breached the slump mass. The debris flow from the upper slump evidently occurred after the debris flow from the lower slump mass, because it forms a lobate deposit that overlies the debris deposit from the lower slump.

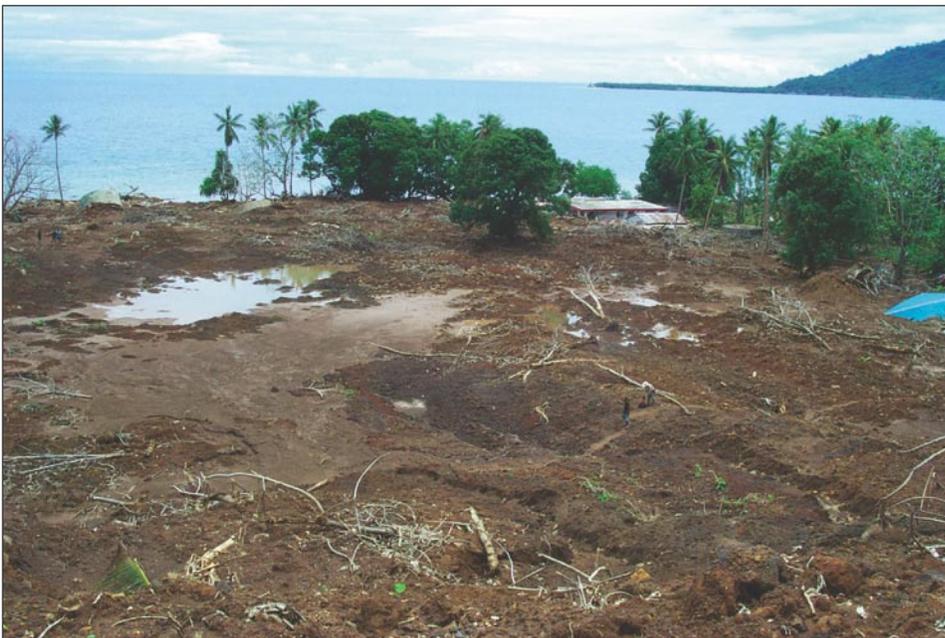
Figure 8. Deposits from Nechap debris flow showing destroyed homes and displaced concrete water tanks (upper left in photo near shoreline).

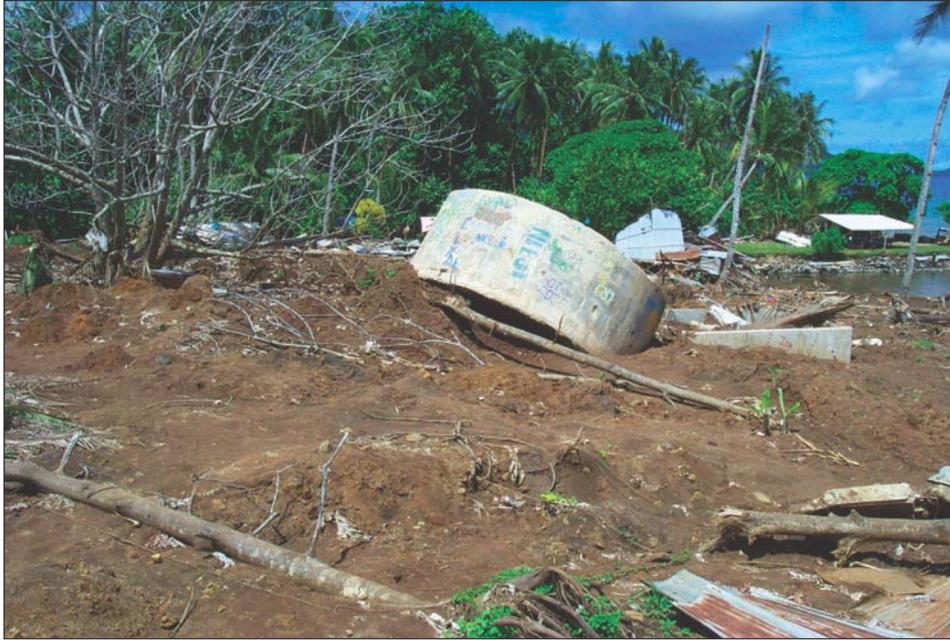
Figure 9. Distal part of Nechap debris flow, near the ocean, showing debris from destroyed houses and closeup of water tank.

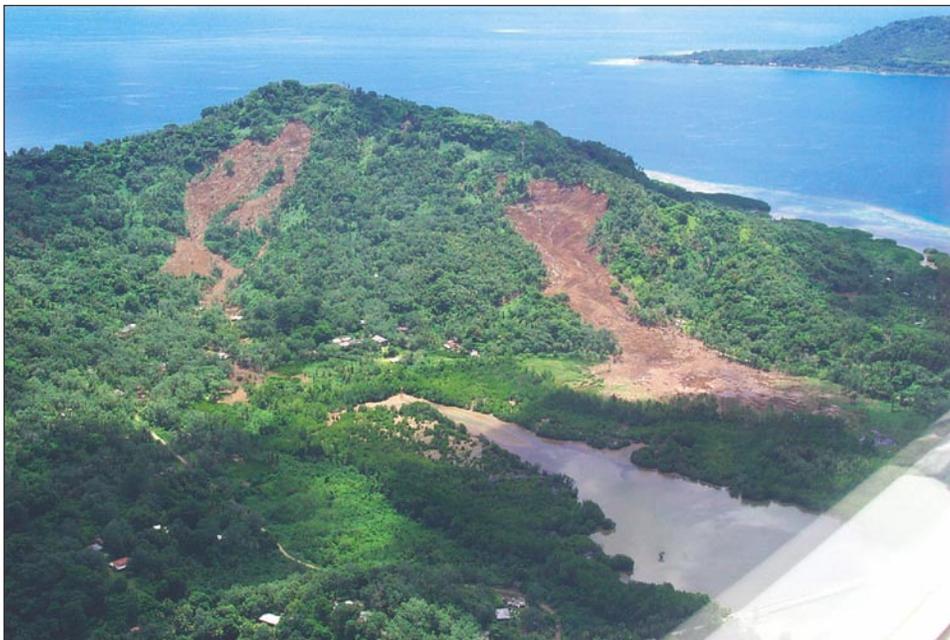
Figure 10. Oblique aerial view of Kuchua slump/debris flow (right) and Roro debris slide/flow (left) on the island of Tonoas.

This landslide is one of the largest triggered by tropical storm Chata'an (fig. 10). The landslide and resulting debris flows resulted in five fatalities and six homes destroyed. The headscarp of the source slide is about 150 m wide, 150 m long in the downslope direction, and 10 m in average thickness, resulting in a total volume of approximately 200,000 m³. The slope of the headscarp area, prior to failure, was approximately 30°-40°. The failure surface is arcuate in cross section, and initial movement of this mass apparently resulted in the temporary impoundment of a large volume of water draining from the scarp and possibly surface gullies. In addition to impounded water infiltrating the slump mass, catastrophic failure likely resulted from overtopping of the slump mass by the impounded water, and/or from piping and subsequent rapid failure. The catastrophic failure mobilized much of the slump material, and the resulting flows cut a deep erosion channel through the slump. This channel exits at the east side of the source area and indicates where mixed water and debris flowed out of the source area. According to Chester Gustav, who lives near the distal end of the debris flow, the first wave of debris and water arrived at 10:00 a.m. on July 2, followed by two more waves of debris. The entire debris-flow activity took place over 26 minutes. The distal end of the debris flow

extended about 500 m into the taro field beyond the break in slope at the base of the flow path (figs. 10 and 11). The overall length of the flow is greater than 700 m. The headscarp area has relatively low continuing landslide hazard. Farther down the flow path, considerable debris remains along the west side of the main channel of flow. These slopes are relatively gentle ($\sim 15^\circ$), however, and are unlikely to remobilize into massive debris flows.

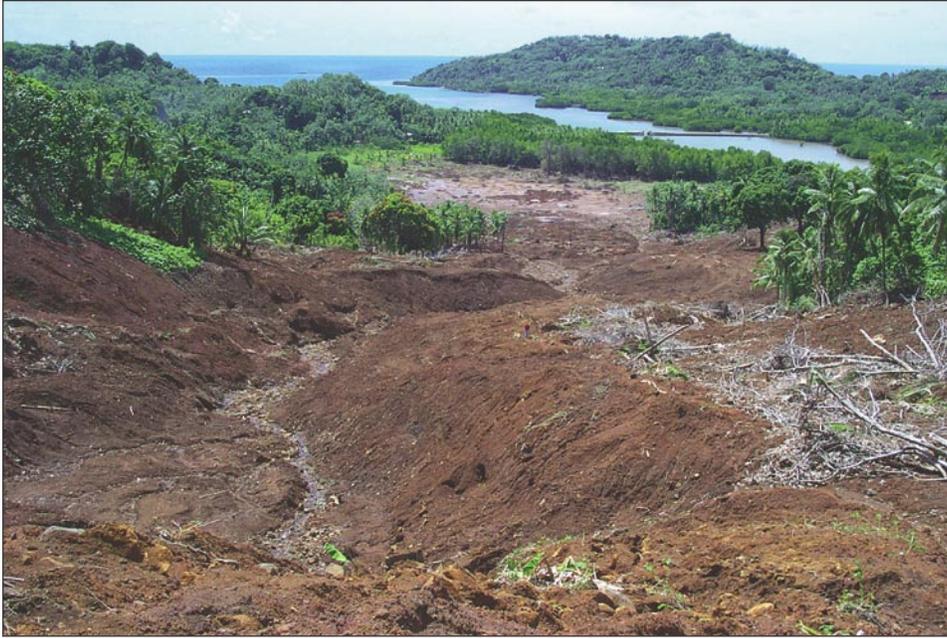
Figure 11. Downslope view of Kuchua slump/debris-flow path. Deposits from this flow covered taro fields at the distal end of the deposit.

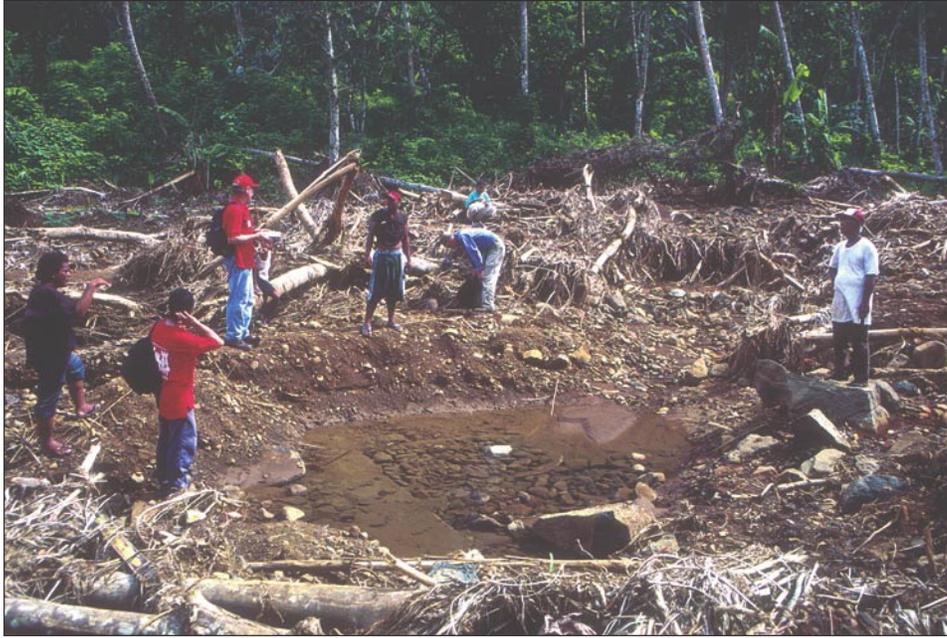
Figure 12. Water catchment basin inundated by debris from the Roro debris slide/flow. Part of the basin wall (in the small pond) has been exposed by digging after the debris flow event.

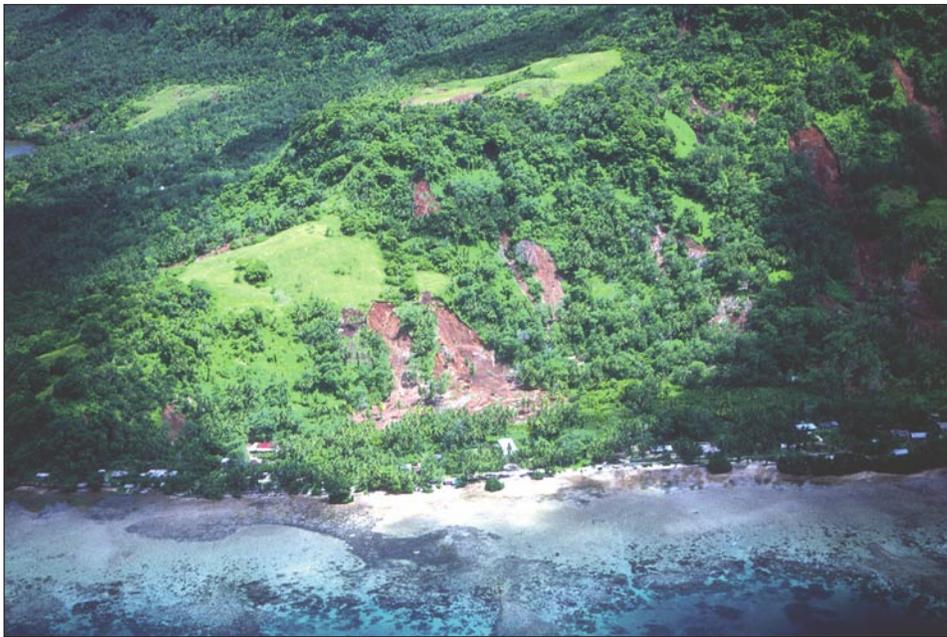
Figure 13. Aerial view of Pwene slump/debris flow on the island of Fefan. This site shows a debris-flow doublet (center of photo) with a downslope line of trees located on a ridge between the two debris flows that coalesced.

and coalesced to produce a 28,000 m³ debris flow (figs. 13 and 14). A 50-m-wide tree covered ridge that did not fail during the storm separates the two slump sources. The debris flow spread out across a nearly flat field behind the school. The slumps underwent extensive mobilization into debris flows, and little material remains in the headscarp area.

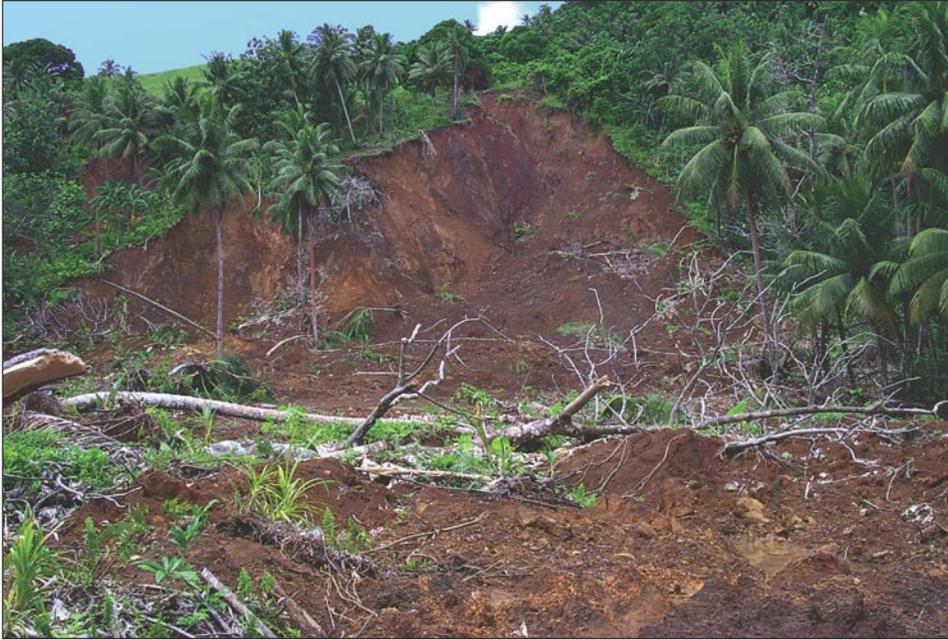
Figure 14. Head scarp of the northern Pwene slump/debris flow.

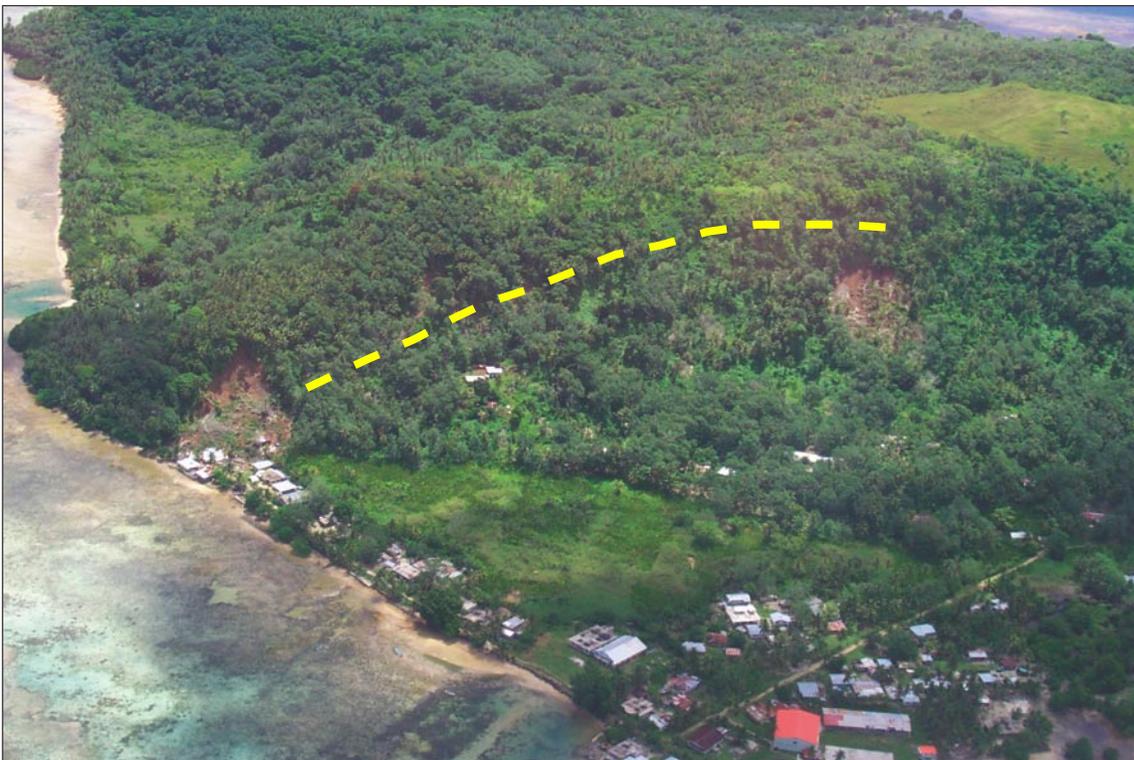
Figure 15. Oblique aerial view of Sapore slump/debris flow (left center) on the island of Fefan. Dashed line indicates approximate position of reactivated head scarp of preexisting large incipient slump. Preexisting slump mass is below and to the right of dashed line.

On the southern end of the island of Fefan, a slump/debris flow buried a road, destroyed nine homes, and killed four people during Chata'an (figs. 15 and 16). The slump originated on slopes of 35° and moved about 10,000 m³ of weathered volcanic rock before transforming into a debris flow. Most of the slump material has undergone 5-10 m of displacement, and any additional movement likely will be small and confined to the source area. The headscarp of a large incipient slide extends from this slump scar northward along the hillslope for at least 500 m. This scarp has recent vertical displacement of 2-3 m (Figure 17), although older roots near the slump scar suggest that at least part of the scarp was preexisting. A 15 m-long toe is present below this scarp about 300 m from the slump where the slump mass has overthrust the ground surface by about 0.5 m. Several houses are located near and downslope of the toe. Future behavior of this large incipient landslide is uncertain. It may undergo renewed movement with future rainfall. However, the depth of this slump is estimated to be 15-25 m, and such a deep-seated landslide of this volume would be unlikely to move in response to light or moderate rainfall. Reactivation of this landslide may require abnormally high rainfall intensities and longer durations such as that provided by tropical storm Chata'an.

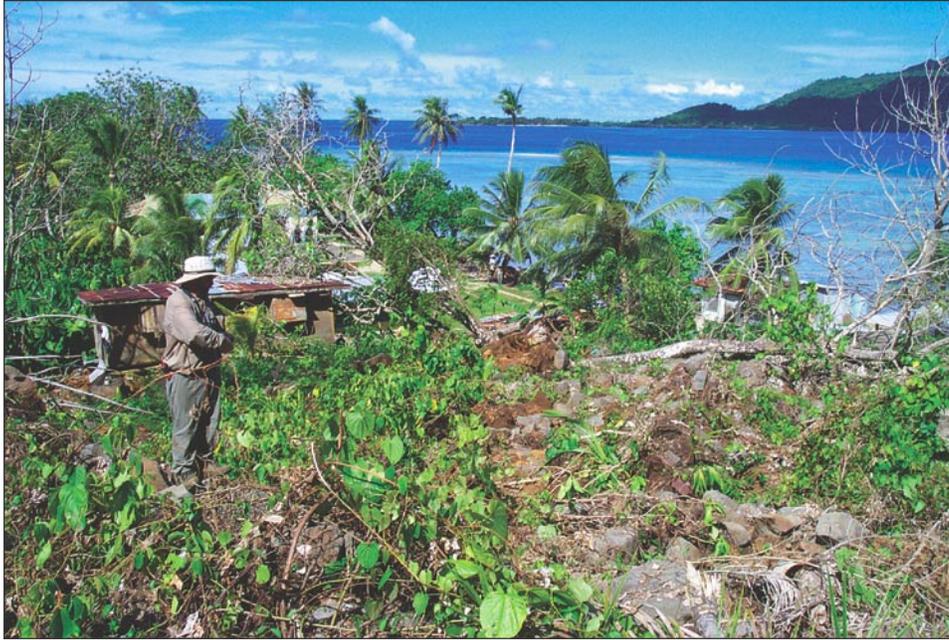
Figure 16. Downslope view of Sapore debris flow showing area where nine houses were buried or destroyed by the deposit.

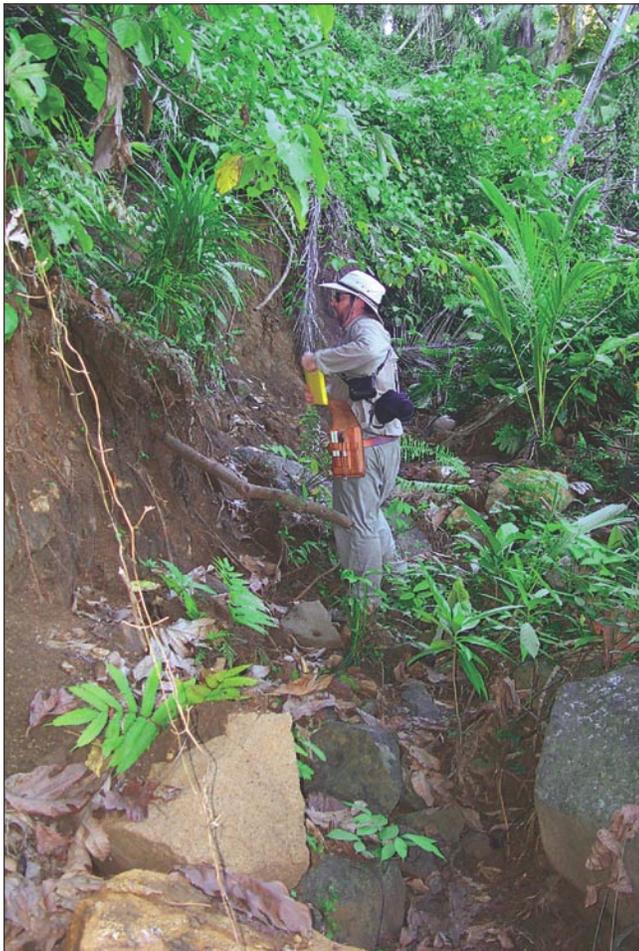
Figure 17. Scarp of reactivated large incipient slump (see fig. 15) near Sapore produced by rainfall from tropical storm Chata'an.

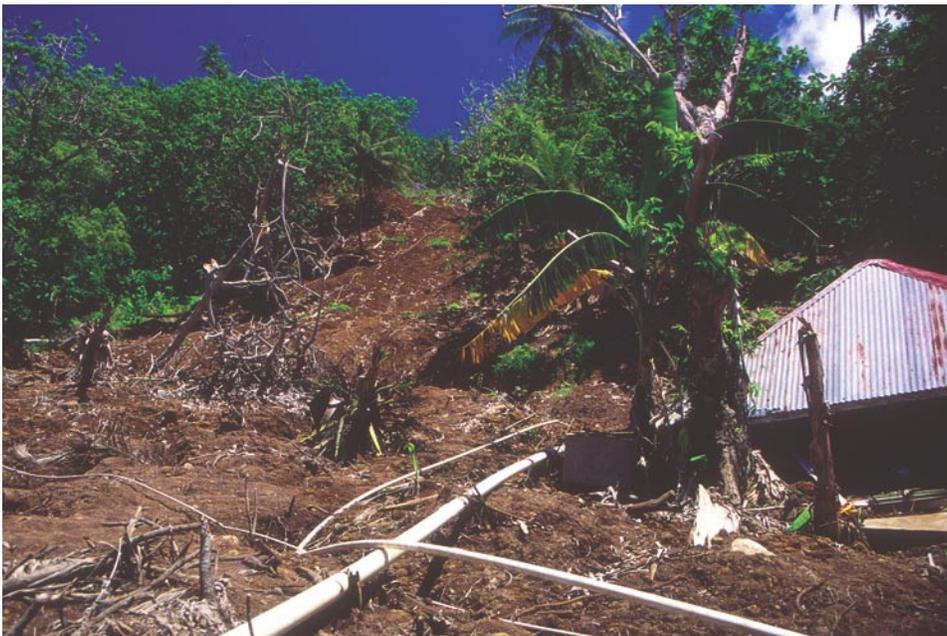
Figure 18. Lower portion of a slump/debris flow at the village of Sanuk on the island of Uman that destroyed 13 homes and a community center.

On the northeastern coast of the island of Uman in the village of Sanuk, another slump that transformed into a debris flow traveled across relatively narrow coastal lowlands. The debris flow buried 13 homes, a community center, a road, and caused one fatality. The 50-m high, 6,000 m³- slump initiated on slopes of about 30° in highly weathered volcanic rocks (fig. 18). After transforming into a debris flow, it traveled about 140 m downslope to the coastal lowlands and incorporated about 4,000 m³ of colluvium and weathered bedrock along its travel path. The resulting total volume of the flow deposit is about 10,000 m³. Some of the slump debris still remains in the slide source area; however, this material is unlikely to travel beyond the original source area due to small source volumes and roughness of the existing flow path.

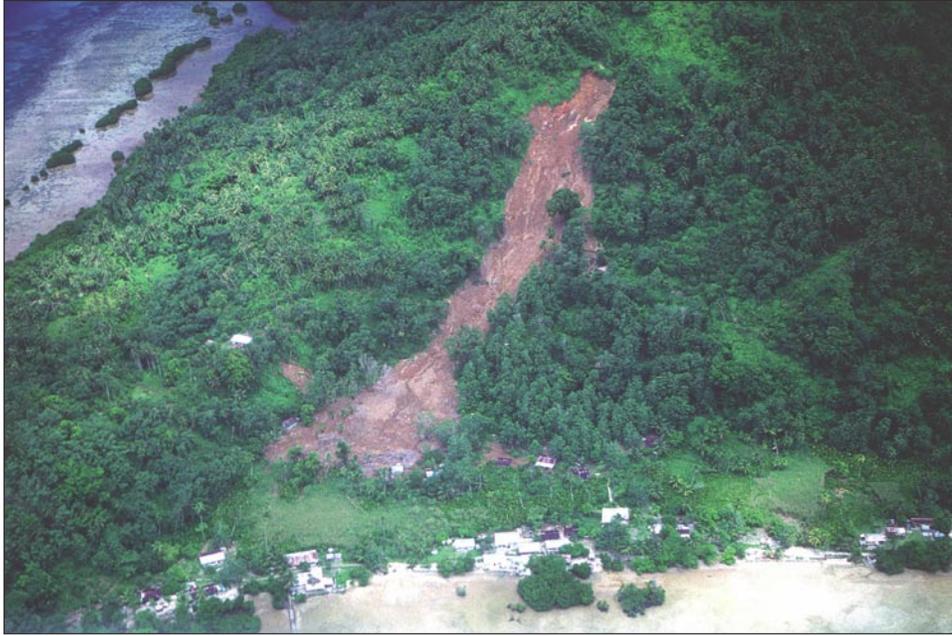
Figure 19. Aerial oblique view of slump/debris flow at the village of Penia on the island of Udot.

A slump located on the northwestern side of the island of Udot mobilized into a debris flow, traveled about 220 m downslope to the coastal flats, and caused four fatalities. The initial slump source had an 80 m-high scar and an estimated volume of 10-15,000 m³ (fig. 19). As with most of the other larger landslides triggered by Chata'an, the source area is located in deeply weathered, basaltic-volcanic rocks. According to local residents, this event occurred at about 7:00 or 8:00 a.m. on July 2. Small remnants of the original

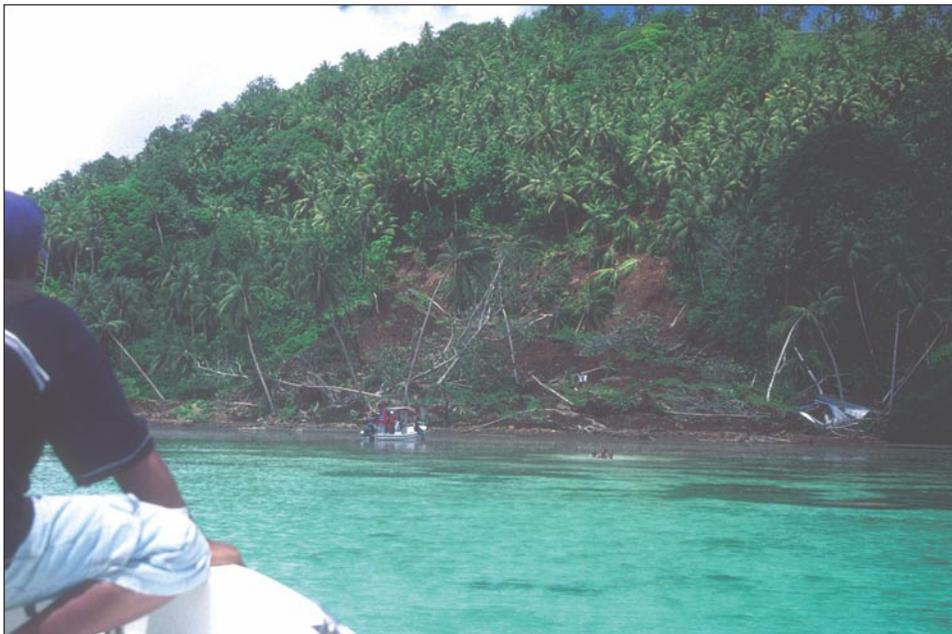
Figure 20. Faia slump/debris flow and incipient slumps that destroyed 15 homes and a dispensary on the island of Fanapanges.

On the eastern coast of the island of Fanapanges, a continuous series of slumps and incipient slumps were triggered during Chata'an, again within highly weathered, basaltic-volcanic rocks. The entire complex affects at least 250 m of trail along the coastline. The northernmost of these slumps, 50 m in height, with a volume of about 8,000 m³, transformed into a debris flow and traveled about 100 m to the shoreline (fig. 20). This flow destroyed 15 homes, a water basin, and a dispensary in the village of Faia. According to local residents, this event occurred about 10:00 a.m. on July 2. Incipient cracking, with a vertical displacement of about 0.5-1.5 m, extends southward from the headscarp of this slump (A, fig. 21). Adjacent to this slump and below the incipient cracking is a relatively intact, wedge-shaped incipient slide, 60 m wide along the trail (B, fig. 21). South of this, shallow blocky failures from the toe of a larger slump extend for about 90 m along the trail and reach the coastline (C, fig. 21). According to residents, this slump occurred a few minutes after the destructive northern debris flow. To the south of this feature, incipient cracks curve and step shoreward, crossing the trail about 70 m south of recent slumps (D, fig. 21). During very wet periods, this entire area (about 250 m long) may be subject to renewed slumping and possibly debris-flow activity. This extensive area remains potentially hazardous and would be a relatively poor site for relocating a dispensary.

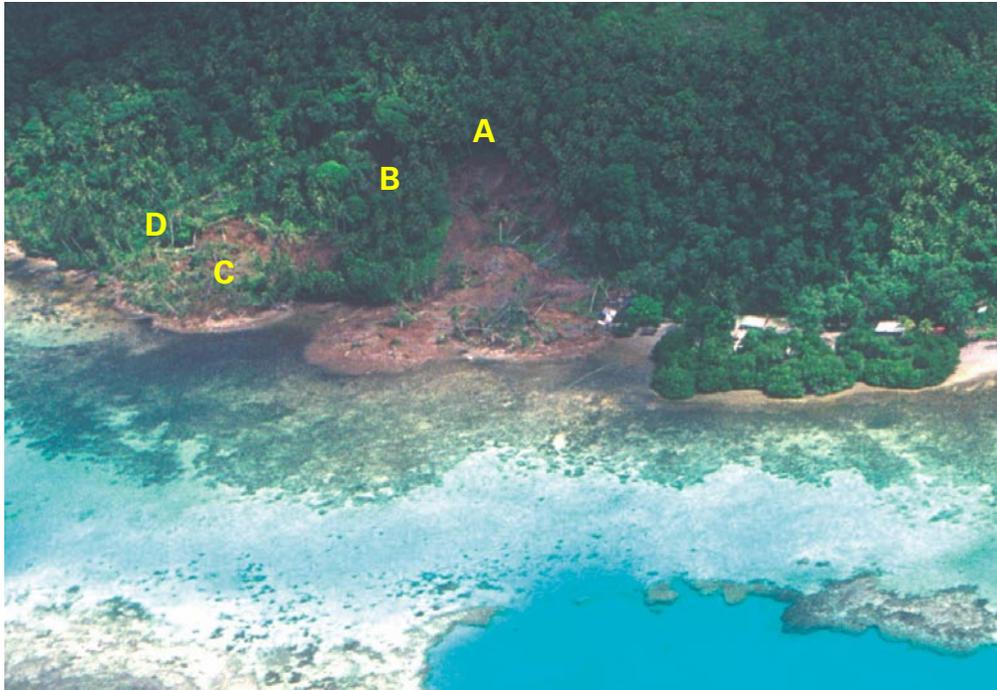
Figure 21. Aerial view of the Faia landslide and incipient slumps. Letters denote locations described in text.

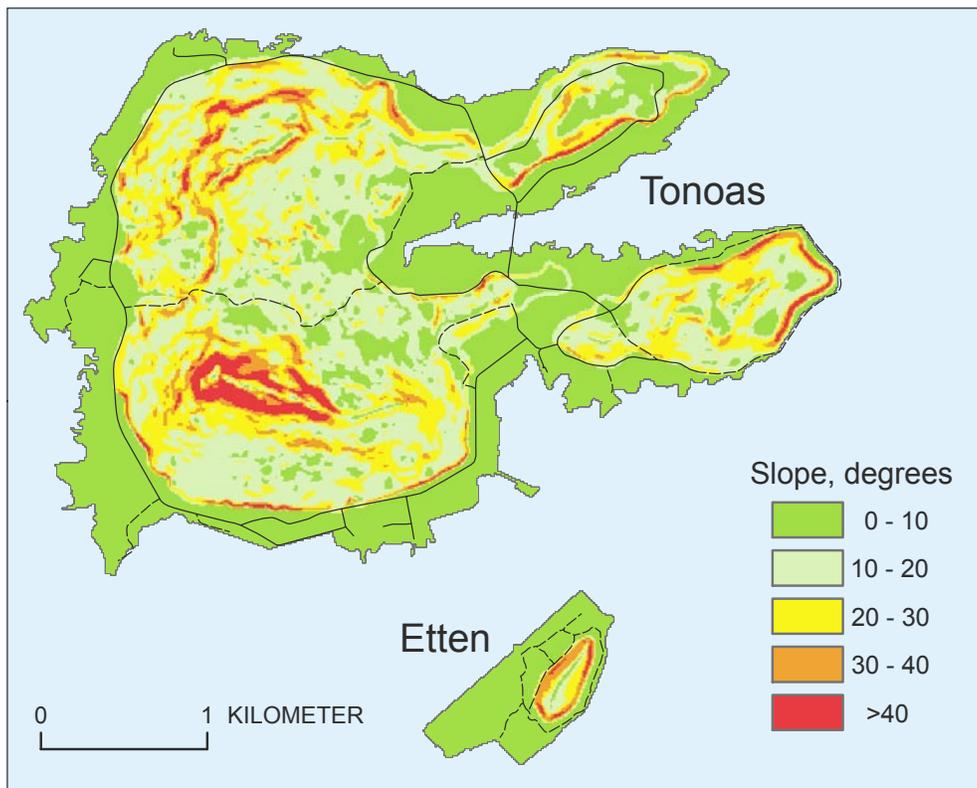
Figure 22. Slope map of the island of Tonoas prepared from a 10-m digital-elevation model (DEM).

a slope map for the island of Tonoas is shown in figure 22. The thickness of the potential sliding block (t in equation 1) at each cell was estimated at a constant 3.5 m, reflecting an average thickness of Chata'an-triggered landslides. For ground-water conditions during intense rainfall similar to tropical storm Chata'an, we assumed a fully saturated soil column with slope-parallel ground-water flow within all cells ($m = 1$ in equation 1). Ground-water conditions undoubtedly varied from place to place and over time during Chata'an; nevertheless this assumption provides a relative "worst case" condition for computing slope stability.

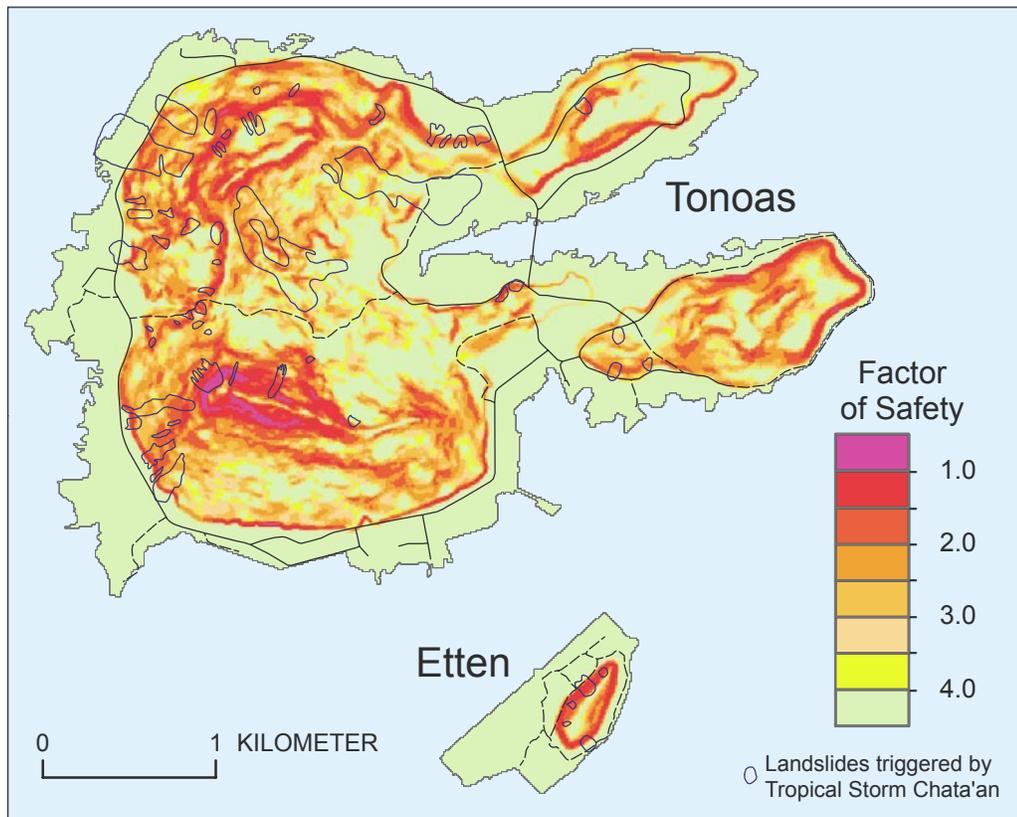
Figure 23. Factor-of-safety (susceptibility) map of the island of Tonoas using the slope-stability analysis described in text.

Using equation 1, we computed the static factor of safety, FS , for each 10-m grid cell of the affected Chuuk islands. The resulting slope-stability (factor-of-safety) map was then used to construct the debris-flow hazard map described in the next section. An example of the factor-of-safety map for the island of Tonoas is shown in figure 23. Factor-of-safety categories are portrayed on the map as different colors, ranging from magenta and red for the lowest values or least stable slopes to green for the highest values or most stable slopes. These colors indicate the general susceptibility of a given slope to landsliding in a storm similar to Chata'an. Overall, most of the debris flows initiated within slopes

shown as magenta, red, or orange colors in figure 23, indicating a generally good agreement between the actual locations of landslide-source areas and those slopes predicted to be highly susceptible. There are, however, debris flows that initiated on slopes containing a significant number of cells of intermediate susceptibility. Notably, some of the larger debris flows on Tonoas, including those at Nechap, Kuchua, and Roro, initiated on slopes such as these. These debris flows began as complex deep-seated failures (greater than 10-m thick and much larger than a 10-m grid cell) with complex failure mechanisms (see discussions above). They are poorly represented by the slope-stability analysis described by equation 1. In general, the smaller, thinner, and more numerous debris flows more closely approximate the assumptions of our stability analysis, for example, a simple sliding block of constant thickness. For these more common debris flows, our analysis performed well.

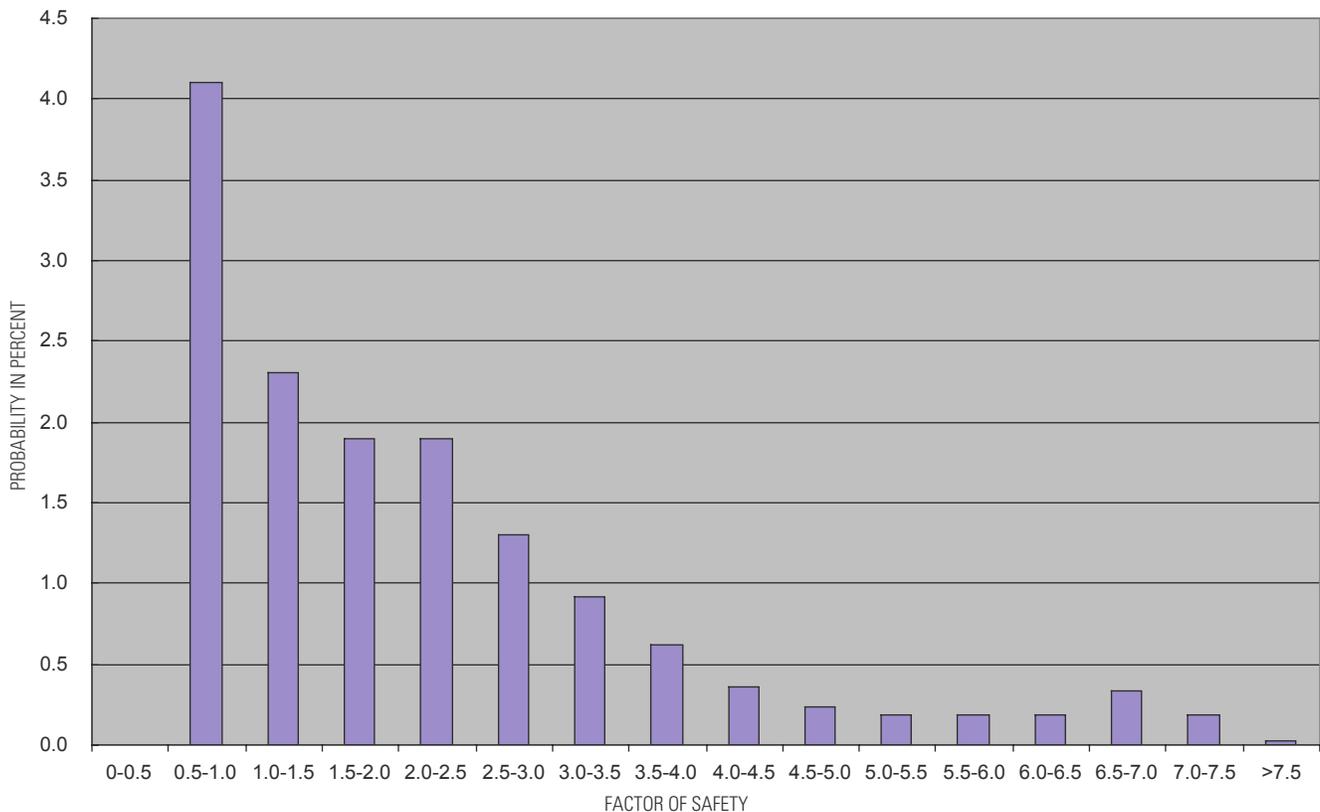
Figure 24. Histogram of debris-flow source probability versus factor-of-safety based on slope stability analysis of the islands of Weno, Tonoas, Fefan, Etten, Uman, Udot, Eot, and Fanapanges. Larger probabilities indicate an increased likelihood that a Chata'an-triggered landslide (debris-flow source) occurred on hillslopes with the corresponding factor-of-safety.

having FS values of between 1.0 and 1.5 had a 2.3 percent probability of sliding, and the pattern of decreasing percent probability continues with increasing FS (fig. 24). With debris-flow source probability plotted versus FS in figure 24, we were able to establish debris-flow hazard categories in terms of FS .

yellow, and green, respectively, on plate 2. Figure 24 shows that $FS=0.5-1.0$ stands out noticeably from the rest of the data (highest probability), but the areal extent of this category is small. For this reason, we combined this FS category with the three adjacent bins, $FS=1.0-2.5$, that have similar values, to form the “high” hazard category. The limits of the “moderate” category are somewhat more arbitrary ($FS=2.5-4.0$), although the probabilities in these two bins are significantly higher than in the rest of the bins ($FS > 4.0$). The bins with low probabilities form the “low” hazard category. In summary, areas of “high” hazard have a 2 percent probability, areas of “moderate” hazard have a 1 percent probability, and areas of “low” hazard have a 0.1 percent probability of producing slump/debris flows during rainfall conditions similar to those of tropical storm Chata’an in the eastern islands of Chuuk State.
