# **Extent of a Mine Contamination Plume on the Willow Creek Floodplain, Creede, Colorado, as Determined by Willow Leaf Analysis**

Open-File Report 2005-1267

*By* James A. Erdman<sup>1</sup>, Leigh Ann Vradenburg<sup>2</sup>, and Shea Clark Smith<sup>3</sup>

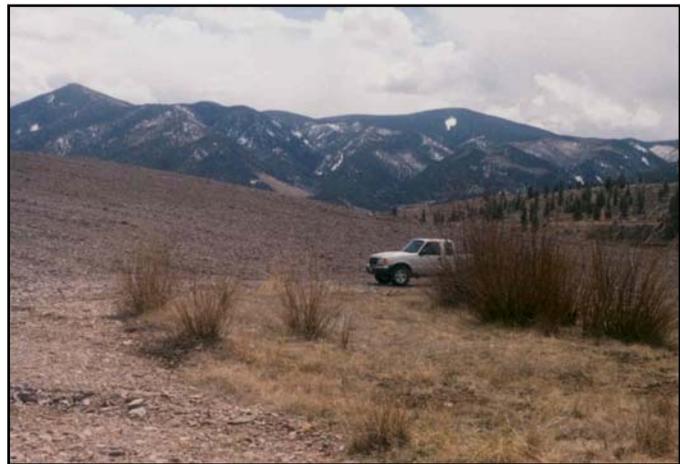
**Figure 5.** Willow sampling site #7- Note the gravel-capped tailings pile from the former Emperious Mill in the mid-distance.

Site #5 at MW17, Site #6 at MW13, Site #7 at MW14, and Site #8 at MW3. Sites #6 and #7 occur at the base of the capped tailings. The willow leaf sample from Site #6 was most likely blue willow (*Salix drummondiana*) and not the more common sandbar willow, *S. exigua*. Two sampling sites are on or near the Rio Grande River upstream of Willow Creek: Site #10 near the Marshall Park Campground and Site #11 on a tributary stream, Miners Creek (Figures 1 and 3). Sample sites #12, #13, and #14 are located on the southwest side of the Rio Grande River between the La Garita Bridge and Wagon Wheel Gap approximately seven miles from Creede (Figures 1 and 4). Figures 5 and 6 are views from sampling sites #7 and #9, respectively.

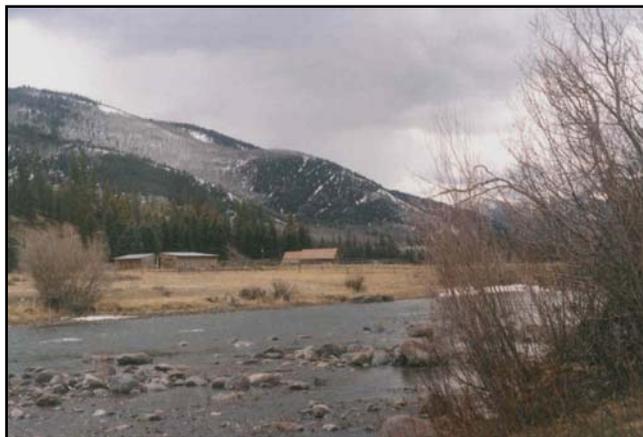
**Figure 6.** Willow sampling site #9- The willow cluster on the right lies on the edge of the Rio Grande River, nearly a mile upriver from Willow Creek.
