# **Decadal-Scale Analysis of Coastal Landslides Along the Big Sur Coast: Rates And Processes**

Open-File Report 2005-1434

*By Cheryl J. Hapke,<sup>1</sup> and Krystal R. Green<sup>1,2</sup>*

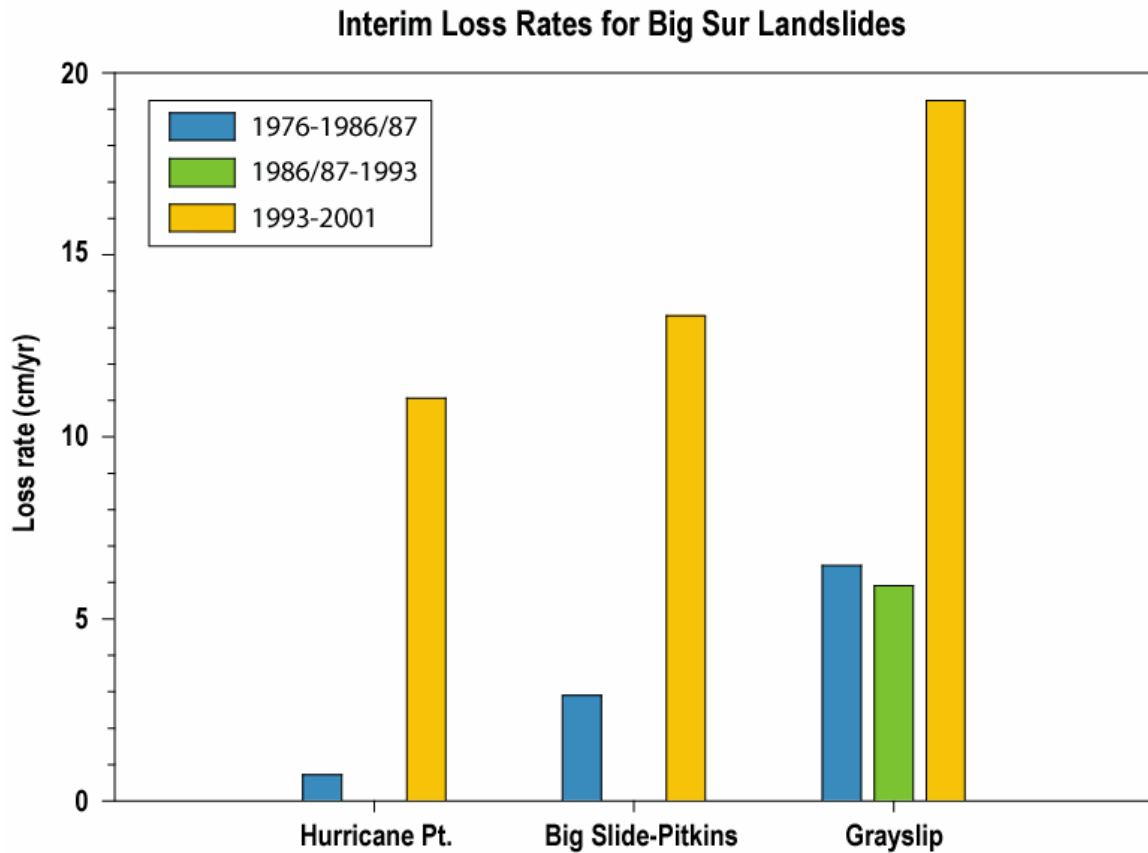
**Figure 3.** Bar graph showing the interim (~decadal) loss rate of material to the nearshore for each of the three landslide sites analyzed.

The average loss rates for each of the three areas are: -3.9 cm/yr for Hurricane Point, -3.7 cm/yr for Big Slide-Pitkins, and -10.5 cm/yr for Grayslip. In both the Hurricane Point and Big Slide-Pitkins landslides, there was a net gain below the road grade during the period from 1986 to 1993. Some of this gain may be anthropogenic, and some may be storage of material at the slope base in the form of debris fans from smaller, surficial flows and rock falls.

These rates represent the average loss over the 25-year period from 1976 to 2001. However, they do not provide information on the highly episodic nature of large slope failures in the area. It is clear from assessing the loss data from the individual time periods (Table 2 and fig. 3) that the periods that include large El Niño years (1982-83 and 1997-98) account for the majority of the material lost. In both the Hurricane Point slide and the Big Slide-Pitkins area, there was no measurable loss of material to the nearshore in the period that did not include a large El Niño winter (1986-1993). This indicates that material deposited at the slope base during this time was stored there until large wave events removed both stored material and enough additional material
