Hydroacoustic Mapping to Define Sedimentation Rates and Characterize Lentic Habitats in DeSoto Lake, DeSoto National Wildlife Refuge

By Caroline M. Elliott, Robert B. Jacobson, and Kimberly A. Chojnacki

Open-File Report 2006–1254

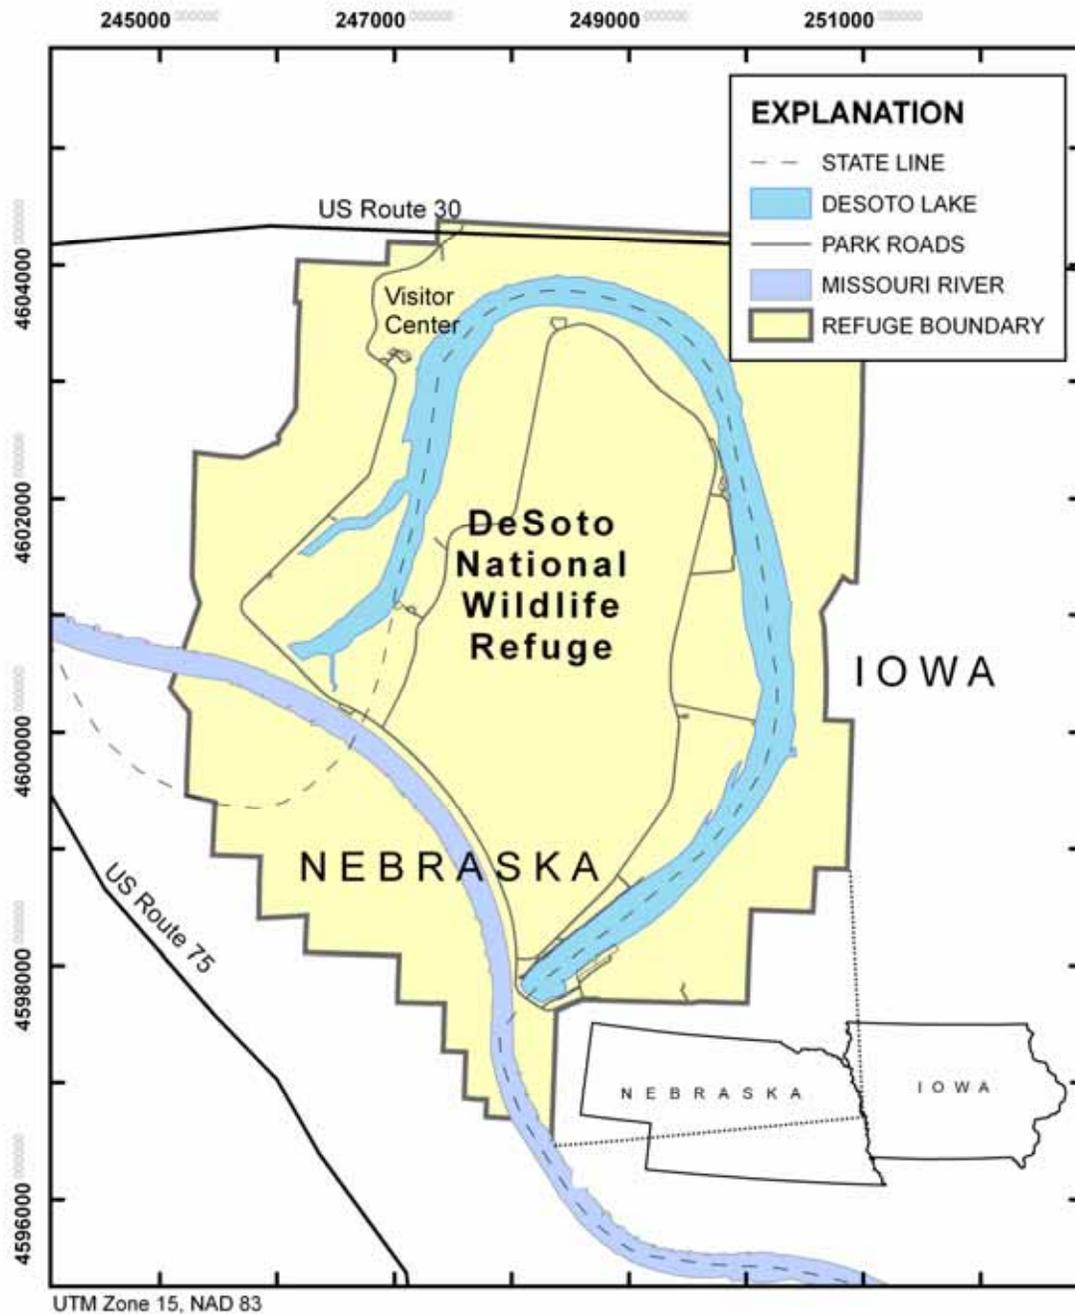
Figure 1. DeSoto National Wildlife Refuge and DeSoto Lake.

DeSoto Lake is located on the DeSoto NWR on the Nebraska and Iowa border (fig. 1). The lake was cut off from the Missouri River by the U.S. Army Corps of Engineers when the navigation channel was shortened by construction of a cut-off channel and levee in 1960. Its connection to the Missouri River today is through engineered inlet and outlet structures in the levee. There are three inlet ditches that drain adjacent farmland and appear to be a significant source of suspended sediment, contributing mainly silt-sized sediment to the lake.

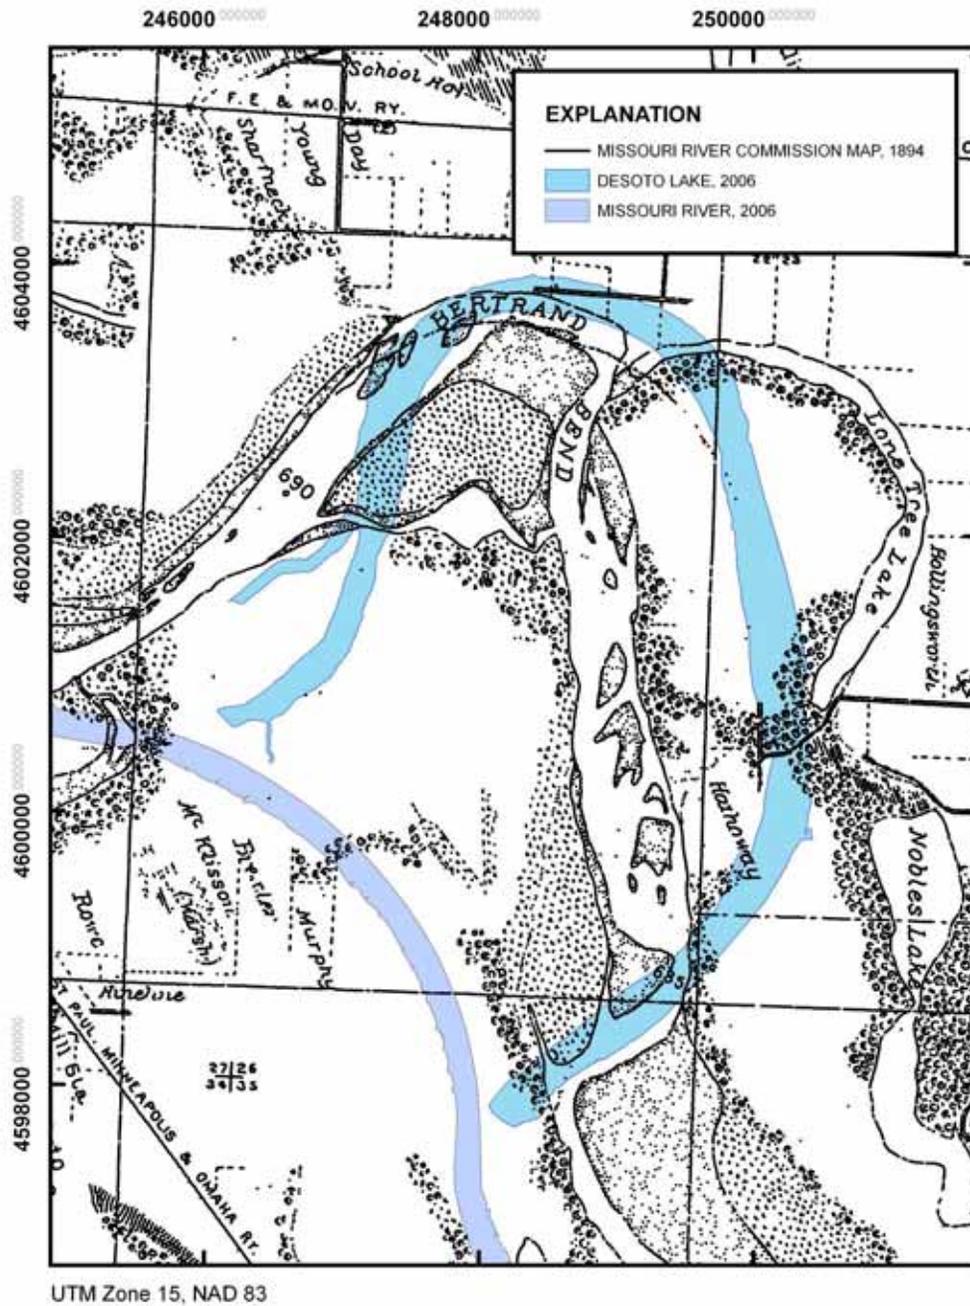
Figure 2. Missouri River Commission map of the Missouri River flood plain (Missouri River Commission, 1894) and the current positions of the Missouri River and DeSoto Lake.

DeSoto Lake is located in a wide flood plain adjacent to the Lower Missouri River and lies completely within the recent meander belt of the Missouri River. DeSoto Lake does not occupy the same position today as indicated in the 1894 Missouri River Commission maps (fig. 2). It appears the river was quite active in the time between 1894 and 1927 when channel stabilization work was authorized between Kansas City and Sioux City. The lakebed and adjacent lands are composed of fairly recent Missouri River alluvium—sand, silt, and clay sediments. Some bank segments in DeSoto Lake, particularly areas that were previously on the outside bend of the river, are armored by the coarse rip rap and wooden pilings used to narrow the river channel in the 1940s for the creation of the 9-foot deep, 300-foot wide Lower Missouri River navigation channel (Ferrell, 1996).

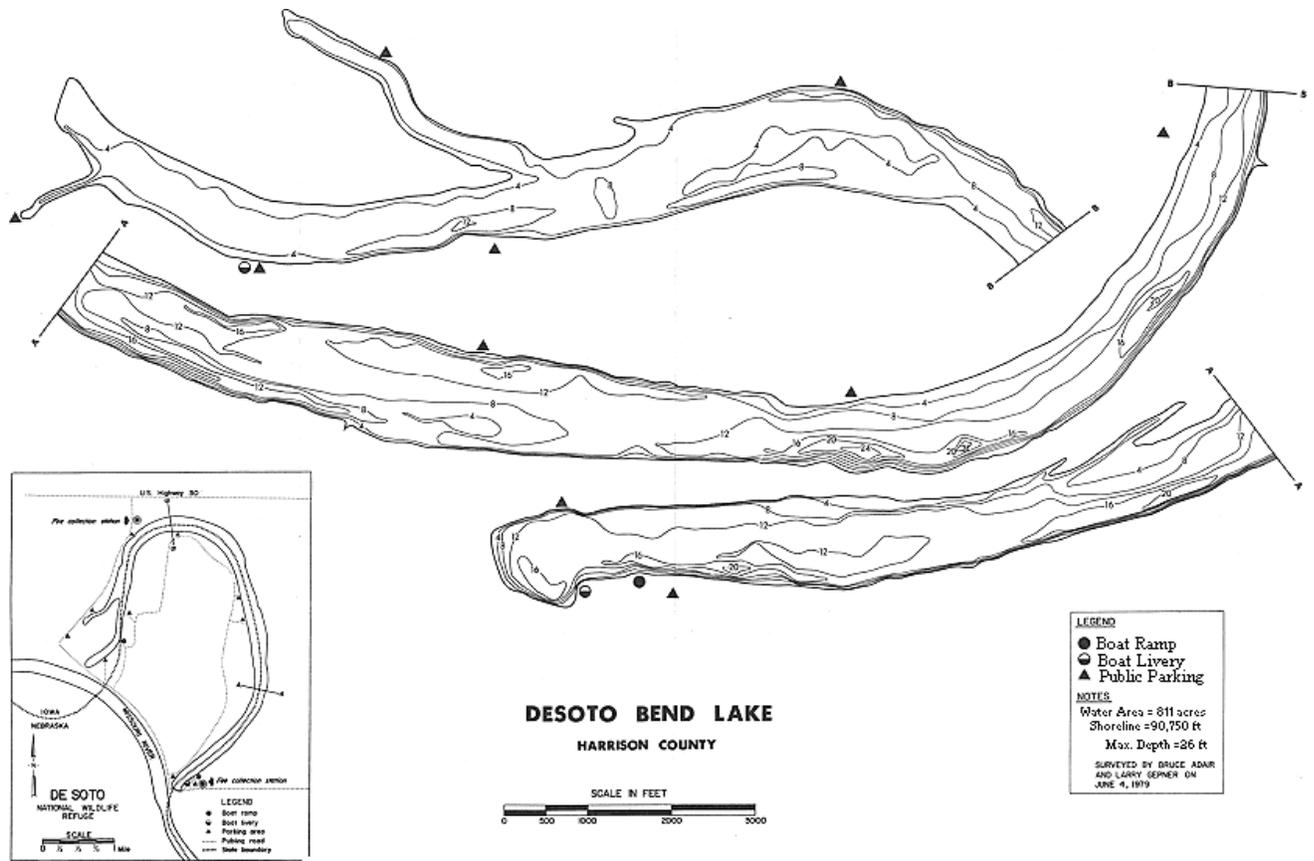
Figure 3. DeSoto Lake in 1979 (Iowa Conservation Commission, 1980).

Refuge records indicate that the lake was mapped in March 1967 by the U.S. Fish and Wildlife Service. The archived maps are 5-foot interval contour maps of depth mapped from a lake elevation of 988.5 ft (feet). The lake was surveyed again in June 1979 (fig. 3). The lake elevation at the time of this mapping was not documented, and the contour interval is 4 ft. Both the 1967 and 1979 maps were hand-contoured from surveys with undocumented data density. This makes quantitative comparison to the 2006 mapping impossible, as actual elevations of the bottom cannot be determined. As part of a lake assessment of all large Iowa lakes in 2004, the Iowa State University Limnology Lab created a grid from the 1979 mapping and compiled physical characteristics of DeSoto Lake in a report (Bachmann, 1994). The grid is interpolated from contour data, does not indicate water surface elevations, and cannot be used to calculate sedimentation rates.

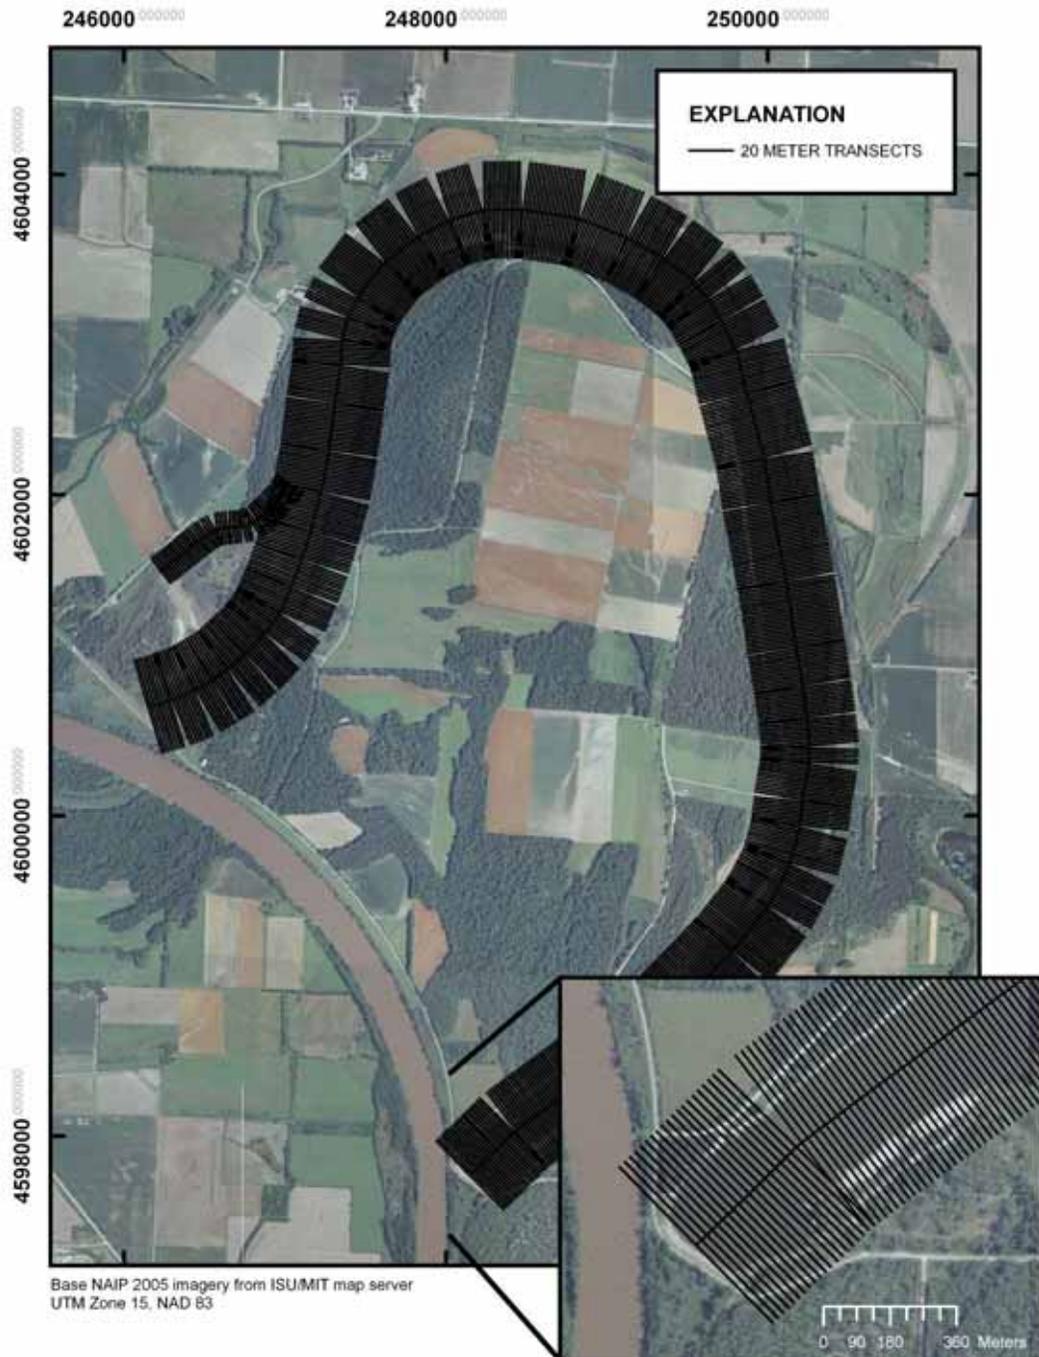
Figure 4. Transects created for data collection using a 20-m line spacing.

Hydroacoustic mapping was conducted using standard CERC procedures (Jacobson and others, 2002; Elliott and others, 2004). Transects were planned using digital aerial photography of DeSoto Lake acquired from the Iowa State University/Massachusetts Institute of Technology map server. The digital maps were used as base maps for transect design and real-time navigation using HyPack hydrographic software (Coastal Oceanographics, Middletown, Connecticut). Sampling transects were generated with a 20-m (meter) spacing and oriented generally perpendicular to the lake centerline (fig. 4). The transect spacing was selected to provide sufficient spatial coverage for creating continuous

surface maps of depth, elevation, and substrate data given usual scales of variation of these characteristics. DeSoto Lake's centerline is 12-km (kilometers) long; therefore, approximately 600 transect lines were drawn for data collection (fig. 4). Transects were terminated laterally when the depth became too shallow for the boat to survey at approximately 0.30 m.

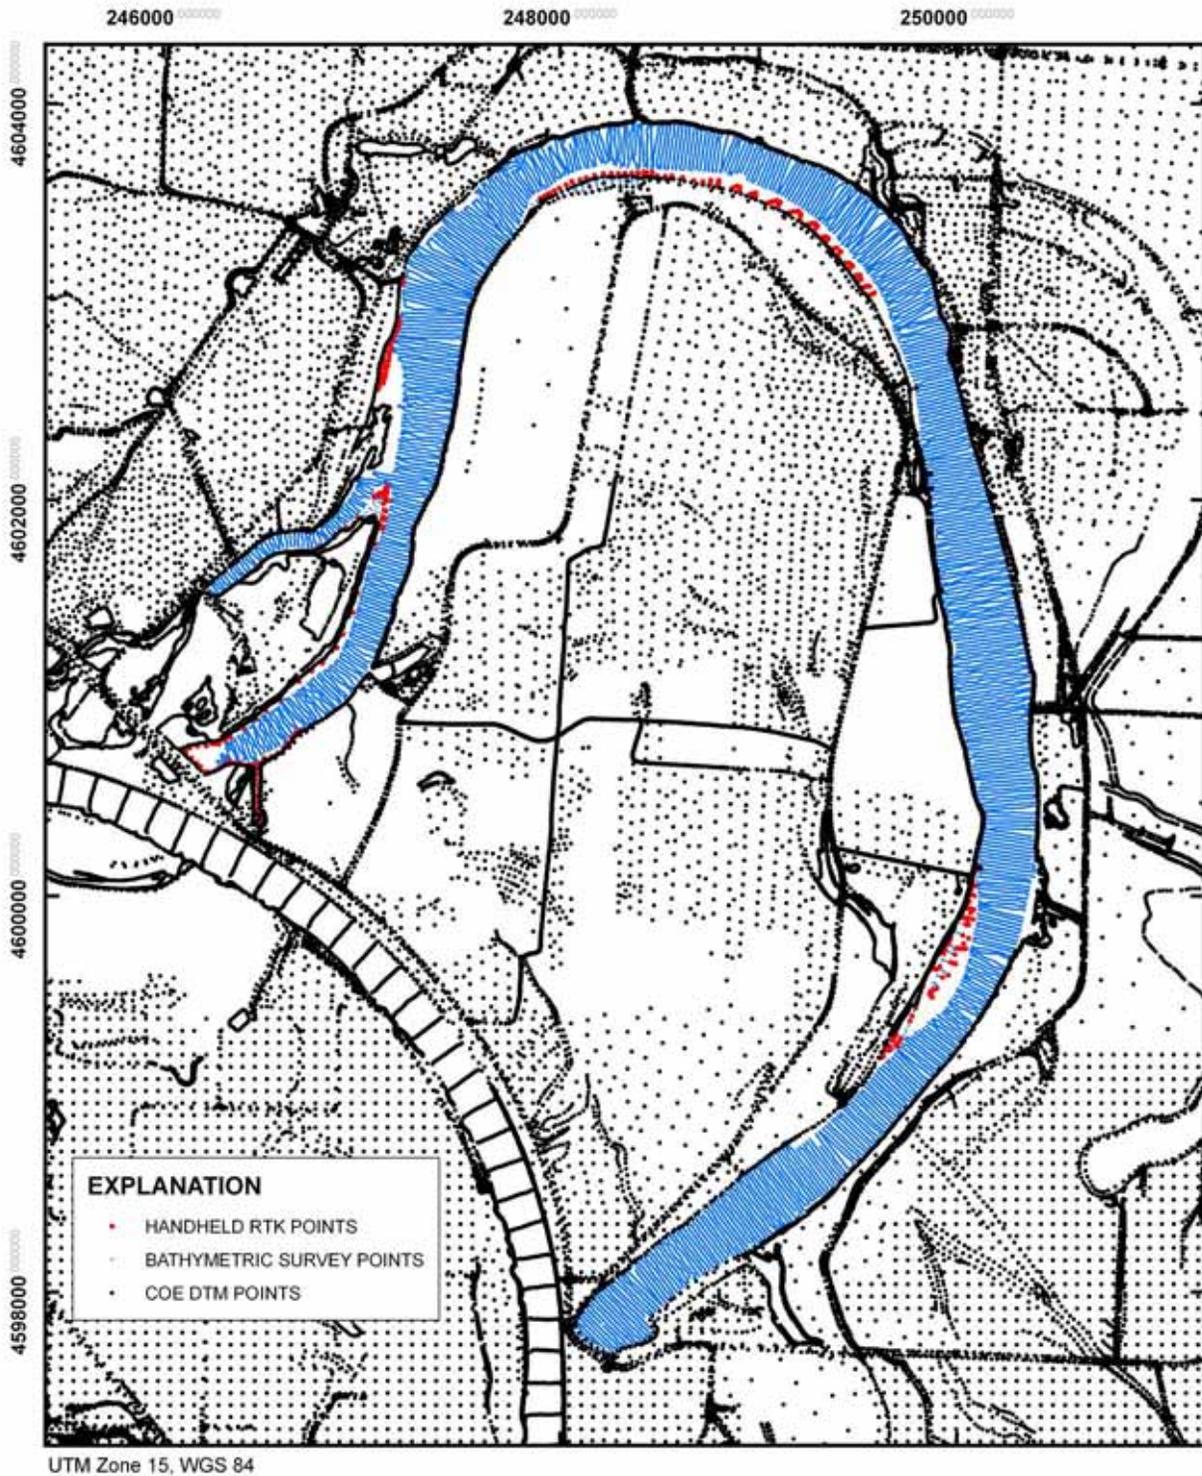
Figure 5. Survey points from the bathymetric survey, ground survey, and U.S. Army Corps of Engineer's Digital Terrain Model in the DeSoto Lake region.

Elevation data were further supplemented by data points from a digital terrain model for the Missouri River flood-plain region acquired from the U.S. Army Corps of Engineers. These points were collected using photogrammetric techniques from 1999 aerial orthophotography in the flood plain and 1994–1995 bathymetric surveys in the Missouri River (fig. 5). The flood-plain data consist of spot points and breaklines, with a higher point density on linear features in the flood plain (such as roads and levees). The Missouri River data consist of cross sections spaced approximately every 500 ft. The points have a root mean square error (RMSE) of 0.67–1.33 ft. These points were reprojected and joined with the points collected in the bathymetric and ground surveys to create a detailed Triangular Irregular Network (TIN) of elevation. The Missouri River points were separated from the main flood-plain dataset and breaklines were added to improve interpolation. A 5-m grid in the Missouri River was created by kriging in ArcMap. The TIN of the flood plain was then converted to an ESRI grid with 5-m spacing and merged with the Missouri River grid. The resulting flood-plain grid was then merged with the Missouri River grid and the elevation grid created for DeSoto Lake to create an elevation grid of the DeSoto NWR and adjacent lands. All elevation data are reported in NAVD 88 using the GEOID 03 model for conversion from ellipsoid height.

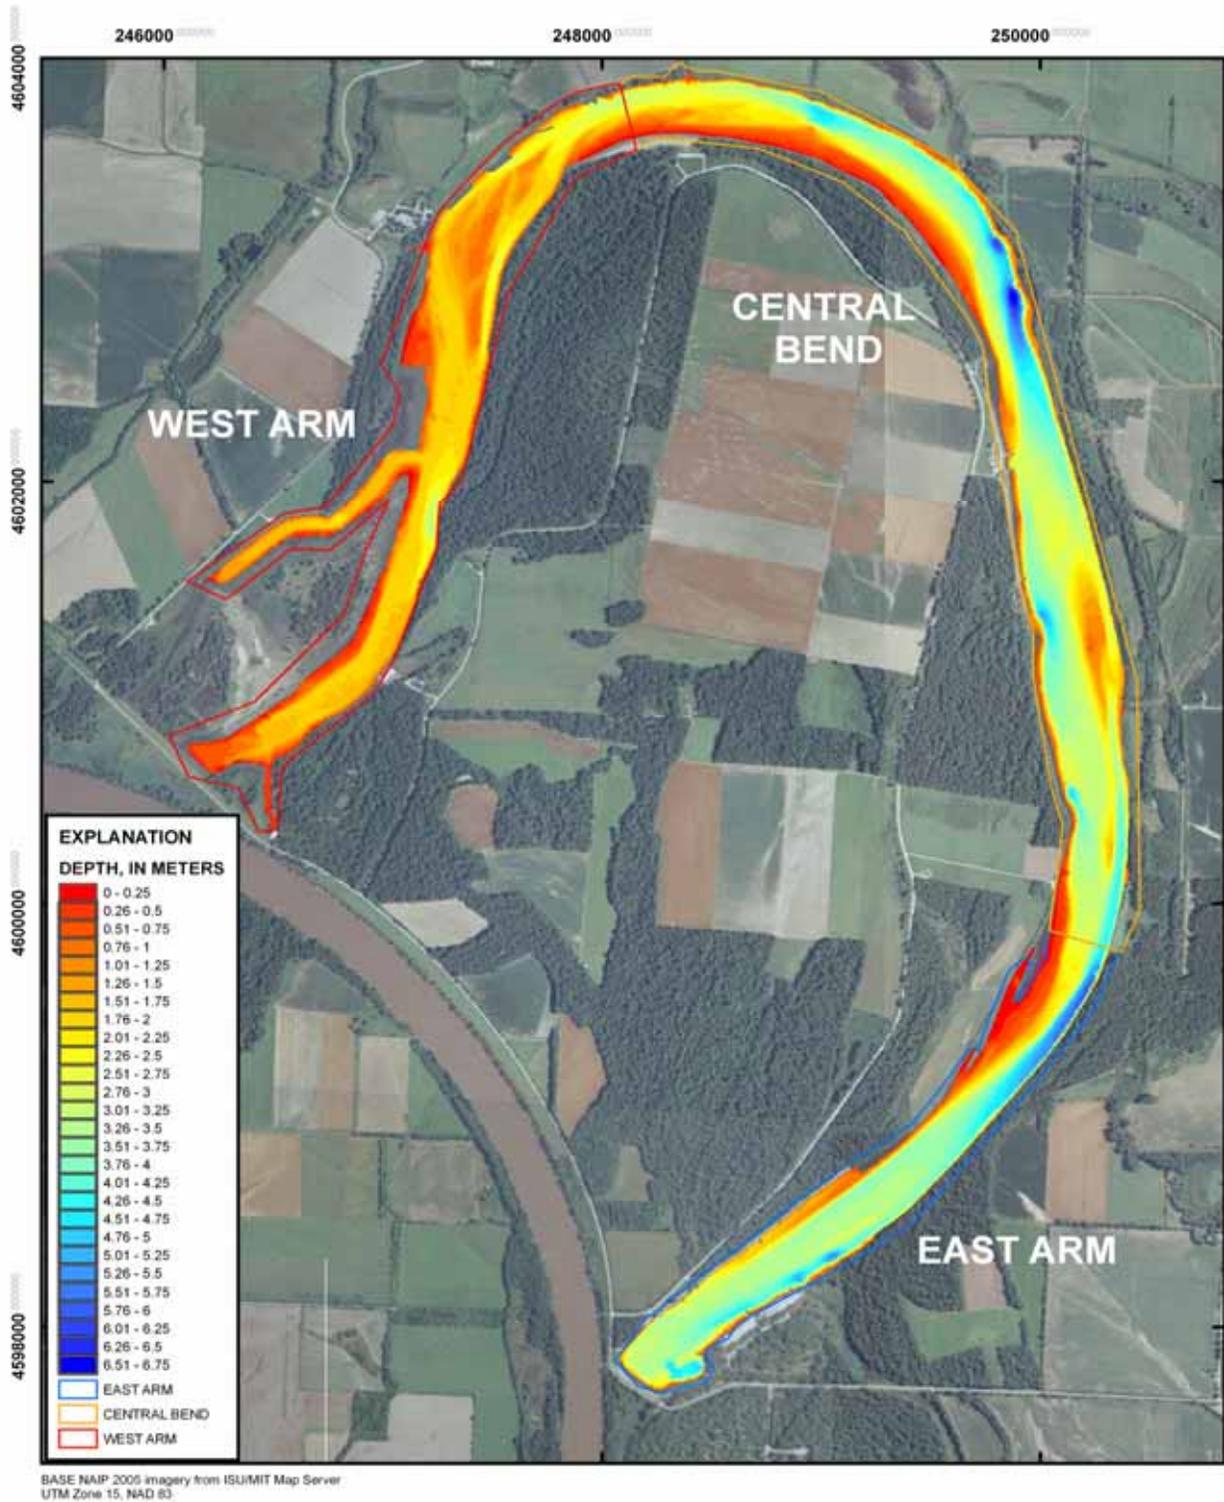
Figure 6. Depth map of DeSoto Lake at a water surface elevation of 301.45 m above mean sea level (988.76 ft), 2006.

A depth map of DeSoto Lake was created at a lake elevation of 301.45 m above MSL (mean sea level) (988.76 ft), which is within 10 cm (centimeters) (0.33 ft) of the average lake elevation for the year according to the current DeSoto NWR CPP (fig. 6; U.S. Fish and Wildlife, 2001). The mean depth of the lake is 2.32 m (7.6 ft). The maximum depth in the lake is 6.7 m (21.98 ft). The standard deviation in depth is 1.24 m (4.06 ft). A histogram of depth values in the entire lake, as well as the west and east arms of the lake and central segment of the lake are shown in fig. 7. The west arm of the lake is significantly shallower than the east arm or central part of the bend. There is no portion of the west arm of the lake deeper than 3.5 m.

Lake topography is typical of Missouri River topography in this region. The west arm of the lake has likely filled in with more sediment than the east since closure of the levees in 1960. The deeper regions of the lake are holes on the outside of the central segment of the bend and the east arm of the lake. This is probably what is left of the former river thalweg. The former thalweg meanders back to the right bank (inside bend) in the middle of the east side of the lake. At this point, there is a bar located on the outside bank directly across from the former channel thalweg. Mid-bend crossovers like the one seen in the bathymetry of DeSoto Lake are common in this segment of the Lower Missouri River.

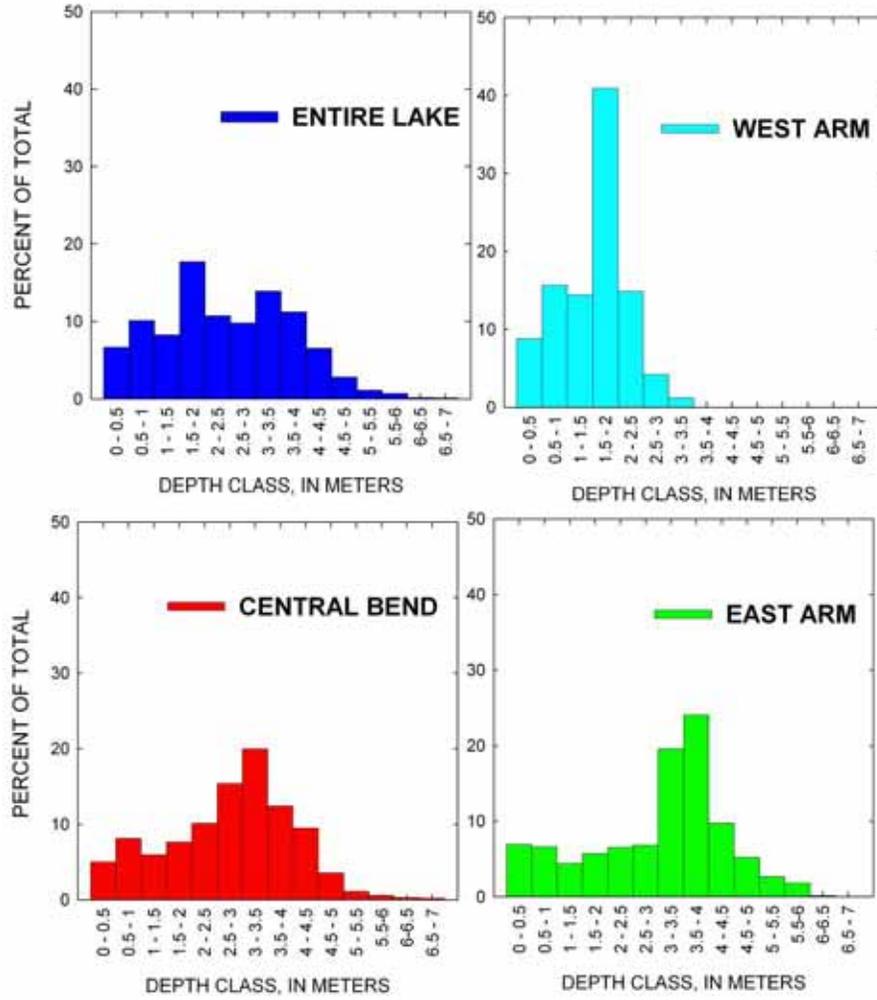
Figure 7. Depth histograms for DeSoto Lake.

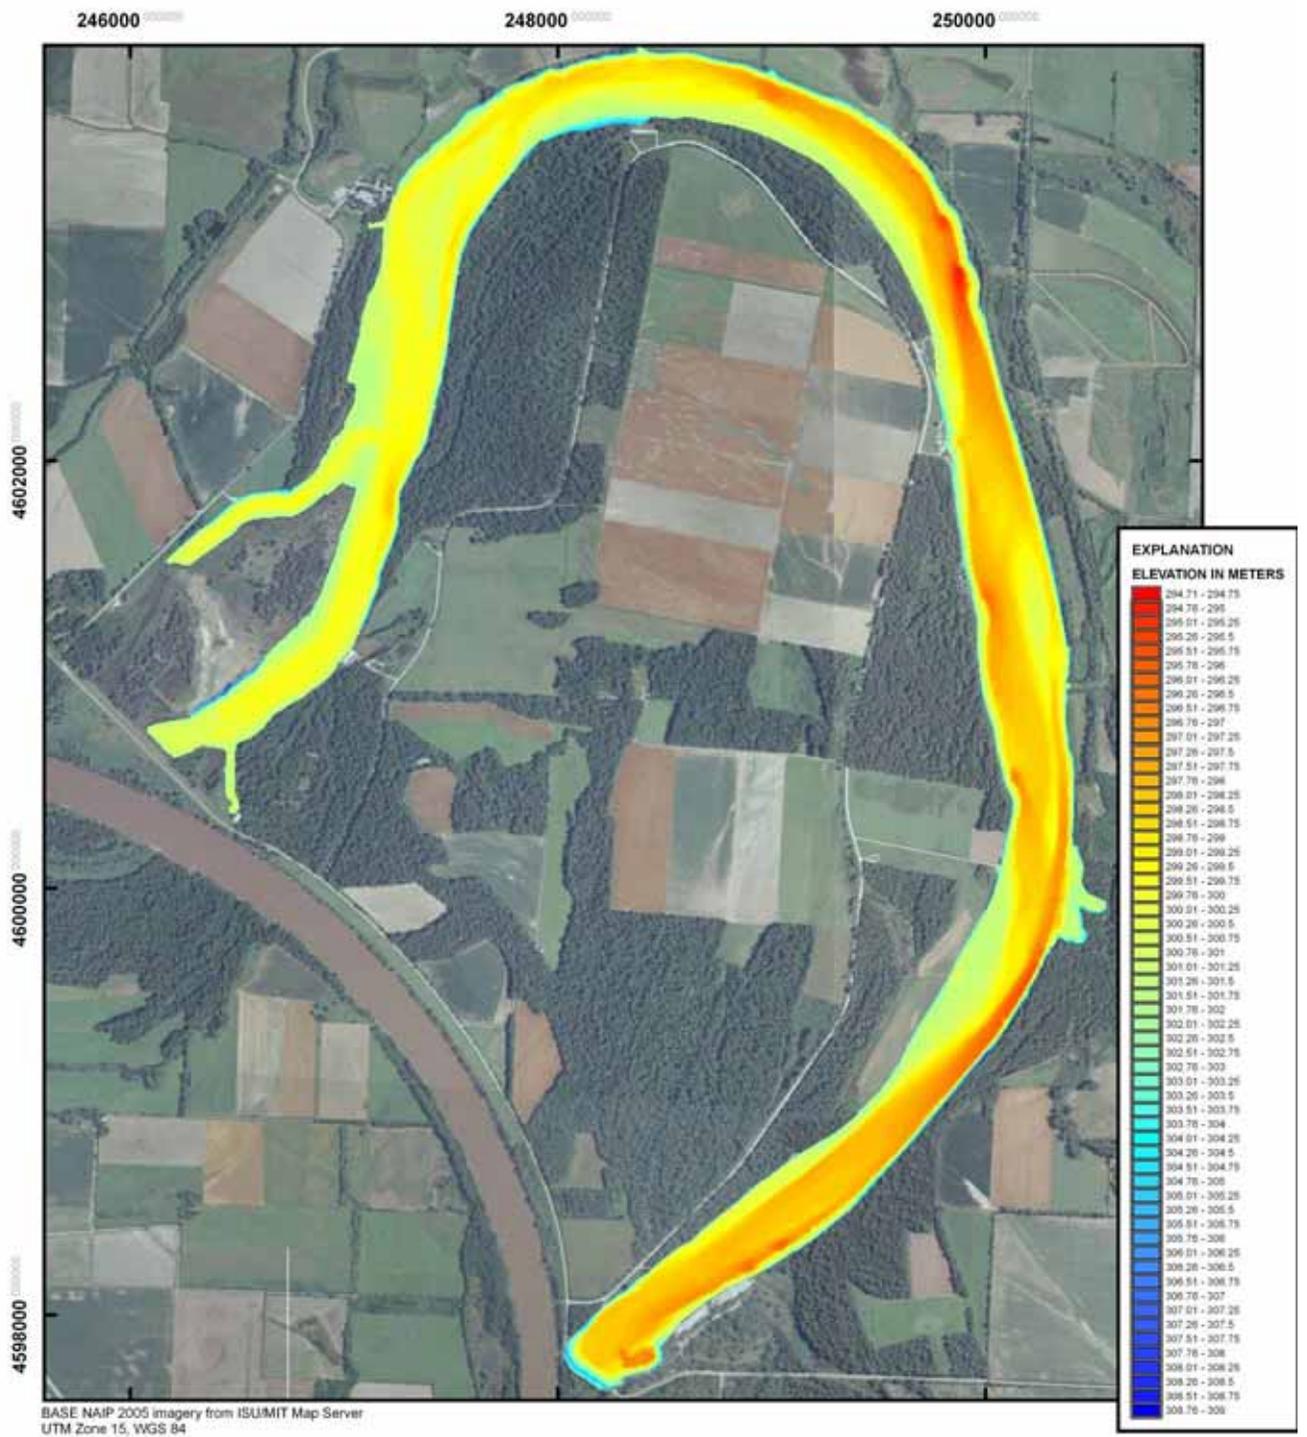
Figure 8. Bed elevation of DeSoto Lake, 2006.

Maps of elevations in DeSoto Lake and the DeSoto NWR region are shown in figures 8 and 9. Individual surveyed transects tied to elevations are stored in archival formats that can be used for a precise transect-by-transect assessment of sedimentation rates during subsequent resurveys of the lake.

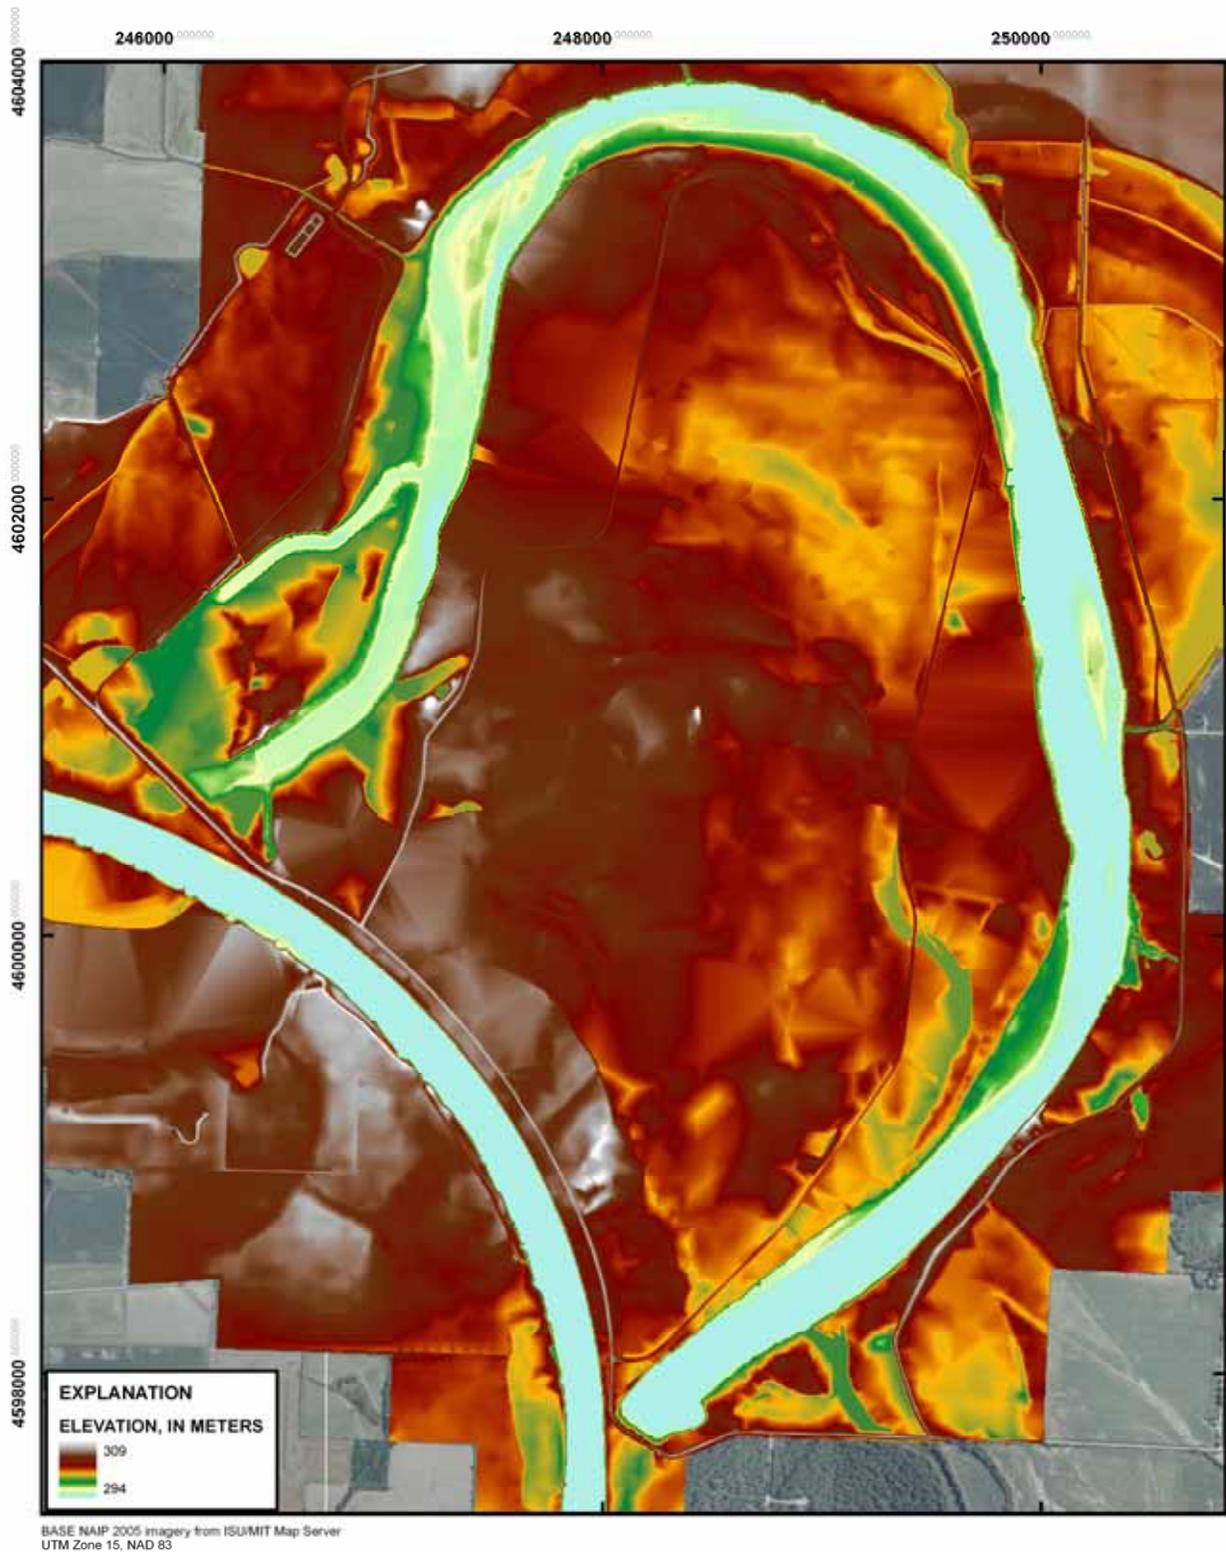
Figure 9. Elevation of DeSoto National Wildlife Refuge, 2006.

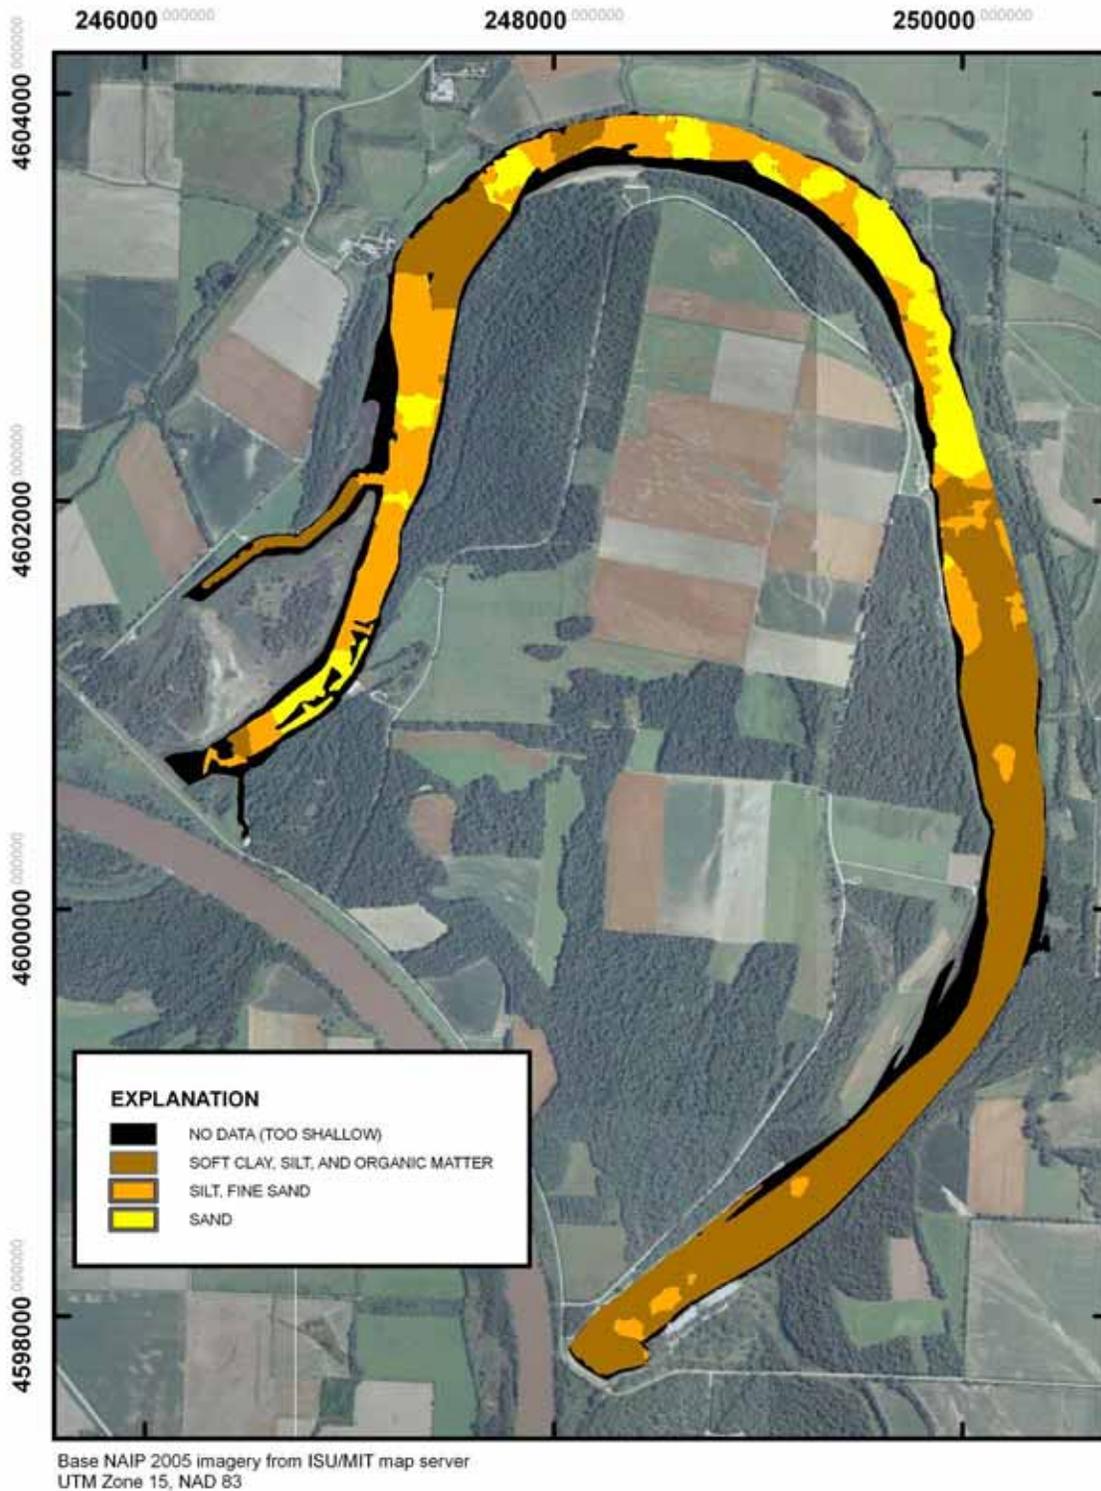
Figure 10. Generalized substrate map of DeSoto Lake, 2006.

The bottom materials of DeSoto Lake are primarily soft silt and fine sand (fig. 10). No data are available in depths shallower than 1.3 m, which is due to instrument range. Sampling conducted to ground-truth substrate data found clay to be very rare in the DeSoto Lake; fines consisted mostly of silt and fine-sand sediment with some organic matter. Harder substrates included compacted silt and fine to coarse sand. Hard and coarse sand were present in parts of the lake, particularly in the wide portion of the west arm of the lake and the central portion of the bend (table 1). Hard sand substrate is very rare in the east arm of the lake. This region was dominated by soft materials, mostly silt, fine sand, and organic matter. There is also a considerable amount of soft silt in the lake near the ditch outlets. This was verified by sampling. Fines were easily suspended in the water column in many shallow areas when disturbed by boat motion. These results are consistent with a high silt content (58.7 percent silt, 10.6 percent clay, and 30.7 percent sand) measured in the east arm of DeSoto Lake in a backwater- and water-quality study in the lake and adjacent backwaters (DeLucchi and others, 2003).

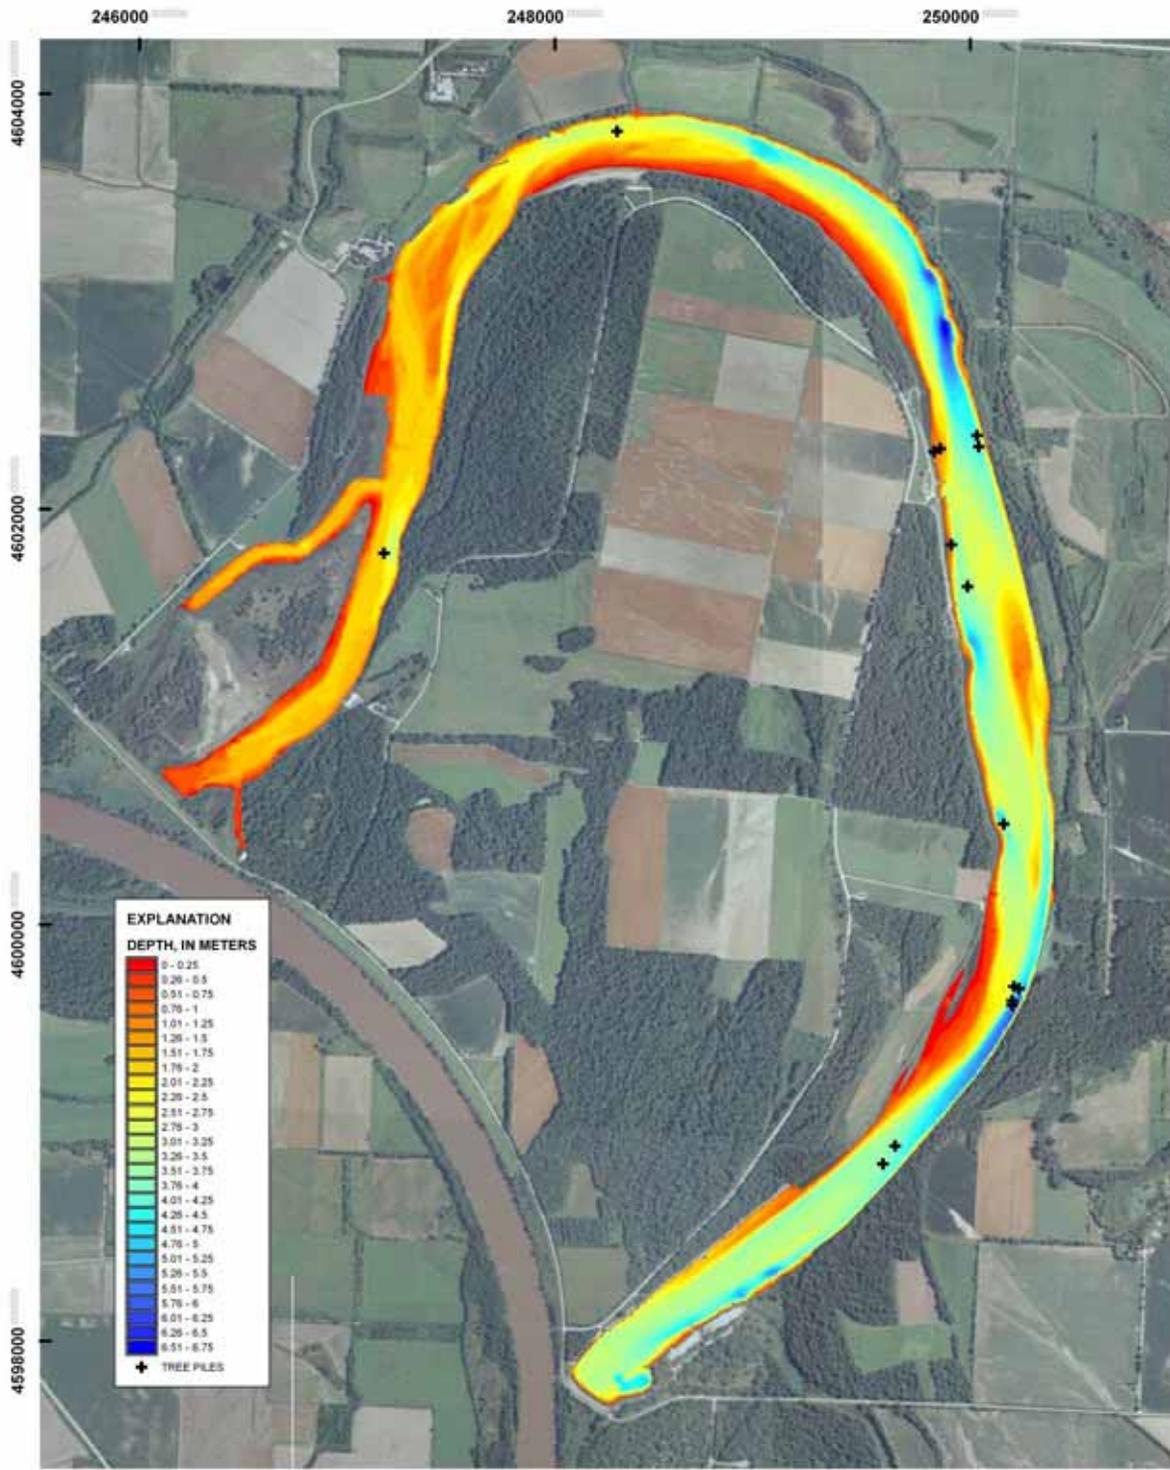
Figure 11. Submersed tree structures for fish habitat enhancement visible and mapped at a water-surface elevation of 301.45 m above mean sea level (988.76 ft).

Numerous tree piles have been constructed in DeSoto Lake for fish habitat enhancement. The locations of tree piles visible at the lake elevation in March 2006 were recorded to within 10 m (fig. 11). Refuge records indicate there are many more tree structures than those mapped during this project. Additional structures may have been completely submerged during this survey.

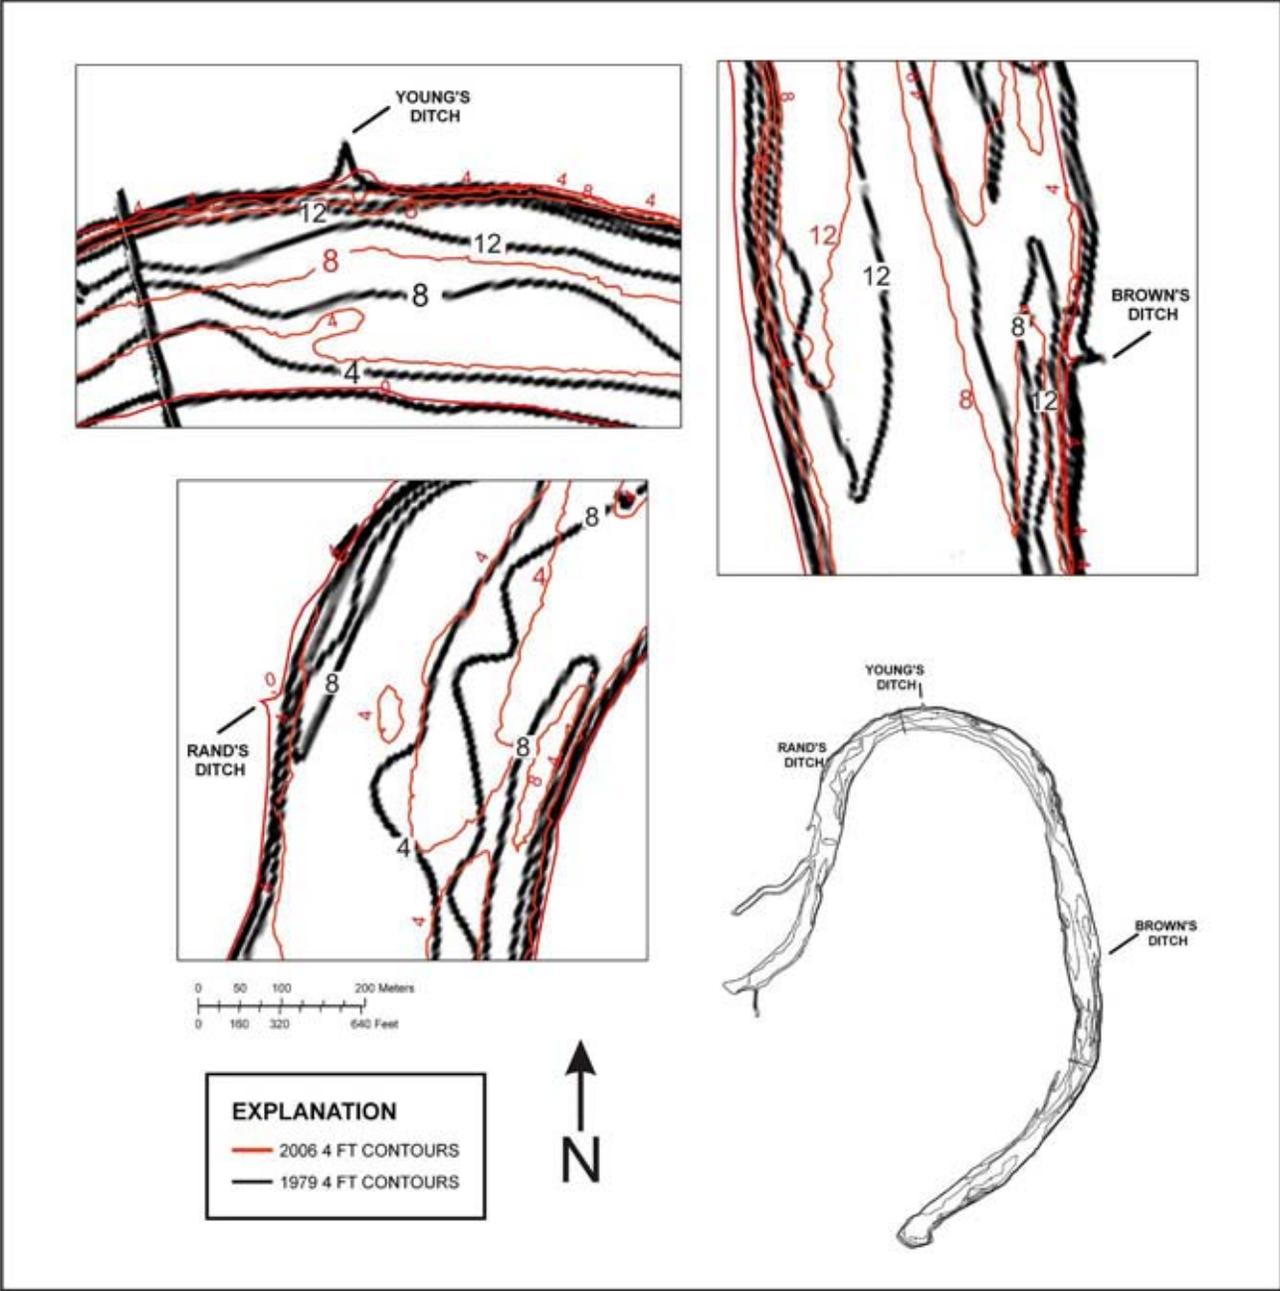
Figure 12. Comparison between 2006 and 1979 four-foot contours near Brown's Ditch, Young's Ditch, and Rand's Ditch.

The 1979 bathymetric map was only available in paper and scanned format. For a comparison analysis, the scanned 1979 map was clipped using image processing software and roughly georeferenced in ArcMap by matching to 2002 digital orthophotography acquired from the Iowa Department of Natural Resources. The resulting 4-foot contour map can be overlain and qualitatively compared to the 2006 bathymetric mapping. In general, there appears to be a shallowing trend in the overall bathymetry of DeSoto Lake in the 27-year period between 1979 and 2006, if it can be assumed that lake elevations were similar during the two surveys. Under this assumption, there appears to be detectable change in the regions where the three ditches, Young's Ditch, Rand's Ditch, and Brown's Ditch, enter the lake (fig. 12). Near Young's Ditch on the north end of the lake, the deepest part of the channel is now 8 ft, compared to 12 ft in 1979. There appears to have been sedimentation near Rand's Ditch on the west arm of the lake as the 8-foot contour line is no longer adjacent to the ditch's mouth. There also appears to be around 4 ft of sedimentation near Brown's Ditch. Sedimentation appears to be mostly localized near the ditches.
