Hydroacoustic Mapping to Define Sedimentation Rates and Characterize Lentic Habitats in DeSoto Lake, DeSoto National Wildlife Refuge

By Caroline M. Elliott, Robert B. Jacobson, and Kimberly A. Chojnacki

Open-File Report 2006–1254

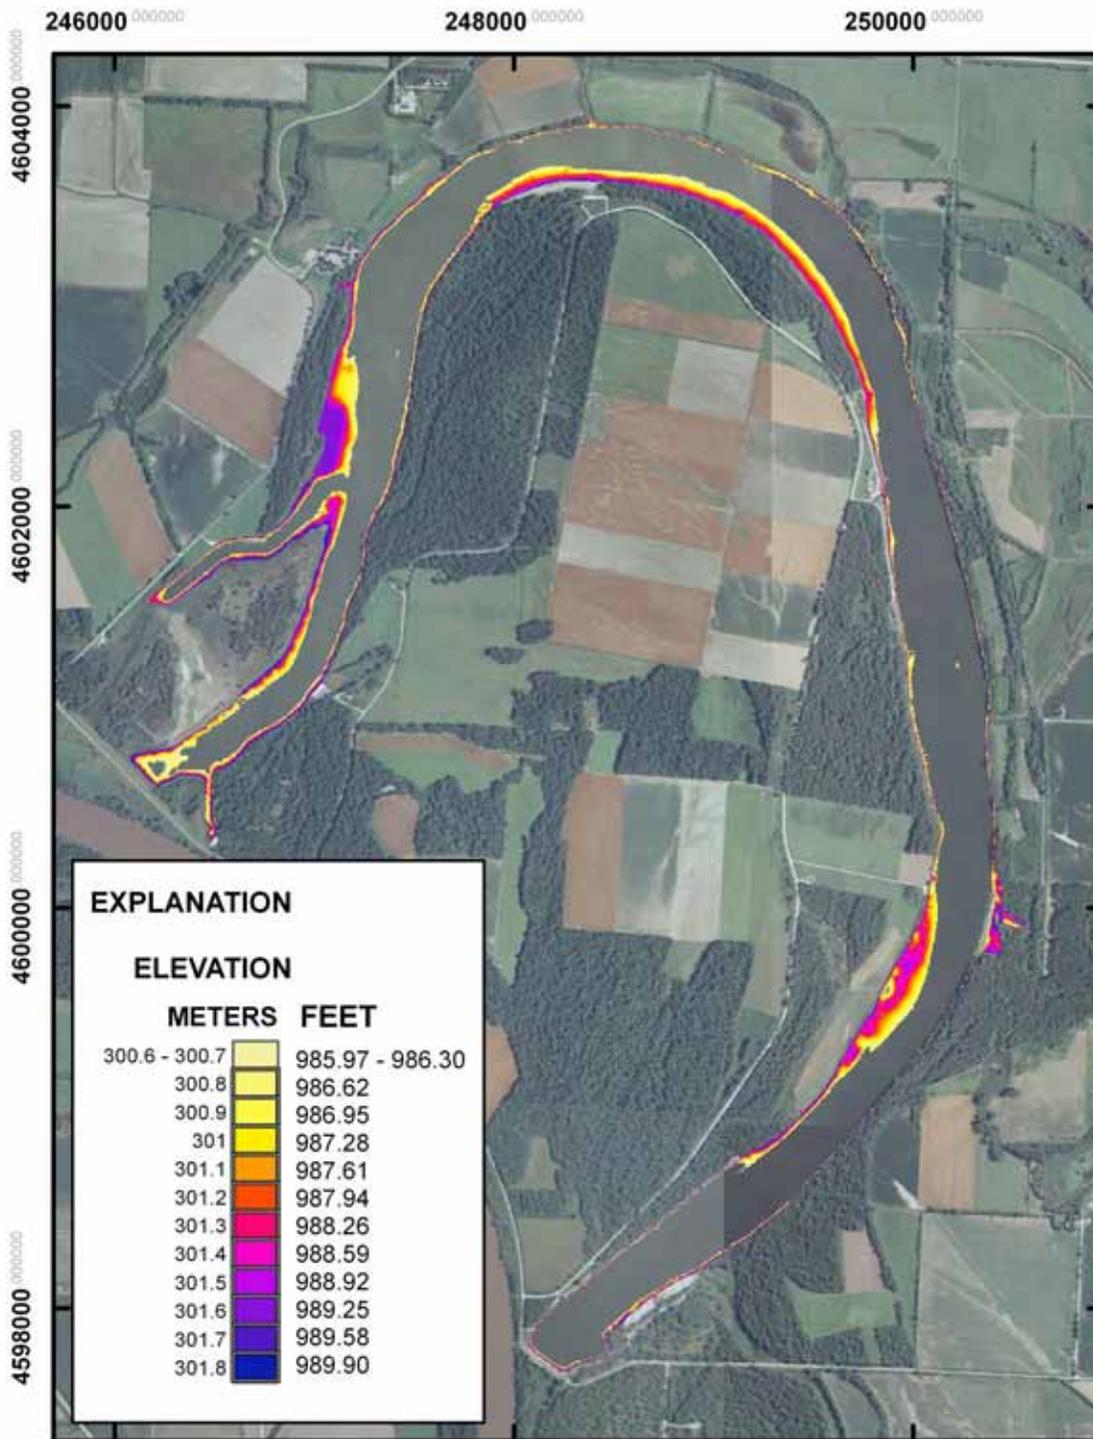
Figure 13. Elevations of shallow water regions in DeSoto Lake, 2006.

In the 46 years since the lake was cut off from the Missouri River channel, DeSoto Lake still retains many features from the Missouri River. According to the DeSoto NWR Comprehensive Conservation Plan, the ideal lake level for DeSoto Lake fluctuates between 300.8 m MSL (986.5 ft) and 301.7 m MSL (989.5 ft) (U.S. Fish and Wildlife Service, 2001). This fluctuation affects the entire perimeter of the lake, as well as specific shallow areas on the inside of the bend and the west arm of the lake (fig. 12). Within the operating conditions between 300.8 m MSL (986.62 ft) and 301.7 m MSL (989.58 ft), there is a difference in 633,425 square meters (156.52 acres), or 16.2 percent of the total lake area below the 301.8-m contour line (fig. 13; table 4). Due to DeSoto Lake's connection with the Missouri River, the refuge has a limited ability to regulate lake level (U.S. Fish and Wildlife Service, 2001). Under ideal conditions, lake levels are drawn down in the fall for waterfowl management and predation on forage fish (U.S. Fish and Wildlife Service, 2001). In the winter, lake levels are higher to reduce fish winterkills, and lake levels are reduced in the spring to accommodate spring runoff. When river levels are above the inlet elevation, it is no longer possible to manage lake levels and unfavorably high lake conditions can occur (U.S. Fish and Wildlife Service, 2001).

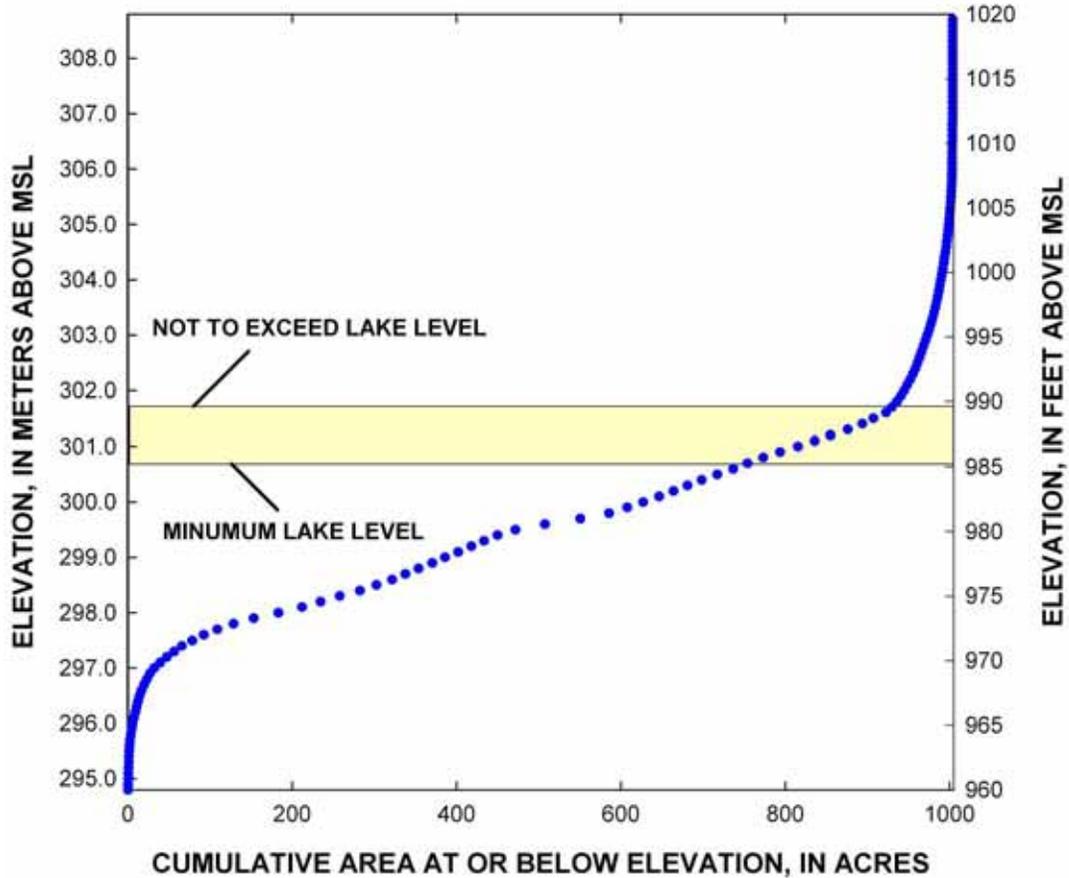
Figure 14. Hypsometric graph for DeSoto Lake with optimal minimum- and maximum-lake elevations indicated. Lake level information is from the DeSoto National Wildlife Refuge Comprehensive Conservation Plan (U.S. Fish and Wildlife Service, 2001).
