Water-Surface Elevations, Discharge, and Water-Quality Data for Selected Sites in the Warm Springs Area near Moapa, Nevada

Open-File Report 2006–1311

By David A. Beck, Roslyn Ryan, Ronald J. Veley, Donald P. Harper, and Daron J. Tanko

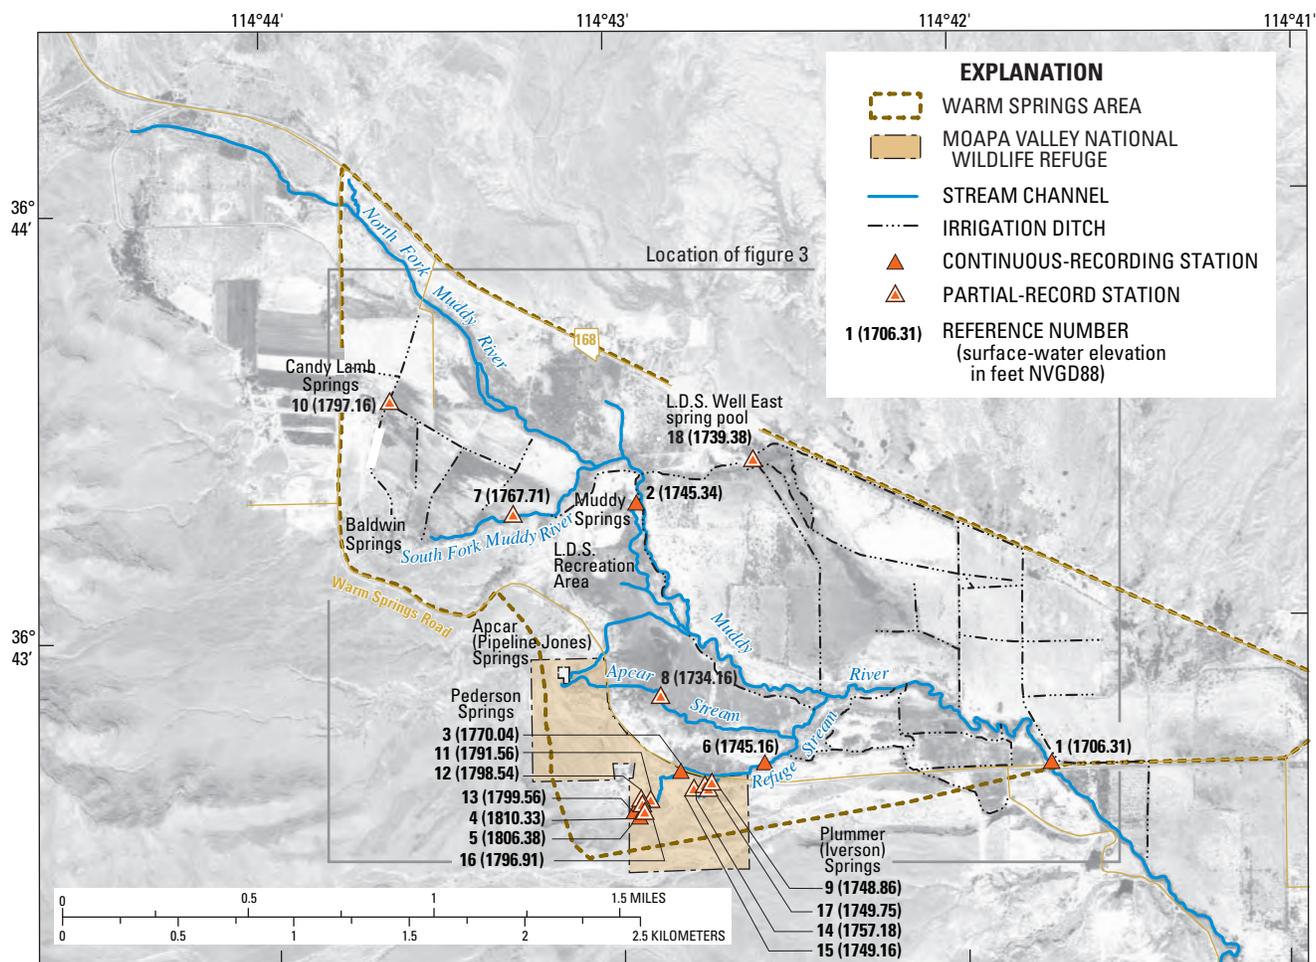
Figure 2. Location of major spring groups, U.S. Geological Survey monitoring stations, and water-surface elevations on August 17, 2004, in the Warm Springs area near Moapa, Nevada.

On August 17, 2004, water levels were obtained from the staff plates at all the USGS monitoring sites. The only exception was the water level at an unnamed spring-fed pool near well L.D.S Well East ([fig. 2](#)). The water-surface elevation of the pool which is located about 100 ft east of the well was measured using the optical theodolite survey for the BM at the well. In early July 2004, flow was observed to be discharging from several pools in the area and flowing into the Muddy River. By August 17, 2004, most of the pools had completely dried up and water no longer discharged from the area. On October 1, 2004, water was observed to be emanating from the surveyed well pond and other nearby pools and discharging to the Muddy River.

In October 1986, the USGS, in cooperation with LVVWD and NDWR, installed an aluminum weir and continuous-stage recorder on the Pederson Springs pool (site 4, [fig. 2](#)). The purpose of this gage was to collect daily discharge data near the outlet of one of the major springs in the Moapa Valley National Wildlife Refuge. By early 2004, most of the palm trees surrounding the spring had been removed by the U.S. Fish and Wildlife Services (FWS), and in April 2004, a new weir was installed because water was leaking around the weir and the gage was not measuring flows accurately. Graphs and tables of daily mean discharges for the period of record are included in [Appendix B \(fig. B30, table B20\)](#).

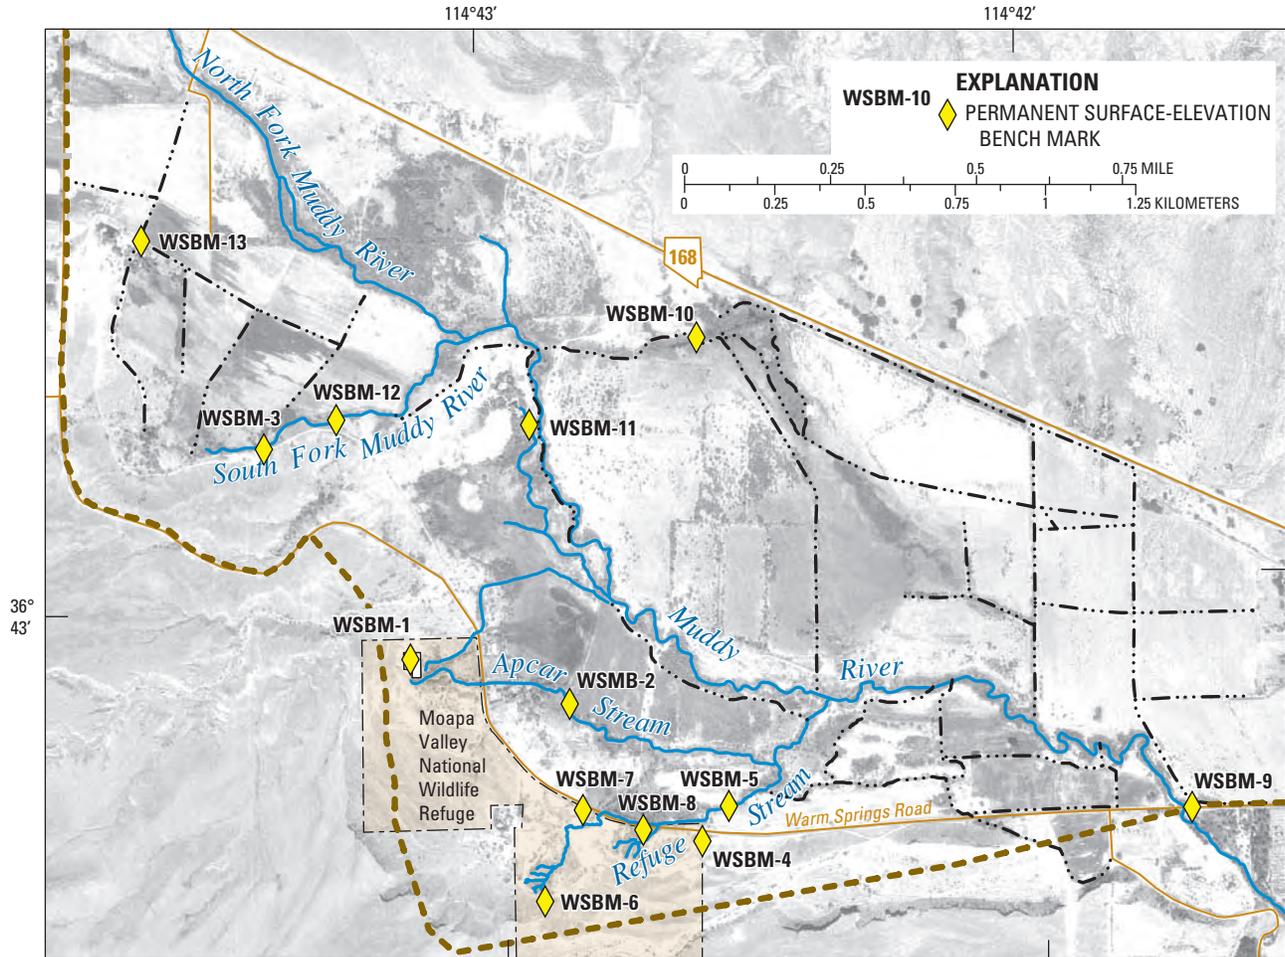
Figure 3. Location of permanent surface-elevation bench marks in the Warm Springs area near Moapa, Nevada.

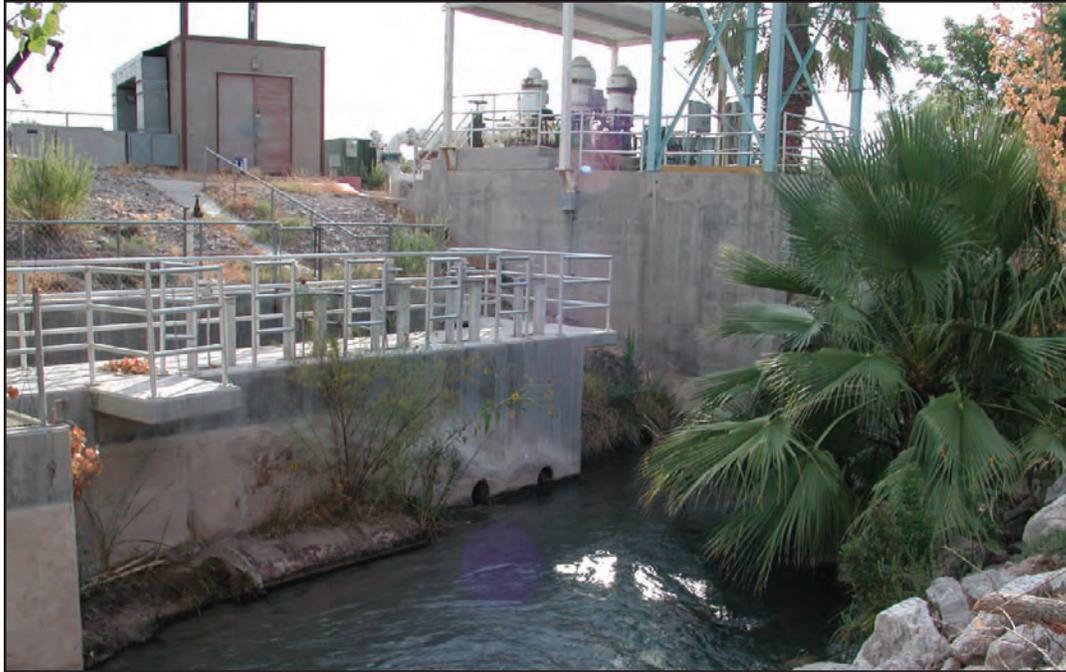
Figure A10. View looking downstream at Nevada Power Company water diversion and pumping station on the Muddy River, in the Warm Springs area near Moapa, Nevada. The diversion is about 100 feet upstream of the U.S. Geological Survey streamflow-gaging station at Warm Springs Road. Photographed in February 2004 by D. Beck.

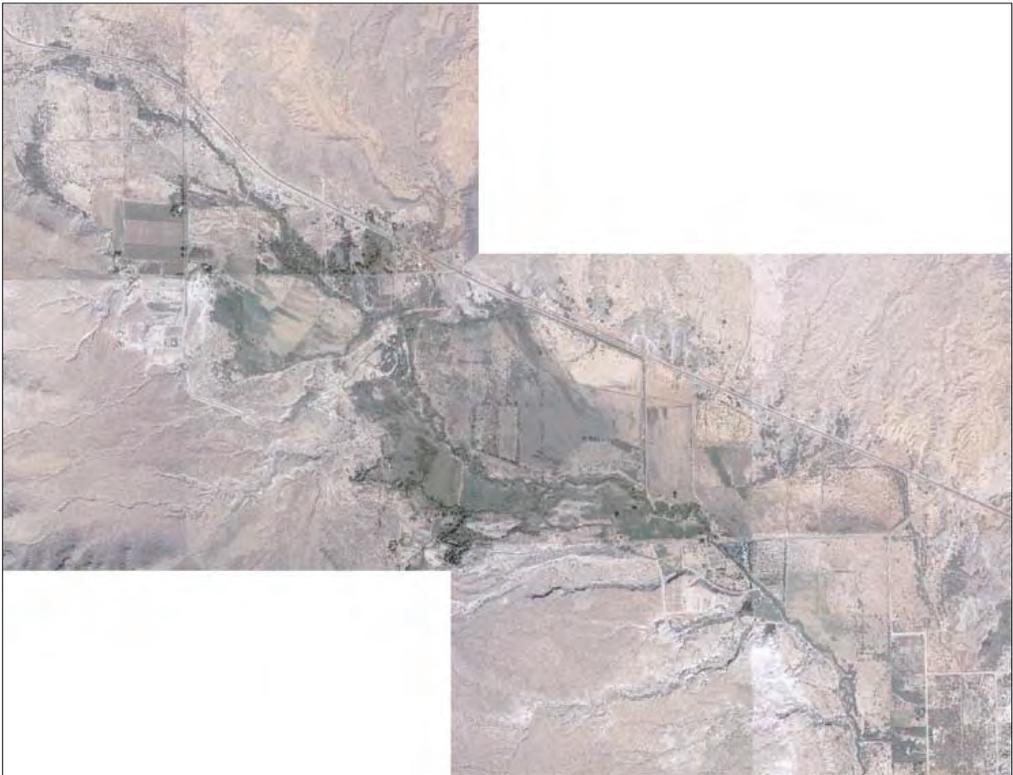
Figure A14. Irrigated acreage in the Warm Springs area near Moapa, Nevada, in 1976 and 2003.

Farming and ranching continues today within the Warm Springs area, but land usage has dropped significantly since its peak in the mid-1970s. The set of aerial photographs in figure A14 depict the difference in the amount of acreage irrigated during 1976 and 2003. Estimated acreage irrigated in 1976 was about 600 acres compared with about 100 acres in 2003.

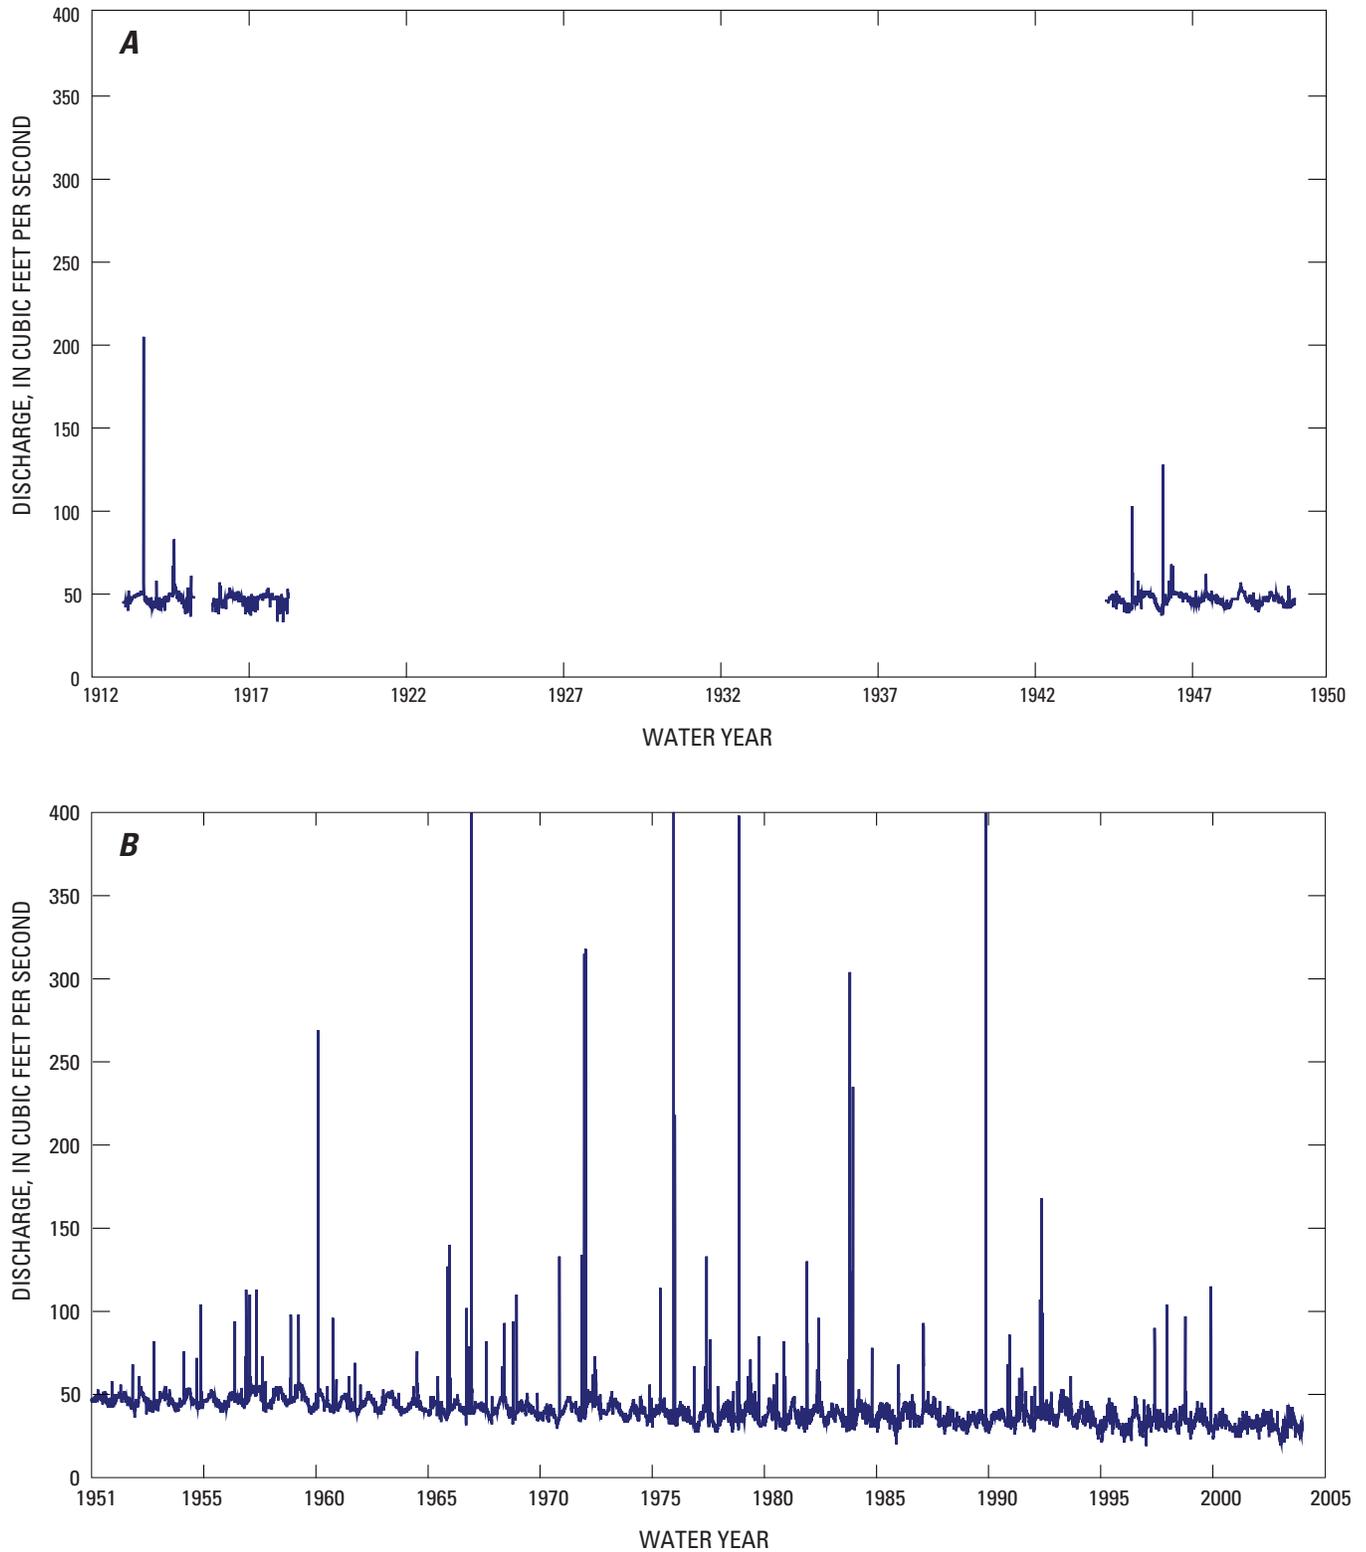
Figure B3. Daily mean discharges for stream-gaging station 09416000, Muddy River near Moapa, Nevada, for (A) water years 1913–15, 1916–18, and 1944–47, and (B) water years 1951–2004.

Daily mean discharges for the period of record are plotted on [figure B3](#) and listed in [table B1](#). Photographs of the bench and reference marks established for this gage on June 2, 2004, are shown in [figure B4](#).

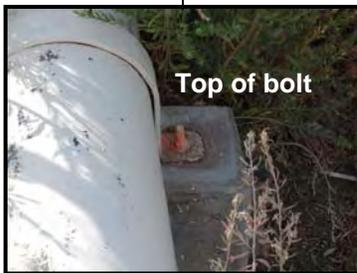
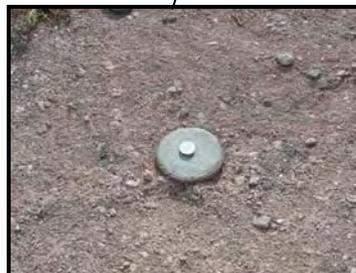
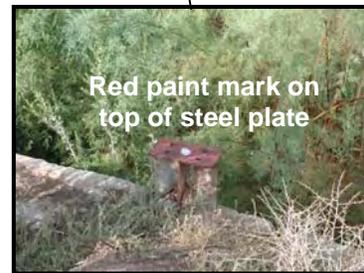
RM-7
(1,719.74 ft)

WSBM-9
(1,715.83 ft)

RM-5
(1,717.23 ft)

Figure B4. Location and elevation of bench mark WSBM-9 and reference marks RM-5 and RM-7 at stream-gaging station 09416000, Muddy River near Moapa, Nevada, June 2, 2004, elevation in feet above NGVD 88. Photographed by D. Beck.

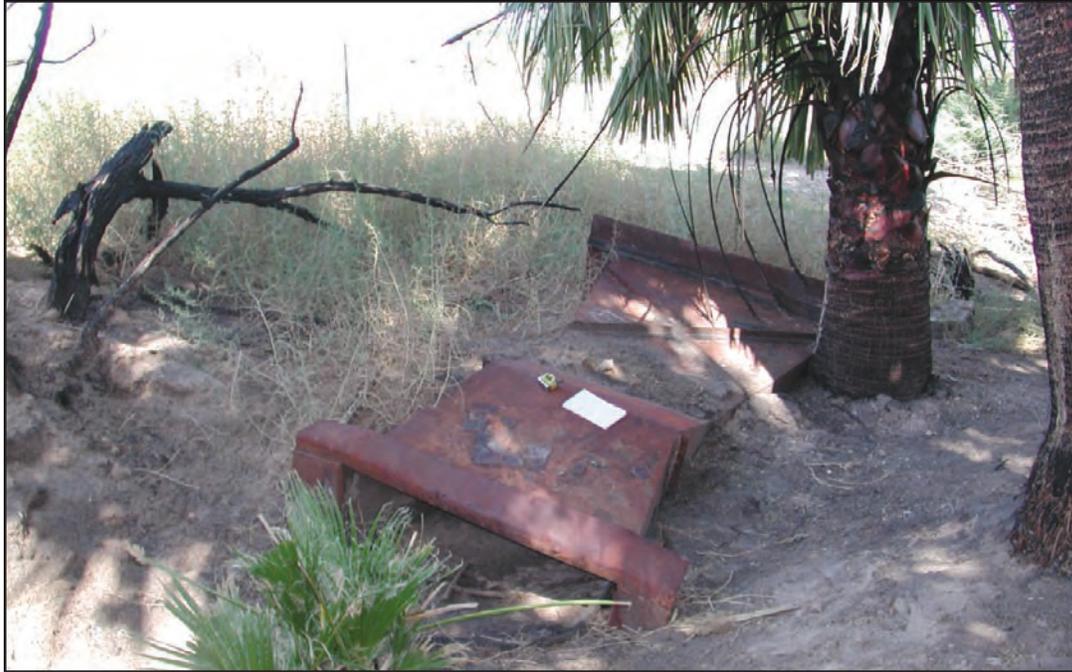
Figure B6. Former Big Wash flume on right bank of North Fork Muddy River in the Warm Springs area, near Moapa, Nevada. The flume is about 500 feet upstream of confluence with South Fork Muddy River. Photographed in September 2004 by D. Beck.

former flume site was visited by the U.S. Geological Survey on September 16, 2004, and a 3-ft steel Parshall flume was observed upside down on the south bank of the river ([fig. B6](#)).

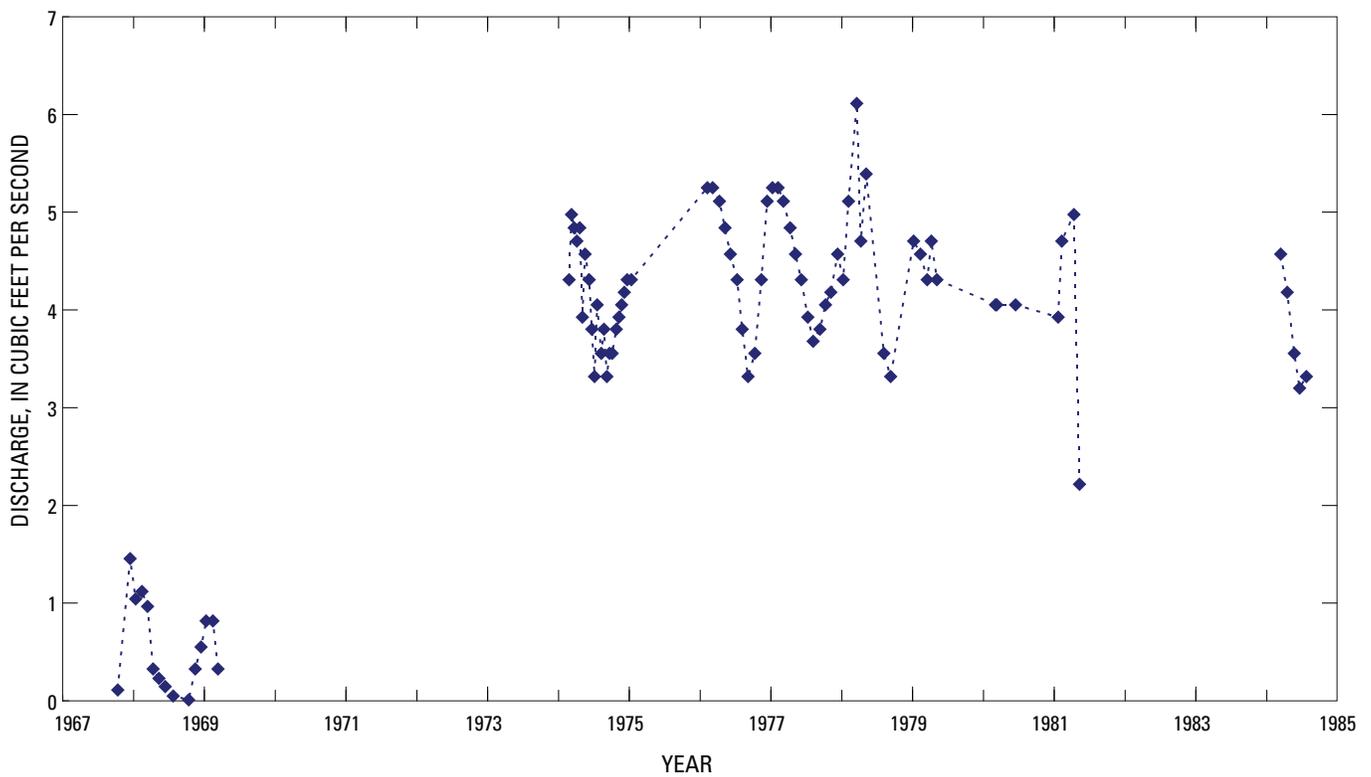
Figure B7. Instantaneous discharges for the Big Wash flume in the Warm Springs area near Moapa, Nevada, 1967–69, 1974–81, and 1984.

As only water-level measurements were provided by NDWR, discharge rates were computed using a standard rating equation for the 3-ft Parshall flume (Leupold and Stevens, 1987). A plot of the computed discharges from October 1967 to July 1984 is shown in [figure B7](#). A complete listing of the water-level measurements and computed discharges are included in [table B2](#). Discharges computed from October 1967 to March 1969 are substantially less than the computed discharges for the remainder of the period. Although flow may have been bypassing the flume at that time, documentation was unavailable to verify it.

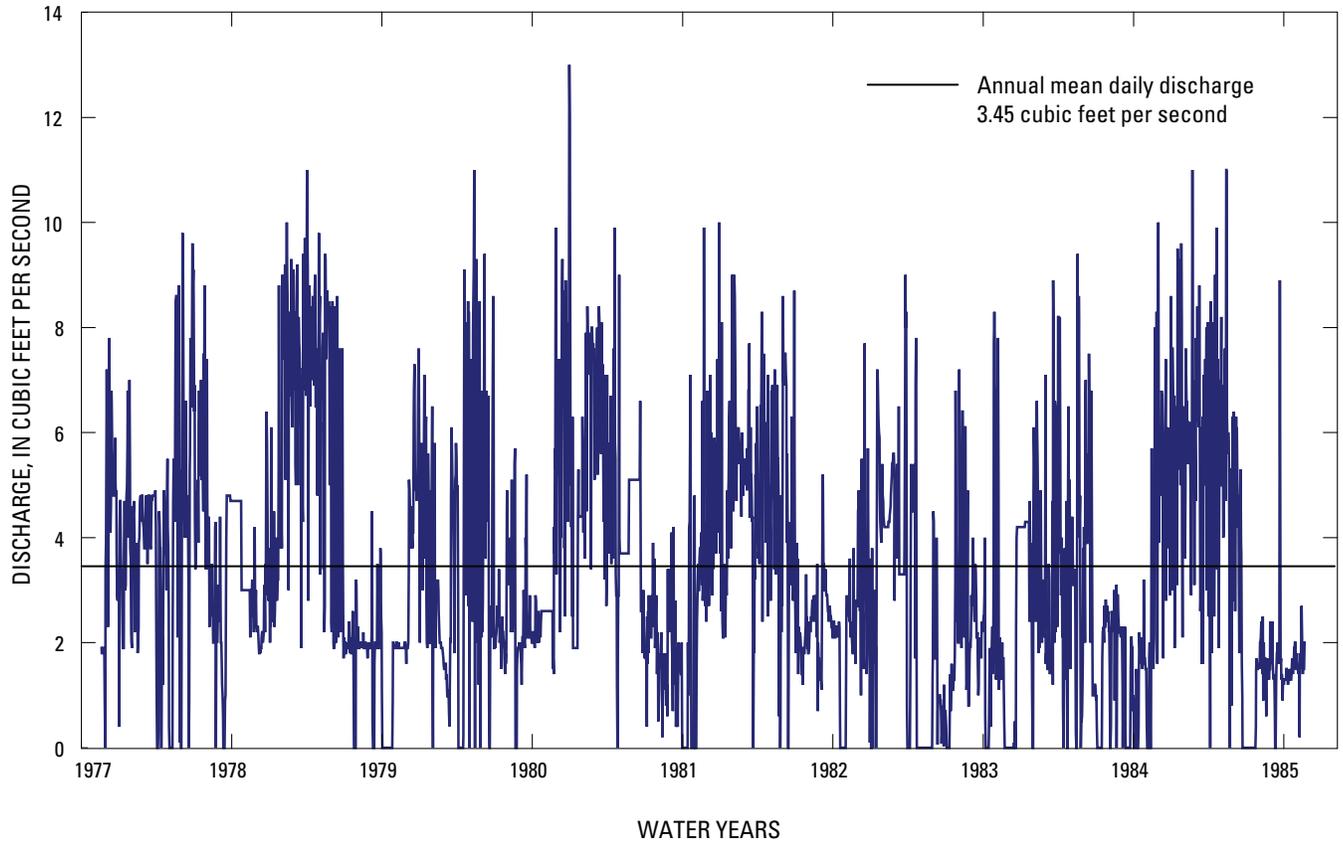
Figure B8. Daily mean discharges for the Muddy River power diversion in the Warm Springs area, near Moapa, Nevada, water years 1978–85. Pumping data was provided to U.S. Geological Survey by Nevada Power Company.

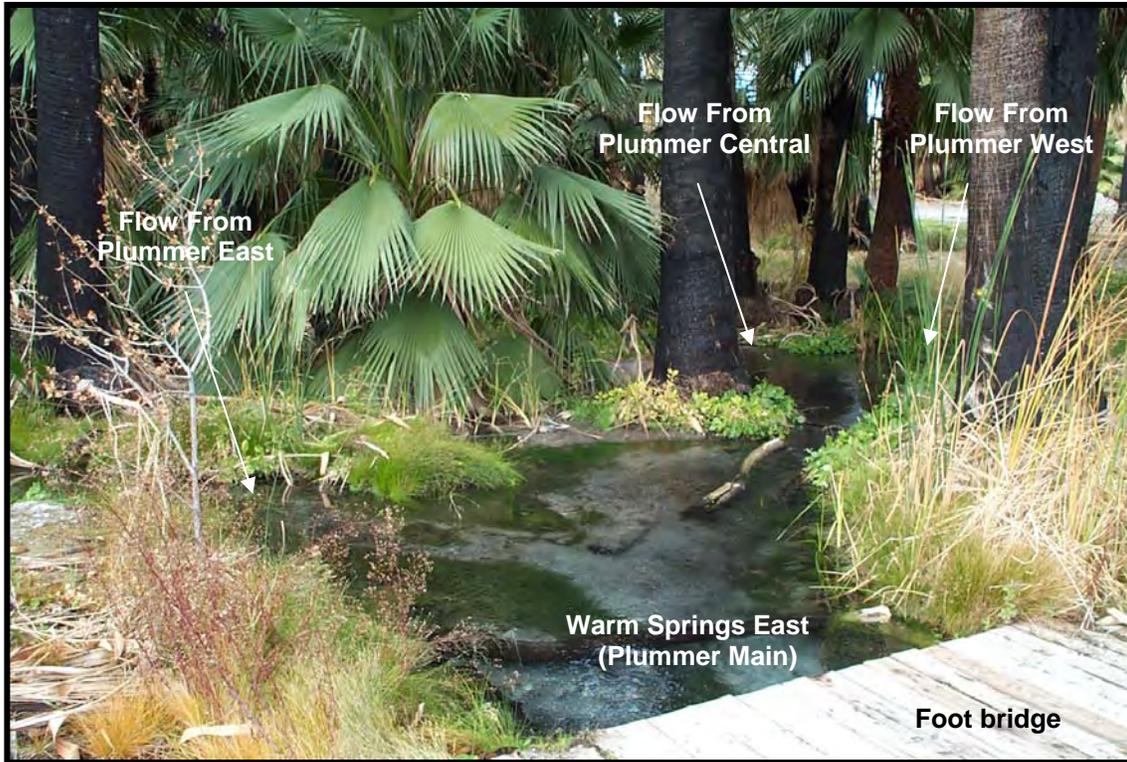
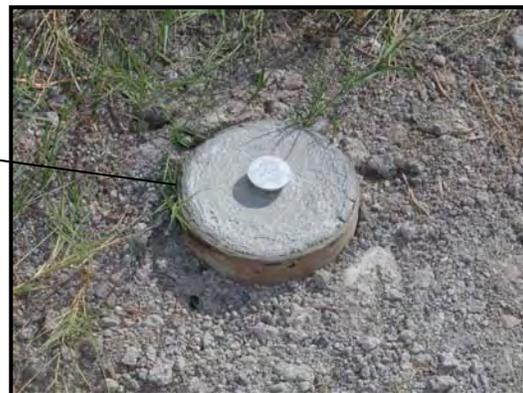
Warm Springs East
RM-1 (1,751.08 ft)

WSBM-8
(1,750.70 ft)

Figure B11. Location of bench mark WSBM-8 and reference mark RM-1 for stream-gaging station 364236114424301 Warm Springs East near Moapa, Nevada. Photographed June 10, 2004 by D. Beck. Elevation bench and reference marks in feet above NAVD 88.

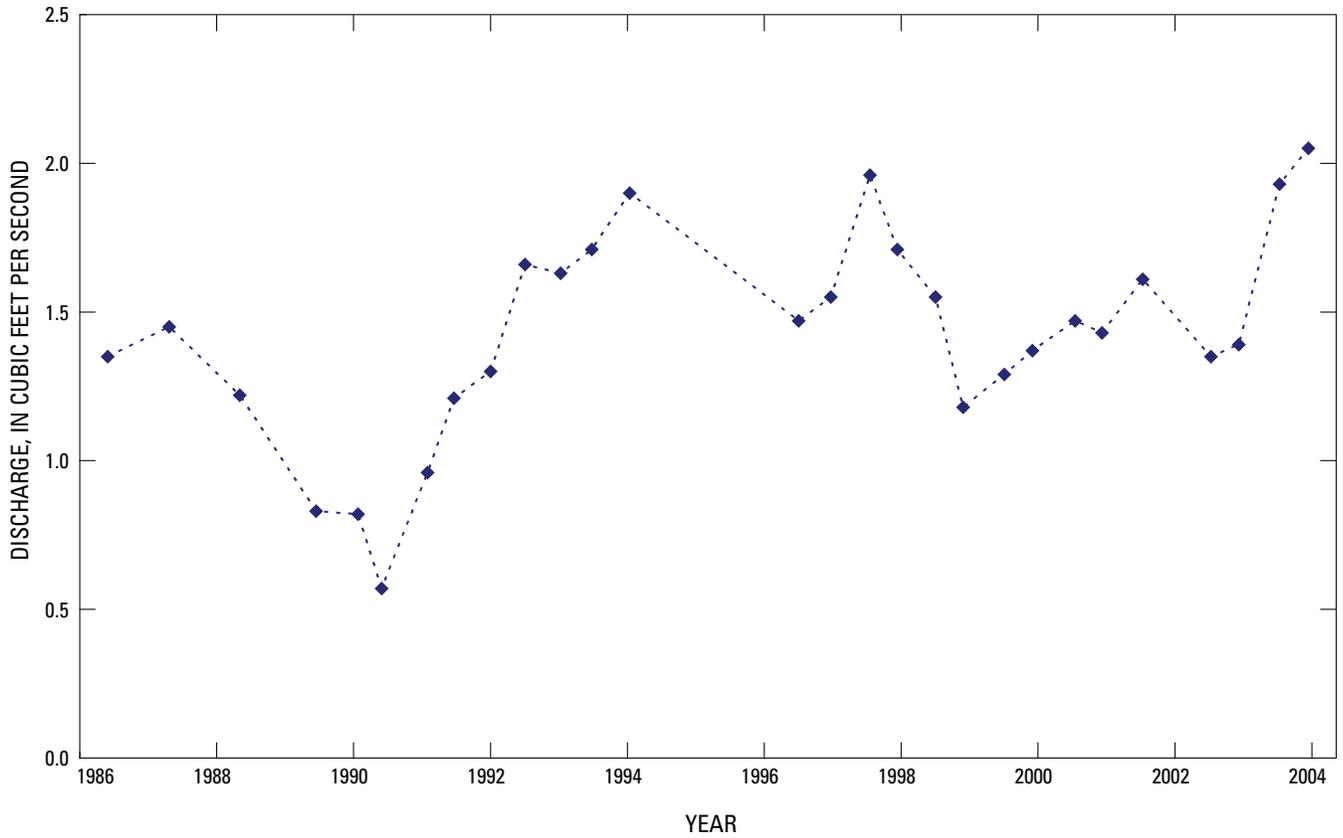
Figure B12. Periodic discharge measurements for partial-record stream-gaging station 364238114424401, Muddy River Springs 15 (M-15) near Moapa, Nevada, 1987–2004. Data from U.S. Geological Survey National Water Information System (NWIS) database, accessed 2005 at <http://waterdata.usgs.gov>.

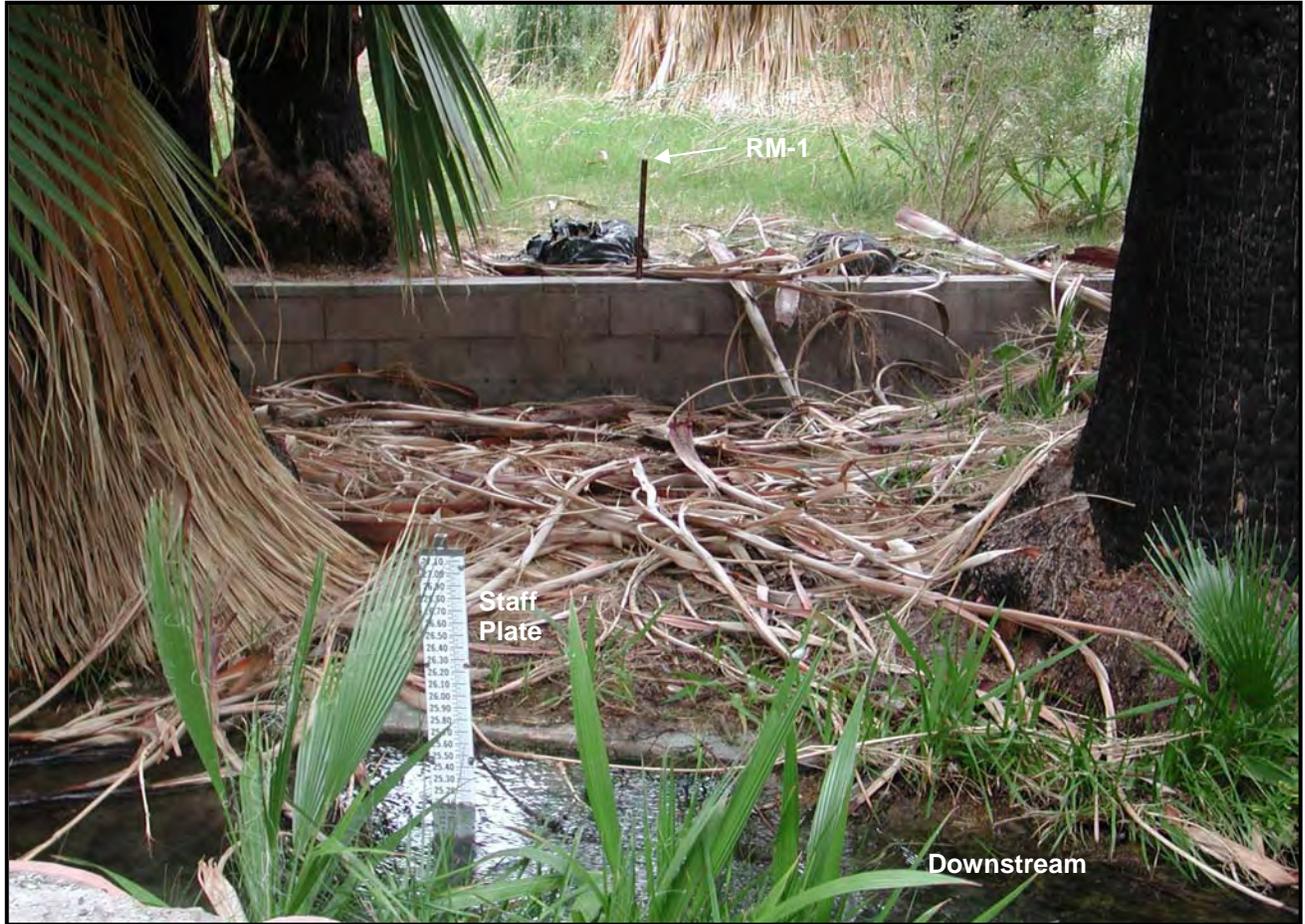
Pond upstream of M-15

Figure B13. Location of staff plate and reference mark (RM-1) at station 364238114424401 Muddy River Springs 15 (M-15) near Moapa, Nevada, and view of upstream pond. Photographed June 10, 2004 by D. Beck.

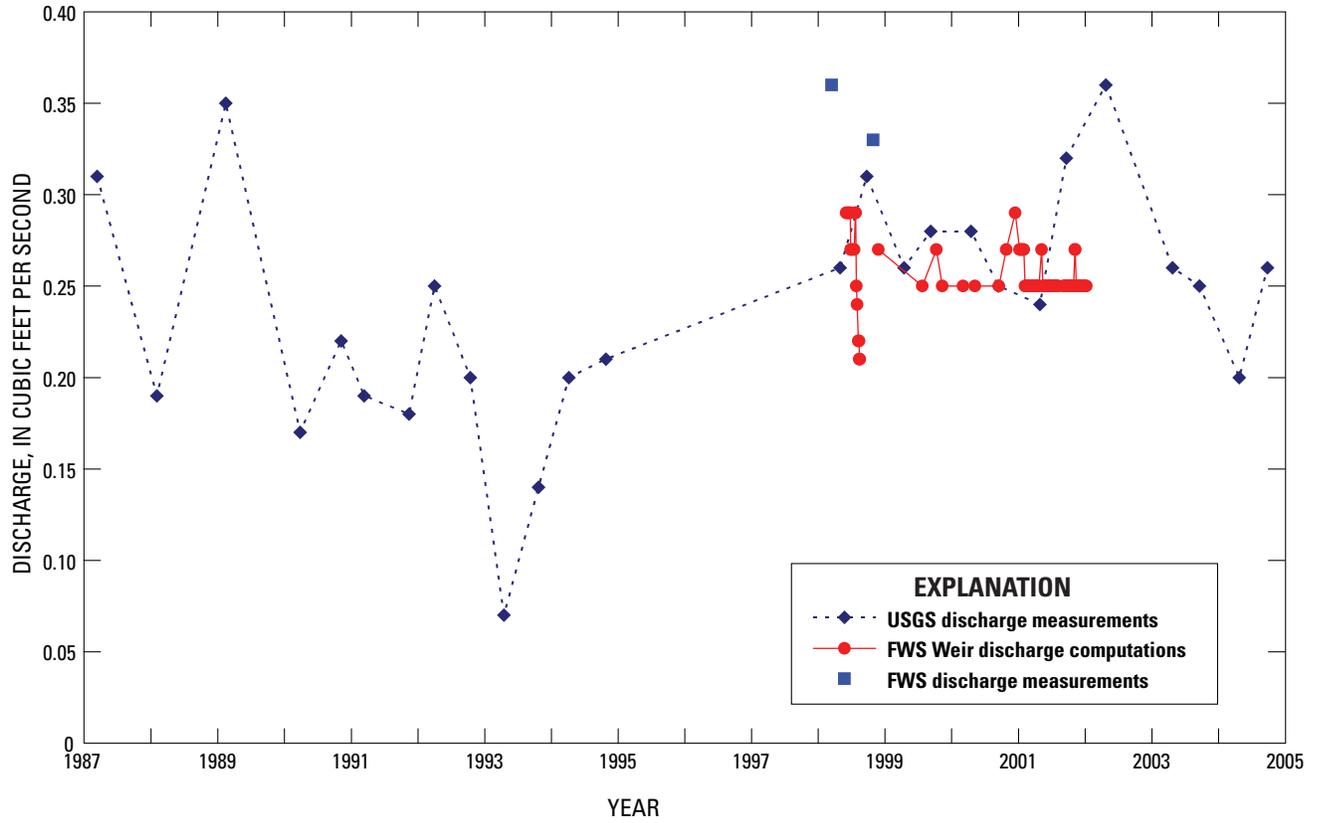
Figure B14. Periodic discharge measurements for partial-record stream-gaging station 364238114424201 Muddy River Springs (M-16) near Moapa, Nevada. Data from U.S. Geological Survey (USGS) National Water Information System (NWIS) database, accessed 2005, at <http://waterdata.usgs.gov>, and U.S. Fish and Wildlife Service (FWS).

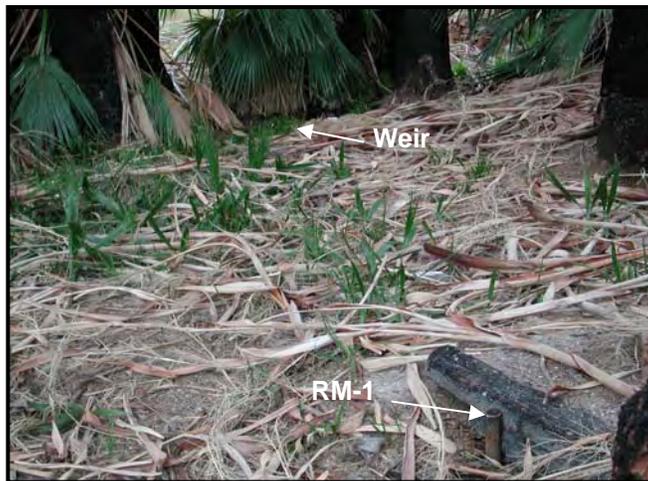
RM-1
(1,758.08 ft)

Figure B15. Location of U.S. Fish and Wildlife Service weir and staff plate, and reference mark (RM-1) at partial-record stream-gaging station 364238114424201 Muddy River Springs 16 (M-16) near Moapa, Nevada. Photographed June 10, 2004 by D. Beck. Elevation of RM-1 in feet above NAVD 88.

Photographs of the FWS weir and staff plate and of the USGS reference mark established on June 10, 2004, are included in [figure B15](#). On May 26, 2005, the weir, staff plate, and reference mark were observed to have been destroyed as a result of restoration work at the refuge.

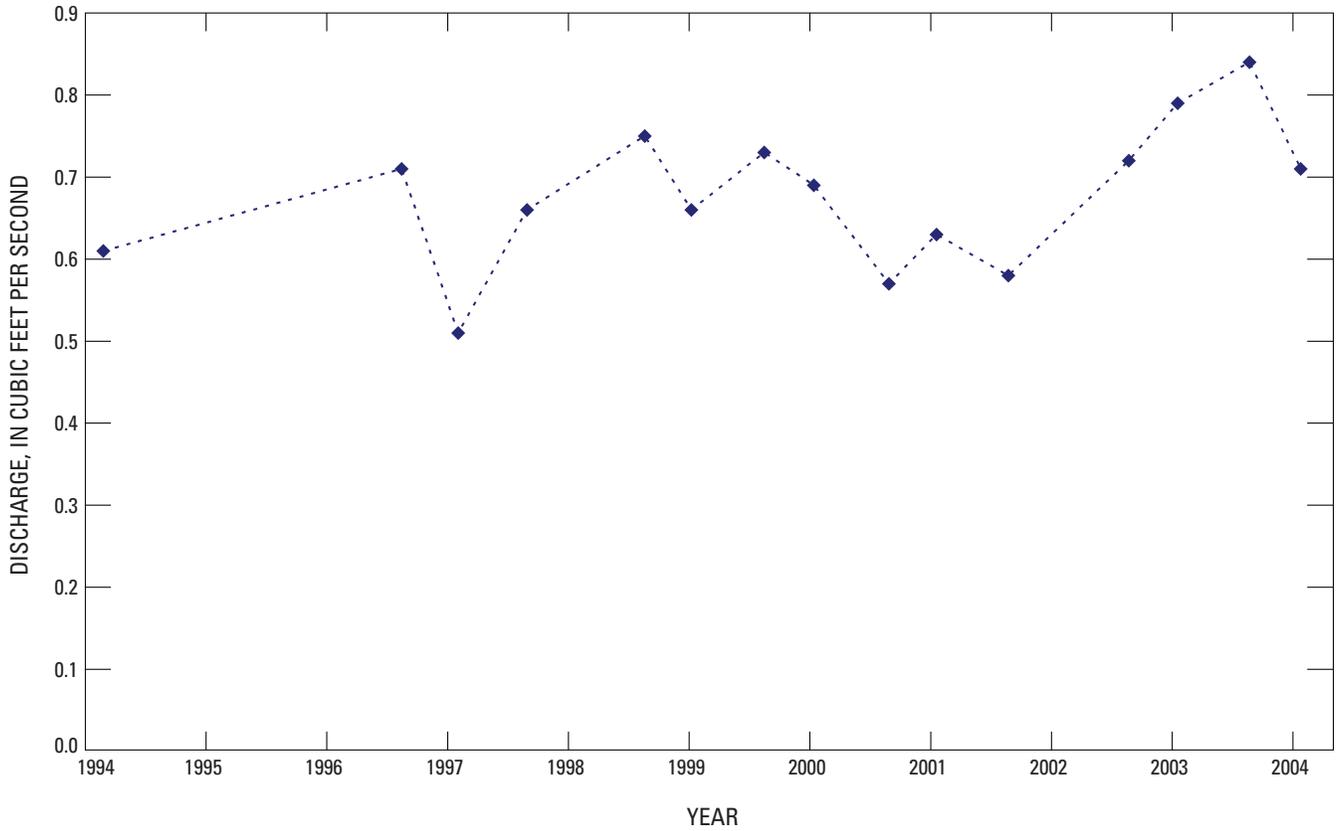
Figure B16. Periodic discharge measurements for partial-record stream-gaging station 364238114424301 Muddy River Springs 20 (M-20) near Moapa, Nevada, 1994–2004. Data from U.S. Geological Survey (USGS) National Water Information System (NWIS) data base, accessed 2005 at <http://waterdata.usgs.gov>

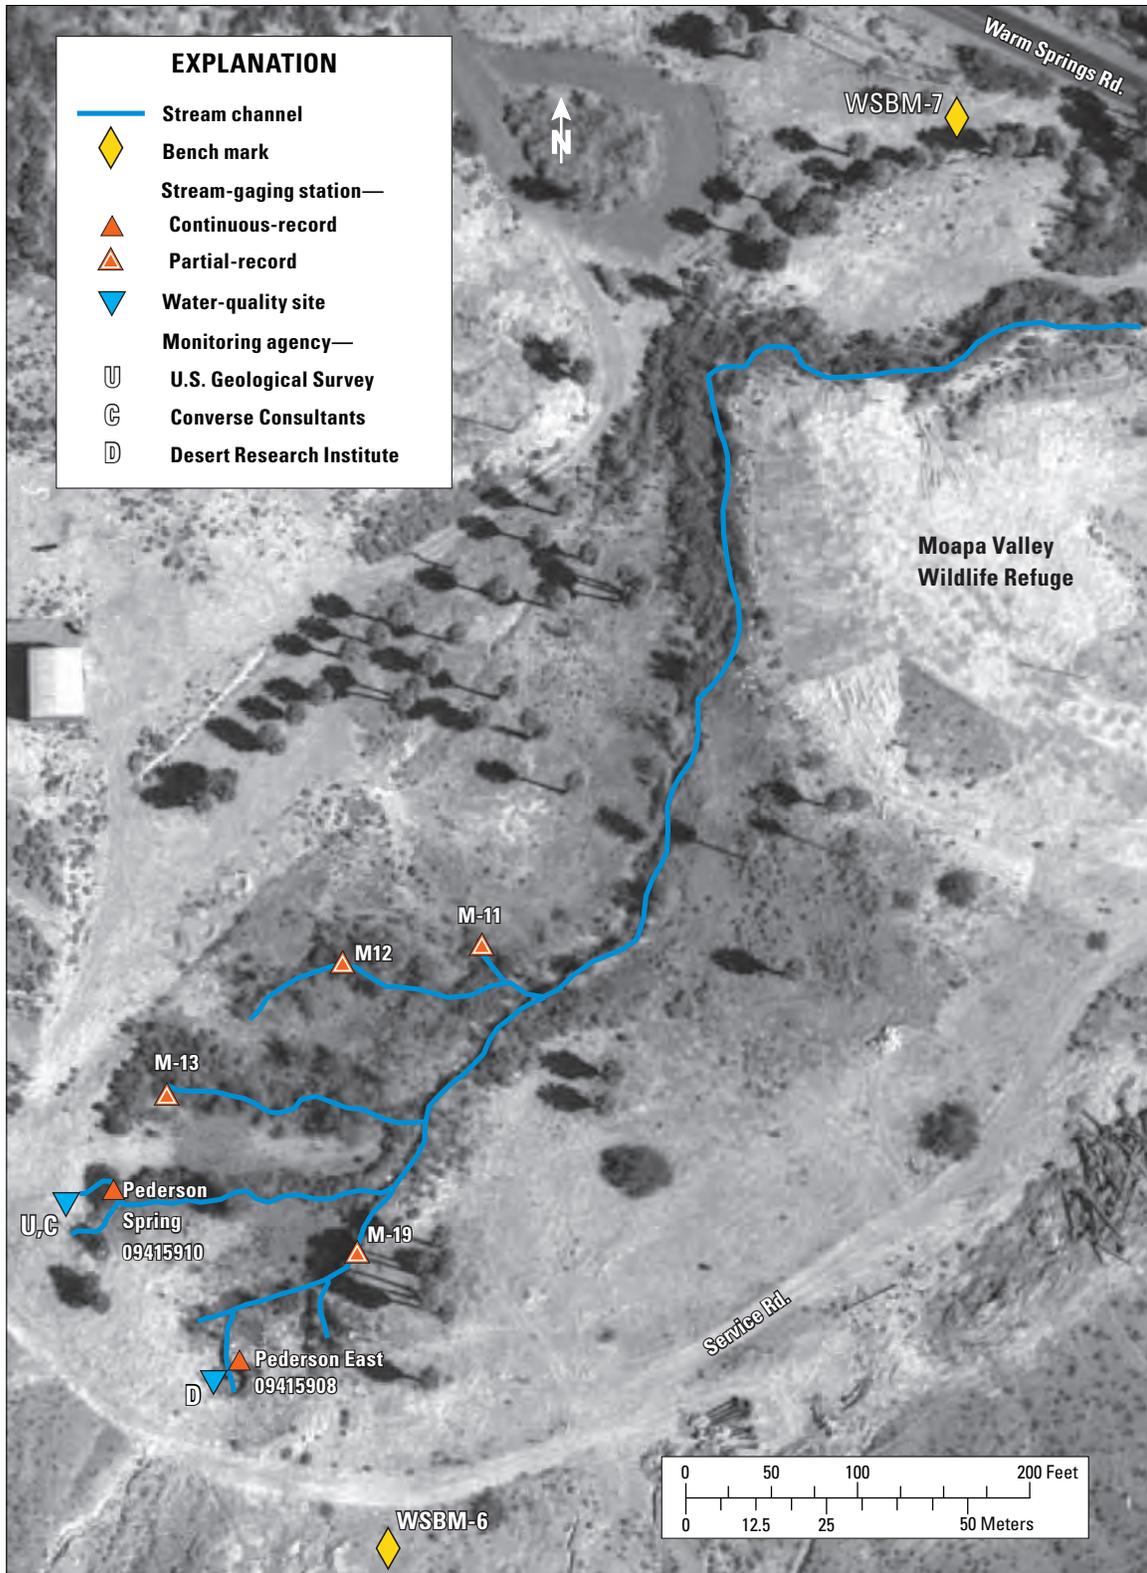
Figure B26. Location of Pederson Springs Group monitoring sites and bench marks WSBM-6 and WSBM-7 in the Warm Springs area near Moapa, Nevada.

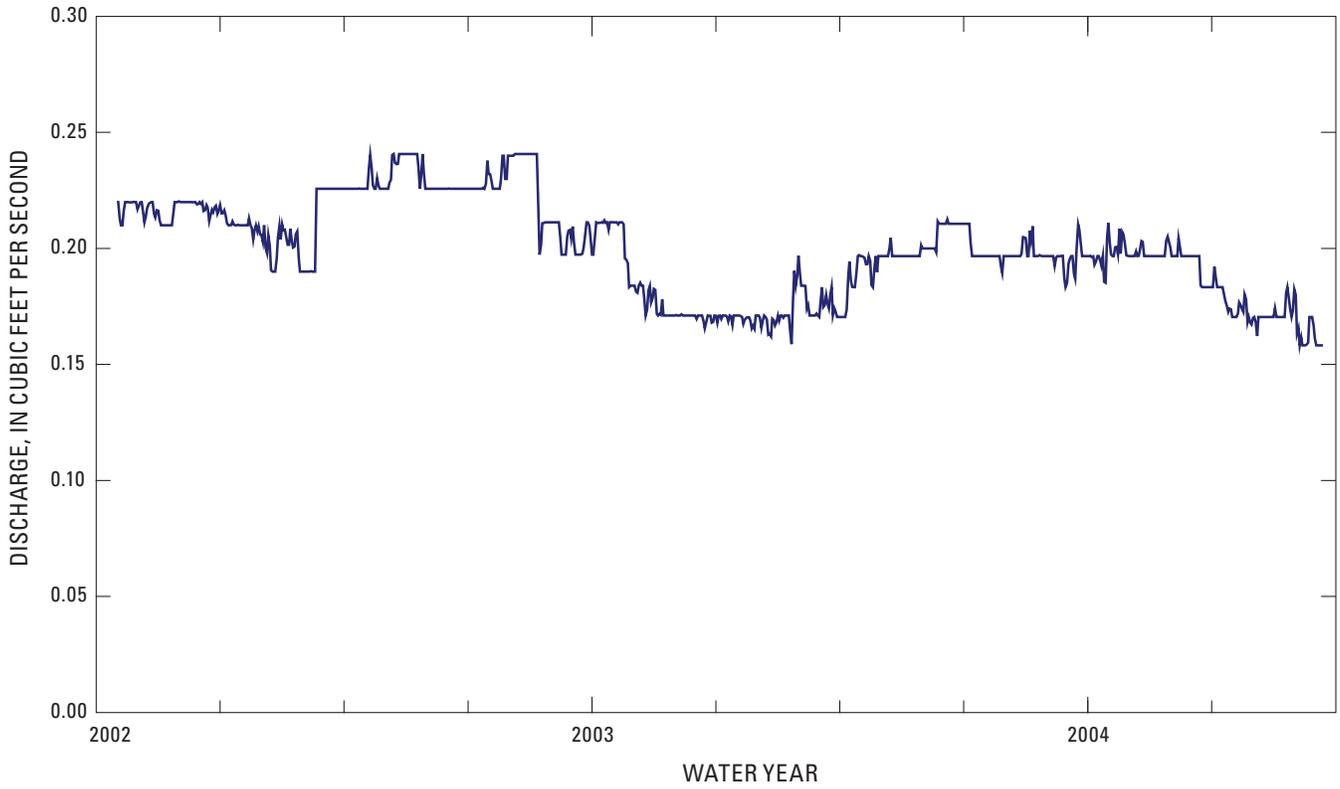
Figure B27. Daily mean discharges for continuous-record stream-gaging station 09415908 Pederson East Spring near Moapa, Nevada, water years 2002–04.

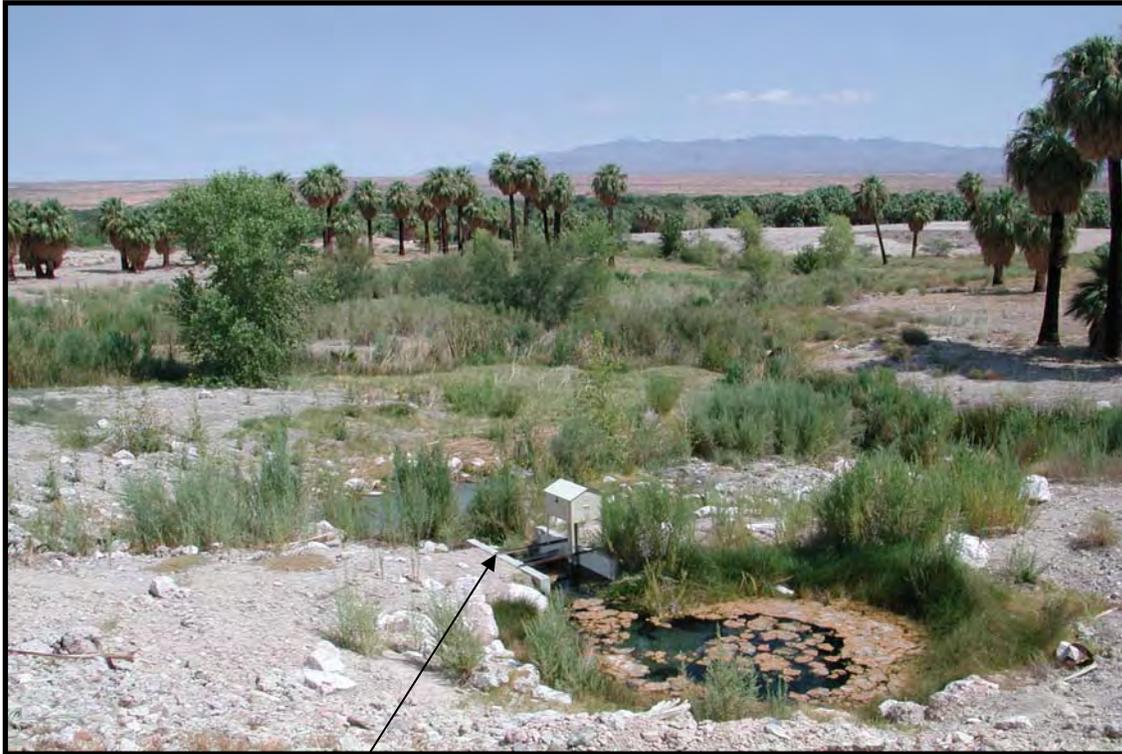
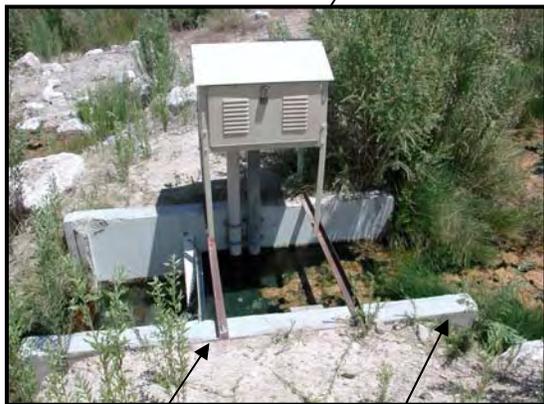
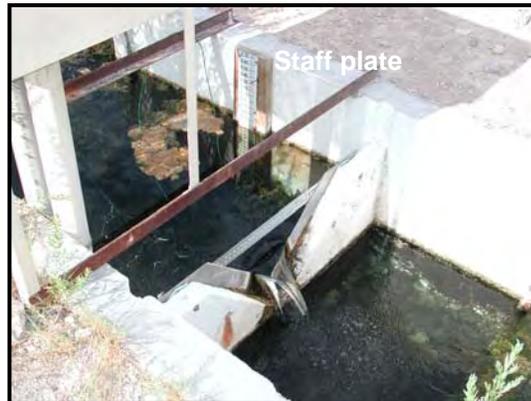
RM-2
(1,807.73 ft)

RM-3
(1,807.62 ft)

Staff Plate
and Weir

Figure B28. Location of staff plate and selected reference marks (RM) for station 09415908 Pederson East Spring in the Moapa Valley National Wildlife Refuge near Moapa, Nevada. Photographed June 9, 2004 by D. Beck. Elevation in feet above NAVD 88.

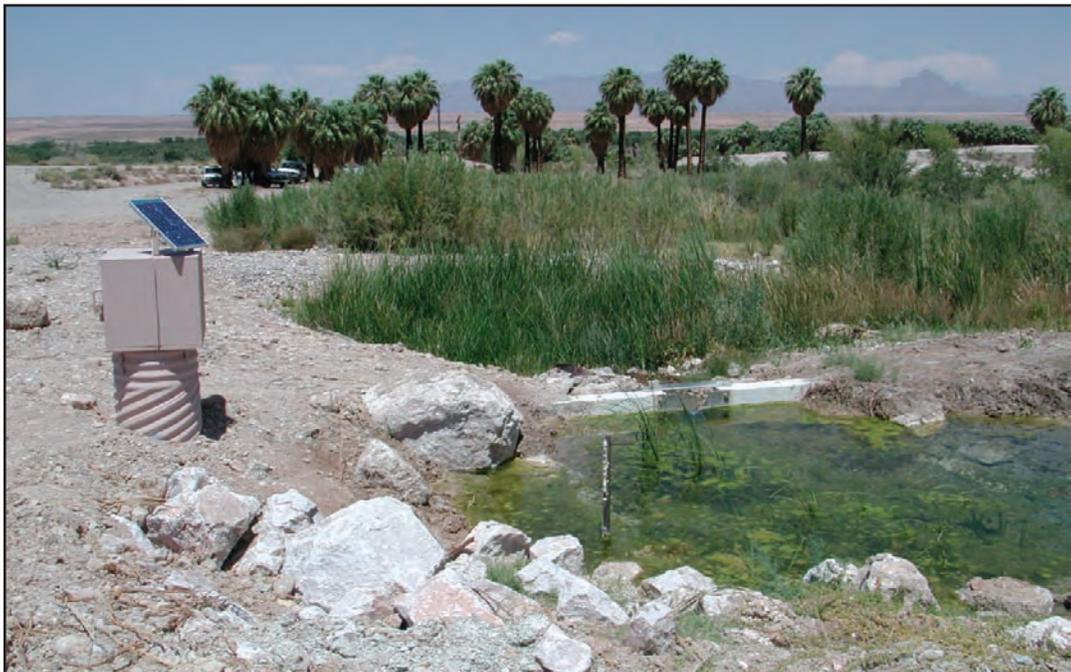
A. View of first weir being installed in 1986.

B. View of new weir installed in 2004.

Figure B29. Looking downstream at continuous-record stream-gaging station 09415910 Pederson Spring near Moapa, Nevada.

A continuous-record stream-gaging station with 45 degree v-notch aluminum weir was established by the U.S. Geological Survey (USGS) on Pederson Spring on October 1, 1986. Pederson Spring is about 50 ft northeast of the Moapa Valley National Wildlife Refuge service road ([fig. B26](#)) and is part of a cluster of springs that drains to the northeast. Flow from Pederson Spring joins with discharge from Pederson East Spring about 250 ft downstream from the gage. Reclamation of the spring and an adjacent area by the U.S. Fish and Wildlife Service began in 2002; a new weir, with 45 degree v-notch, was installed on April 27, 2004 ([fig. B29](#)). The new weir was installed because water was leaking around the old weir and the gage was not measuring the flows accurately.
