Water-Surface Elevations, Discharge, and Water-Quality Data for Selected Sites in the Warm Springs Area near Moapa, Nevada

Open-File Report 2006–1311

By David A. Beck, Roslyn Ryan, Ronald J. Veley, Donald P. Harper, and Daron J. Tanko

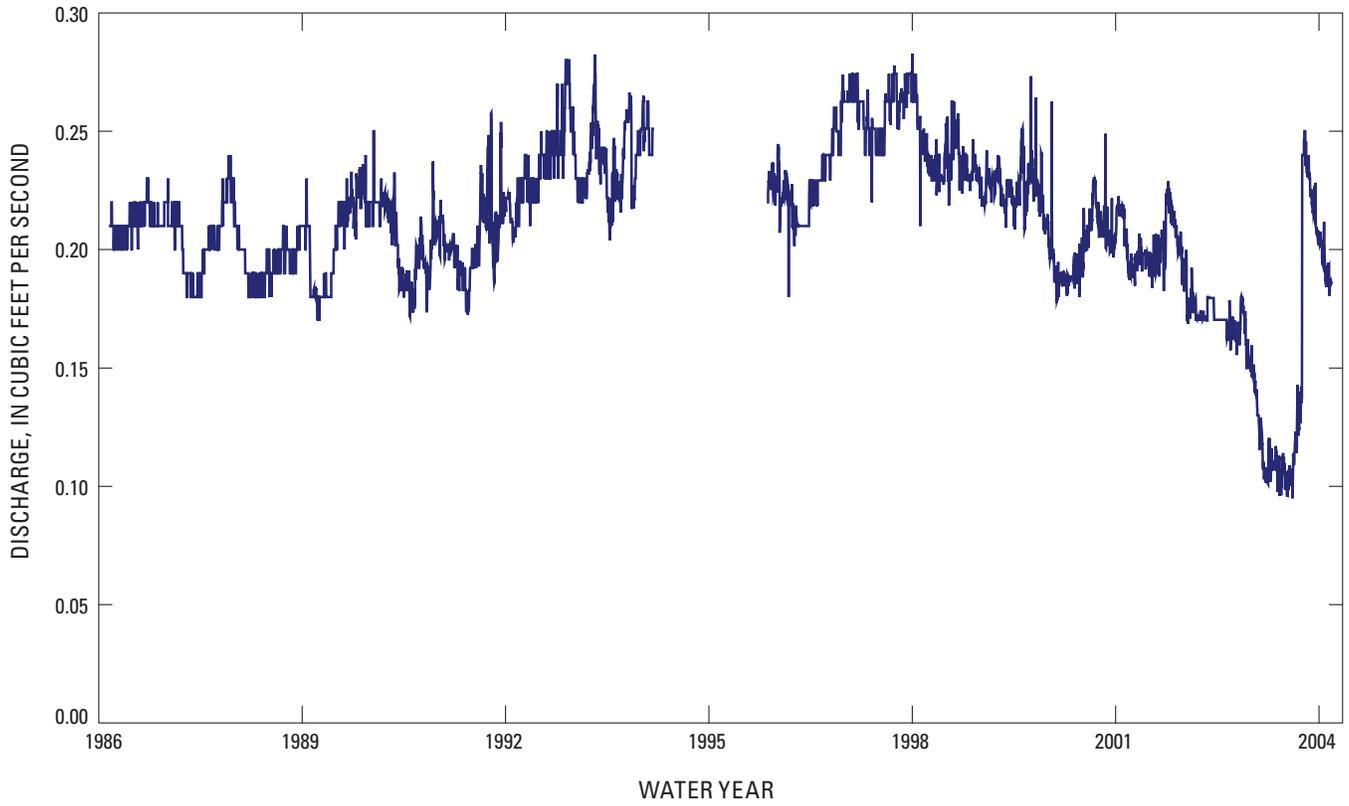
Figure B30. Daily mean discharges for continuous-record stream-gaging station 09415910 Pederson Spring near Moapa, Nevada, water years 1987–2004.

In October 1986, the USGS, in cooperation with LVVWD and NDWR, installed an aluminum weir and continuous-stage recorder on the Pederson Springs pool (site 4, [fig. 2](#)). The purpose of this gage was to collect daily discharge data near the outlet of one of the major springs in the Moapa Valley National Wildlife Refuge. By early 2004, most of the palm trees surrounding the spring had been removed by the U.S. Fish and Wildlife Services (FWS), and in April 2004, a new weir was installed because water was leaking around the weir and the gage was not measuring flows accurately. Graphs and tables of daily mean discharges for the period of record are included in [Appendix B \(fig. B30, table B20\)](#).

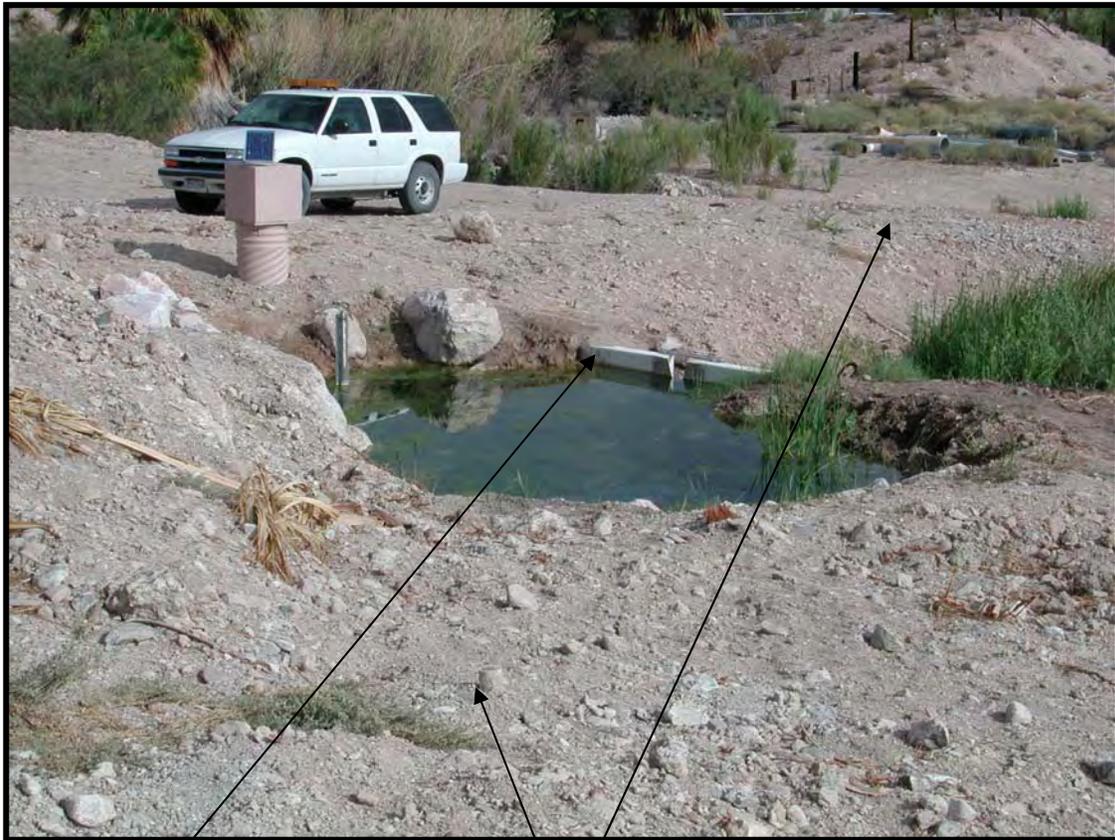
Brass tablet in pipe

**RM-6
(1,810.95 ft)**

3/8-inch
Anchor bolt

**RM-5 (foreground)
(1,814.04 ft)
RM-4 (background)
(1,809.32 ft)**

**View of weir
from
downstream**

Figure B31. Location of selected reference marks (RM) at continuous-record stream-gaging station 09415910 Pederson Spring in the Moapa Valley National Wildlife Refuge near Moapa, Nevada. Photographed June 9, 2004 by D. Beck. Elevation in feet above NAVD 88.

Daily mean discharges for the period of record are plotted on [figure B30](#) and listed in [table B20](#). Photographs of the gage and weir and of selected reference marks established for this gage on June 9, 2004, are shown in [figure B31](#).

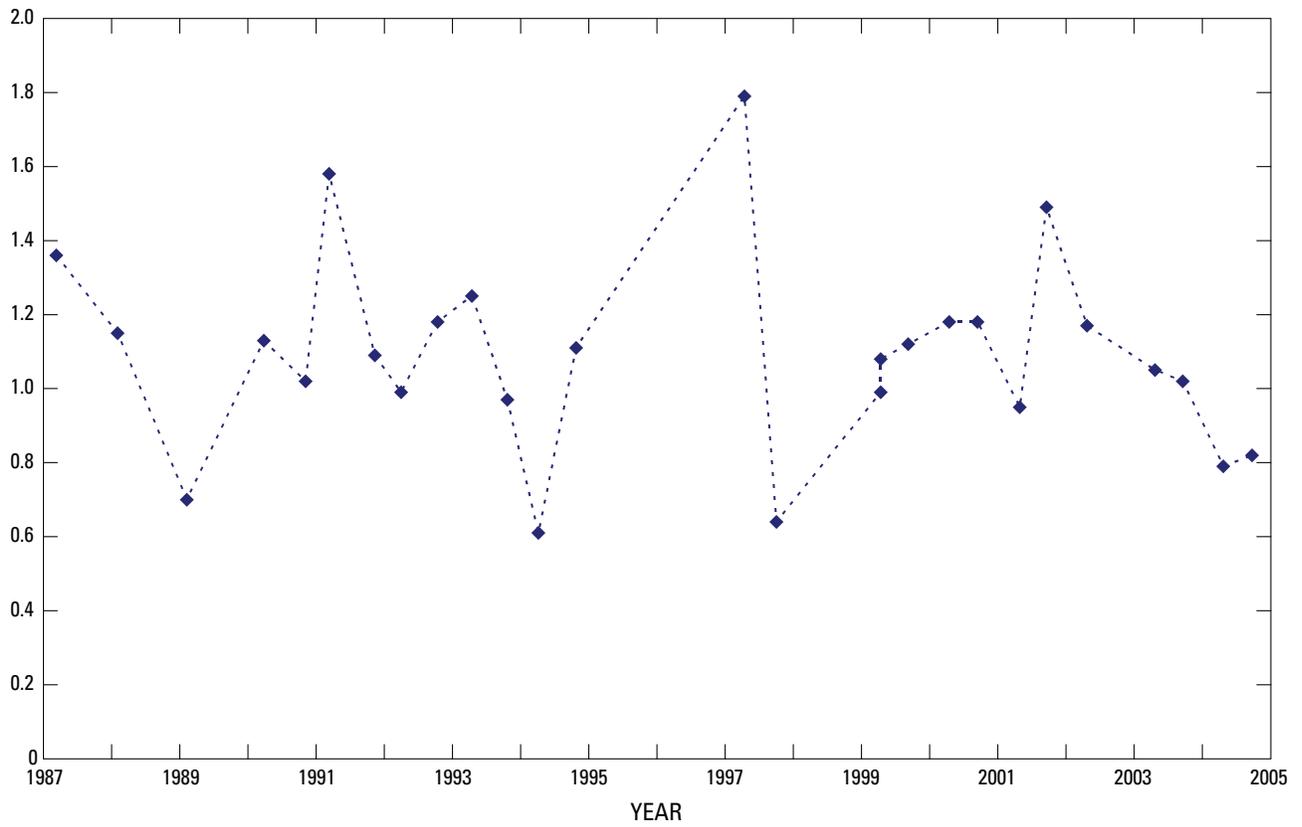
Figure B33. Periodic discharge measurements for partial-record stream-gaging station 364235114425201 Muddy River Springs 11 (M-11) near Moapa, Nevada, 1987–2004.

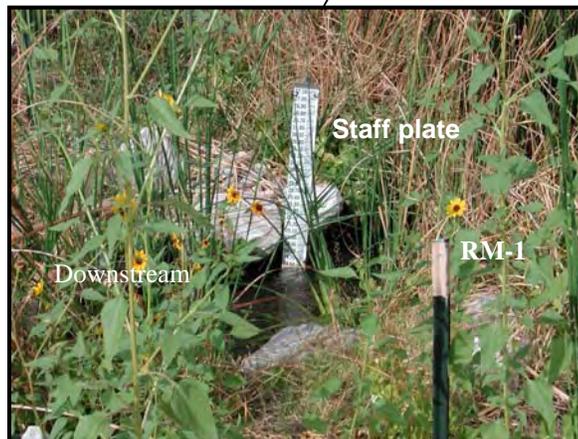
M-11
RM-1
(1,795.09 ft)

Figure B34. Location of staff plate and reference mark (RM-1) for partial-record stream-gaging station Muddy River Springs 11 (M-11) in the Moapa Valley National Wildlife Refuge near Moapa, Nevada. Photographed June 9, 2004 by D. Beck. Elevation in feet NAVD 88.

Periodic discharge measurements have been made by the USGS since March 1987. Discharge measurements for the period of record are plotted in [figure B33](#) and listed in [table B23](#). Photographs of the staff plate and a selected reference mark established for the Muddy River Springs 11 monitoring site on June 9, 2004, are included in [figure B34](#).

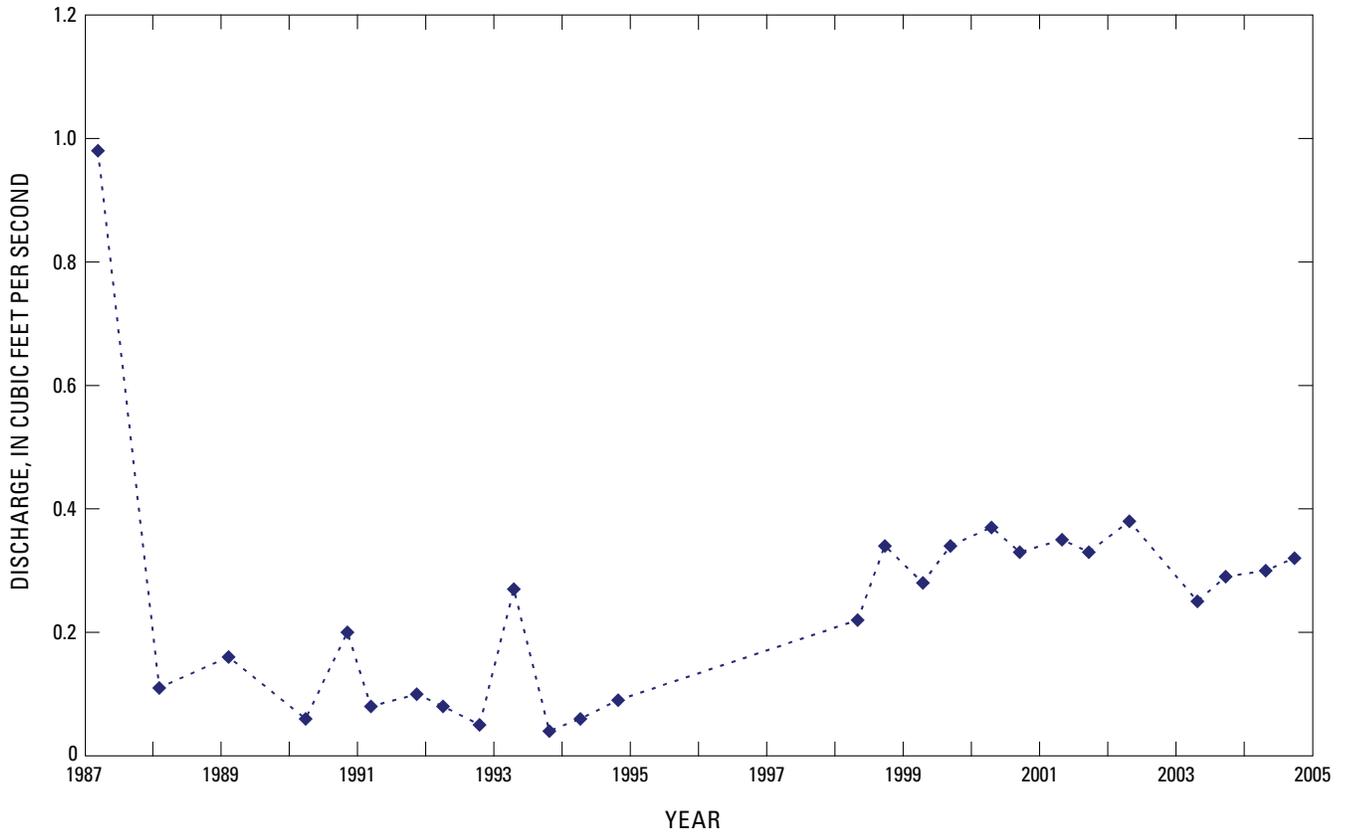
Figure B35. Periodic discharge measurements for partial-record stream-gaging station 364237114425401 Muddy River Springs 12 (M-12) near Moapa, Nevada, 1987–2004.

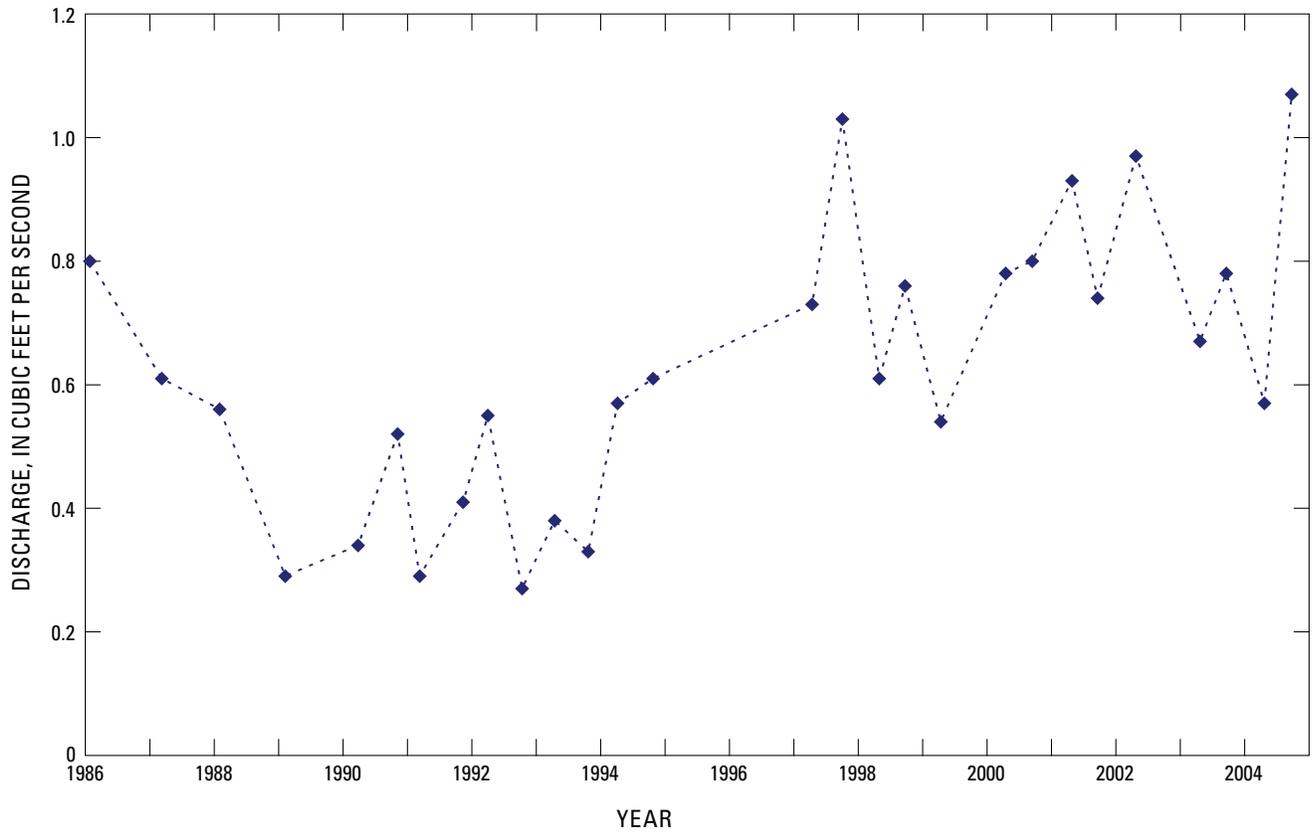
Figure B37. Periodic discharge measurements for stream-gaging station 364236114425401 Muddy River Springs 13 (M-13) near Moapa, Nevada, 1986–2004.

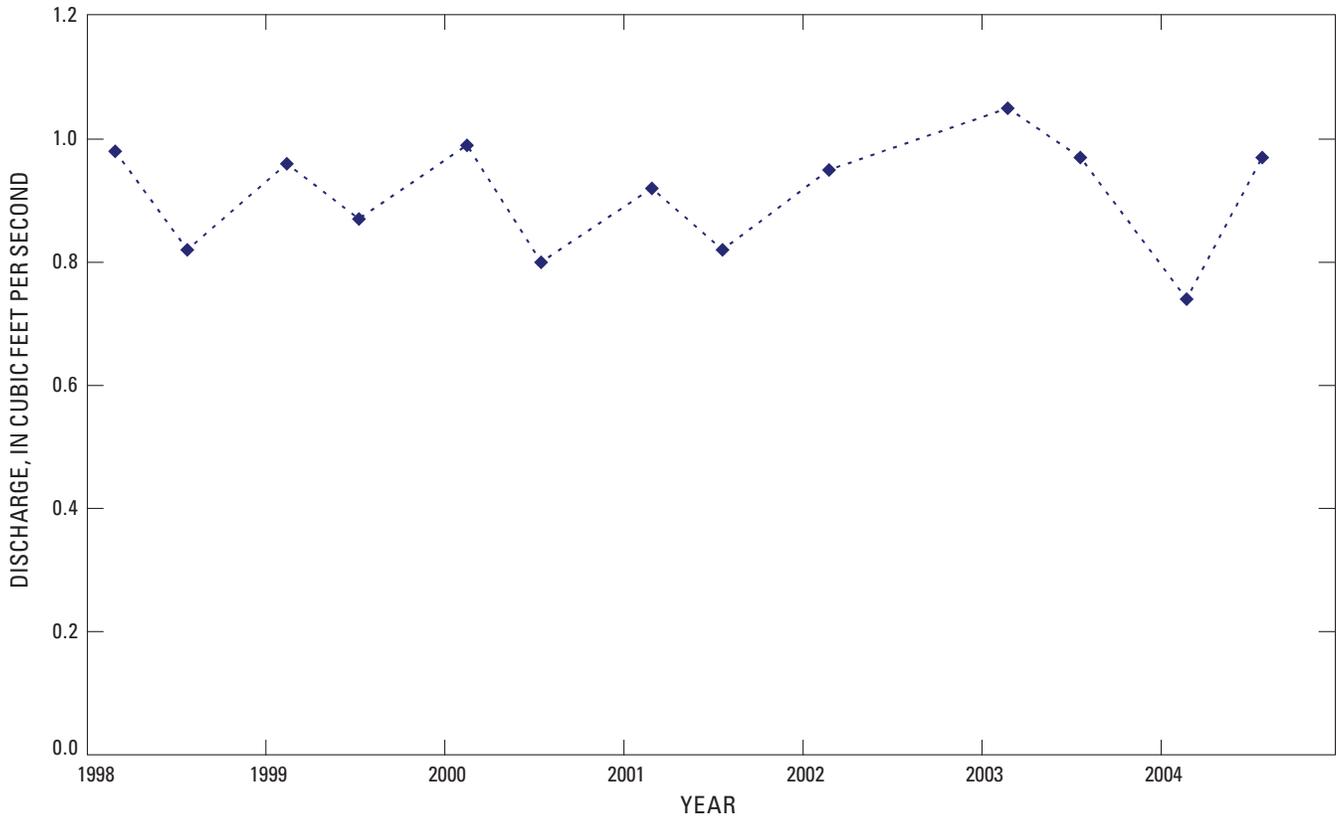
Figure B39. Periodic discharge measurements for partial-record stream-gaging station 3642235114425301 Muddy River Springs 19 (M-19) near Moapa, Nevada, 1998–2004.

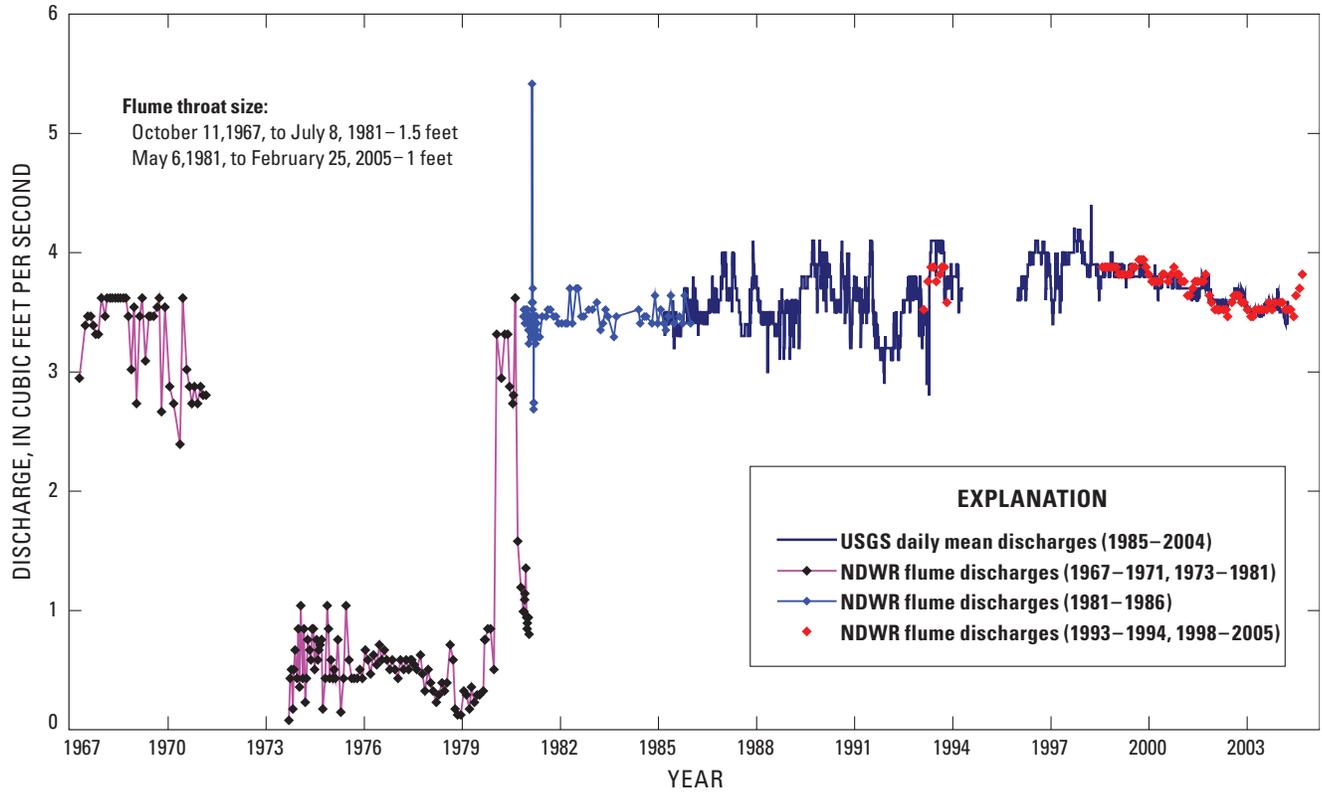
Figure B42. Instantaneous and daily mean discharges for continuous-record stream-gaging station 09415920 Warm Springs West near Moapa, Nevada, 1967–2005. Data from U.S. Geological Survey (USGS) National Water Information System (NWIS) data base, accessed 2005 at <http://waterdata.usgs.gov>. NDWR, Nevada Division of Water Resources.

During the summer of 1993, NDWR replaced the five remaining flumes and continued to make periodic water-level measurements at each site. These periodic measurements are included in the flume records provided by NDWR and are given in [Appendix B \(figs. B42, B46, B53, B63, B66 and tables B30, B33, B41, B49, B50\)](#).

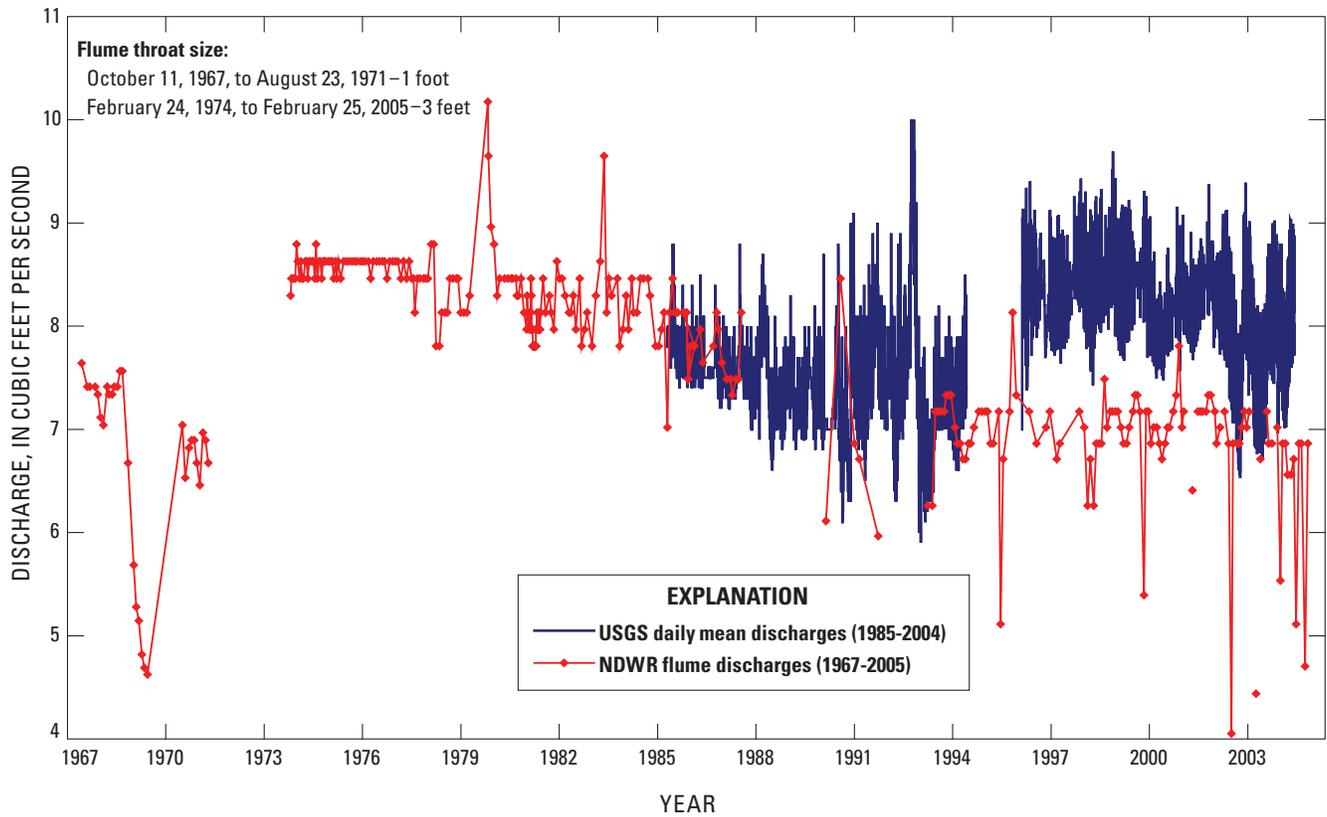
Figure B46. Instantaneous and daily mean discharge for continuous-record stream-gaging station 09415900 Muddy Springs at Latter Day Saints (L.D.S.) Farm near Moapa, Nevada, 1967–2005. Data from U.S. Geological Survey (USGS) National Water Information System (NWIS) data base, accessed 2005 at <http://waterdata.usgs.gov>. NWDR, Nevada Division of Water Resources.

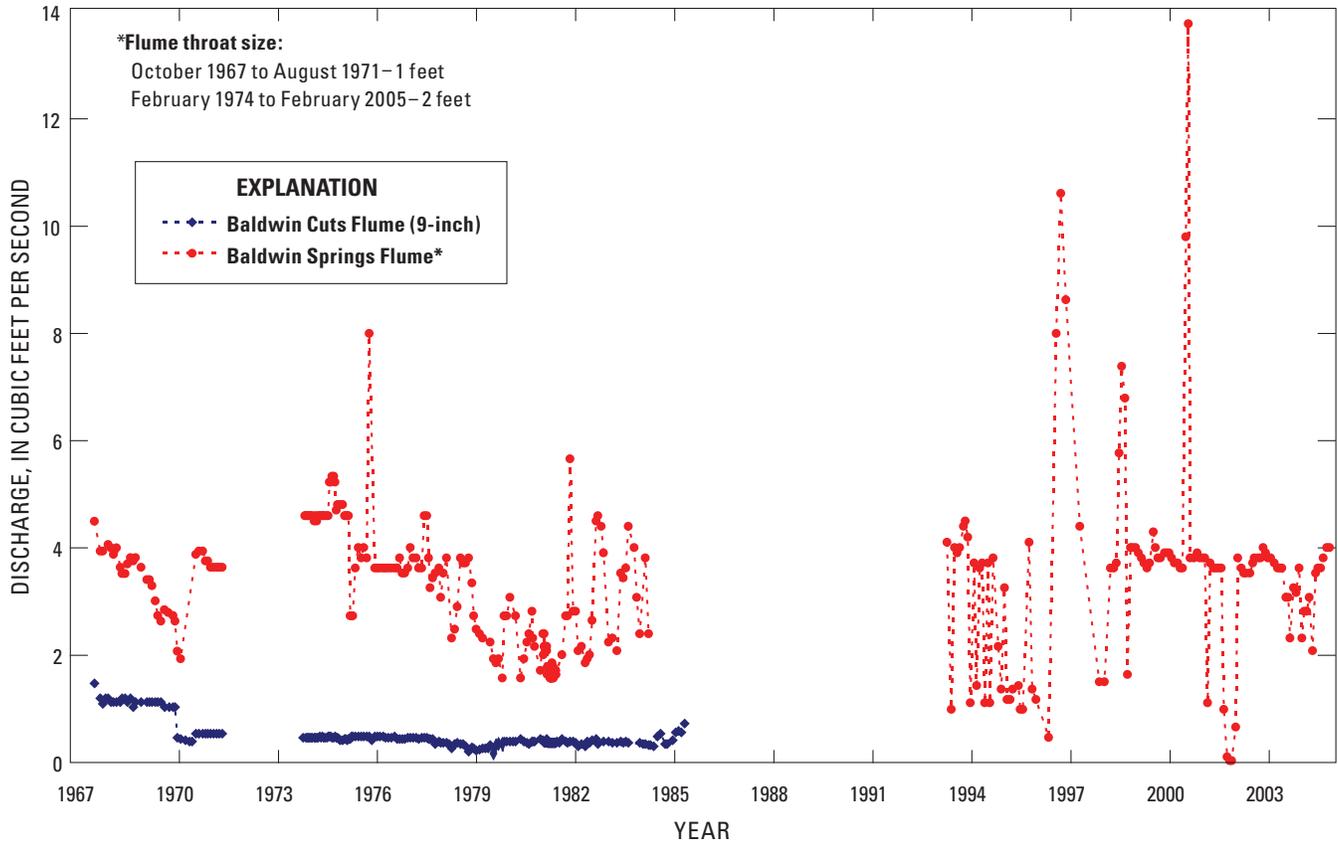
Figure B53. Instantaneous discharges computed from water-level measurements provided by Nevada Division of Water Resources for Baldwin Cuts and Baldwin Springs Flumes near Moapa, Nevada, 1967–2005.

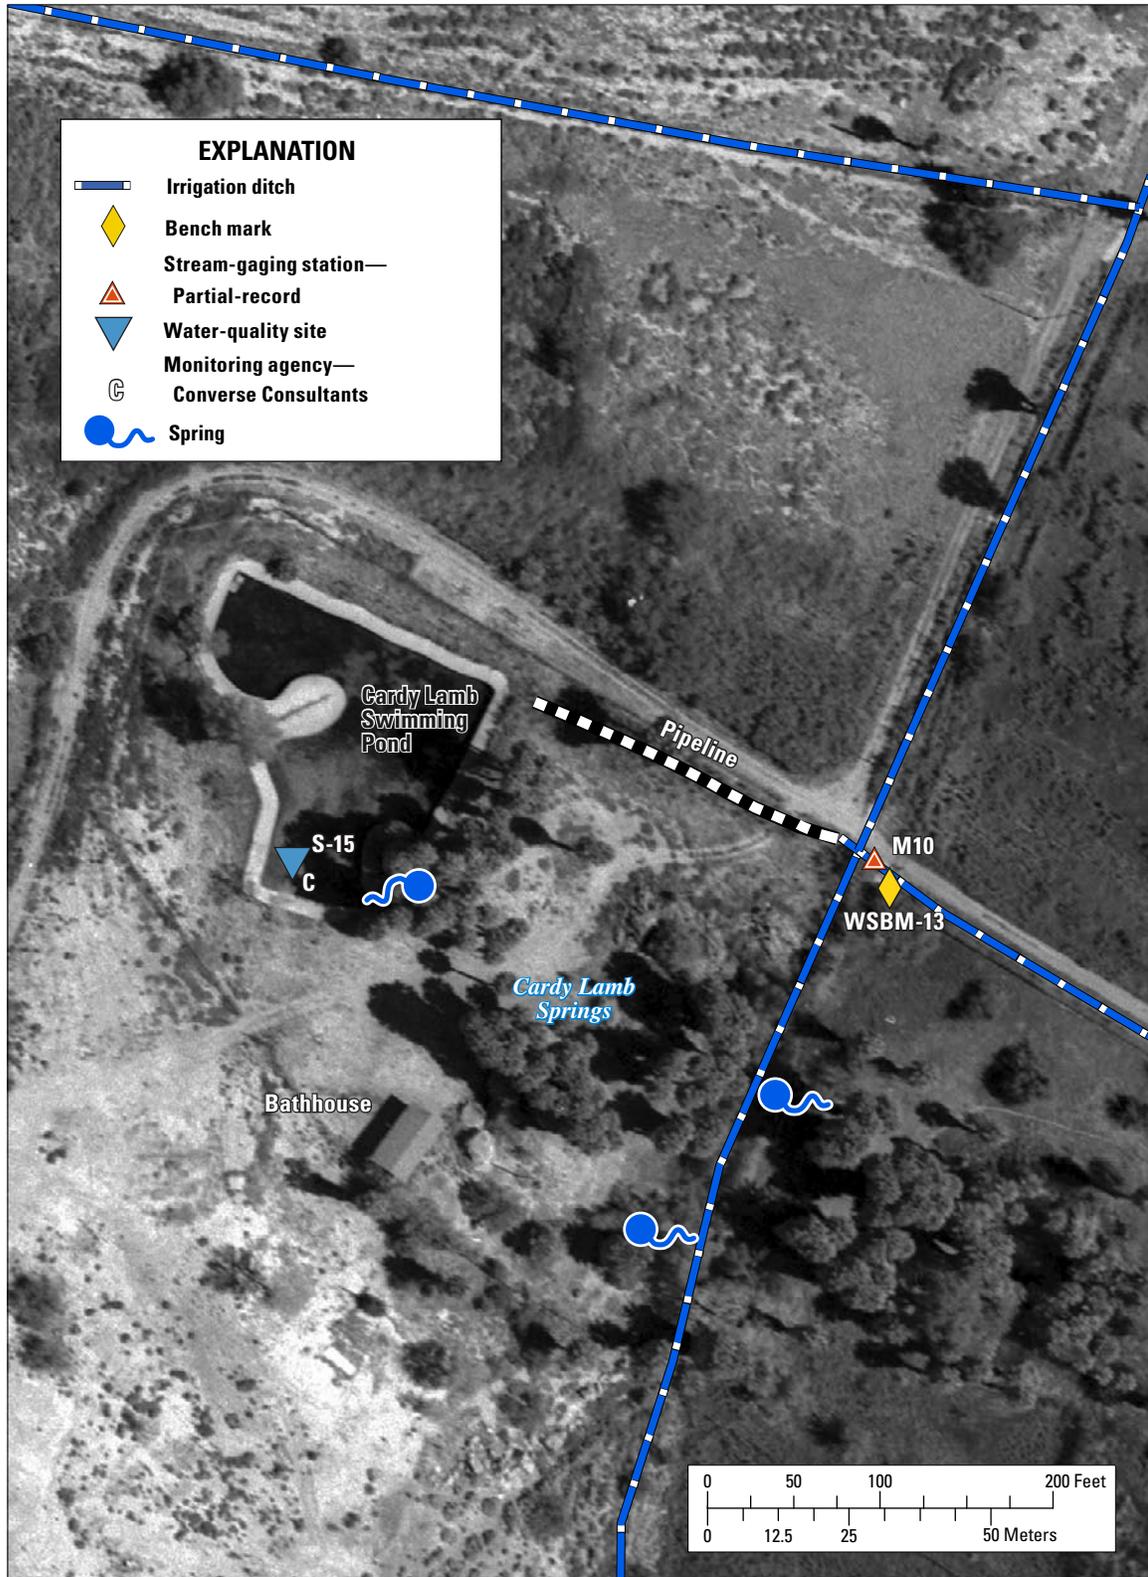
Figure B57. Location of Cardy Lamb Springs swimming pond, bench mark WSBM-13, and monitoring sites in the Warm Springs area near Moapa, Nevada.

The partial-record station at Muddy River Springs 10 (M-10) was established by the U.S. Geological Survey (USGS) on January 28, 1986 and is located about 250 ft east of the swimming pond ([fig. B57](#)). The measurement site is inside an old concrete irrigation ditch about 2 ft downstream from a small concrete culvert. Most of the flow at Muddy River Springs 10 originates from flow within the swimming pond that discharges through the drainage pipe. Water exiting the drainage pipe flows into a small pond approximately 10 ft upstream of the concrete culvert and merges with flows from small springs to the southwest. Periodic discharge measurements have been made by the USGS since January 1986. Discharge measurements for the period of record are plotted in [figure B59](#) and listed in [table B47](#). Photographs of the bench mark, reference points, and selected reference marks established for the Muddy River Springs 10 monitoring site on June 3, 2004, are shown in [figure B60](#).

In April 1997, Converse Consultants, on contract with Nevada Power Company, began quarterly field measurements of water temperature and specific conductance at site S15 ([fig. B57](#)) at the south end of the swimming pond. Measurements were compiled through March 2005 and are plotted in [figure B61](#) and listed in [table B48](#).

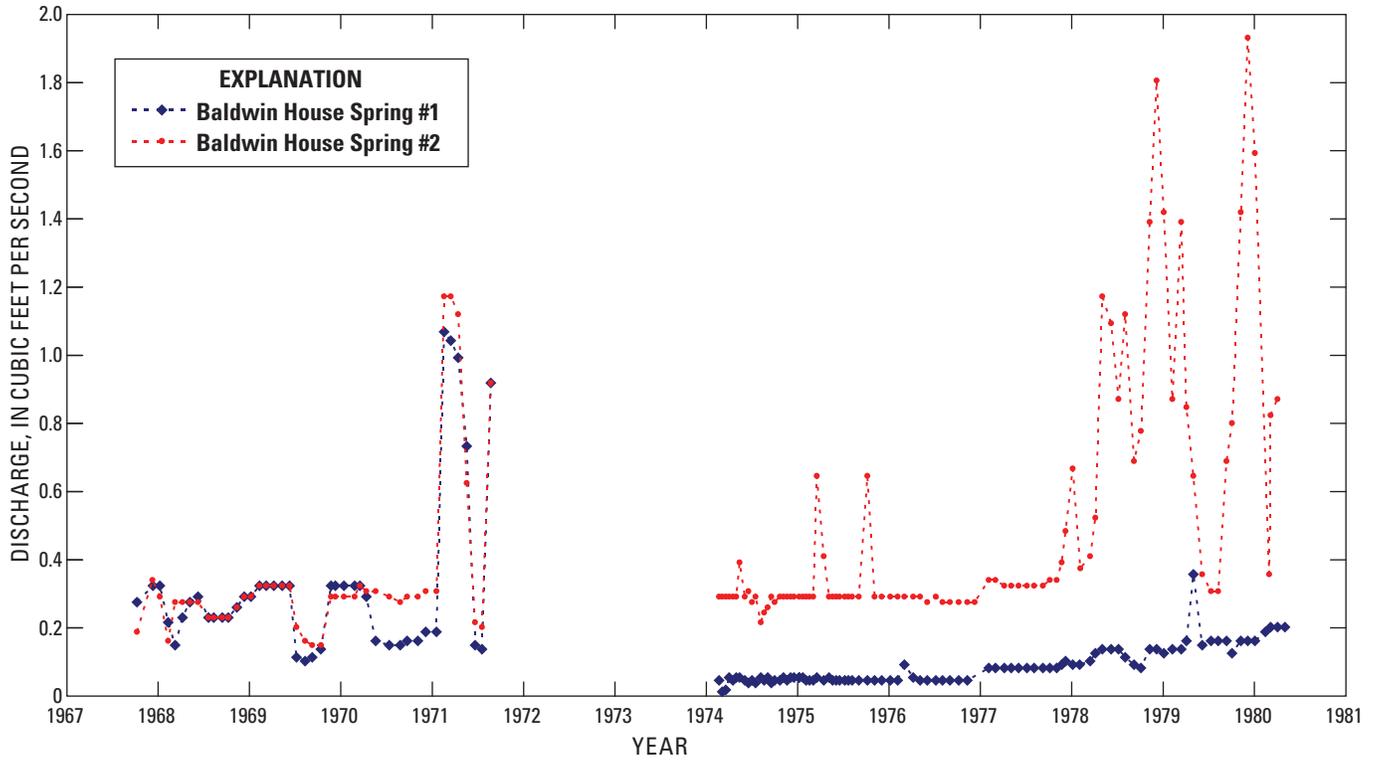
Figure B58. Instantaneous discharges for Baldwin House Springs #1 and #2 flumes at Cardy Lamb Springs near Moapa, Nevada, 1967–80. Data provided by Nevada Division of Water Resources.

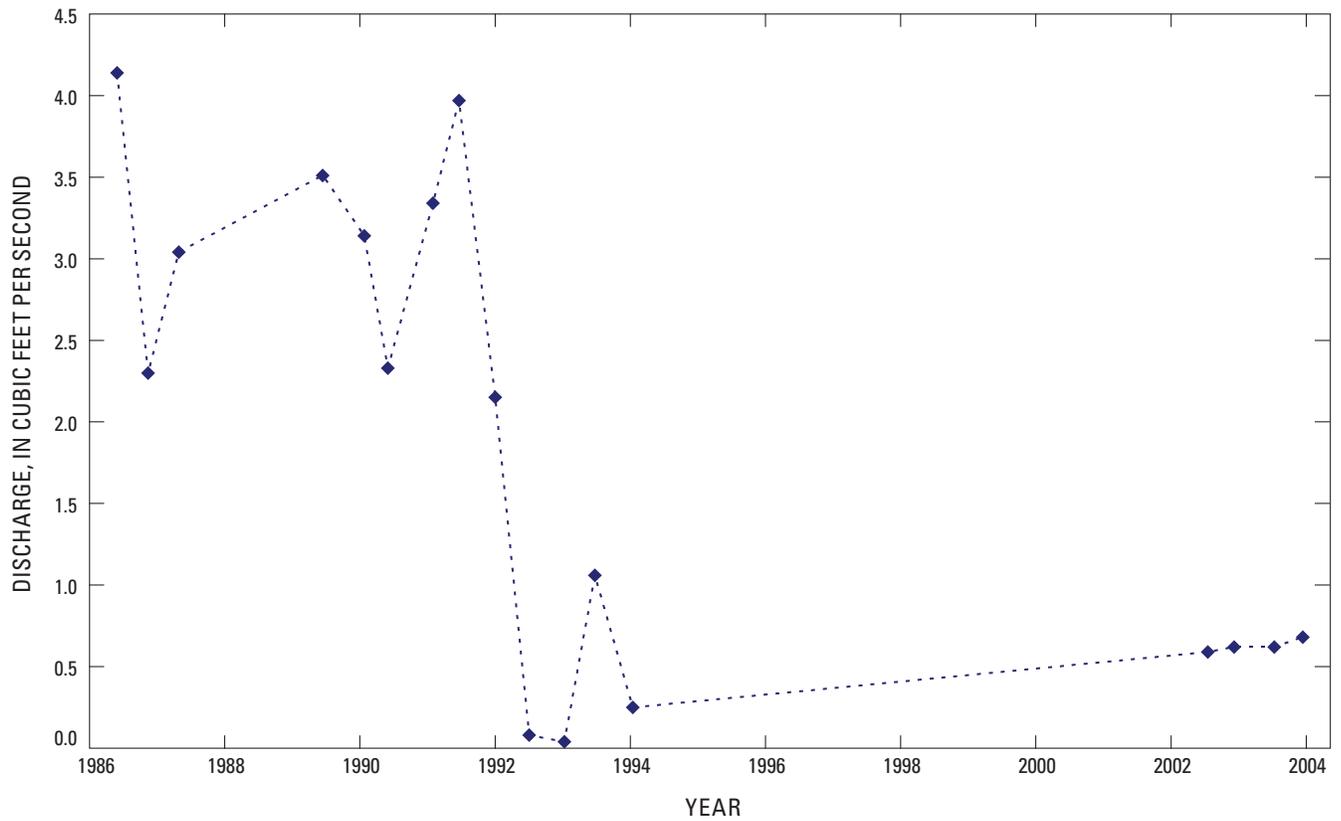
Figure B59. Periodic discharge measurements for partial-record stream-gaging station 364327114430801 Muddy River Springs 10 (M-10) at Cardy Lamb Springs near Moapa, Nevada, 1986–2004.

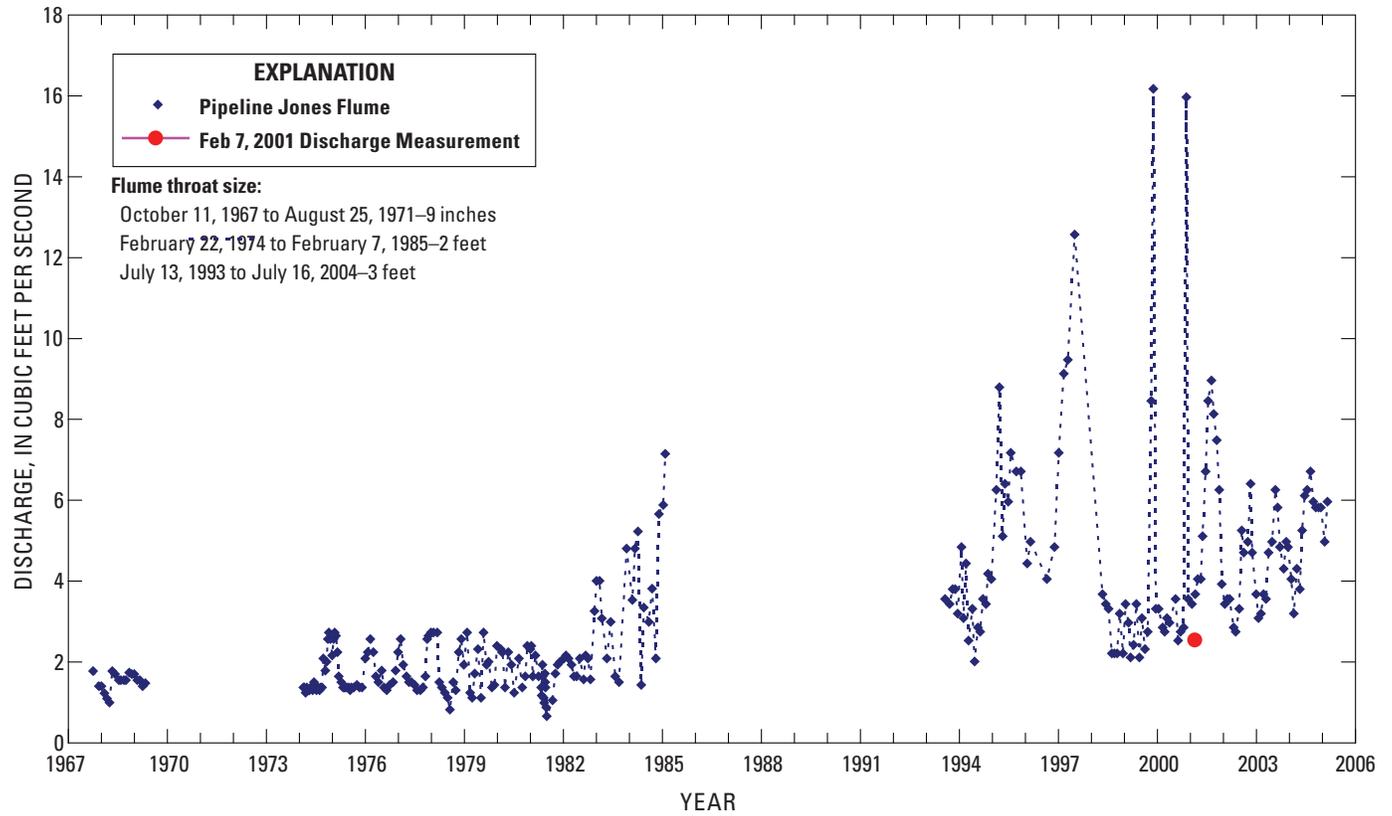
Figure B63. Instantaneous discharges compiled for 1967–2005, and discharge measurement made on February 7, 2001, for partial-record stream-gaging station 09415940 Apcar Stream at Pipeline Jones Flume near Moapa, Nevada.

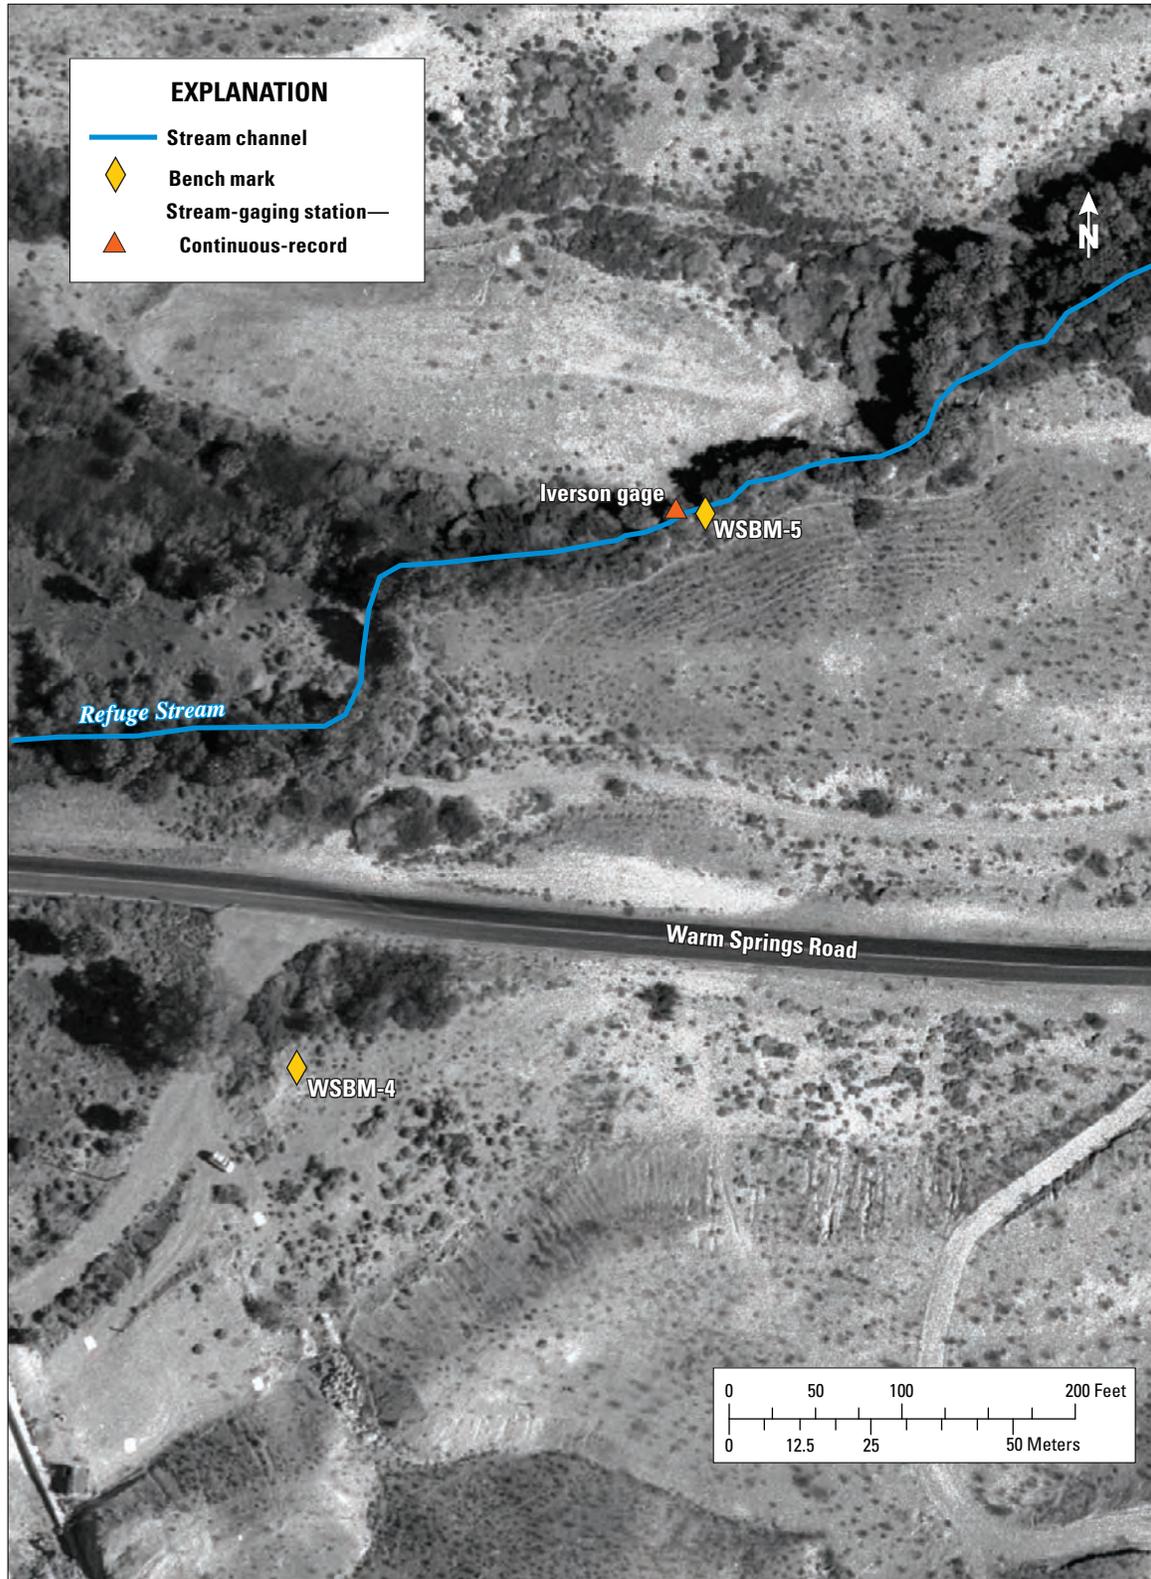
Figure B65. Location of continuous-record stream-gaging station 09415927 and bench marks, WSBM-4 and WSBM-5, Warm Springs Confluence at Iverson Flume near Moapa, Nevada.

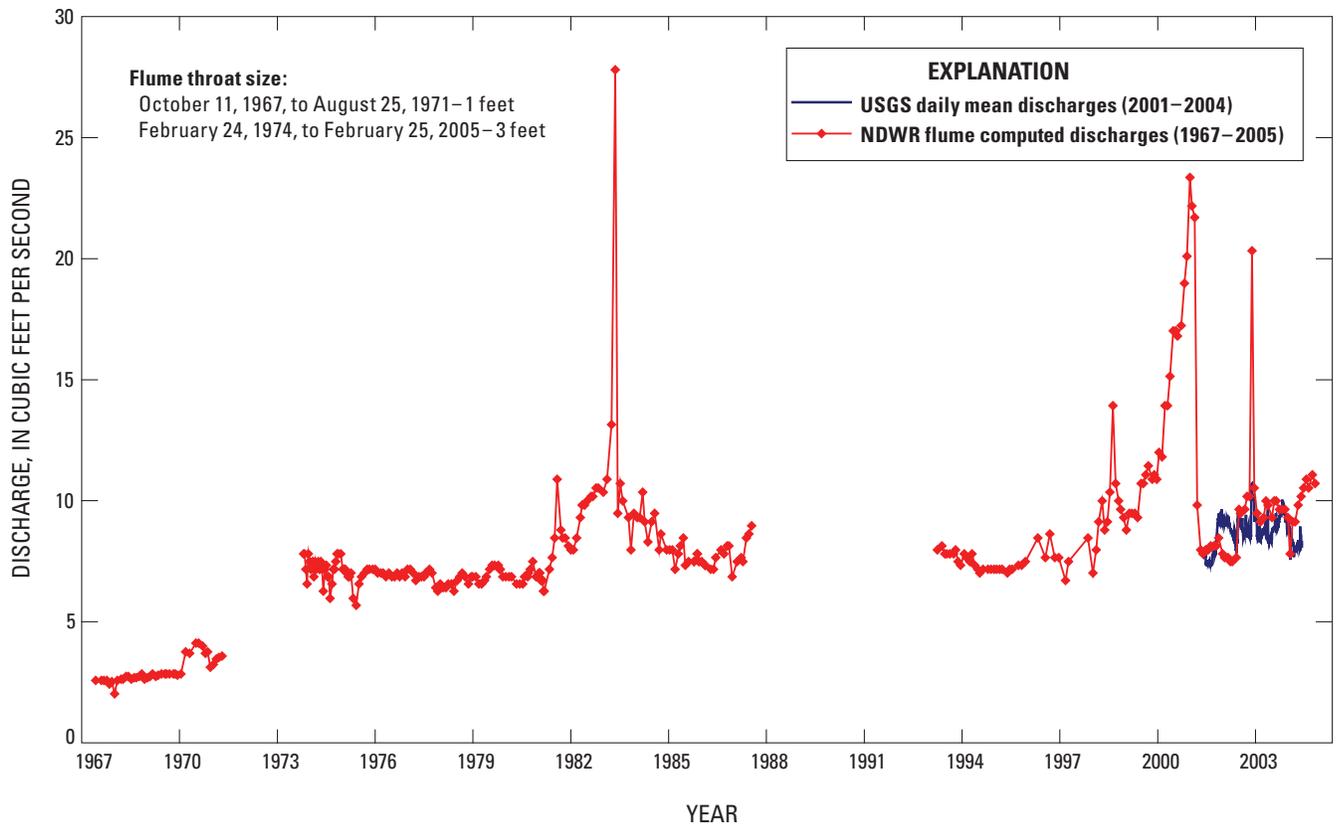
Figure B66. Instantaneous and daily mean discharges for continuous-record stream-gaging station 09415927 Warm Springs Confluence at Iverson Flume near Moapa, Nevada, 1967–2005. Data from U.S. Geological Survey (USGS) National Water Information System (NWIS) data base, accessed 2005 at <http://waterdata.usgs.gov>. Water level measurements used to compute discharges were provided by Nevada Division of Water Resources (NDWR).

A continuous-stage recorder was installed at the flume by the U.S. Geological Survey on October 1, 2001, and maintained through September 30, 2004. From the time that the gage was installed, submerged flow conditions have been in effect owing to the growth of a large palm tree and other plants in the channel downstream from the flume. Discharge measurements are routinely made at the site and used to define the stage-discharge relation for the flume. Daily mean discharges computed for the period of record have been included for comparison on the plot in [figure B66](#) and listed in [table B51](#). Photographs of the current flume, bench mark, and a selected reference mark established for this gage on June 3, 2004, are shown in [figure B67](#).

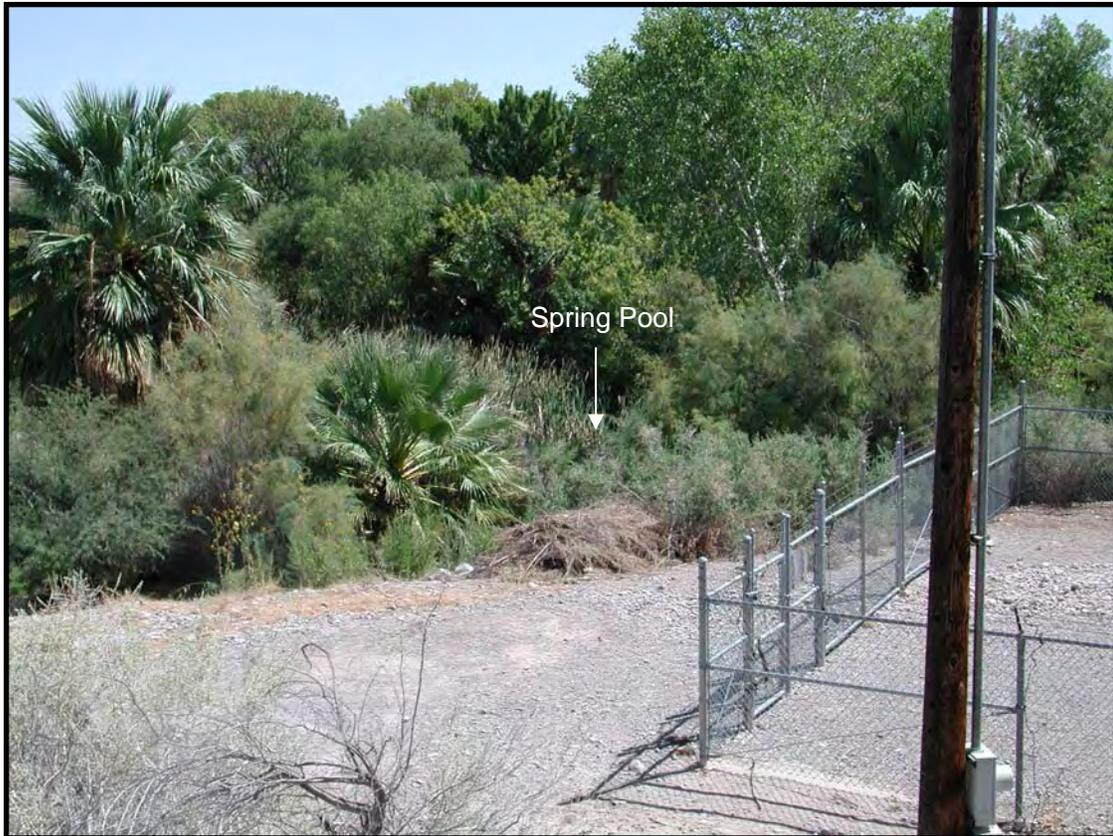
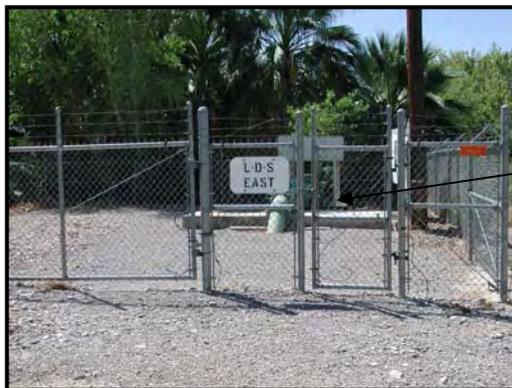
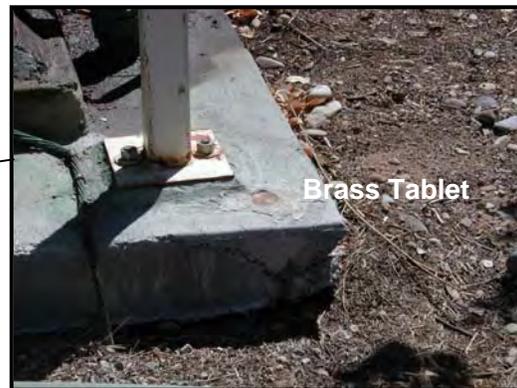
WSBM-10
(1.752.32 ft)

Figure B69. Location of bench mark WSBM-10 at L.D.S. East well and spring-fed pool surveyed on August 17, 2004, at unnamed springs near Moapa, Nevada. Elevation of bench mark in feet above NAVD 88.

On August 17, 2004, water levels were obtained from the staff plates at all the USGS monitoring sites. The only exception was the water level at an unnamed spring-fed pool near well L.D.S Well East ([fig. 2](#)). The water-surface elevation of the pool which is located about 100 ft east of the well was measured using the optical theodolite survey for the BM at the well. In early July 2004, flow was observed to be discharging from several pools in the area and flowing into the Muddy River. By August 17, 2004, most of the pools had completely dried up and water no longer discharged from the area. On October 1, 2004, water was observed to be emanating from the surveyed well pond and other nearby pools and discharging to the Muddy River.
