Water-Surface Elevations, Discharge, and Water-Quality Data for Selected Sites in the Warm Springs Area near Moapa, Nevada

Open-File Report 2006–1311

By David A. Beck, Roslyn Ryan, Ronald J. Veley, Donald P. Harper, and Daron J. Tanko

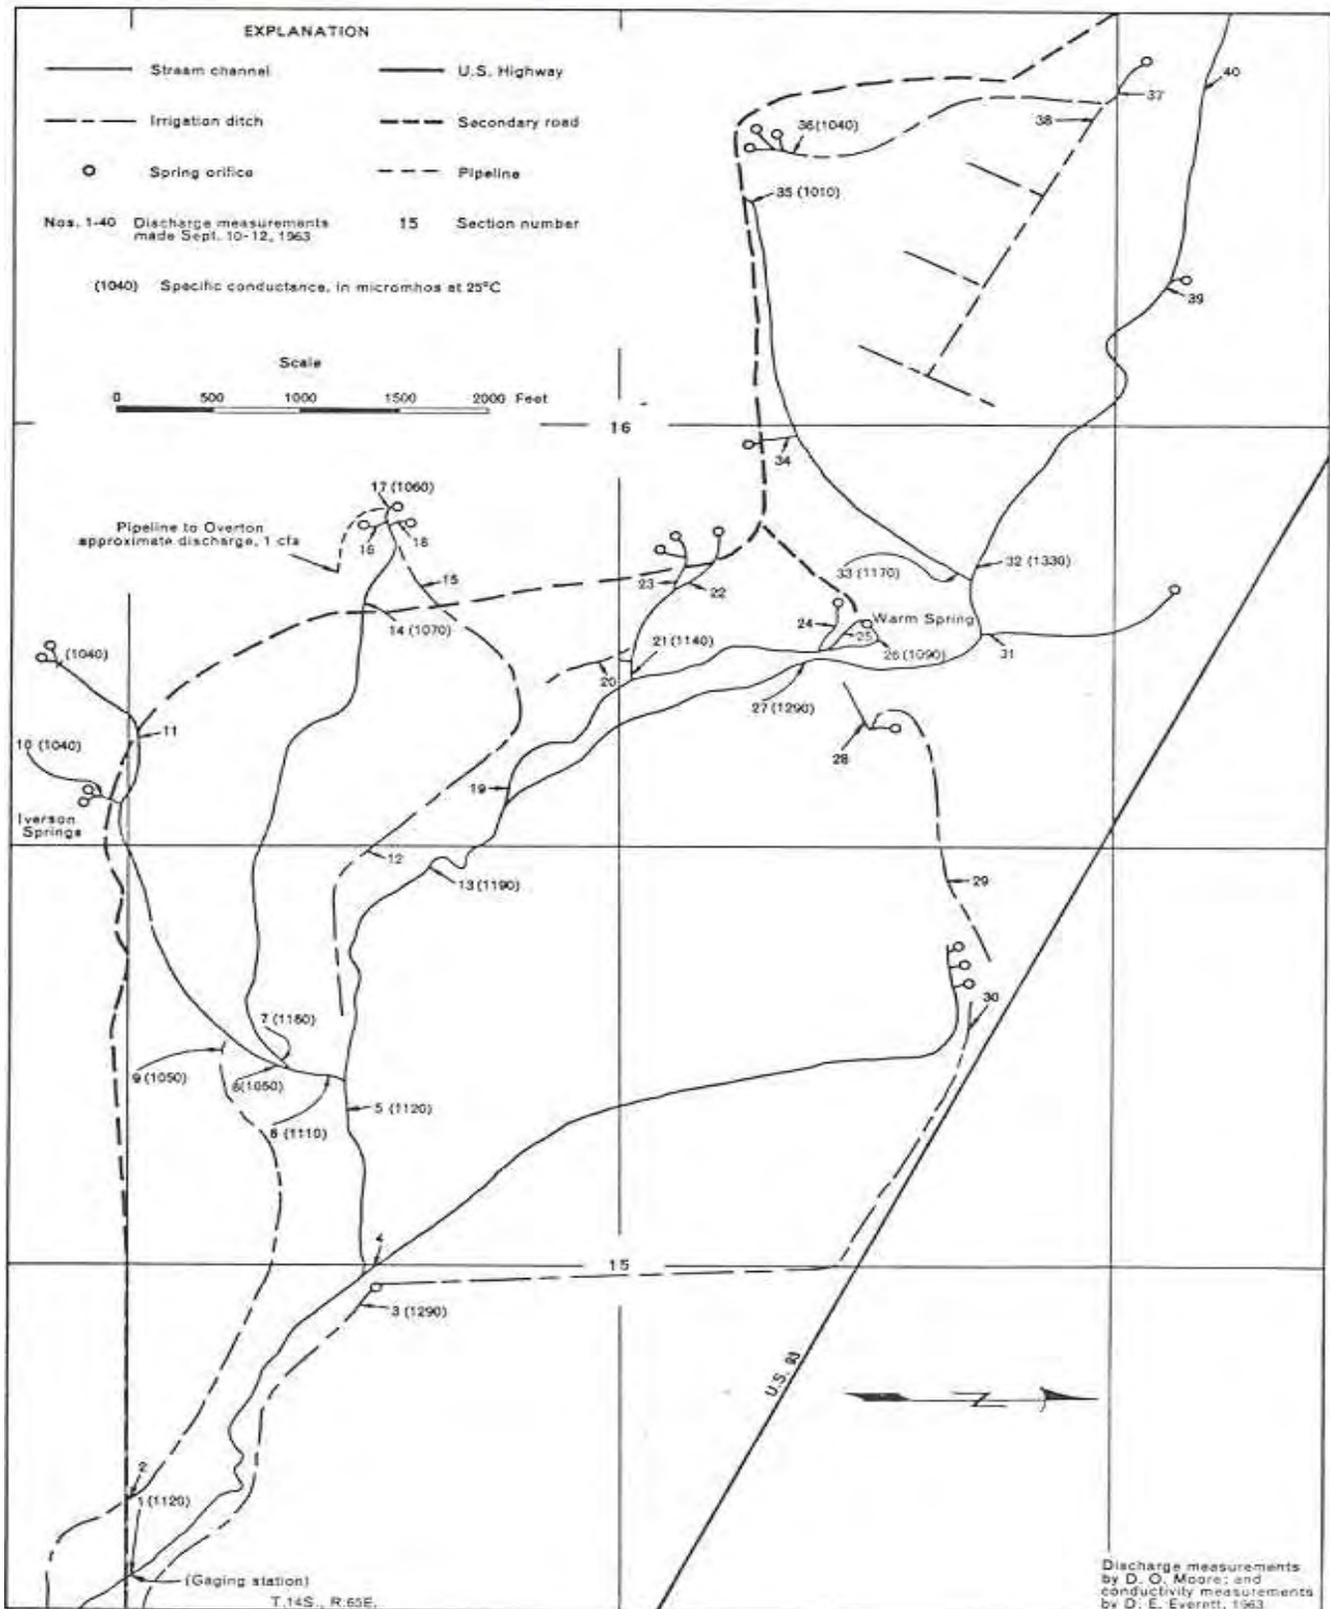
Figure D1. Sketch map showing location of discharge measurement sites in the Warm Springs area, September 12, 1963. (From Eakin, 1964.)
