**Appendix B. Water-Level, Discharge, and  
Water-Quality Data for Selected Monitoring Sites  
Within the Warm Springs Area Near Moapa, Nevada**

## 09416000 Muddy River near Moapa, Nevada

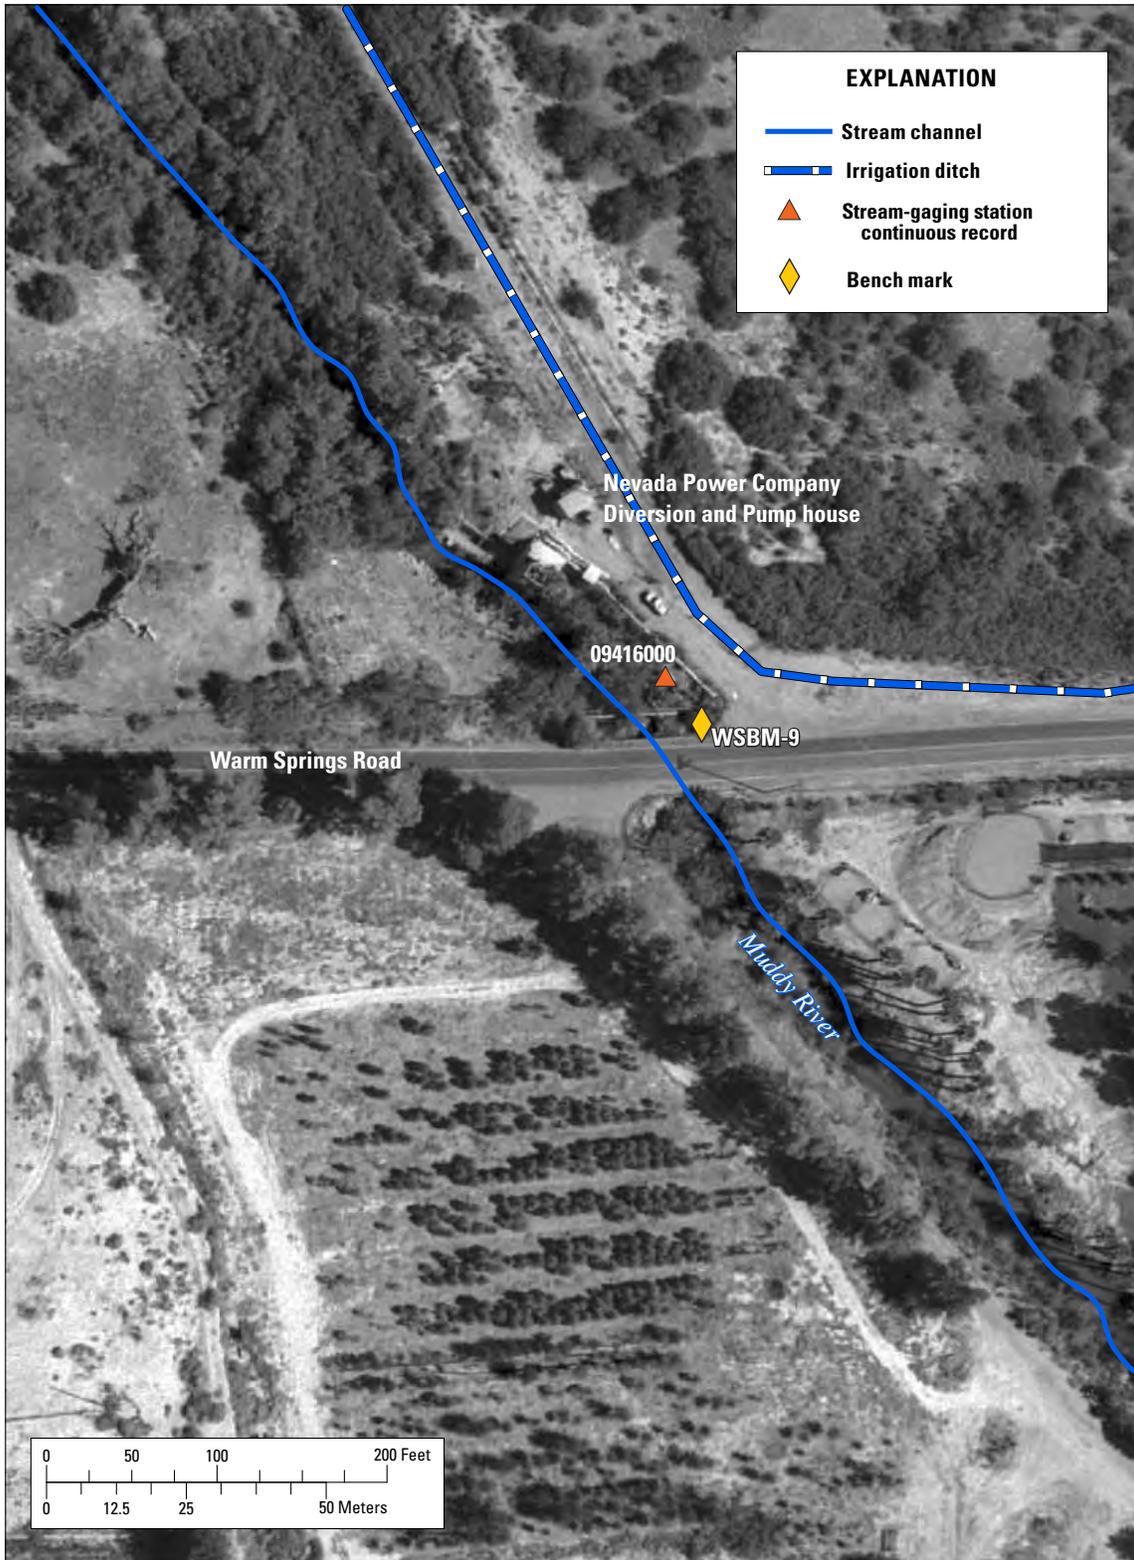
**Figure B1.** Location of Muddy River stream-gaging station (09416000), bench mark WSBM-9, and Nevada Power Company's diversion and pump house in the Warm Springs area near Moapa, Nevada.

The stream-gage at Muddy River near Moapa originally was established by the Muddy Valley Irrigation District (MVID) on July 1, 1913, at its present location upstream of Warm Springs Road ([fig. B1](#)). Water-level record and discharge measurements were collected by the MVID from July 1913 to September 1915 and from April 1916 to September 1918. The gage was reactivated in June of 1928 by the University of Nevada Agricultural Experiment Station (UNAES). Daily mean gage height and monthly discharge were collected by the UNAES from June 1928 to October 1931 and from April 1932 to July 1932. The Bureau of Reclamation (Reclamation) reactivated the gage October 21, 1944, and collected continuous streamflow data

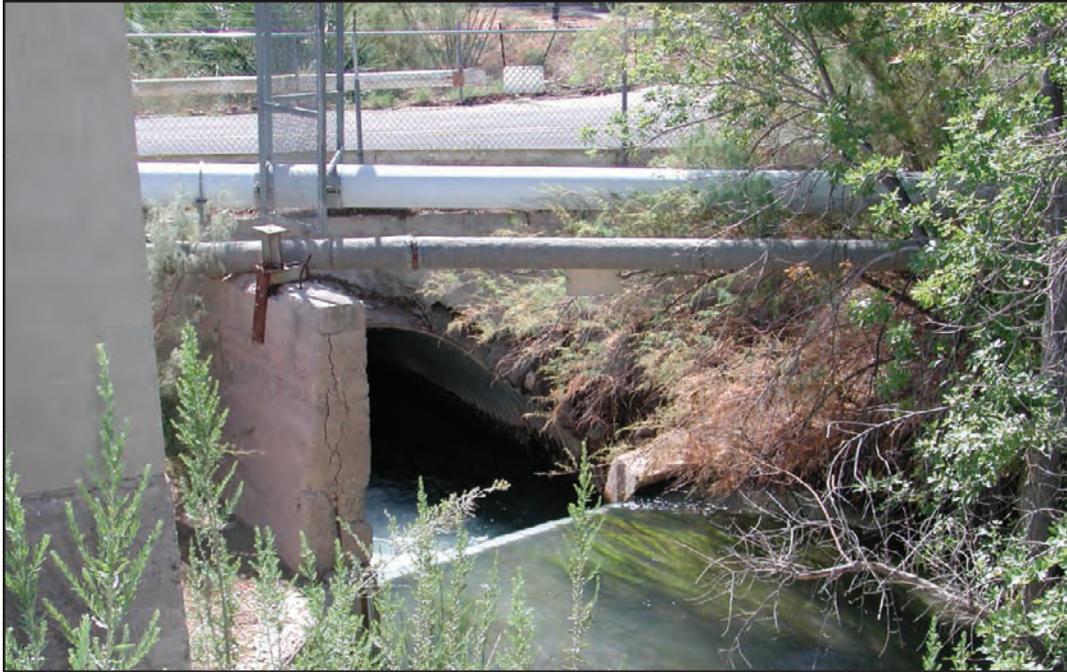
**Figure B2.** View looking downstream of the Cipolletti weir upstream of Warm Springs Road at the Muddy River stream-gaging station (09416000) in the Warm Springs area near Moapa, Nevada. Photographed in June 2004 by D. Beck.

until October 1, 1948, when the operation of the gage became the responsibility of the U.S. Geological Survey. Flow is diverted about 100 ft upstream of the gage by the Nevada Power Company for use at the Reid Gardner Generating Station about 3 mi downstream of the gage ([fig. 1](#)). The hydraulic control for this site is the 10-ft concrete Cipolletti weir, which was installed by the USBR in 1944 just upstream from the Warm Springs Road crossing ([fig. B2](#)).

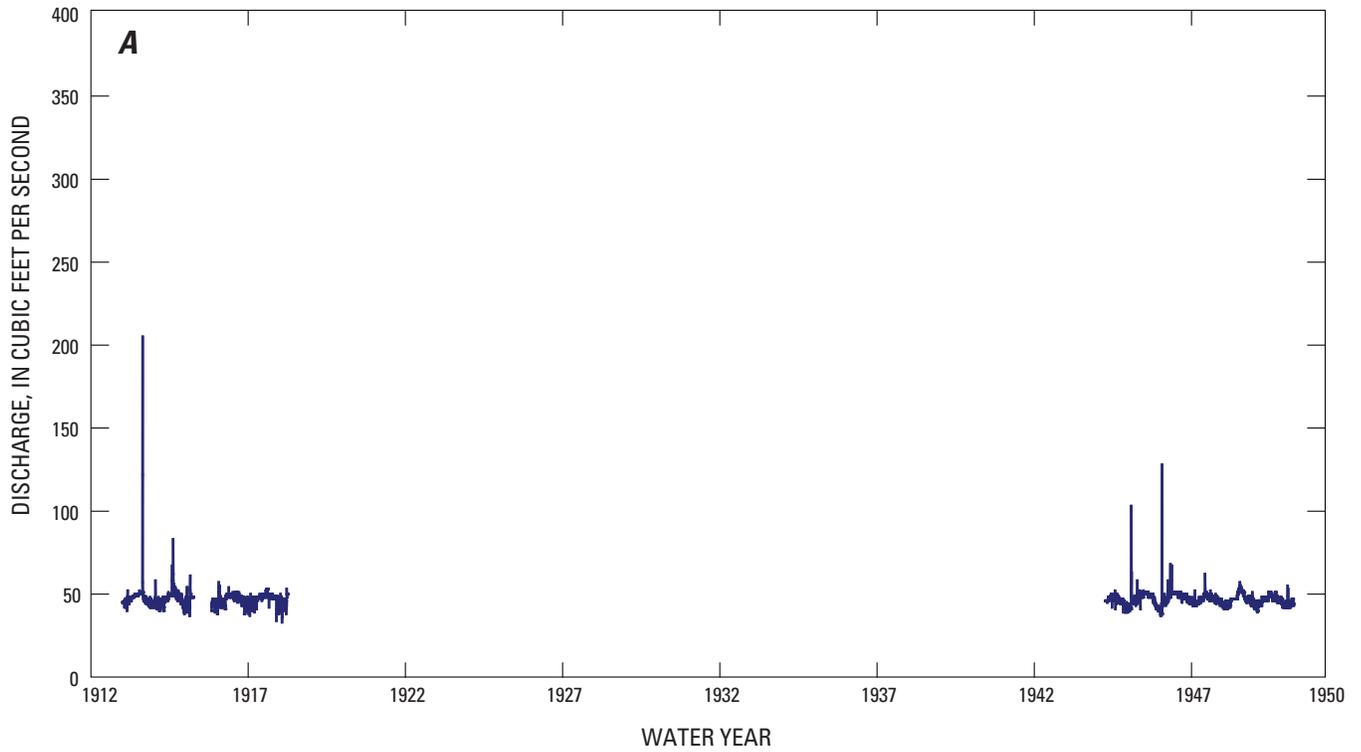
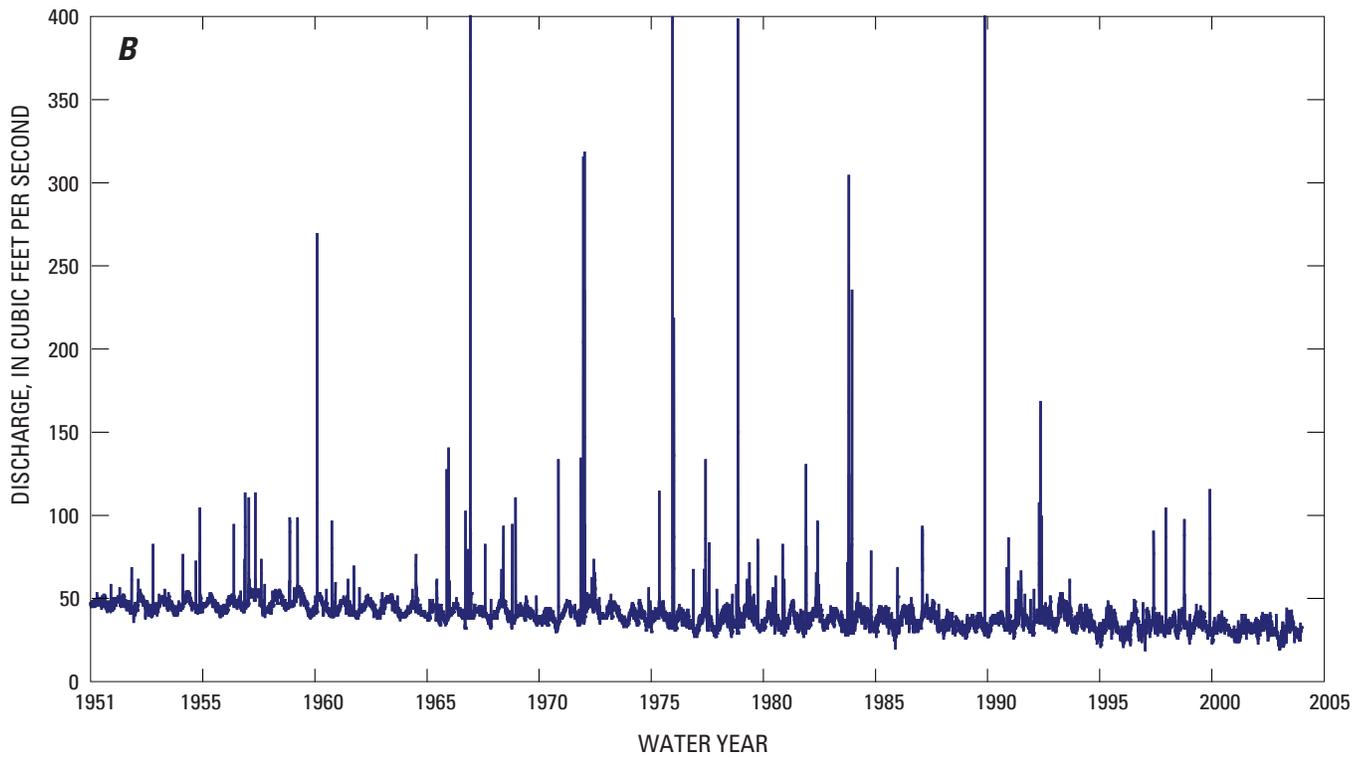
**Figure B3.** Daily mean discharges for stream-gaging station 09416000, Muddy River near Moapa, Nevada, for (A) water years 1913–15, 1916–18, and 1944–47, and (B) water years 1951–2004.

Daily mean discharges for the period of record are plotted on [figure B3](#) and listed in [table B1](#). Photographs of the bench and reference marks established for this gage on June 2, 2004, are shown in [figure B4](#).

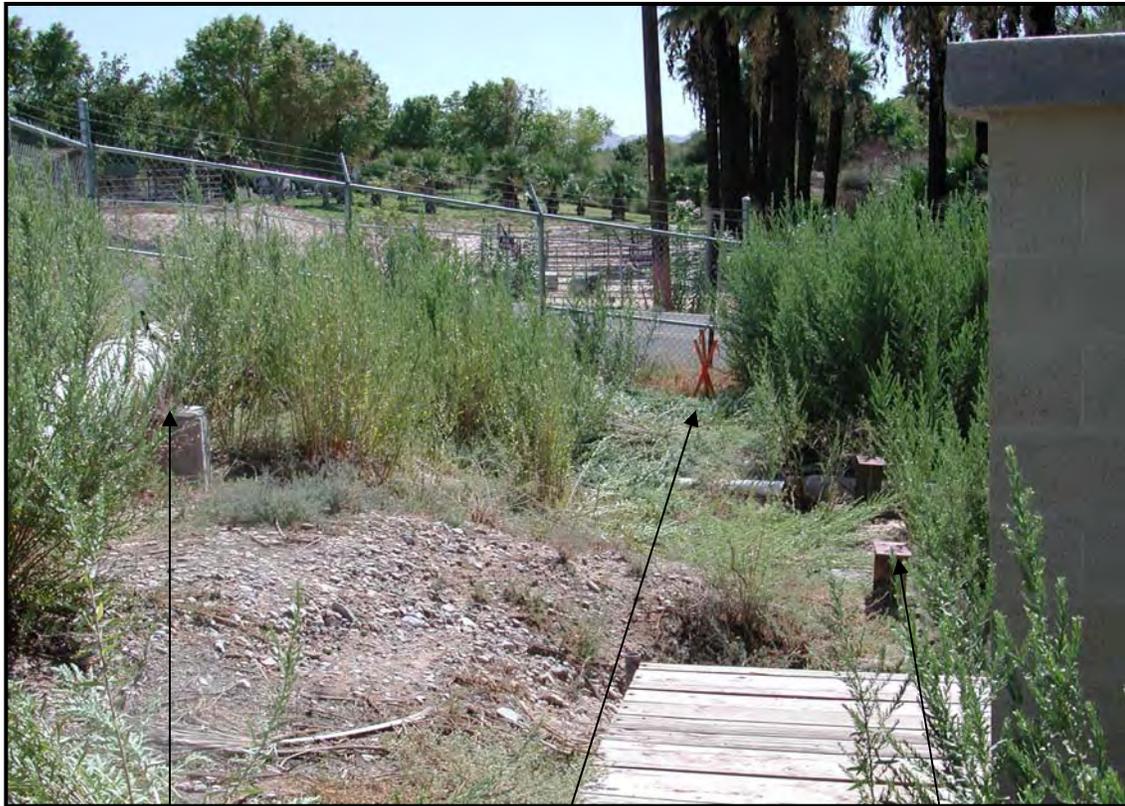
**RM-7**  
**(1,719.74 ft)**

**WSBM-9**  
**(1,715.83 ft)**

**RM-5**  
**(1,717.23 ft)**

**Figure B4.** Location and elevation of bench mark WSBM-9 and reference marks RM-5 and RM-7 at stream-gaging station 09416000, Muddy River near Moapa, Nevada, June 2, 2004, elevation in feet above NGVD 88. Photographed by D. Beck.

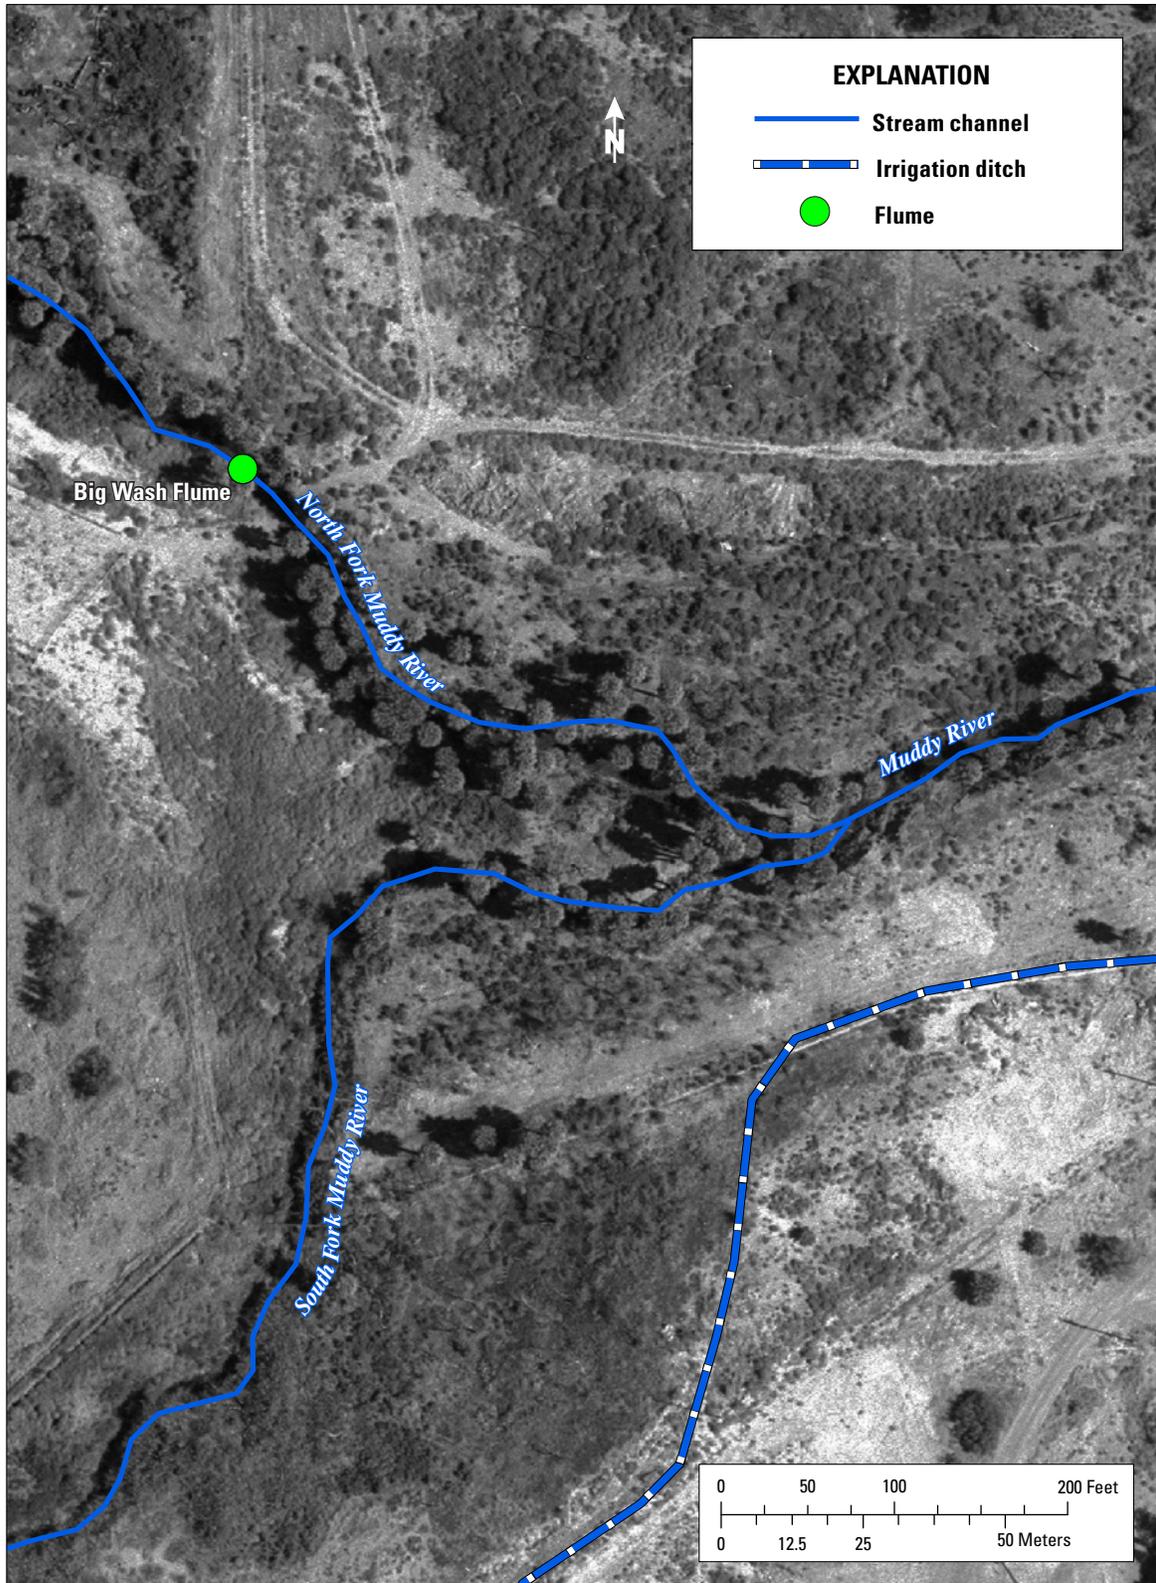
**Figure B5.** Location of former Big Wash flume site on the North Fork Muddy River in the Warm Springs area near Moapa, Nevada.

A 3-ft Parshall flume was installed on Big Wash (North Fork Muddy River) on October 11, 1967, by the Nevada Division of Water Resources (NDWR). The flume was located approximately 500 ft upstream of the confluence with South Fork Muddy River ([fig. B5](#)). The source of water in the river originates from springs and seeps located in the uppermost northwest drainage of the Warm Springs area.

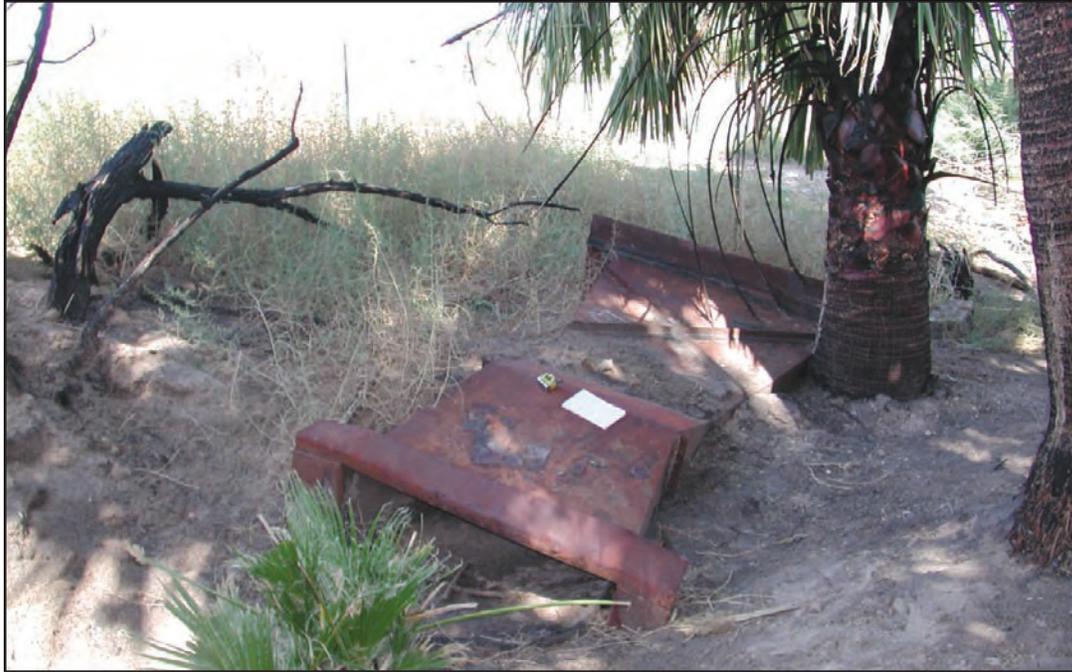
**Figure B6.** Former Big Wash flume on right bank of North Fork Muddy River in the Warm Springs area, near Moapa, Nevada. The flume is about 500 feet upstream of confluence with South Fork Muddy River. Photographed in September 2004 by D. Beck.

former flume site was visited by the U.S. Geological Survey on September 16, 2004, and a 3-ft steel Parshall flume was observed upside down on the south bank of the river ([fig. B6](#)).

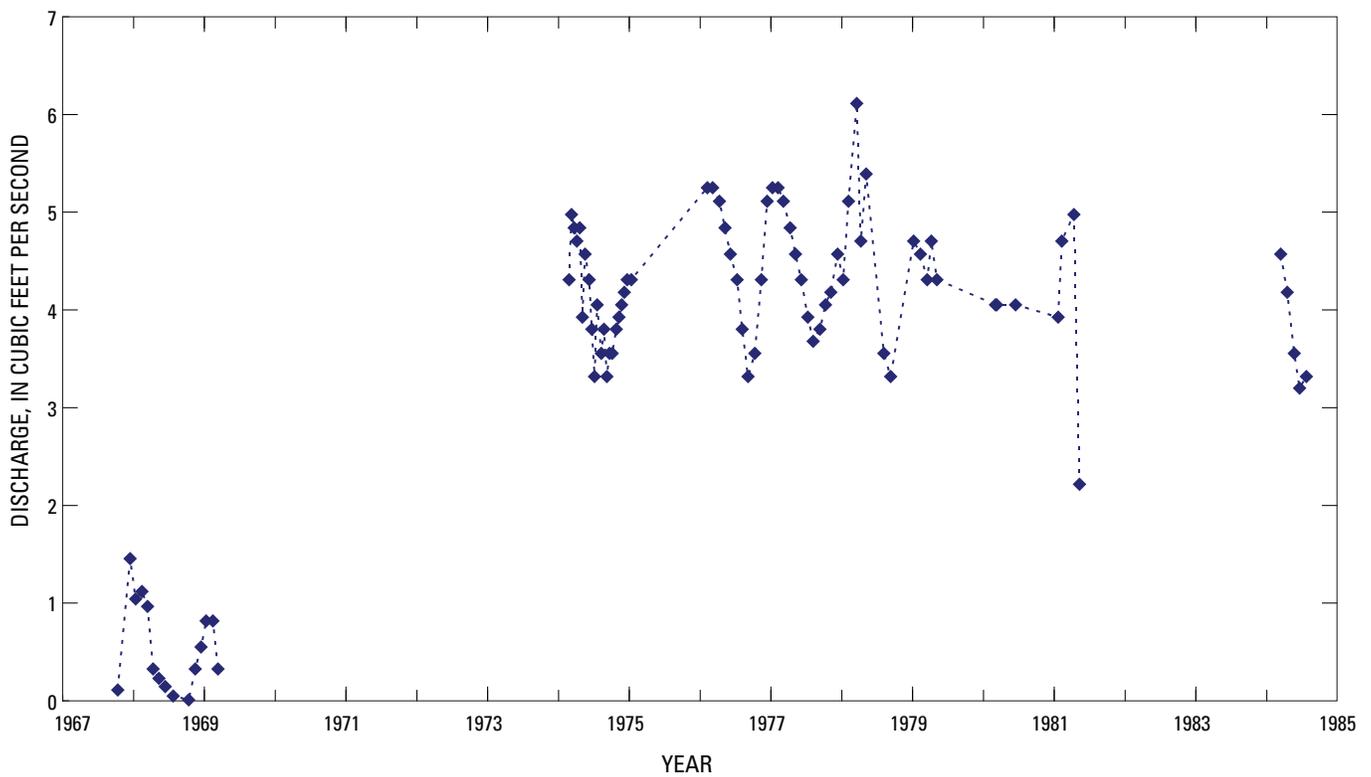
**Figure B7.** Instantaneous discharges for the Big Wash flume in the Warm Springs area near Moapa, Nevada, 1967–69, 1974–81, and 1984.

As only water-level measurements were provided by NDWR, discharge rates were computed using a standard rating equation for the 3-ft Parshall flume (Leupold and Stevens, 1987). A plot of the computed discharges from October 1967 to July 1984 is shown in [figure B7](#). A complete listing of the water-level measurements and computed discharges are included in [table B2](#). Discharges computed from October 1967 to March 1969 are substantially less than the computed discharges for the remainder of the period. Although flow may have been bypassing the flume at that time, documentation was unavailable to verify it.

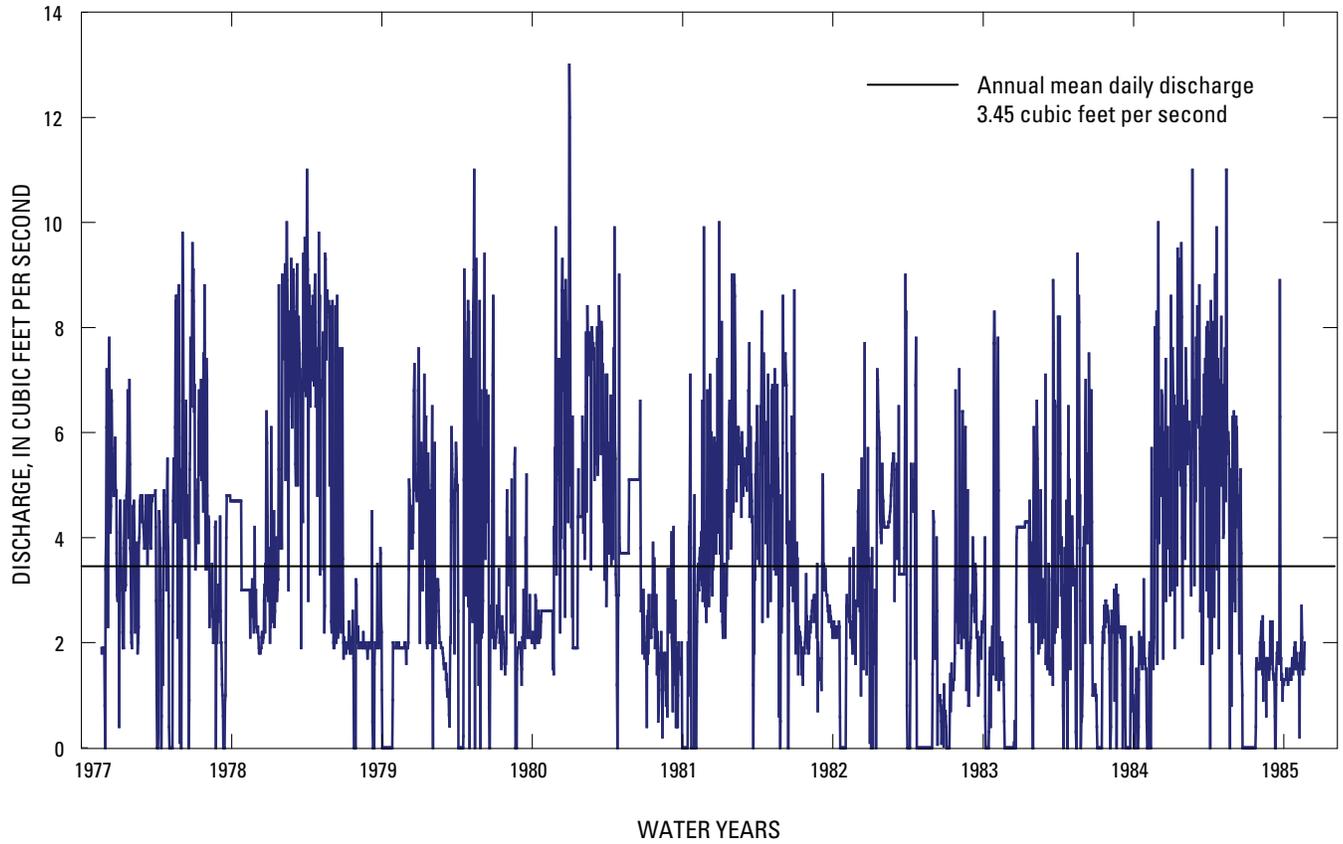
**Figure B8.** Daily mean discharges for the Muddy River power diversion in the Warm Springs area, near Moapa, Nevada, water years 1978–85. Pumping data was provided to U.S. Geological Survey by Nevada Power Company.

from October 1, 1977, to September 30, 1985. Daily mean discharges for the period were computed and published in the USGS, Nevada District, annual data report series between water years 1978 and 1986). See [figure B8](#) and [table B3](#) for a graph and a table, respectively, of the daily mean discharges. Annual mean daily discharge from the diversion for water years 1978 to 1985 was 3.45 ft<sup>3</sup>/s.

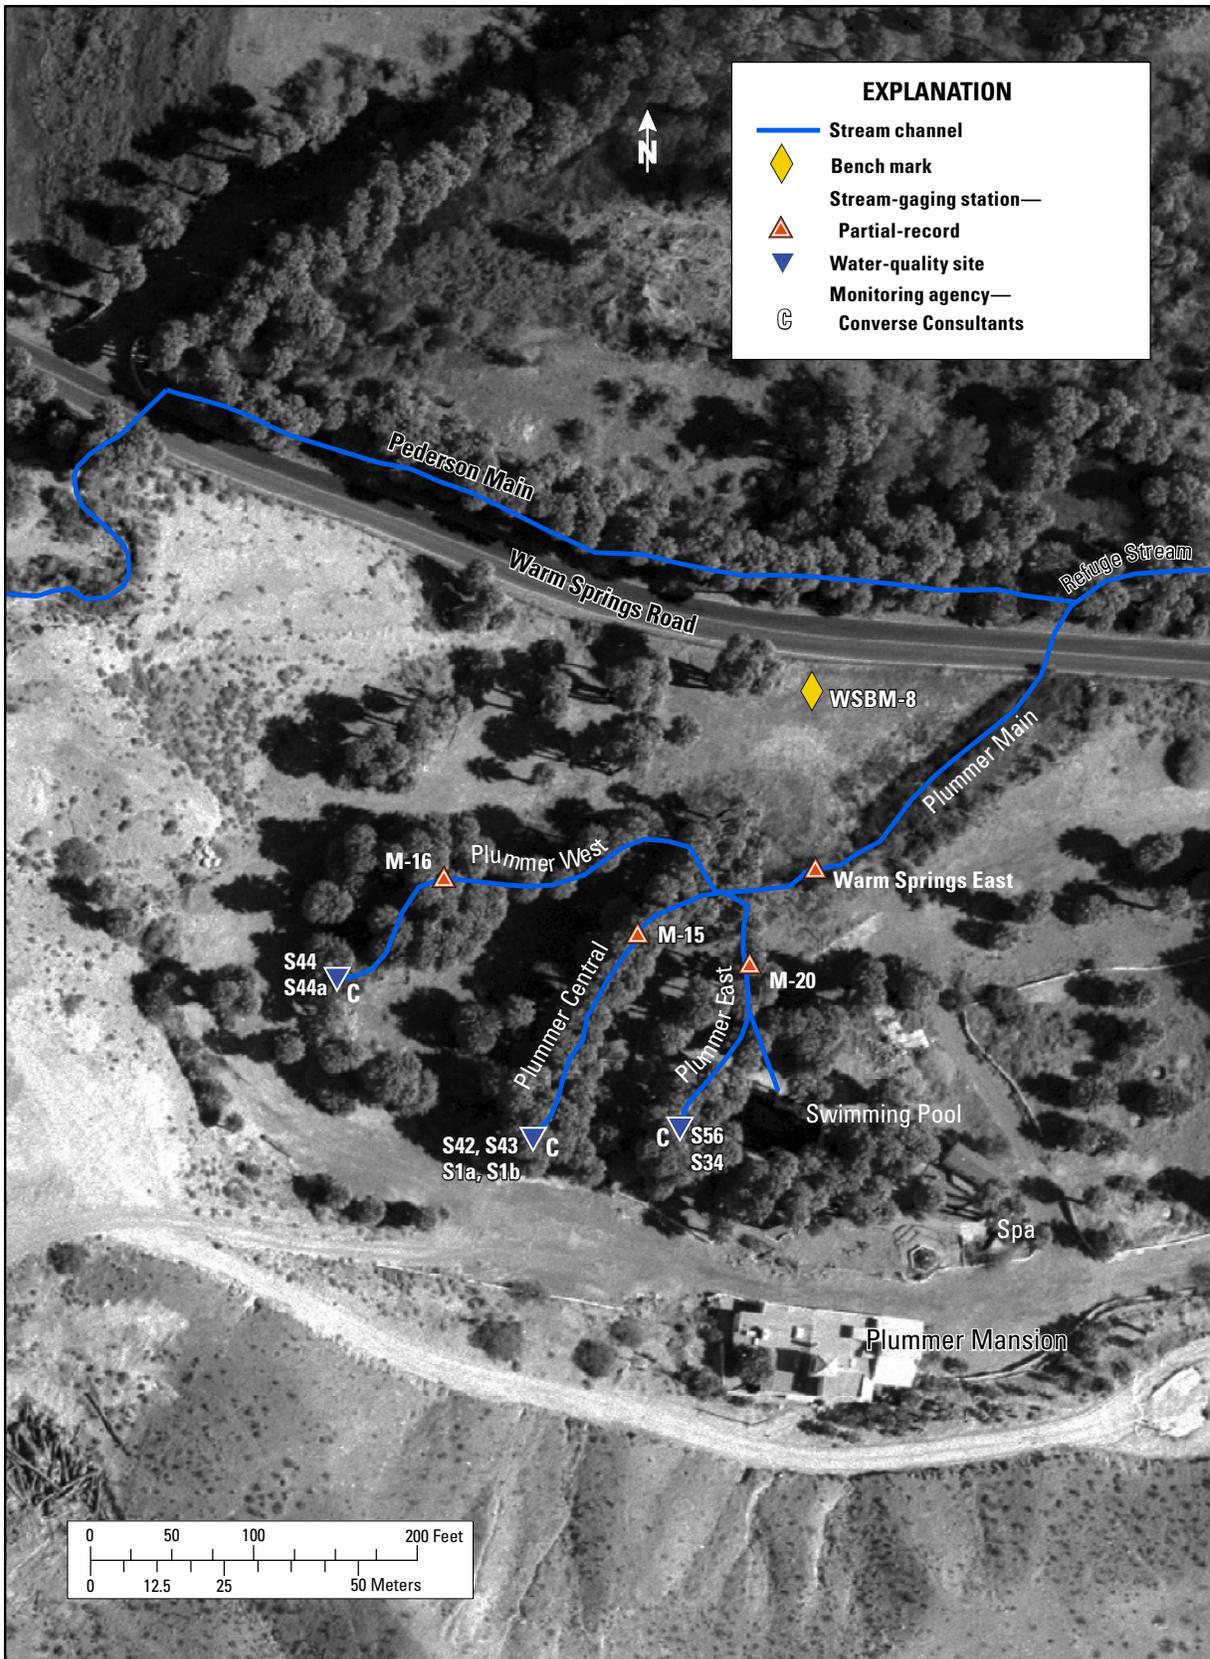
**Figure B9.** Location of Plummer Springs Group stream-gaging station, monitoring sites, and bench mark WSBM-8 in the Warm Springs area near Moapa, Nevada.

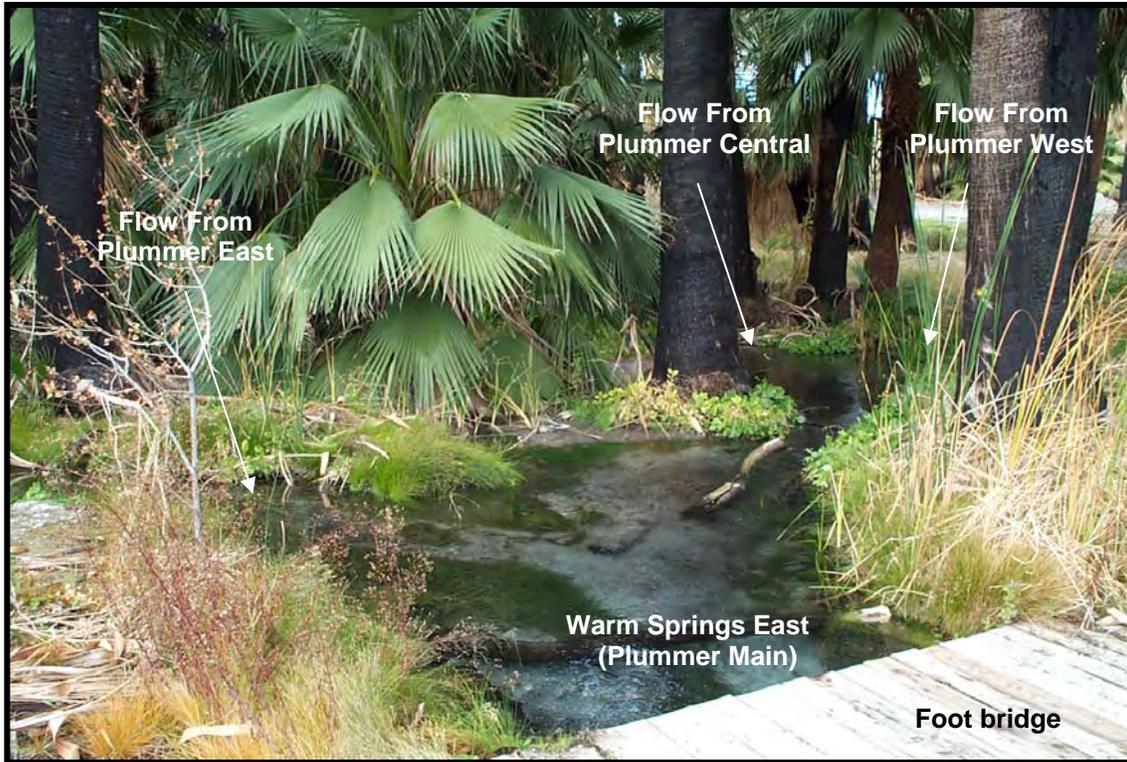
**Warm Springs East  
RM-1 (1,751.08 ft)**

**WSBM-8  
(1,750.70 ft)**

**Figure B11.** Location of bench mark WSBM-8 and reference mark RM-1 for stream-gaging station 364236114424301 Warm Springs East near Moapa, Nevada. Photographed June 10, 2004 by D. Beck. Elevation bench and reference marks in feet above NAVD 88.

Photographs of the staff plate and bench mark, and of the reference mark established by the USGS at the Warm Springs East stream-gaging station on June 10, 2004, are shown in [figure B11](#).

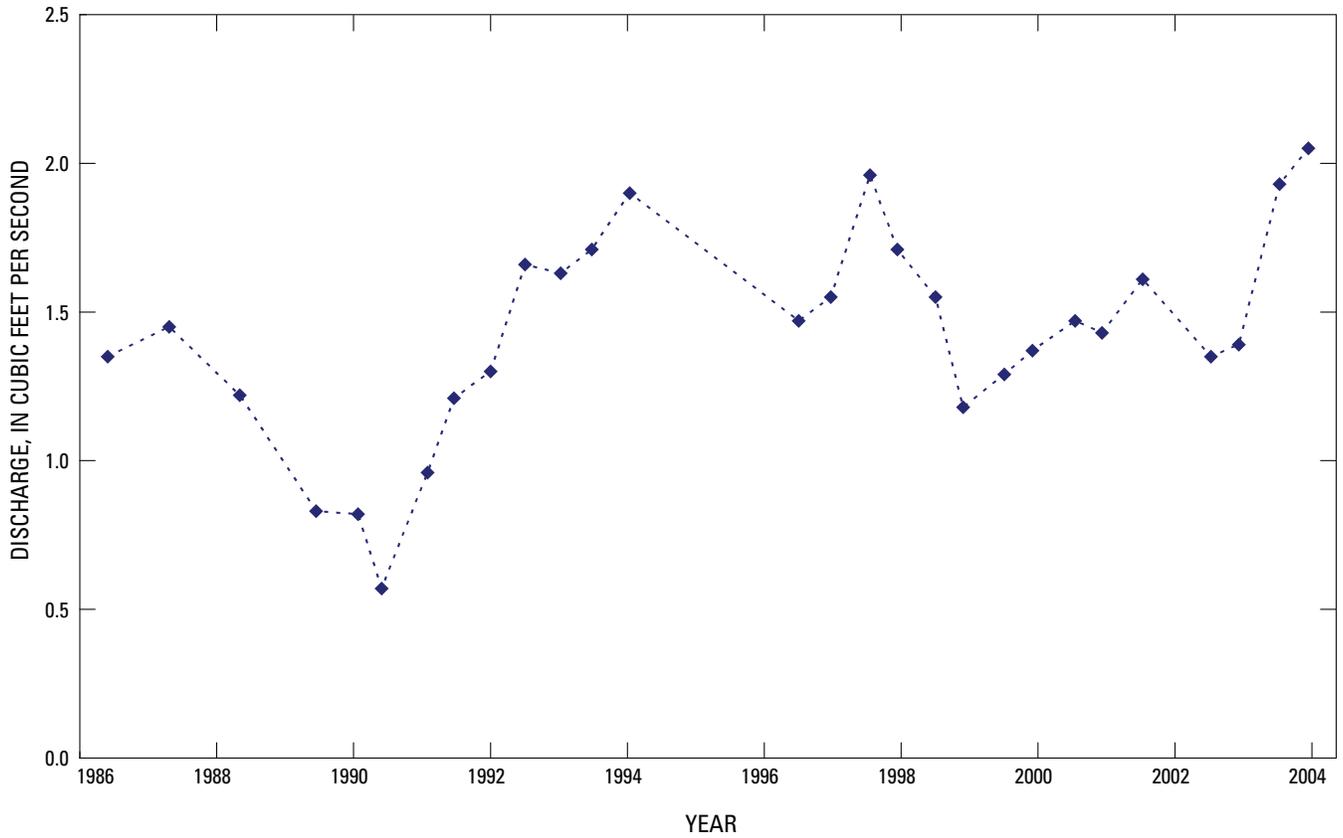
**Figure B12.** Periodic discharge measurements for partial-record stream-gaging station 364238114424401, Muddy River Springs 15 (M-15) near Moapa, Nevada, 1987–2004. Data from U.S. Geological Survey National Water Information System (NWIS) database, accessed 2005 at <http://waterdata.usgs.gov>.

Service (FWS). The FWS removed many of the former resort's recreational facilities and currently is restoring the springs. Periodic discharge measurements have been made by the USGS since 1987. Discharge measurements for the period of record are plotted in [figure B12](#) and listed in [table B6](#).

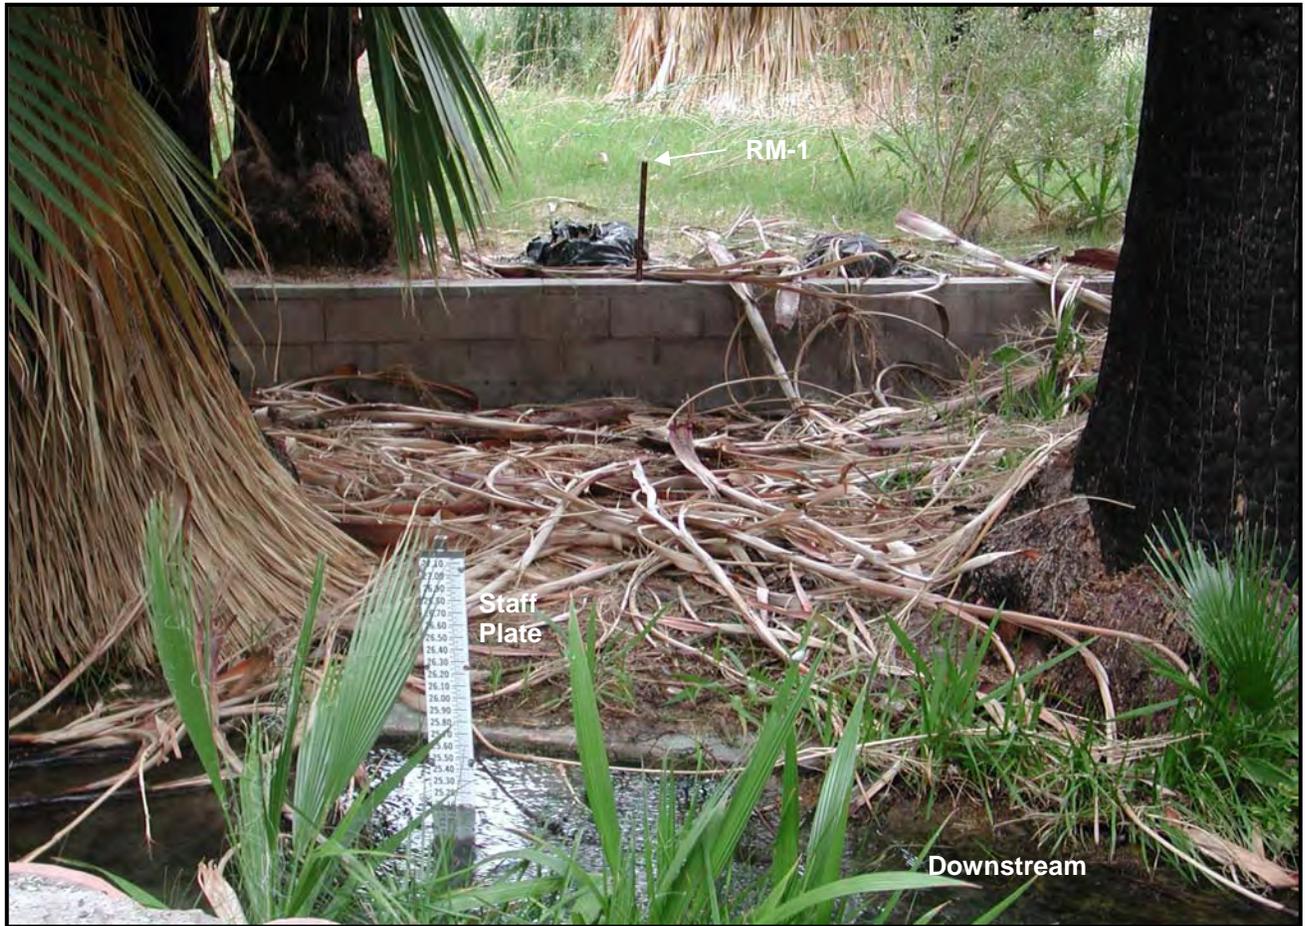
**Figure B13.** Location of staff plate and reference mark (RM-1) at station 364238114424401 Muddy River Springs 15 (M-15) near Moapa, Nevada, and view of upstream pond. Photographed June 10, 2004 by D. Beck.

Photographs of the staff plate and reference mark established for the Muddy River Springs 15 monitoring site on June 10, 2004, are included in [figure B13](#).

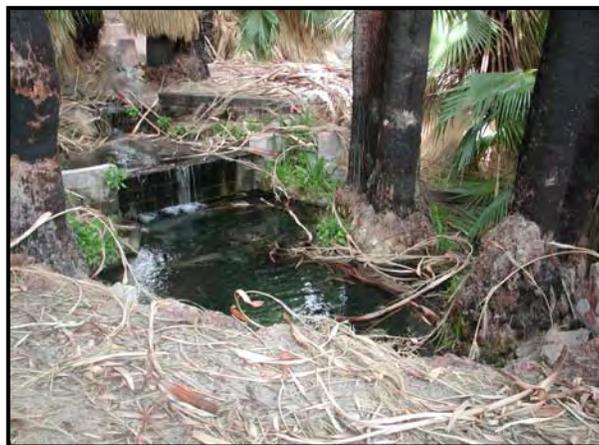
Pond upstream of M-15

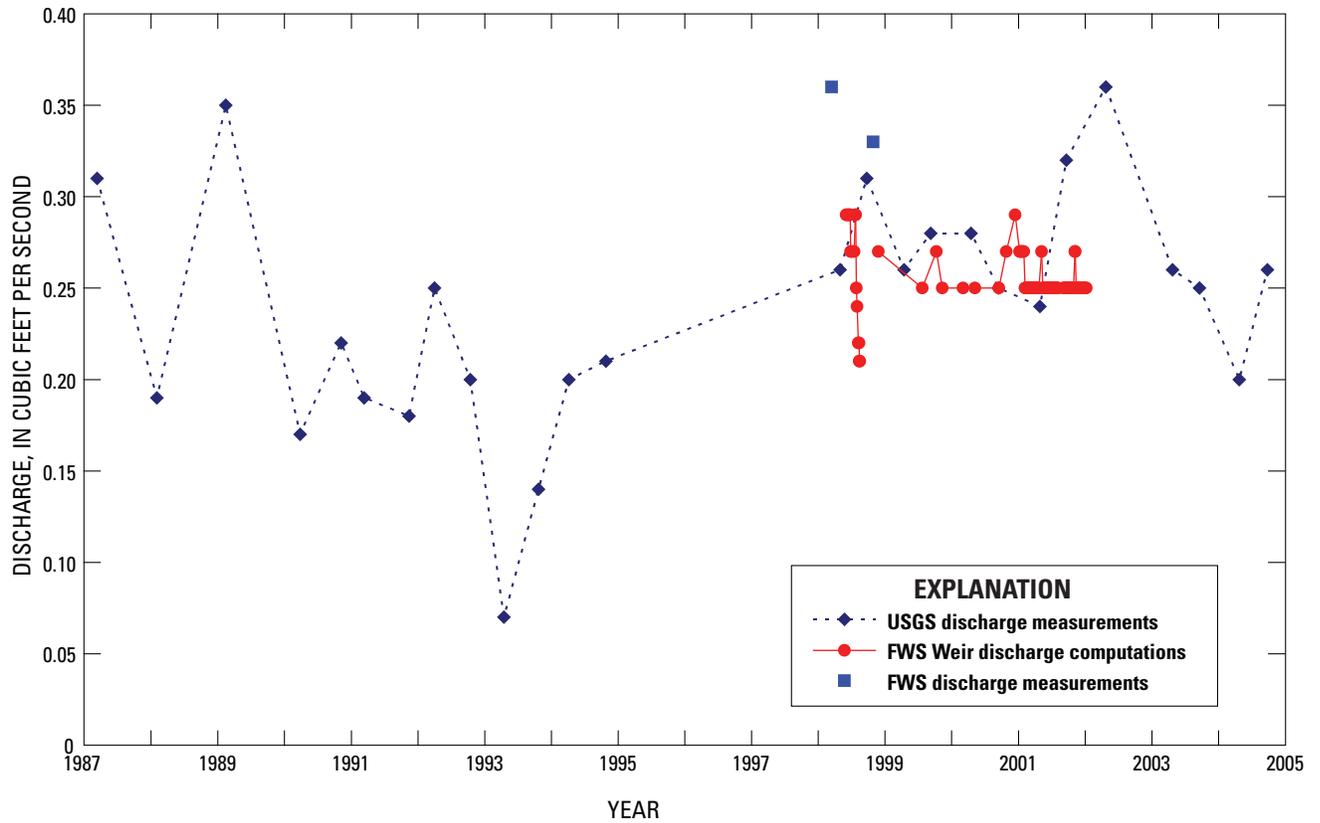
**Figure B14.** Periodic discharge measurements for partial-record stream-gaging station 364238114424201 Muddy River Springs (M-16) near Moapa, Nevada. Data from U.S. Geological Survey (USGS) National Water Information System (NWIS) database, accessed 2005, at <http://waterdata.usgs.gov>, and U.S. Fish and Wildlife Service (FWS).

The partial-record gaging station at Muddy River Springs 16 (M-16) was established by the U.S. Geological Survey (USGS) on March 12, 1987, and is about 225 ft upstream of the confluence with the Plummer Central tributary ([fig. B9](#)). Discharge at Muddy River Springs 16 originates from a spring-fed pond just upstream of the gage. The area around the spring had previously been developed for trailers and recreational vehicles by the former Desert Oasis Warm Springs Resort. The area is now part of the Moapa Valley National Wildlife Refuge. U.S. Fish and Wildlife Service (FWS) has removed many of the resort's facilities and is currently restoring the springs. Periodic discharge measurements have been made by the USGS since 1987. Discharge measurements for the period of record are plotted in [figure B14](#) and listed in [table B7](#).

In March 1998, the FWS installed a 90-degree v-notch weir and staff plate in the channel. From 1998 to January 2002, FWS made periodic water-level measurements at the weir as well as two measurements of discharge. Discharges for the water-level measurements were computed using a standard weir rating (Rantz, 1982) and are plotted in [figure B14](#). The computed and manual discharge measurements are listed in [table B8](#).

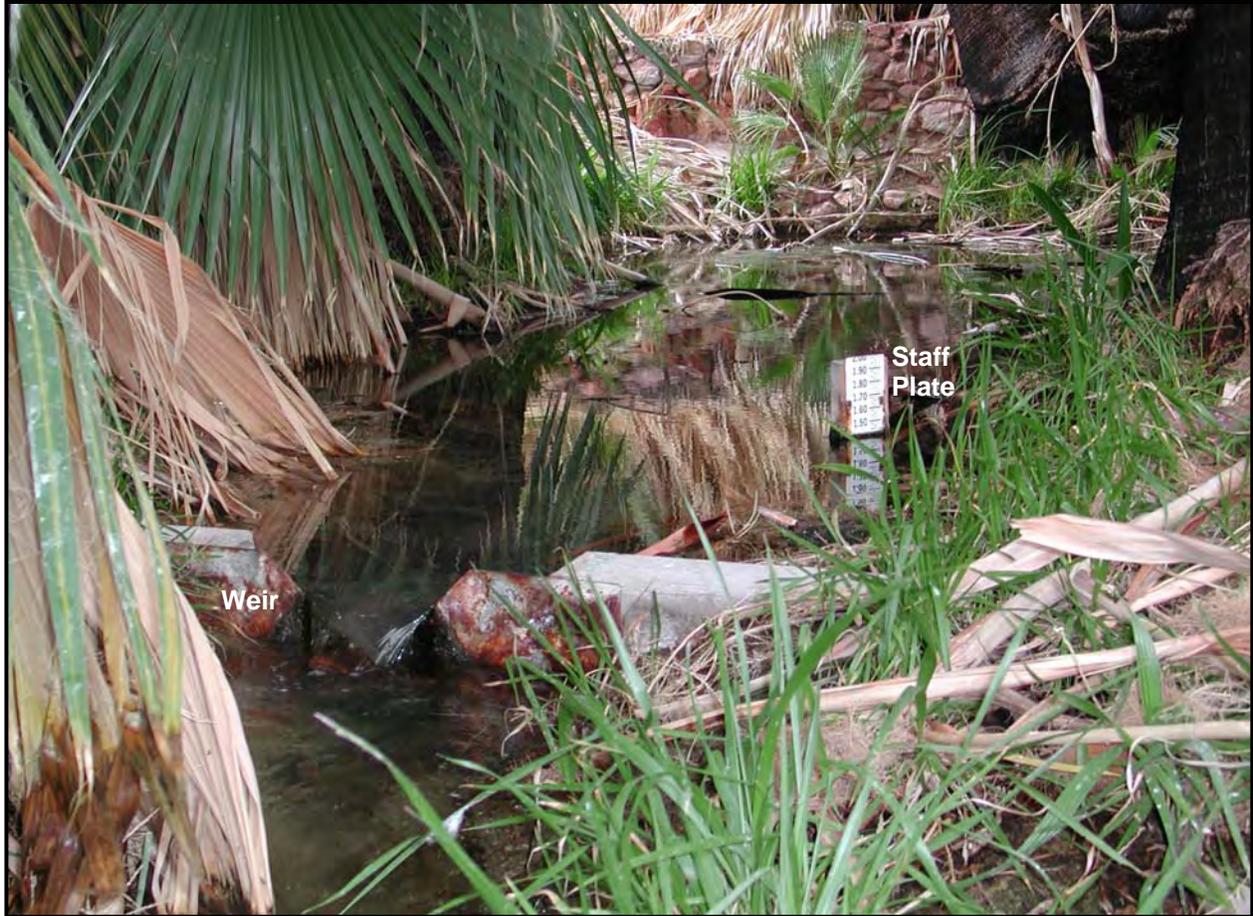
RM-1  
(1,758.08 ft)

**Figure B15.** Location of U.S. Fish and Wildlife Service weir and staff plate, and reference mark (RM-1) at partial-record stream-gaging station 364238114424201 Muddy River Springs 16 (M-16) near Moapa, Nevada. Photographed June 10, 2004 by D. Beck. Elevation of RM-1 in feet above NAVD 88.

Photographs of the FWS weir and staff plate and of the USGS reference mark established on June 10, 2004, are included in [figure B15](#). On May 26, 2005, the weir, staff plate, and reference mark were observed to have been destroyed as a result of restoration work at the refuge.

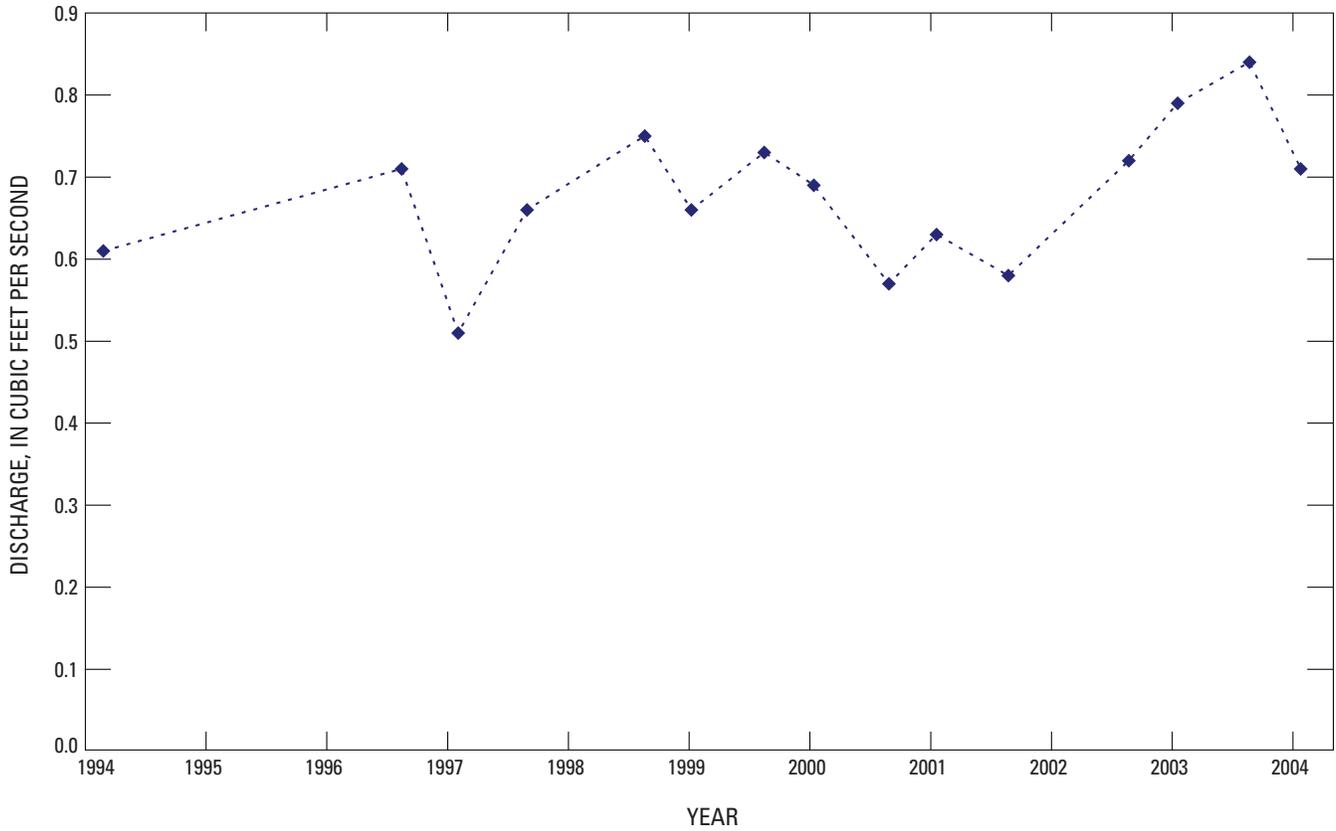
**Figure B16.** Periodic discharge measurements for partial-record stream-gaging station 364238114424301 Muddy River Springs 20 (M-20) near Moapa, Nevada, 1994–2004. Data from U.S. Geological Survey (USGS) National Water Information System (NWIS) data base, accessed 2005 at <http://waterdata.usgs.gov>

recreational facilities and currently is restoring the springs. Periodic discharge measurements have been made by the USGS since 1994. Discharge measurements for the period of record are plotted in [figure B16](#) and listed in [table B9](#).

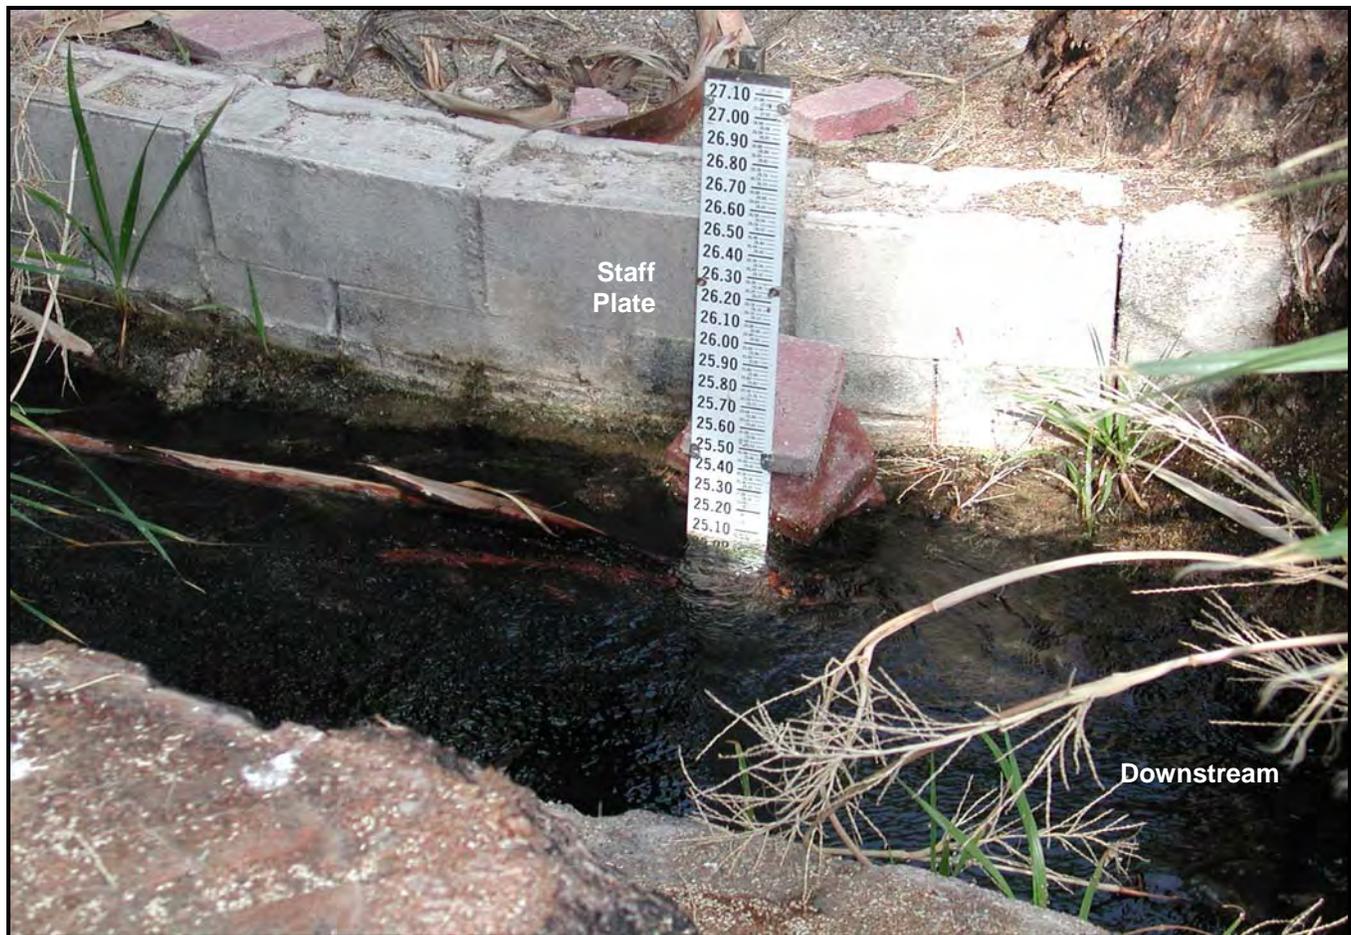
Swimming pool upstream of M-20

**Figure B17.** Location of the staff plate at partial-record stream-gaging station 364238114424301 Muddy River Springs 20 (M-20) near Moapa, Nevada, and view of the spring-fed swimming pool upstream of the gage. Photographed June 10, 2004 by D. Beck.

Photograph of the staff plate established for the Muddy River Springs 20 monitoring station on June 10, 2004, is included in [figure B17](#). On May 26, 2005, the large swimming pool upstream of the gage was observed to have been removed as part of the restoration program at the refuge.
