**Appendix B. Water-Level, Discharge, and  
Water-Quality Data for Selected Monitoring Sites  
Within the Warm Springs Area Near Moapa, Nevada**

## 09416000 Muddy River near Moapa, Nevada

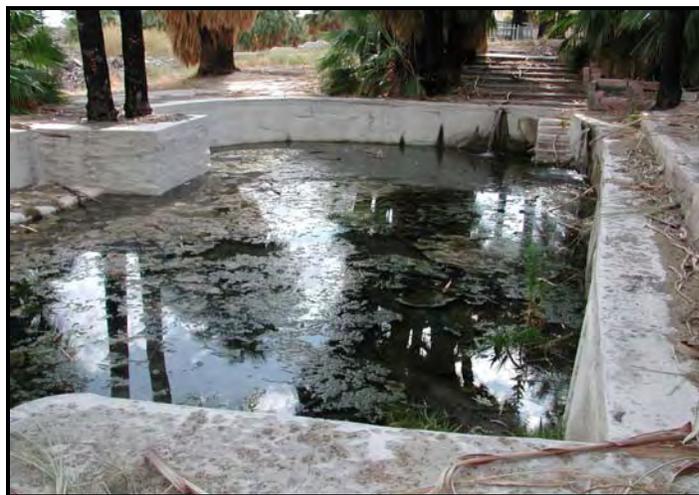
Swimming pool upstream of M-20

**Figure B17.** Location of the staff plate at partial-record stream-gaging station 364238114424301 Muddy River Springs 20 (M-20) near Moapa, Nevada, and view of the spring-fed swimming pool upstream of the gage. Photographed June 10, 2004 by D. Beck.

Photograph of the staff plate established for the Muddy River Springs 20 monitoring station on June 10, 2004, is included in [figure B17](#). On May 26, 2005, the large swimming pool upstream of the gage was observed to have been removed as part of the restoration program at the refuge.

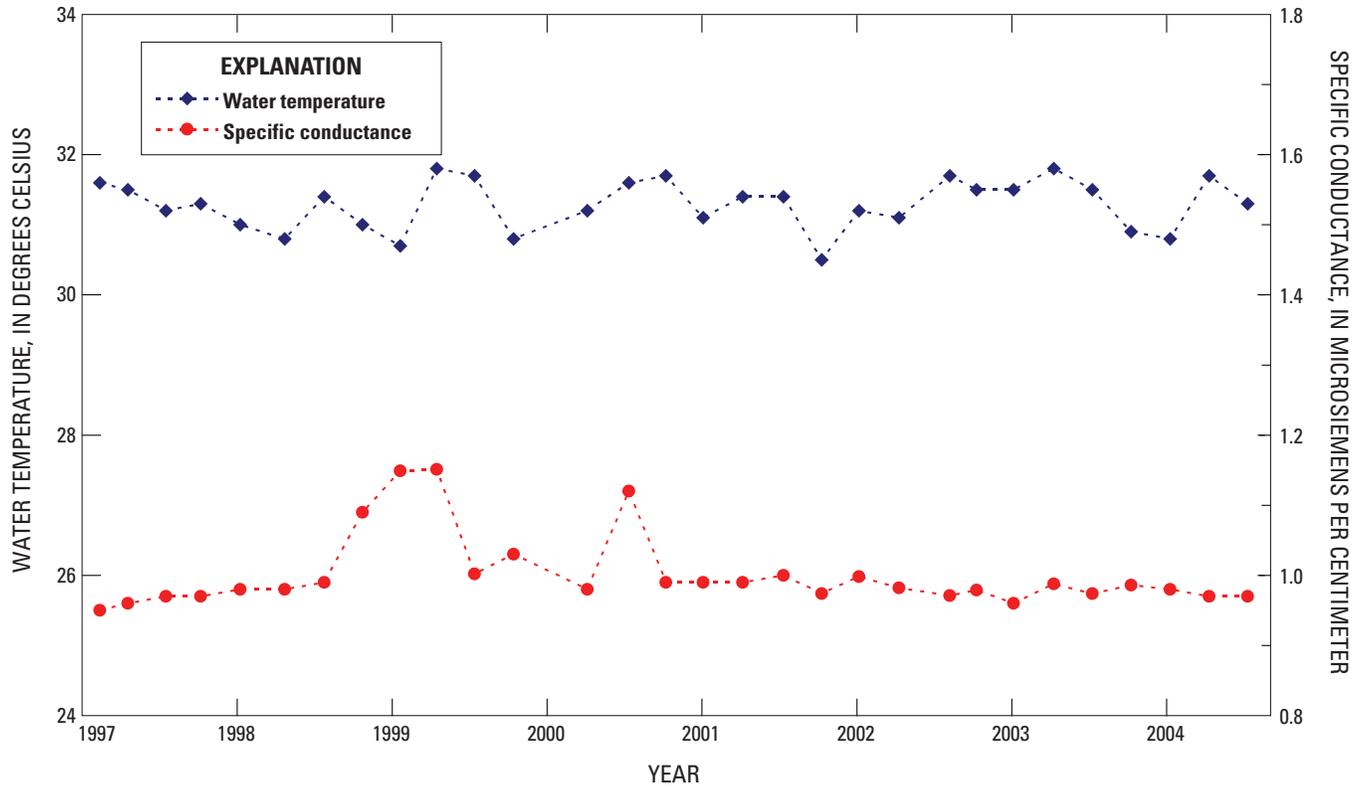
**Figure B18.** Water-temperature and specific-conductance measurements by Converse Consultants at site S1a in the Plummer Springs Group near Moapa, Nevada, 1997–2004.

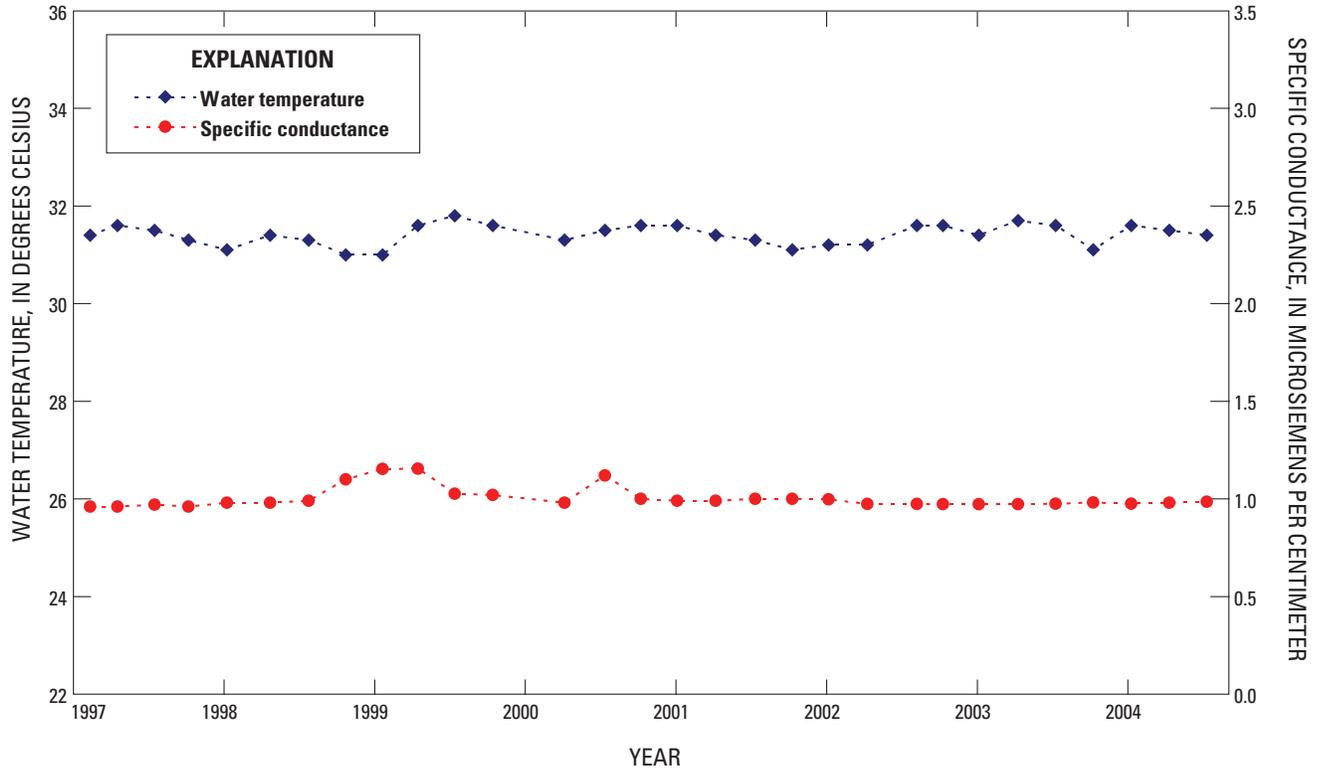
**Figure B19.** Water-temperature and specific-conductance measurements by Converse Consultants at site S1b in the Plummer Springs Group near Moapa, Nevada, 1997–2004.

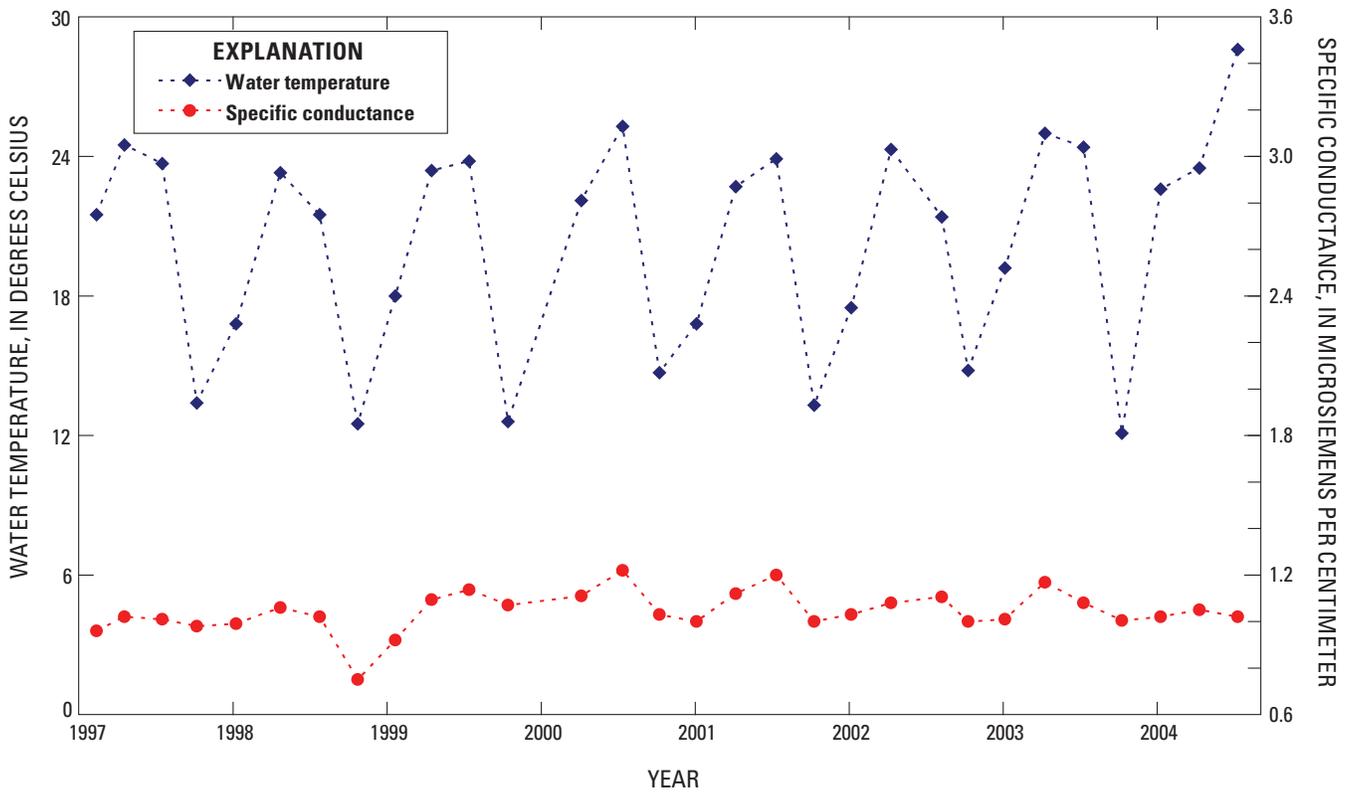
**Figure B20.** Water-temperature and specific-conductance measurements by Converse Consultants at site S34 in the Plummer Springs Group near Moapa, Nevada, 1997–2004.

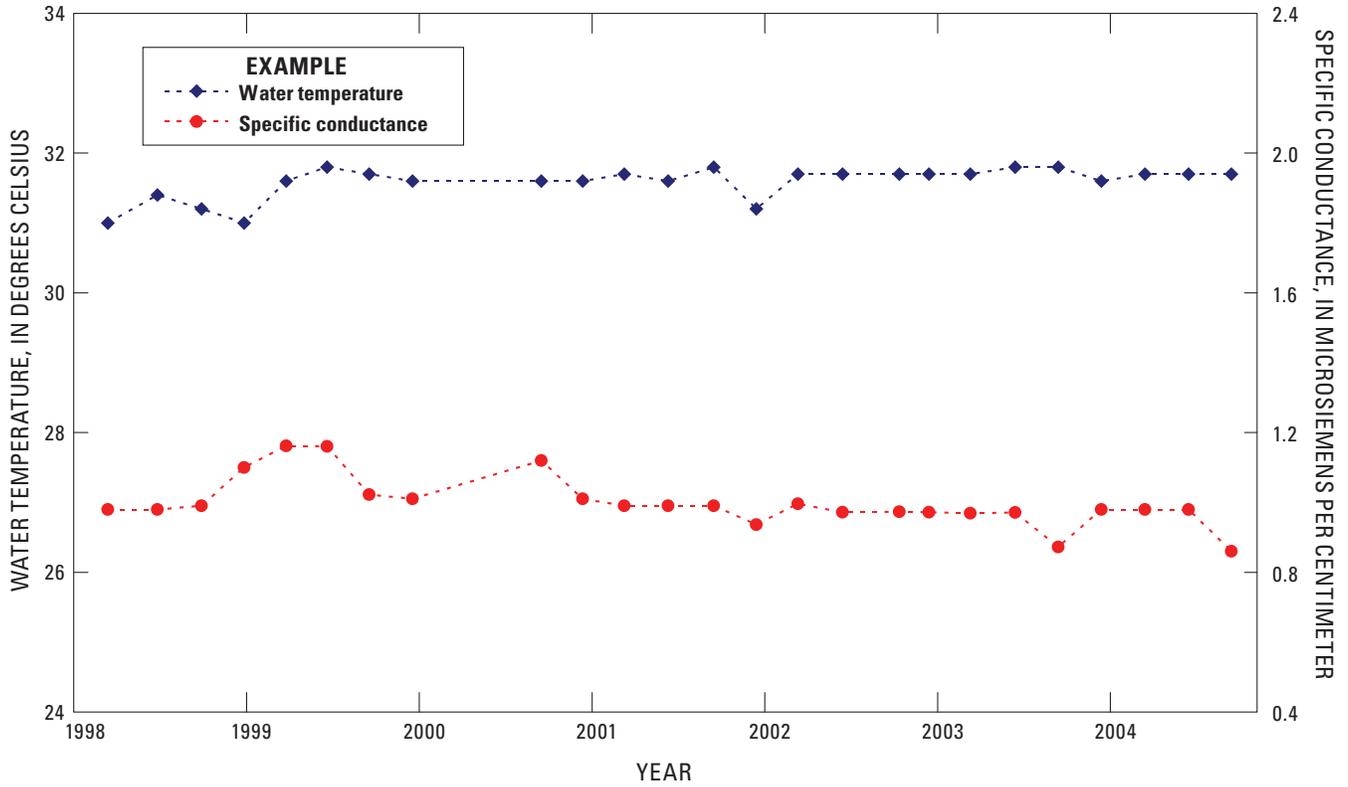
**Figure B22.** Water-temperature and specific-conductance measurements by Converse Consultants at site S43 in the Plummer Springs Group near Moapa, Nevada, 1997–2004.

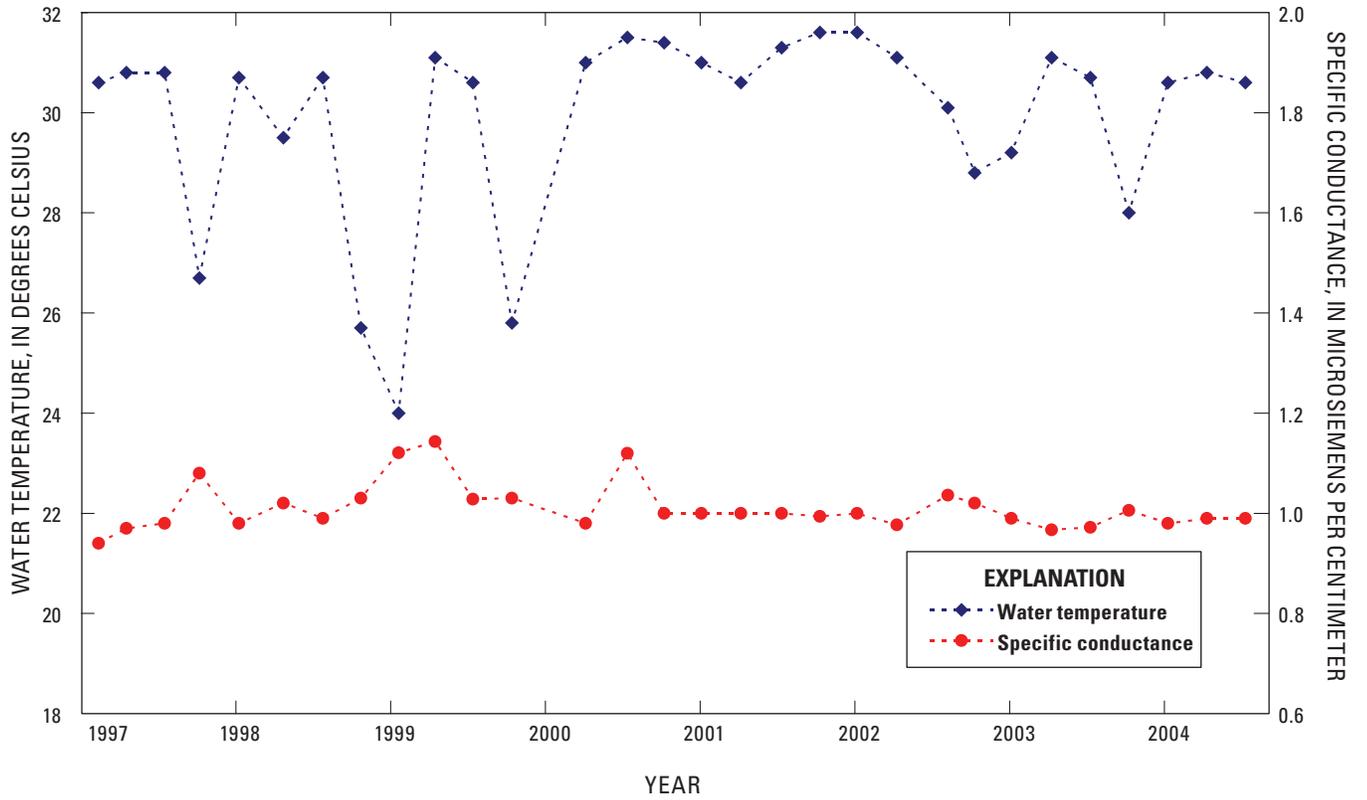
**Figure B23.** Water-temperature and specific-conductance measurements by Converse Consultants at site S44 in the Plummer Springs Group near Moapa, Nevada, 1997–2004.

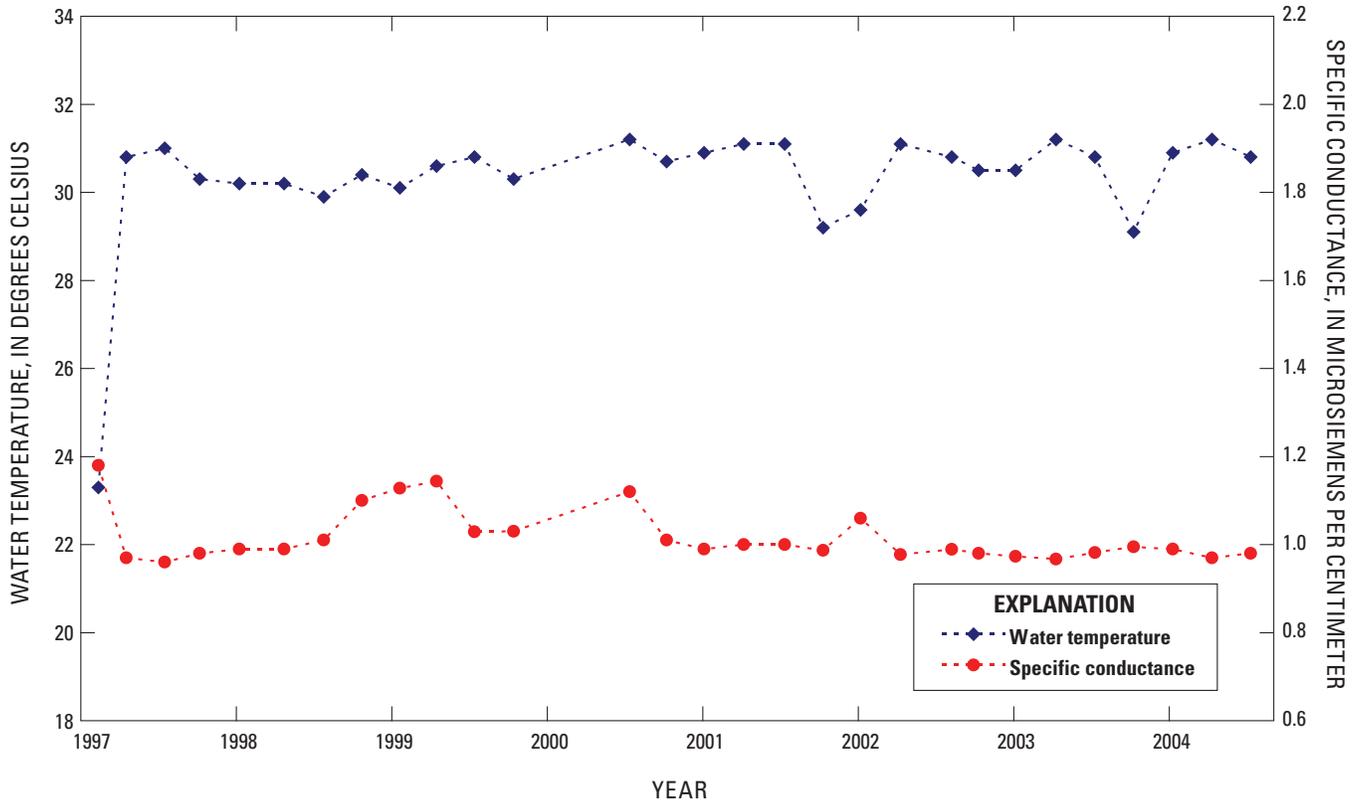
Figure B24. Water-temperature and specific-conductance measurements by Converse Consultants at site S44a in the Plummer Springs Group near Moapa, Nevada, 1997–2004.

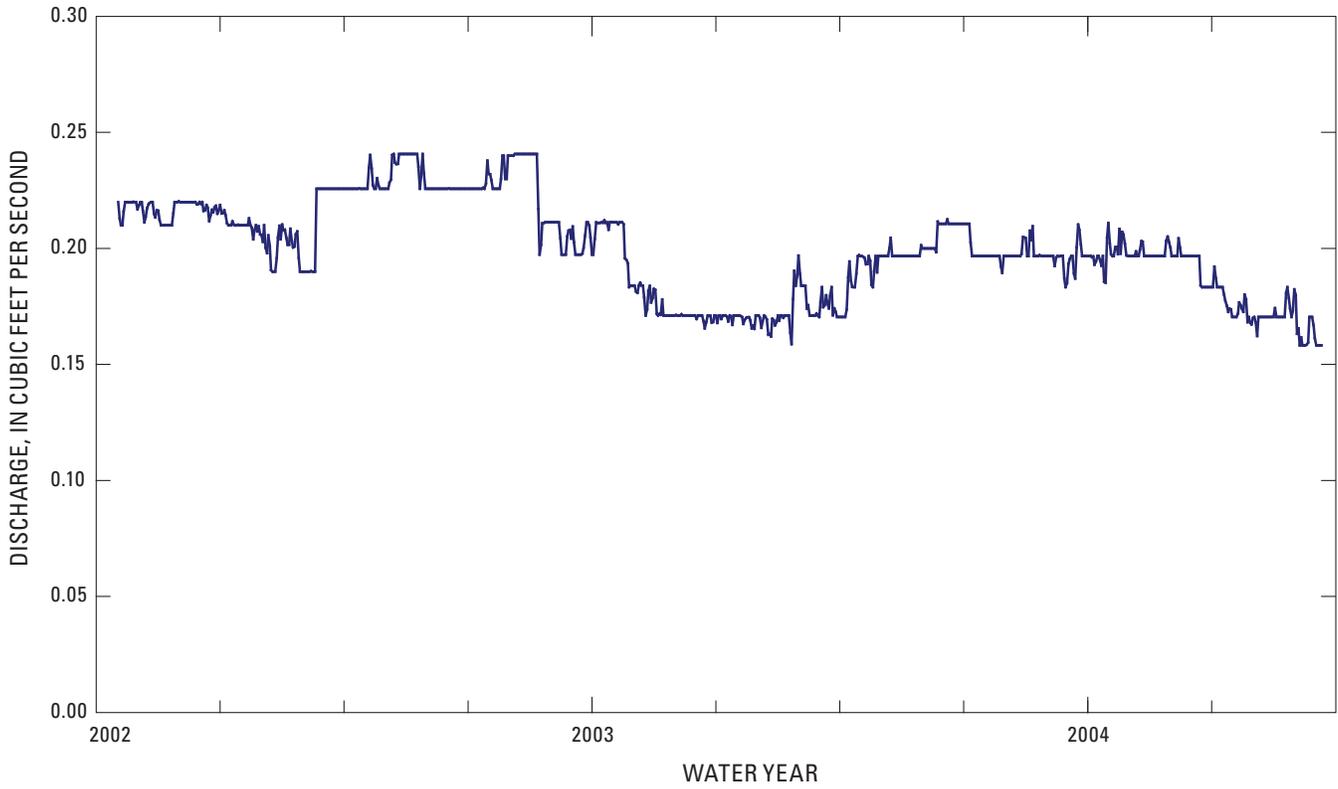
**Figure B27.** Daily mean discharges for continuous-record stream-gaging station 09415908 Pederson East Spring near Moapa, Nevada, water years 2002–04.

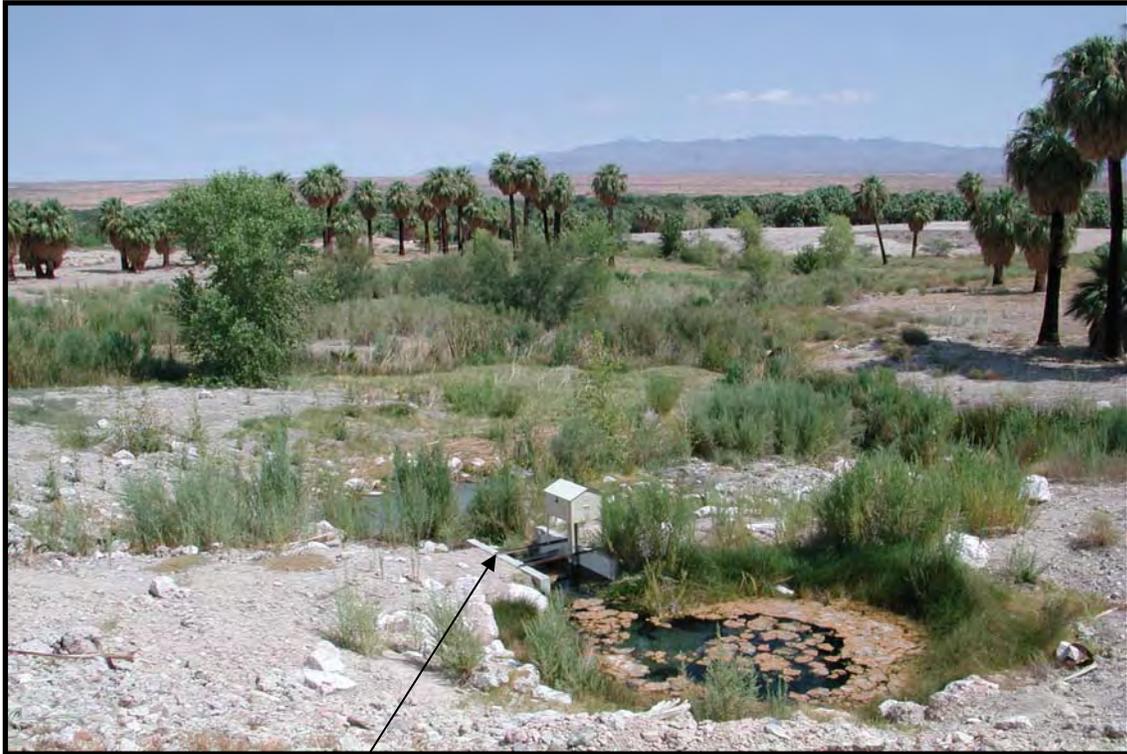
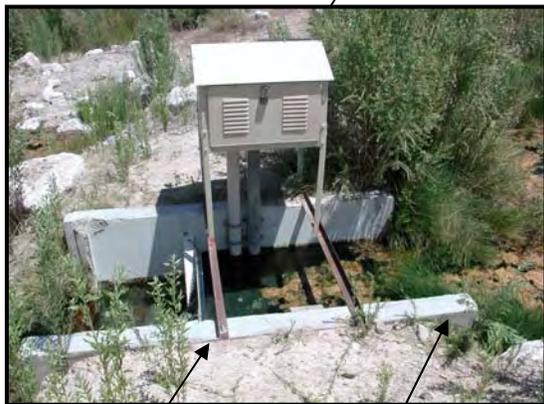
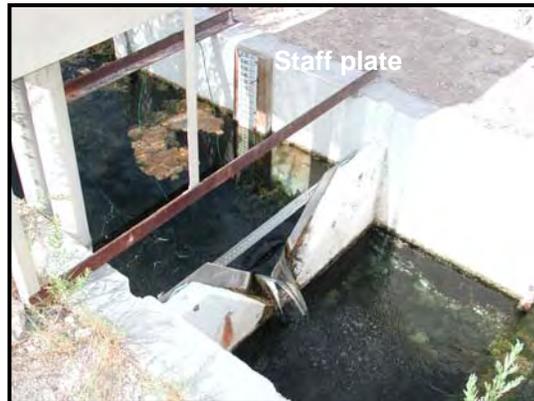
RM-2  
(1,807.73 ft)

RM-3  
(1,807.62 ft)

Staff Plate  
and Weir

**Figure B28.** Location of staff plate and selected reference marks (RM) for station 09415908 Pederson East Spring in the Moapa Valley National Wildlife Refuge near Moapa, Nevada. Photographed June 9, 2004 by D. Beck. Elevation in feet above NAVD 88.

Daily mean discharges for the period of record are plotted on [figure B27](#) and listed in [table B18](#). Photographs of the gage and weir, and selected reference marks established for this gage on June 9, 2004, are shown in [figure B28](#).

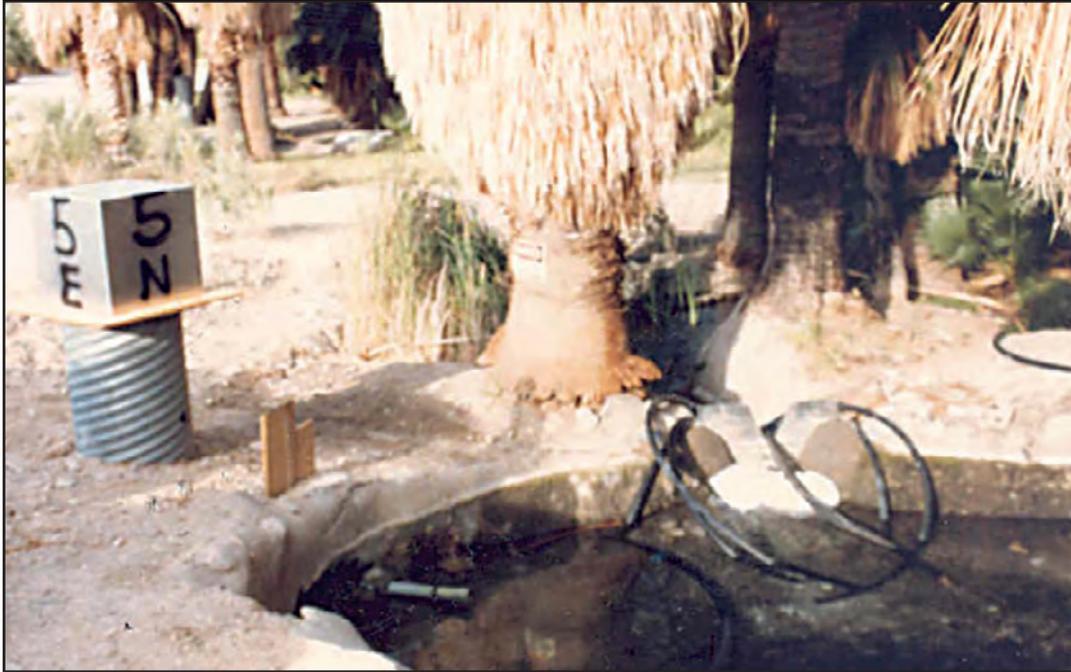
**A.** View of first weir being installed in 1986.

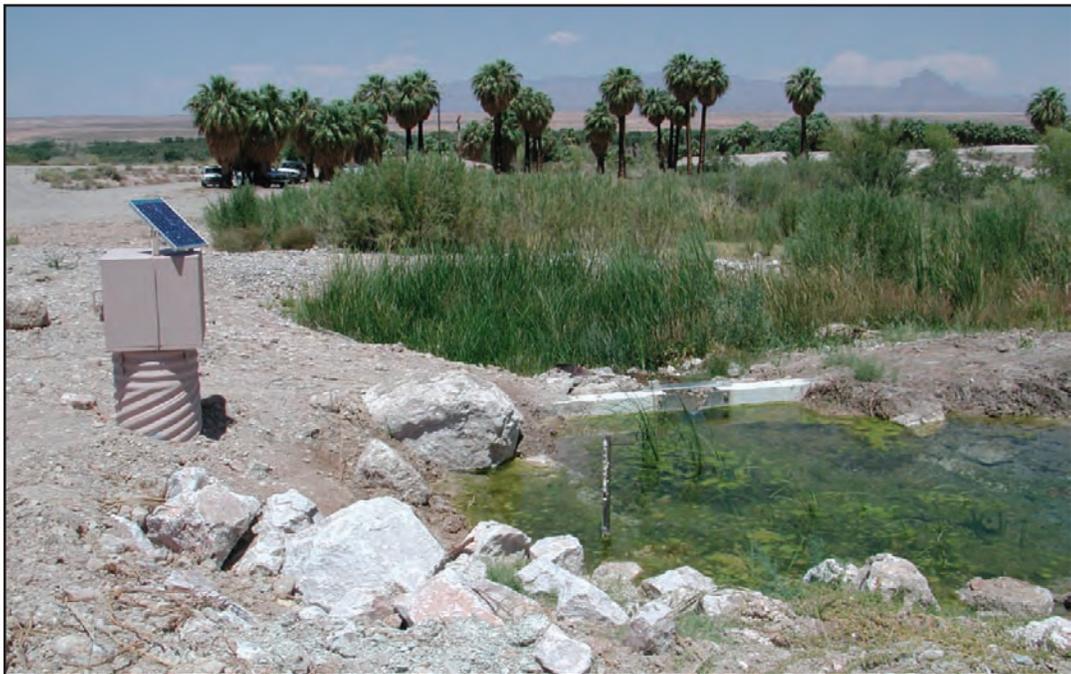
**B.** View of new weir installed in 2004.

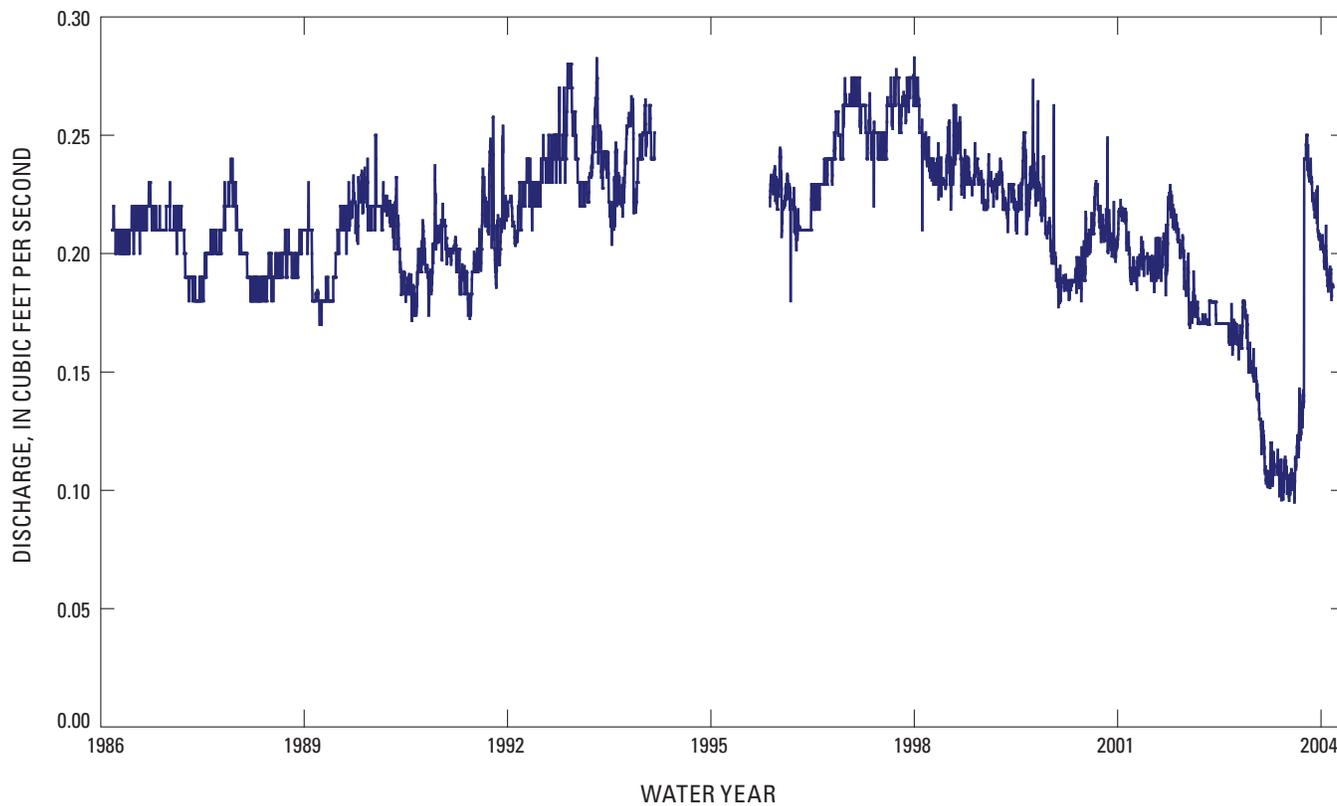
**Figure B30.** Daily mean discharges for continuous-record stream-gaging station 09415910 Pederson Spring near Moapa, Nevada, water years 1987–2004.

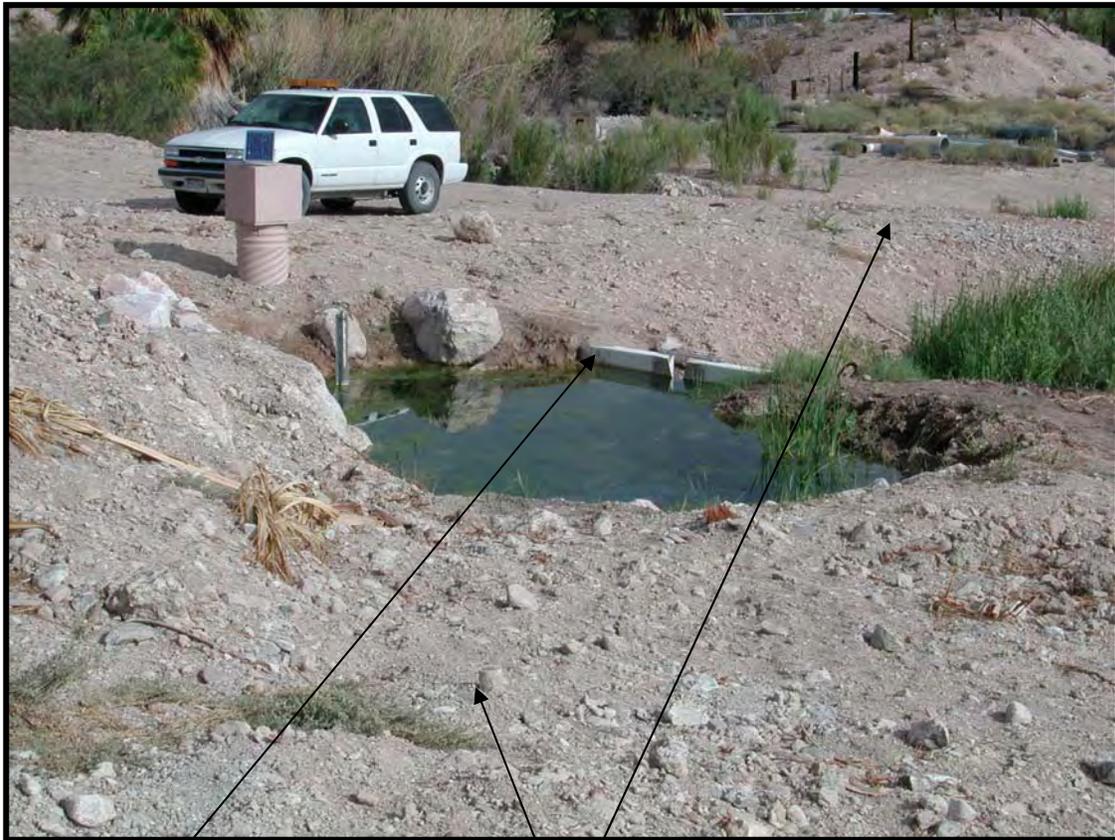
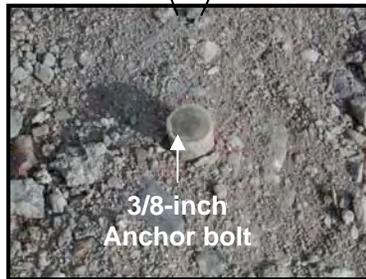
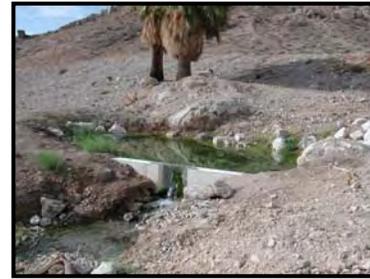
Brass tablet in pipe

**RM-6  
(1,810.95 ft)**

3/8-inch  
Anchor bolt

**RM-5 (foreground)  
(1,814.04 ft)  
RM-4 (background)  
(1,809.32 ft)**

**View of weir  
from  
downstream**

**Figure B31.** Location of selected reference marks (RM) at continuous-record stream-gaging station 09415910 Pederson Spring in the Moapa Valley National Wildlife Refuge near Moapa, Nevada. Photographed June 9, 2004 by D. Beck. Elevation in feet above NAVD 88.

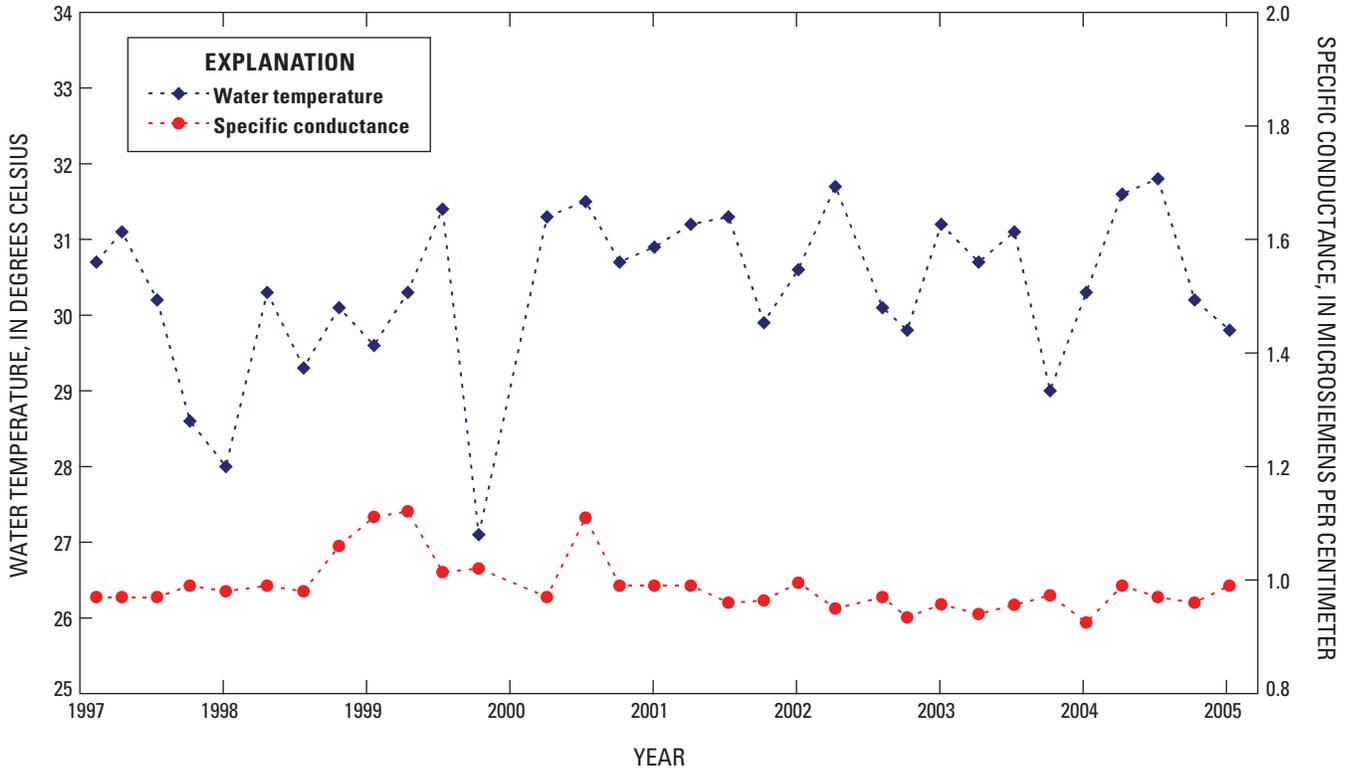
**Figure B32.** Water-temperature and specific-conductance measurements by Converse Consultants for station 09415910 Pederson Spring near Moapa, Nevada, 1997–2005.

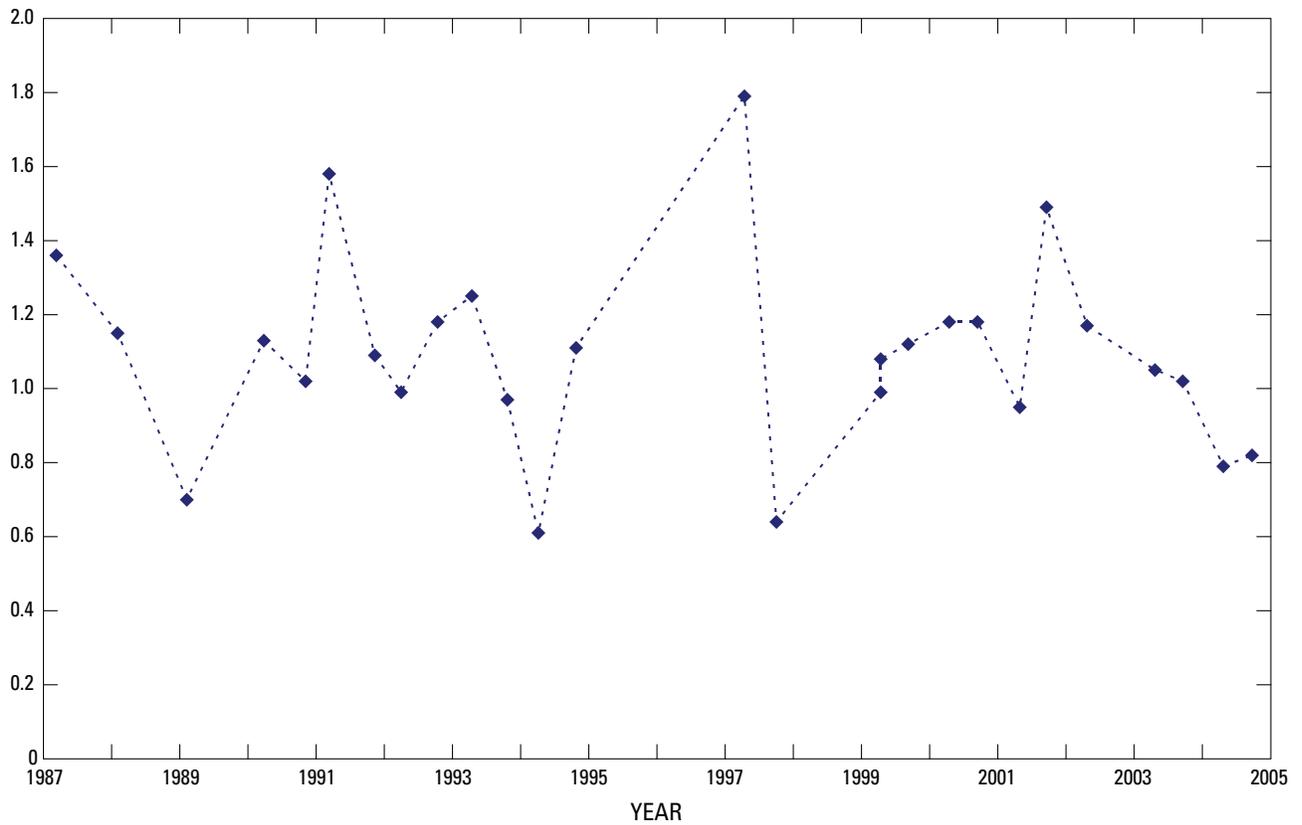
**Figure B33.** Periodic discharge measurements for partial-record stream-gaging station 364235114425201 Muddy River Springs 11 (M-11) near Moapa, Nevada, 1987–2004.

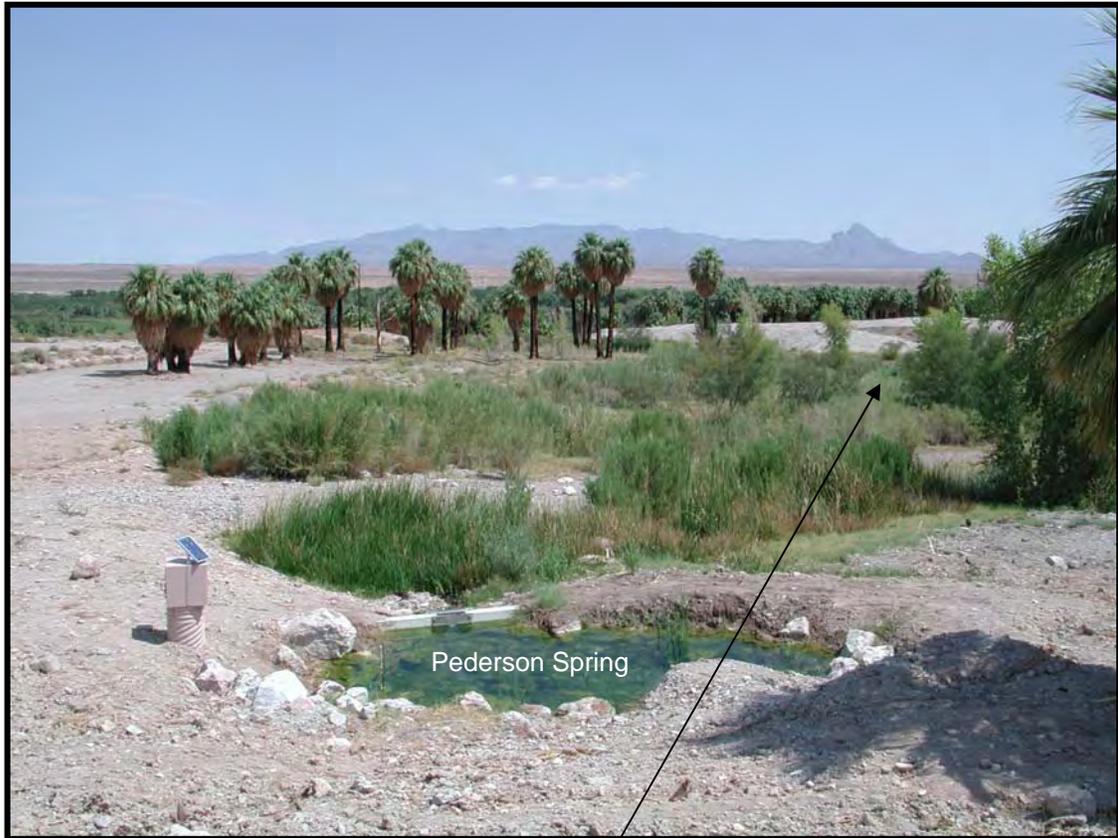
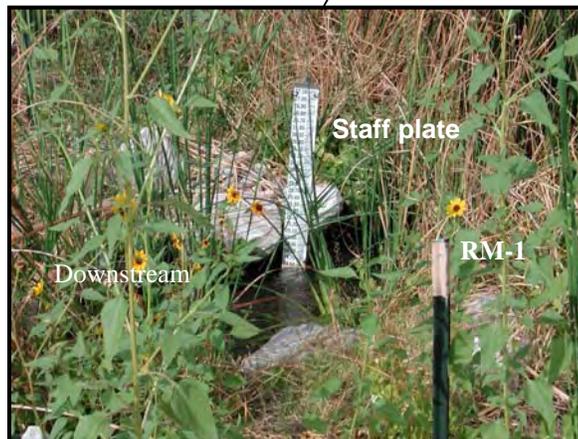
M-11  
RM-1  
(1,795.09 ft)

**Figure B34.** Location of staff plate and reference mark (RM-1) for partial-record stream-gaging station Muddy River Springs 11 (M-11) in the Moapa Valley National Wildlife Refuge near Moapa, Nevada. Photographed June 9, 2004 by D. Beck. Elevation in feet NAVD 88.

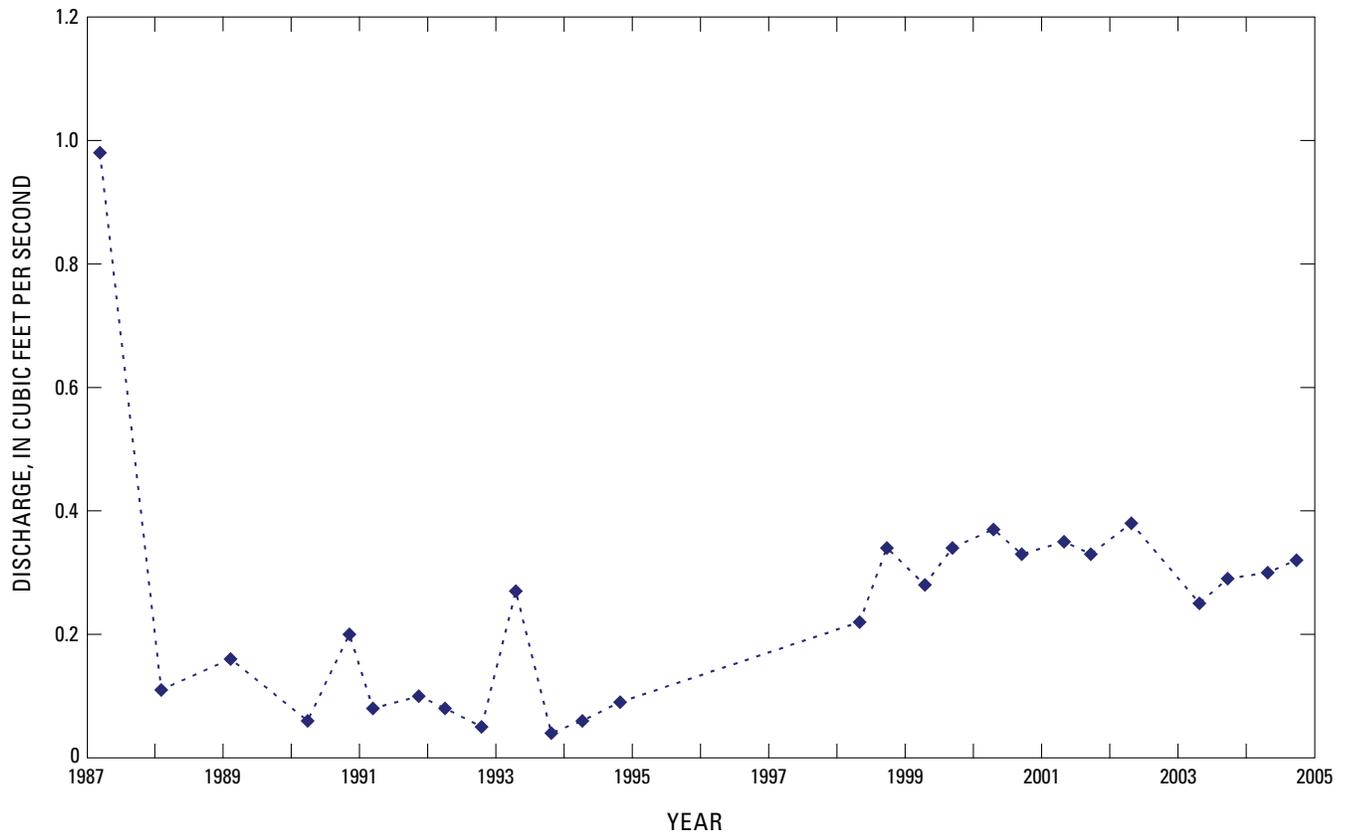
**Figure B35.** Periodic discharge measurements for partial-record stream-gaging station 364237114425401 Muddy River Springs 12 (M-12) near Moapa, Nevada, 1987–2004.

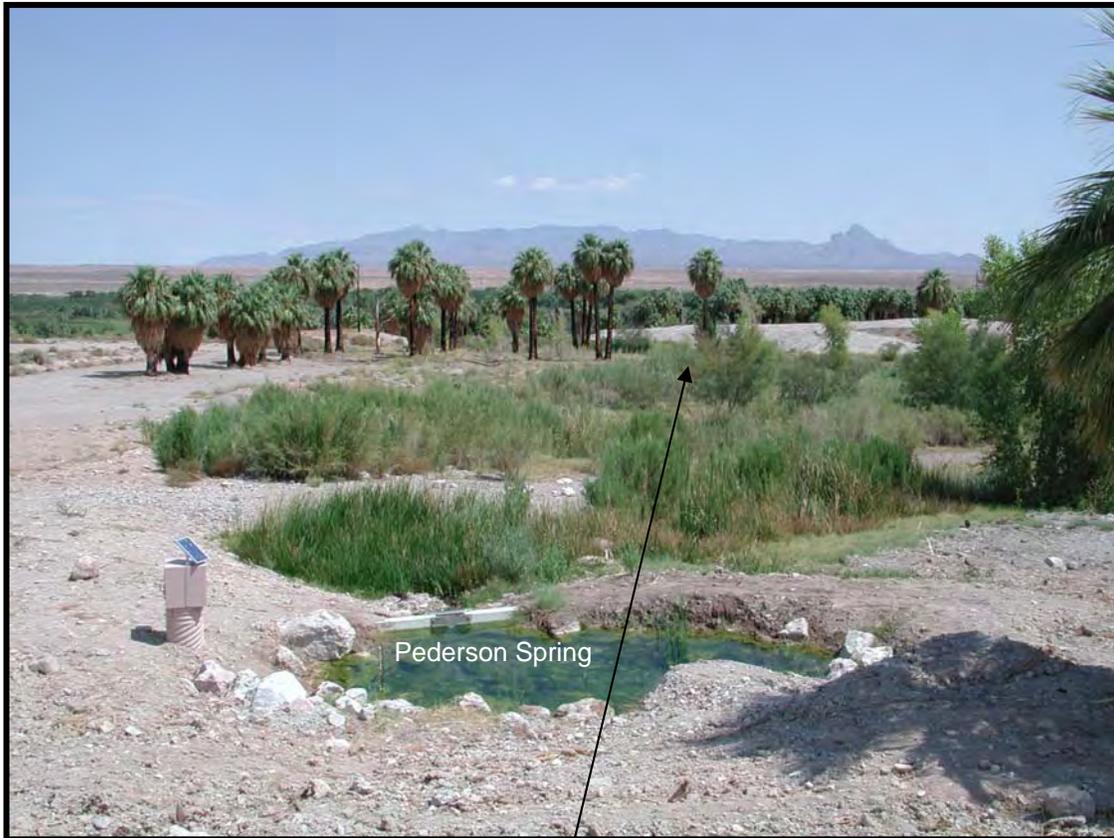
M-12  
RM-2  
**(1,801.49 ft)**

**Figure B36.** Location of staff plate and reference mark (RM-2) for partial-record stream-gaging station Muddy River Springs 12 (M-12) in the Moapa Valley National Wildlife Refuge near Moapa, Nevada. Photographed June 9, 2004 by D. Beck. Elevation in feet above NAVD 88.

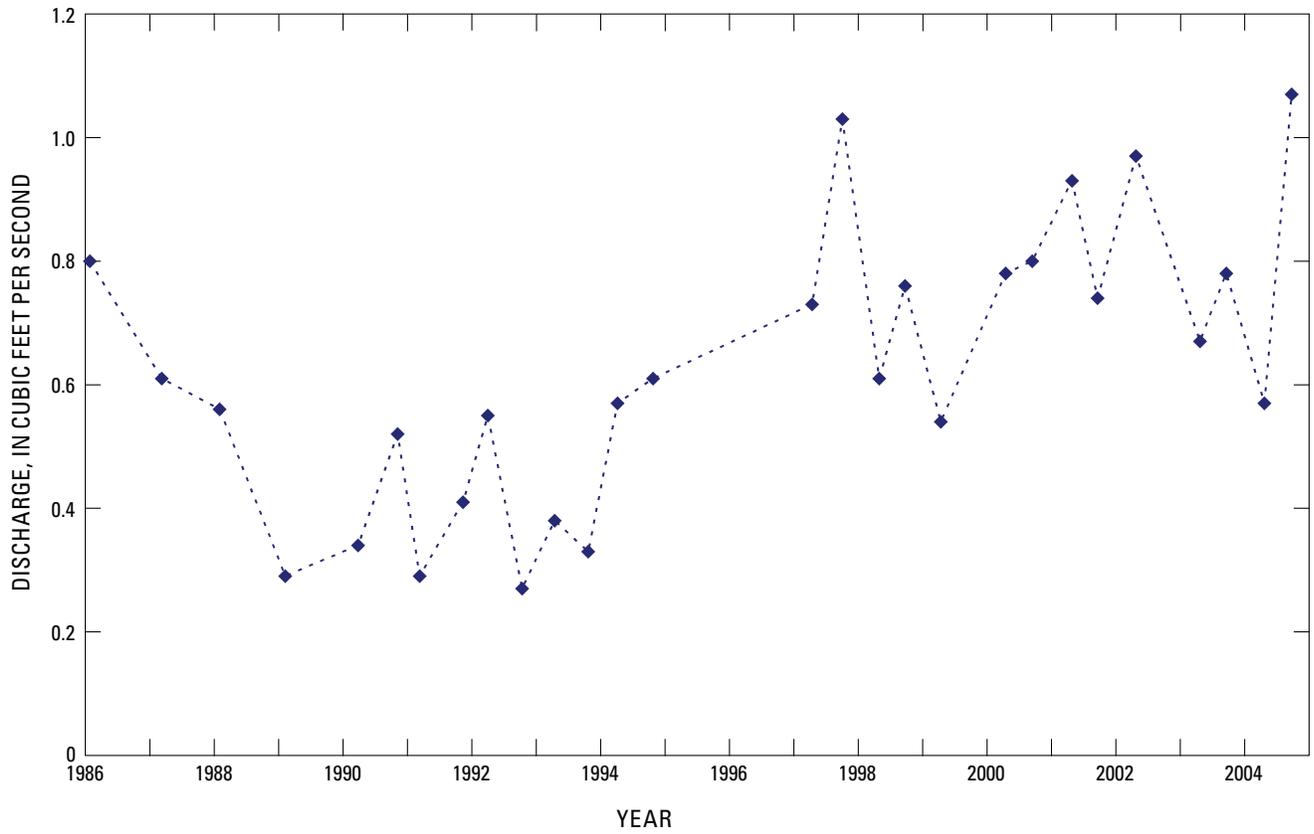
**Figure B37.** Periodic discharge measurements for stream-gaging station 364236114425401 Muddy River Springs 13 (M-13) near Moapa, Nevada, 1986–2004.

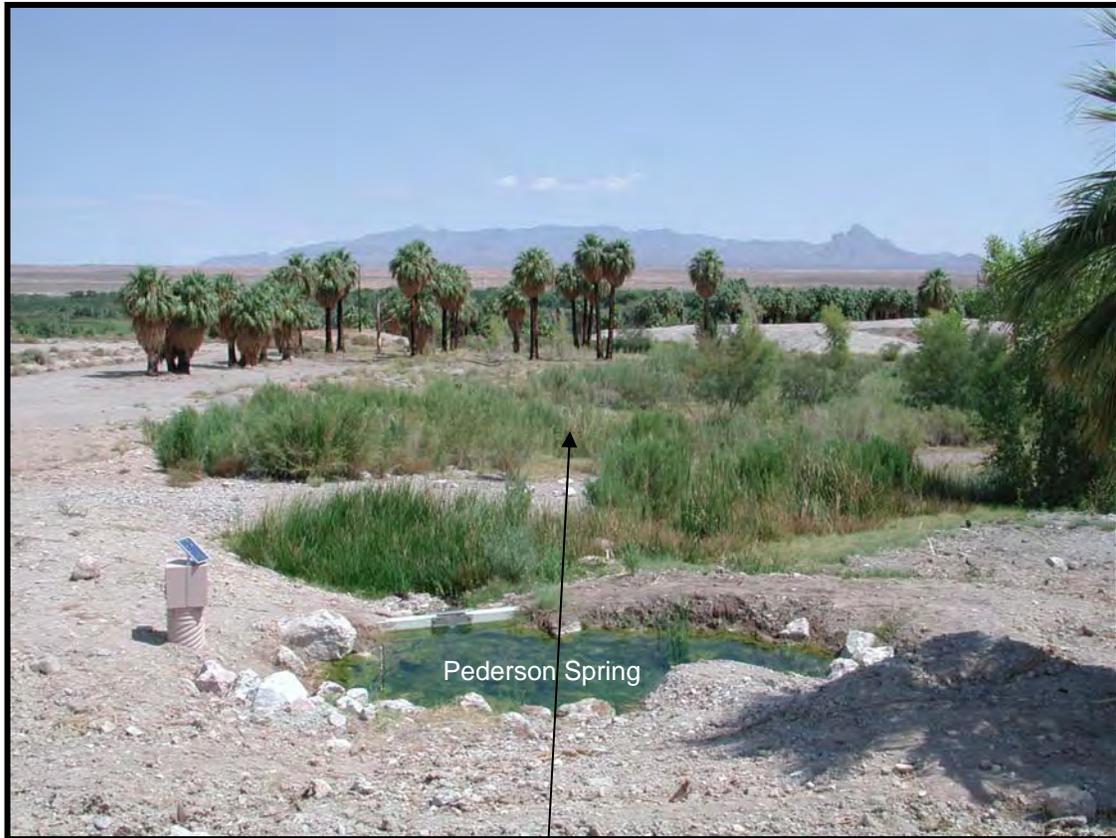
M-13  
RM-1  
(1,802.83 ft)

**Figure B38.** Location of staff plate and reference mark (RM-1) for partial-record stream-gaging station Muddy River Springs 13 (M-13) in the Moapa Valley National Wildlife Refuge near Moapa, Nevada. Photographed June 9, 2004 by D. Beck. Elevation in feet above NAVD 88.

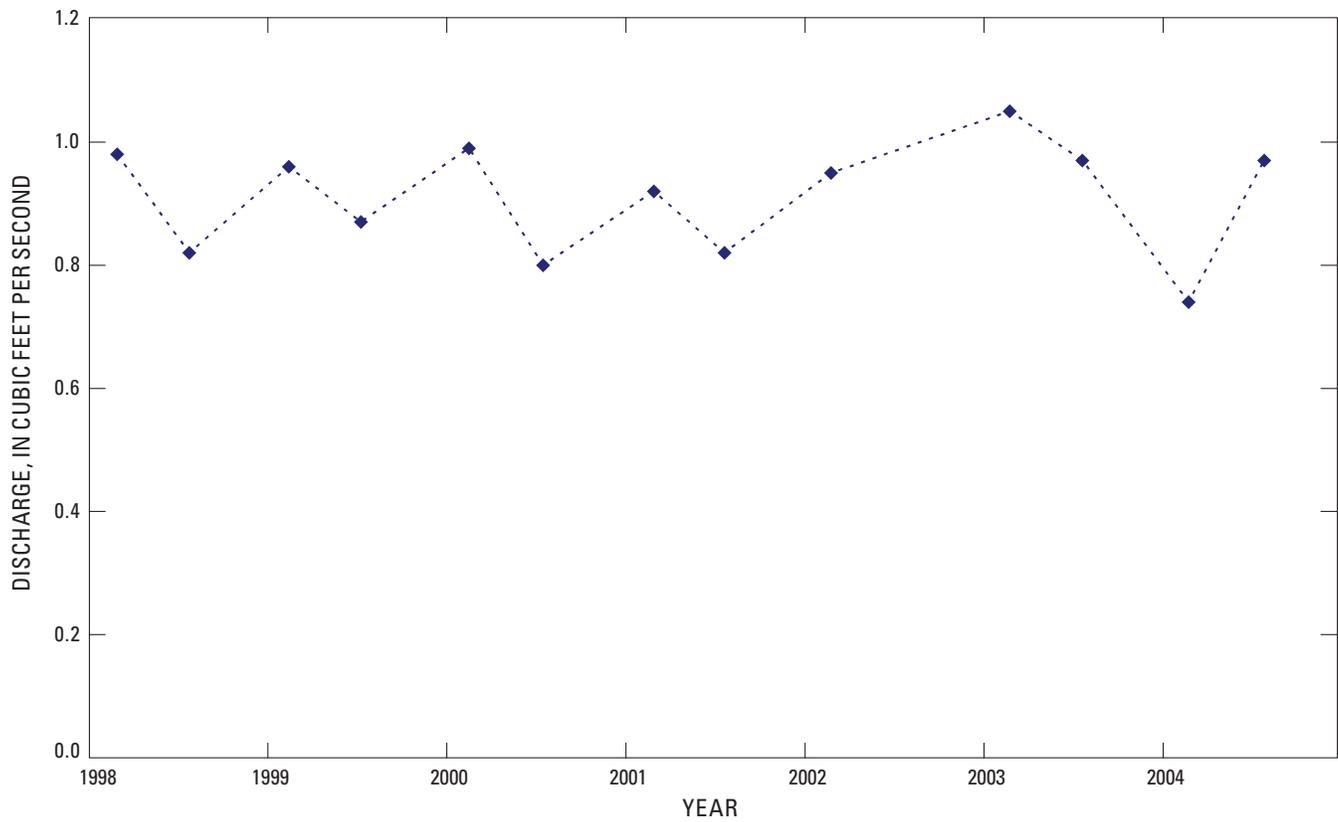
**Figure B39.** Periodic discharge measurements for partial-record stream-gaging station 3642235114425301 Muddy River Springs 19 (M-19) near Moapa, Nevada, 1998–2004.
