**Appendix B. Water-Level, Discharge, and  
Water-Quality Data for Selected Monitoring Sites  
Within the Warm Springs Area Near Moapa, Nevada**

## 09416000 Muddy River near Moapa, Nevada

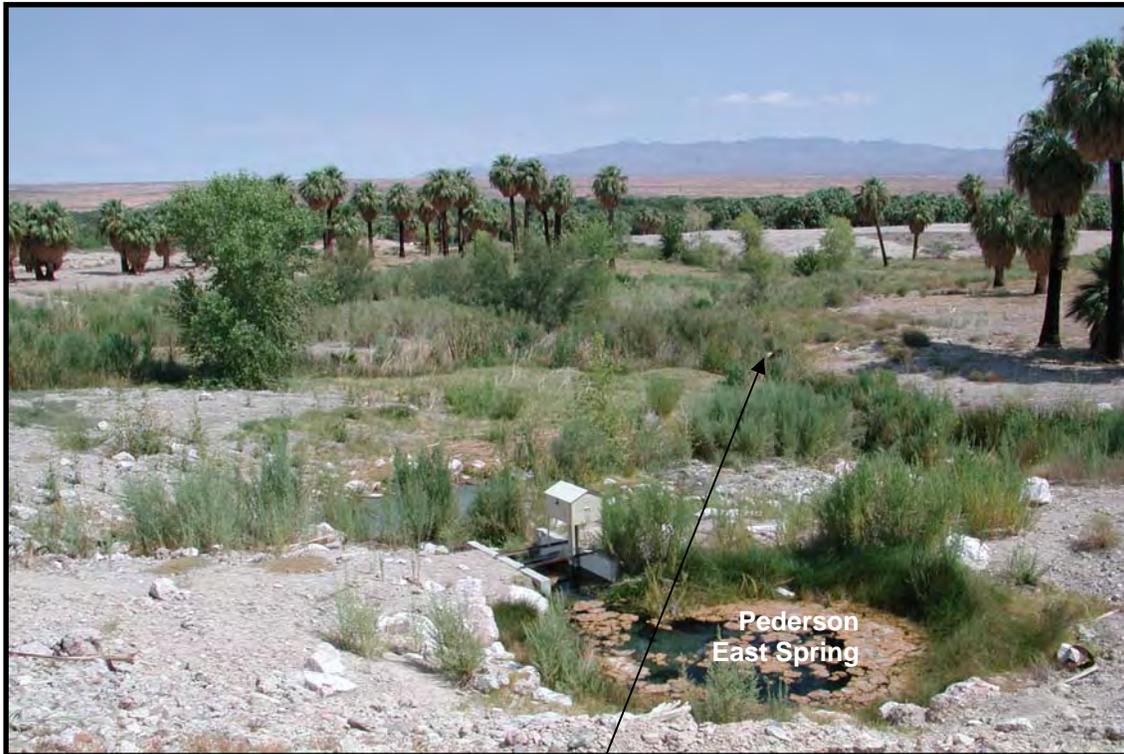
M-19  
RM-1 (1,800.88 ft)

**Figure B40.** Location of staff plate and reference mark (RM-1) for partial-record stream-gaging station Muddy River Springs 19 (M-19) in the Moapa Valley National Wildlife Refuge near Moapa, Nevada. Photographed June 9, 2004 by D. Beck. Elevation in feet above NAVD 88.

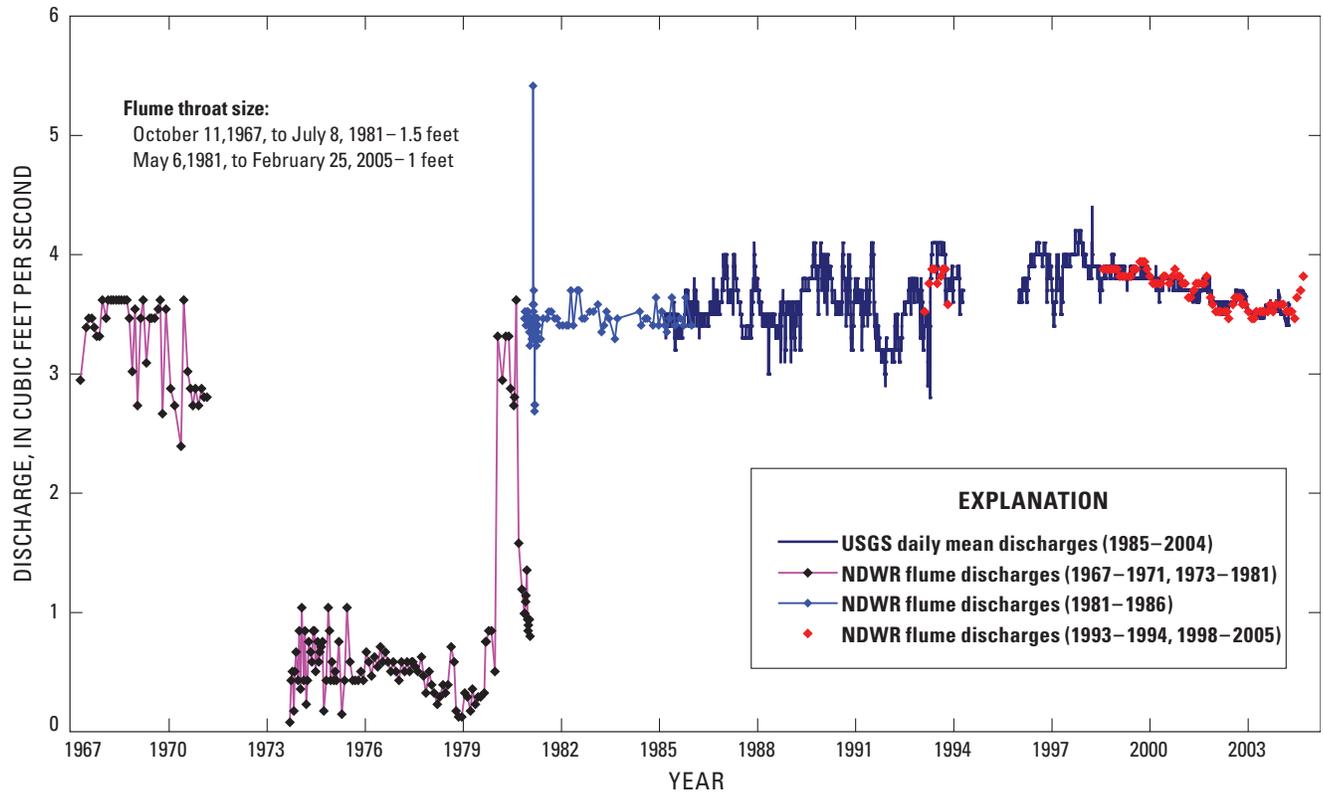
**Figure B42.** Instantaneous and daily mean discharges for continuous-record stream-gaging station 09415920 Warm Springs West near Moapa, Nevada, 1967–2005. Data from U.S. Geological Survey (USGS) National Water Information System (NWIS) data base, accessed 2005 at <http://waterdata.usgs.gov>. NDWR, Nevada Division of Water Resources.

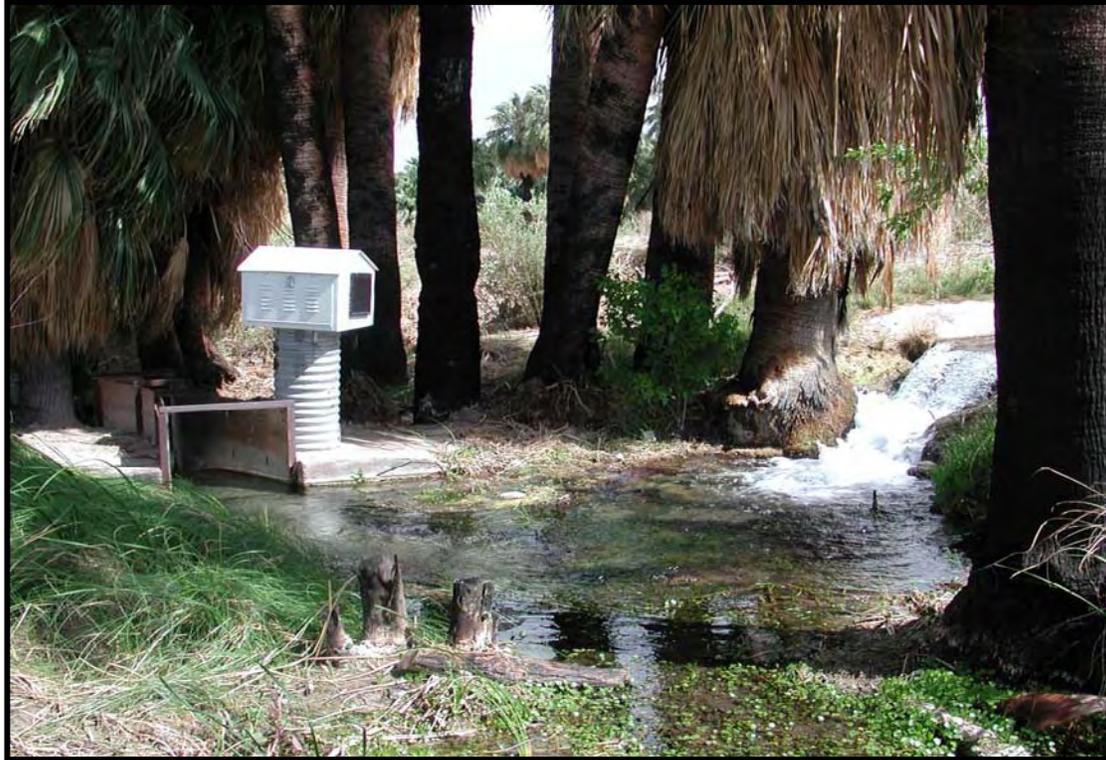
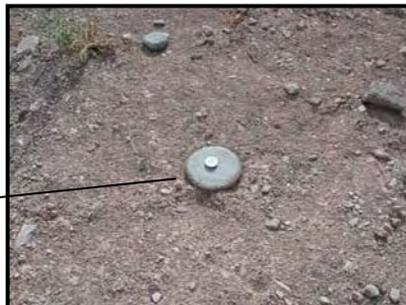
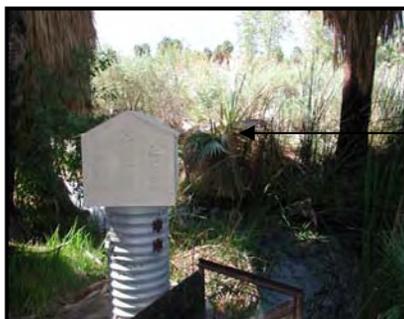
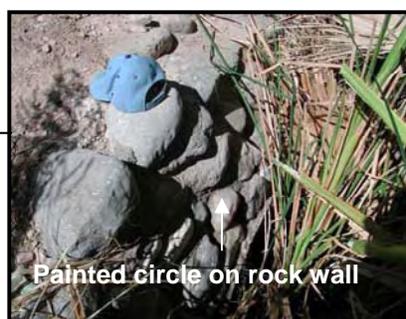
**WSBM-7**  
(1,776.93 ft)

**RM-1**  
(1,772.94 ft)

**Figure B43.** Location of bench mark WSBM-7 and reference mark RM-1 for continuous-record stream-gaging station 09415920 Warm Springs West near Moapa, Nevada. The top picture shows the stream-gaging station photographed in 2001. Elevation of bench and reference marks in feet above NAVD 88.

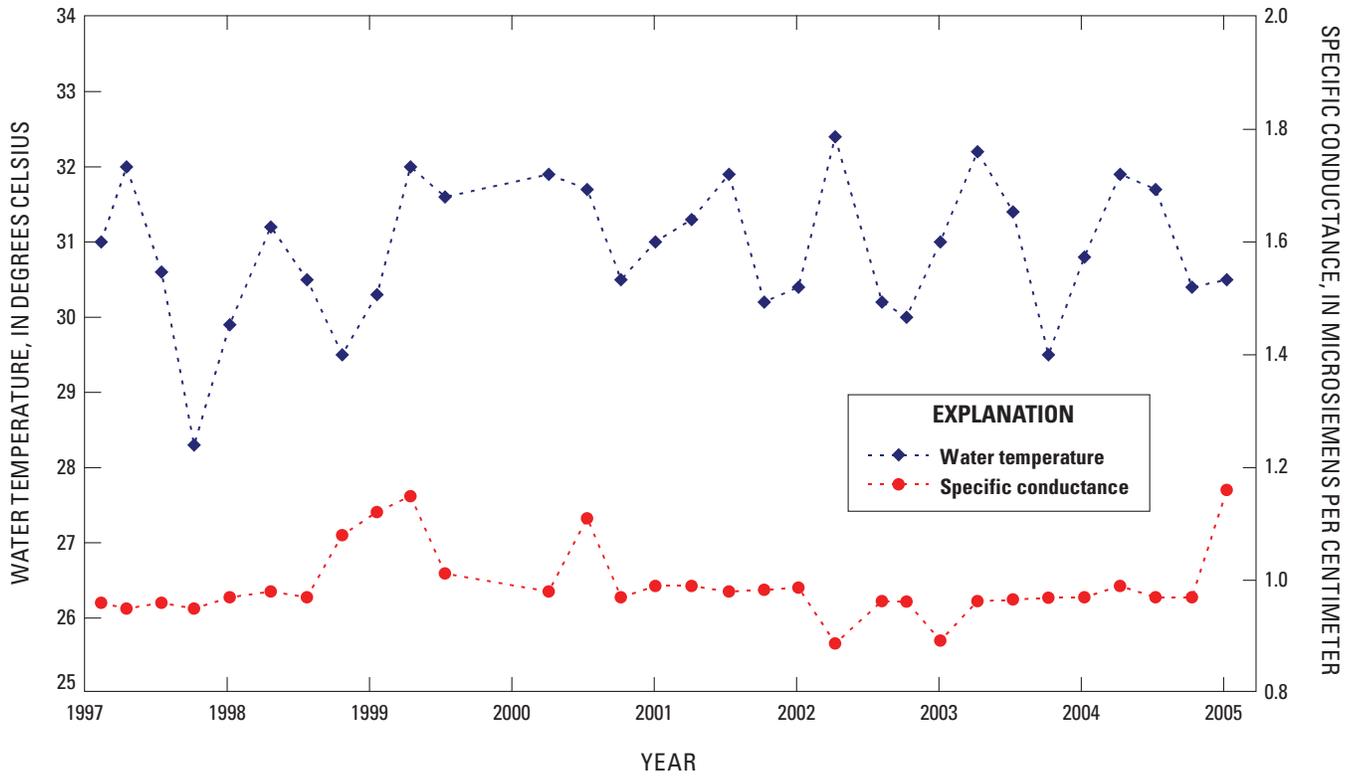
**Figure B44.** Water temperature and specific conductance measurements for continuous-record stream-gaging station 09415920 Warm Springs West near Moapa, Nevada, 1997–2005. Data provided by Converse Consultants.

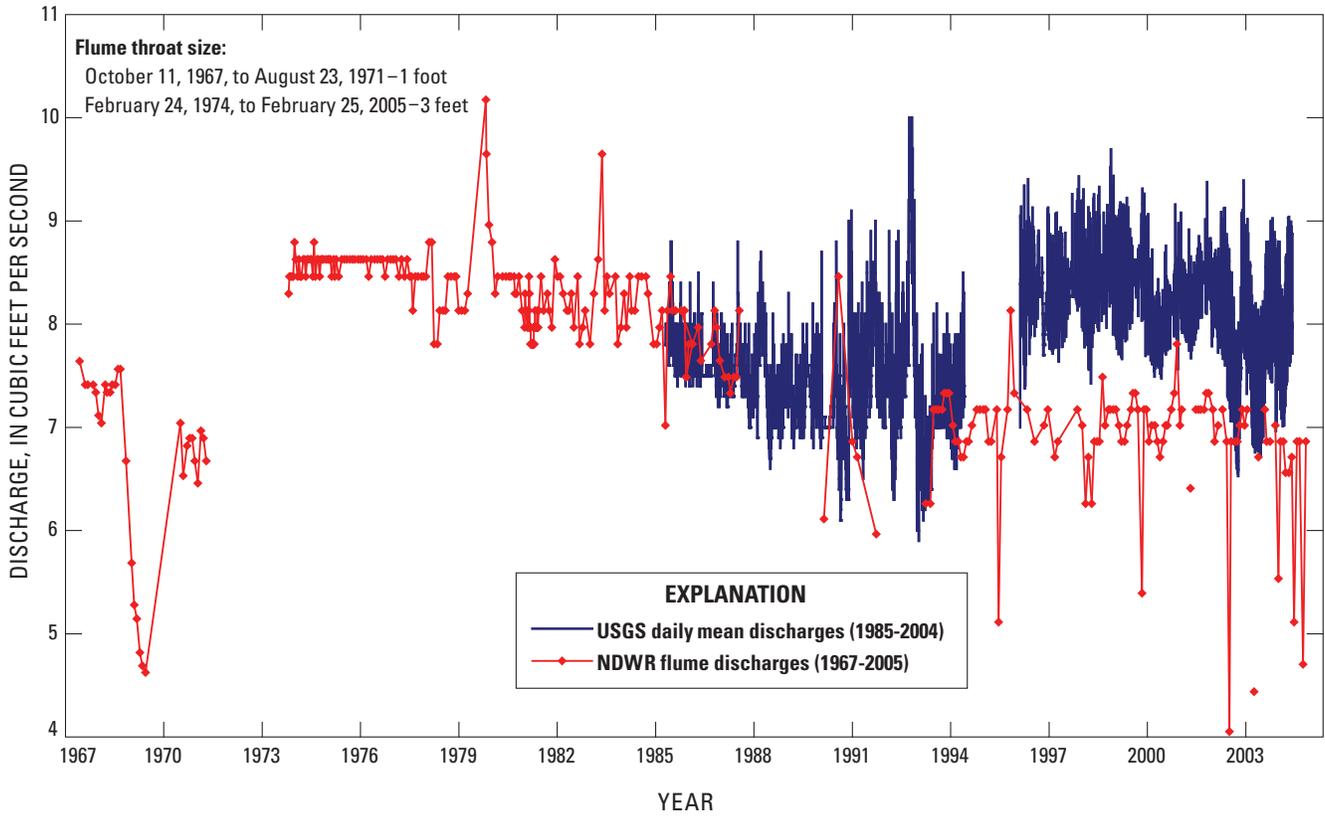
**Figure B46.** Instantaneous and daily mean discharge for continuous-record stream-gaging station 09415900 Muddy Springs at Latter Day Saints (L.D.S.) Farm near Moapa, Nevada, 1967–2005. Data from U.S. Geological Survey (USGS) National Water Information System (NWIS) data base, accessed 2005 at <http://waterdata.usgs.gov>. NWDR, Nevada Division of Water Resources.

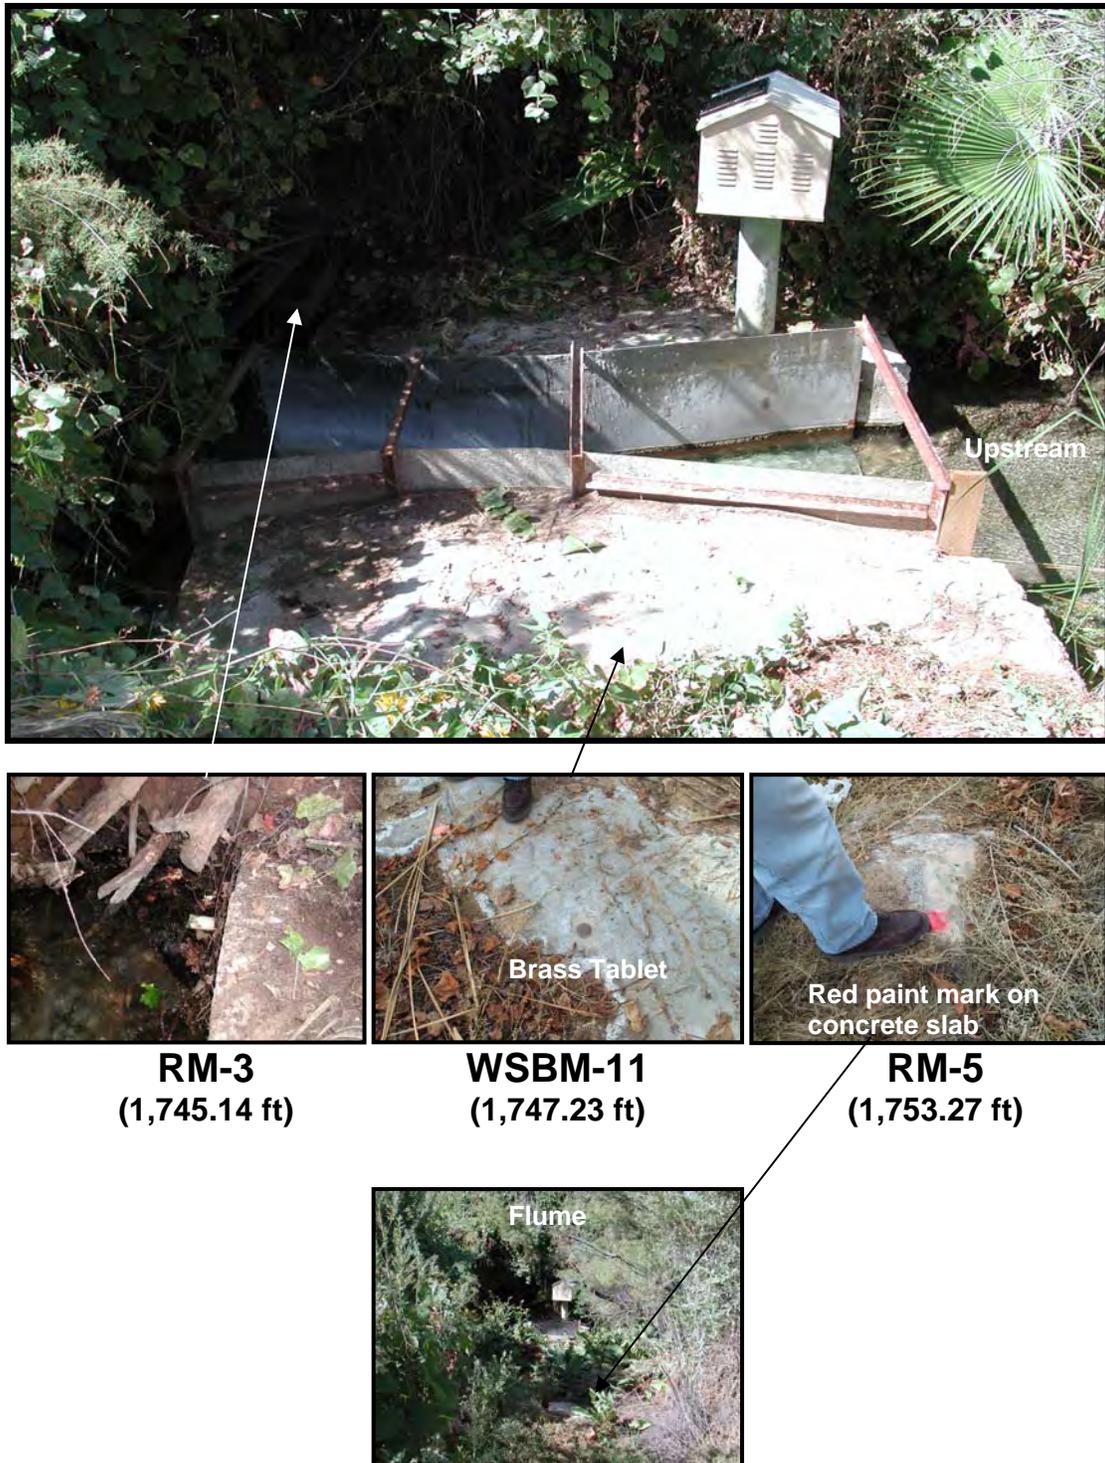
**Figure B47.** Location of bench mark WSBM-11 and reference marks RM-3 and RM-5 at stream-gaging station 09415900 Muddy Springs at L.D.S. Farm near Moapa, Nevada. Photographed June 3, 2004 by D. Beck. Elevation of bench and reference marks in feet above NAVD 88.

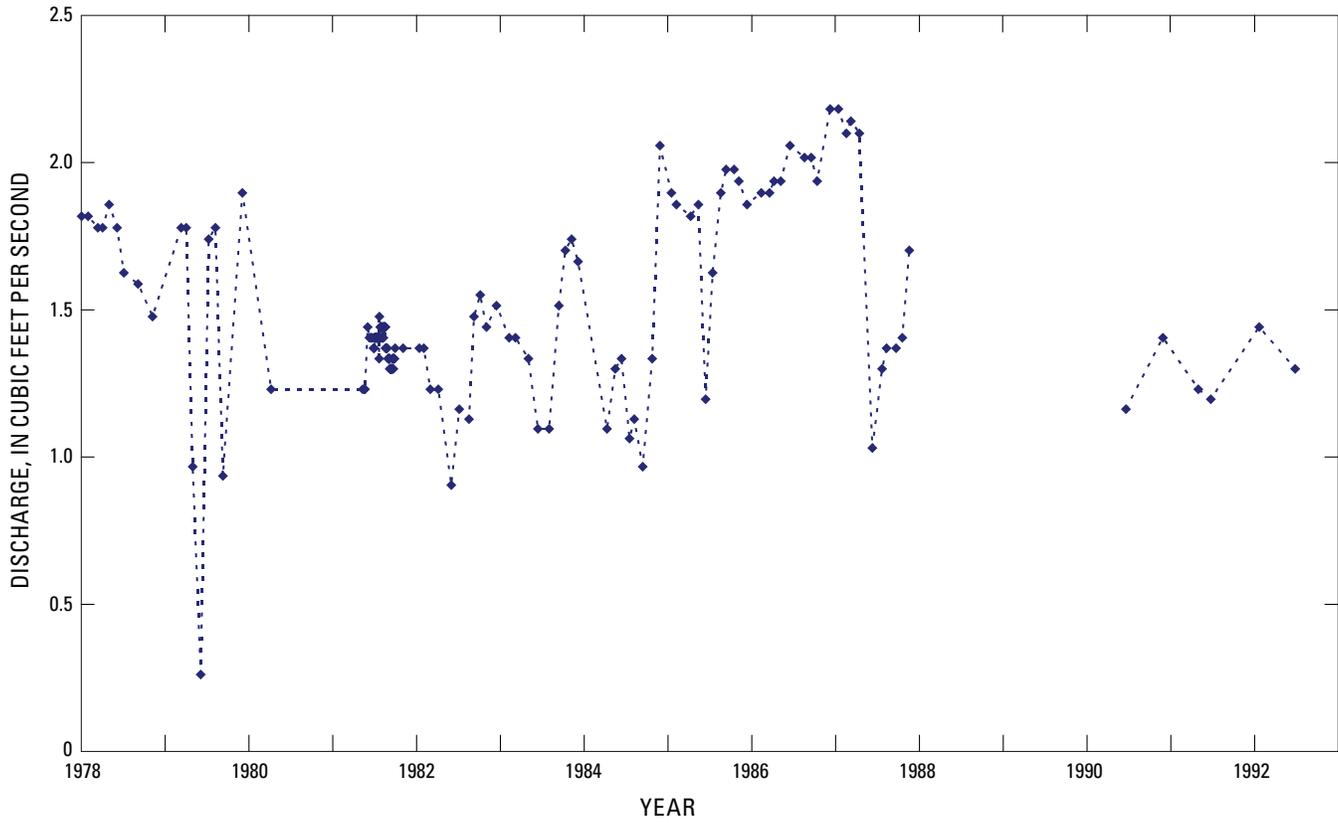
**Figure B49.** Instantaneous discharges computed from water-level measurements provided by Nevada Division of Water Resources for Garden Ditch Flume on North Tributary at Apcar (Pipeline Jones) Springs near Moapa, Nevada, 1978–92. Data provided by Nevada Division of Water Resources.

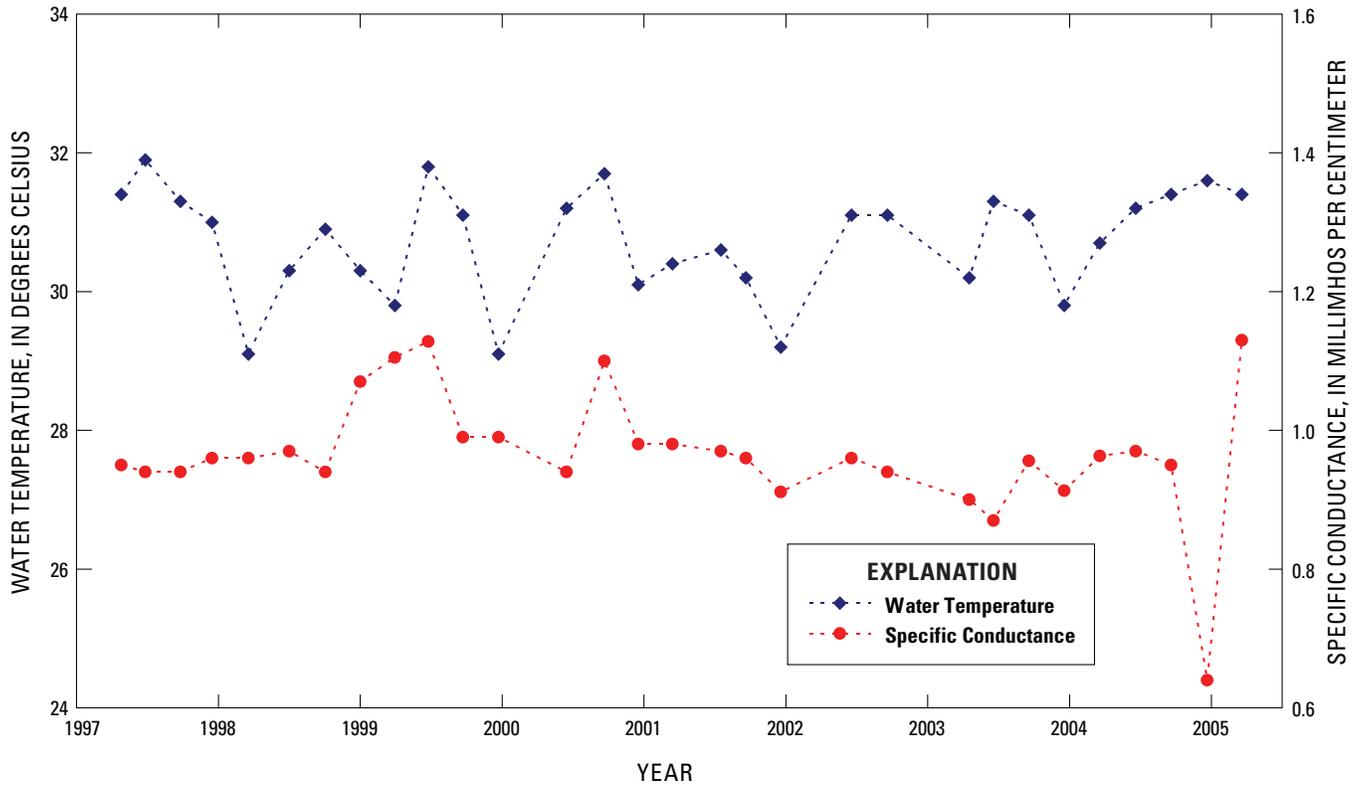
**Figure B50.** Water-temperature and specific-conductance measurements provided by Converse Consultants for site S52 on North Tributary at Apcar (Pipeline Jones) Springs near Moapa, Nevada, 1997–2005.

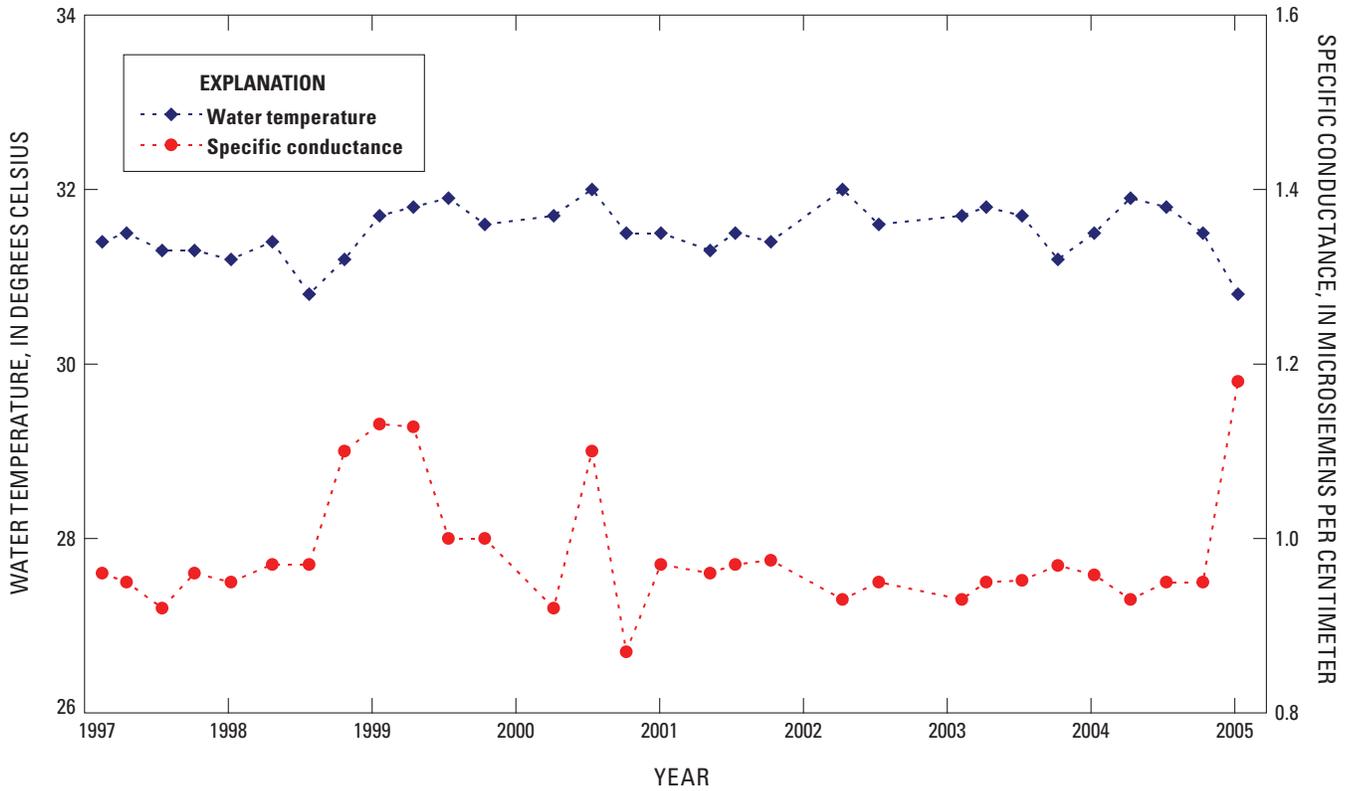
**Figure B51.** Water-temperature and specific-conductance measurements provided by Converse Consultants for site S53 on South Tributary at Apcar (Pipeline Jones) Springs near Moapa, Nevada, 1997–2005..

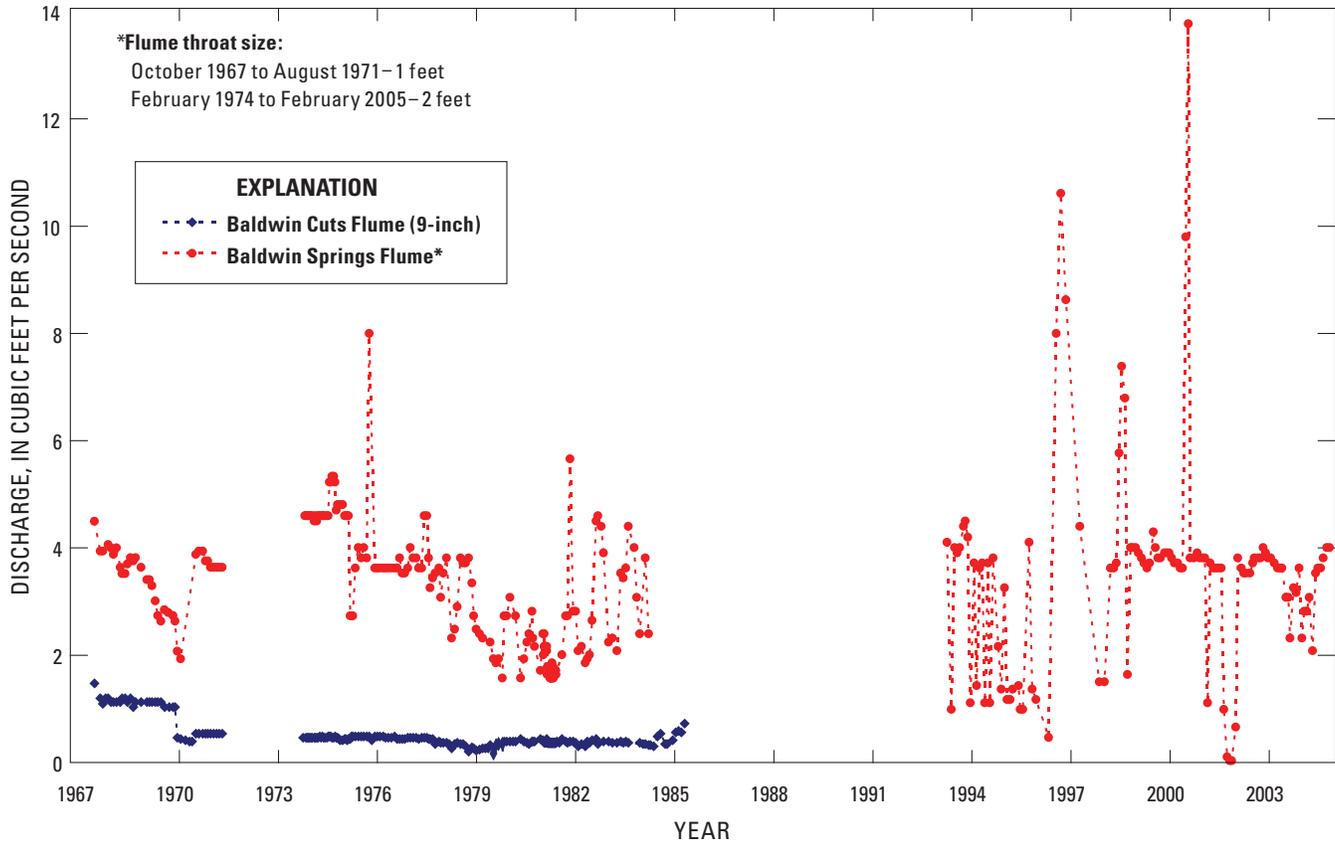
**Figure B53.** Instantaneous discharges computed from water-level measurements provided by Nevada Division of Water Resources for Baldwin Cuts and Baldwin Springs Flumes near Moapa, Nevada, 1967–2005.

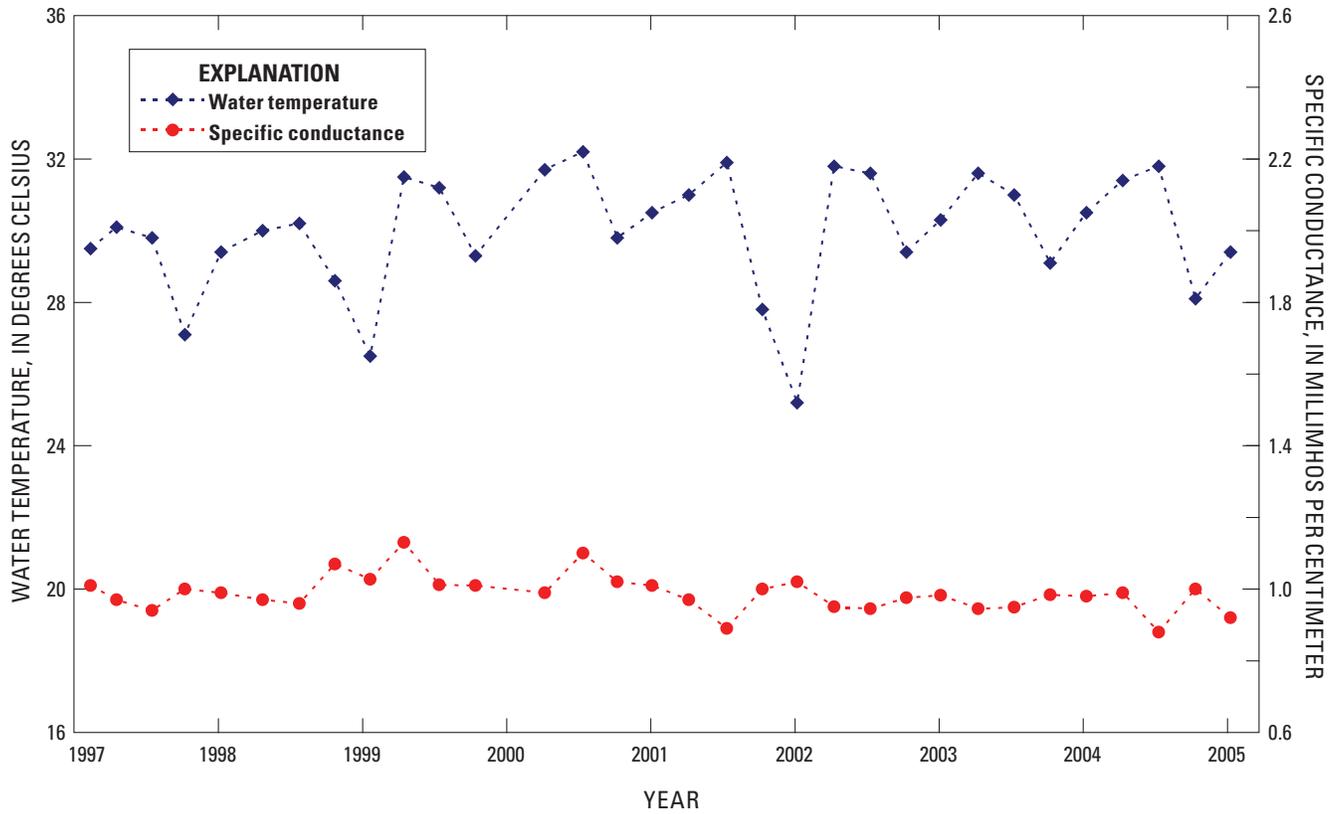
**Figure B55.** Water-temperature and specific-conductance measurements provided by Converse Consultants for Baldwin Springs Flume near Moapa, Nevada, 1997–2005.

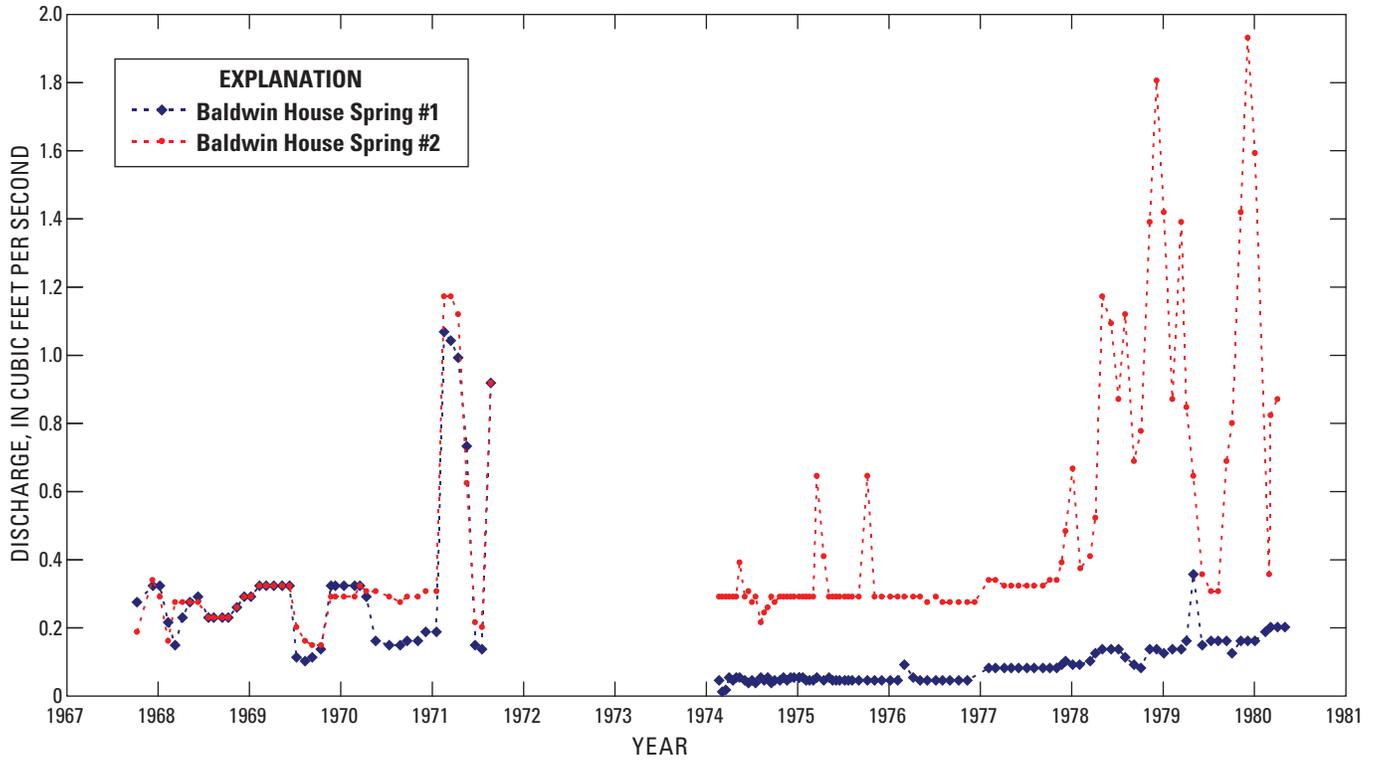
**Figure B58.** Instantaneous discharges for Baldwin House Springs #1 and #2 flumes at Cardy Lamb Springs near Moapa, Nevada, 1967–80. Data provided by Nevada Division of Water Resources.

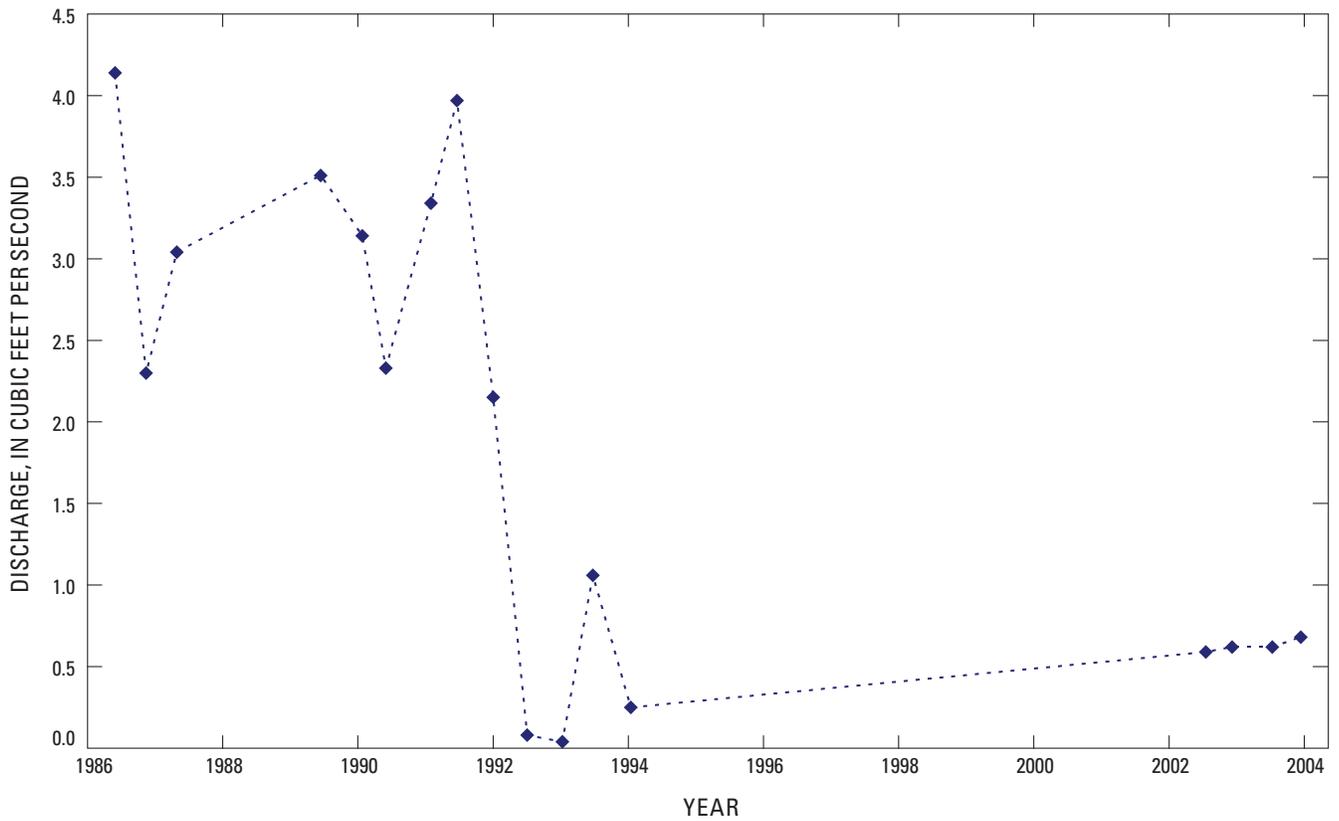
**Figure B59.** Periodic discharge measurements for partial-record stream-gaging station 364327114430801 Muddy River Springs 10 (M-10) at Cardy Lamb Springs near Moapa, Nevada, 1986–2004.

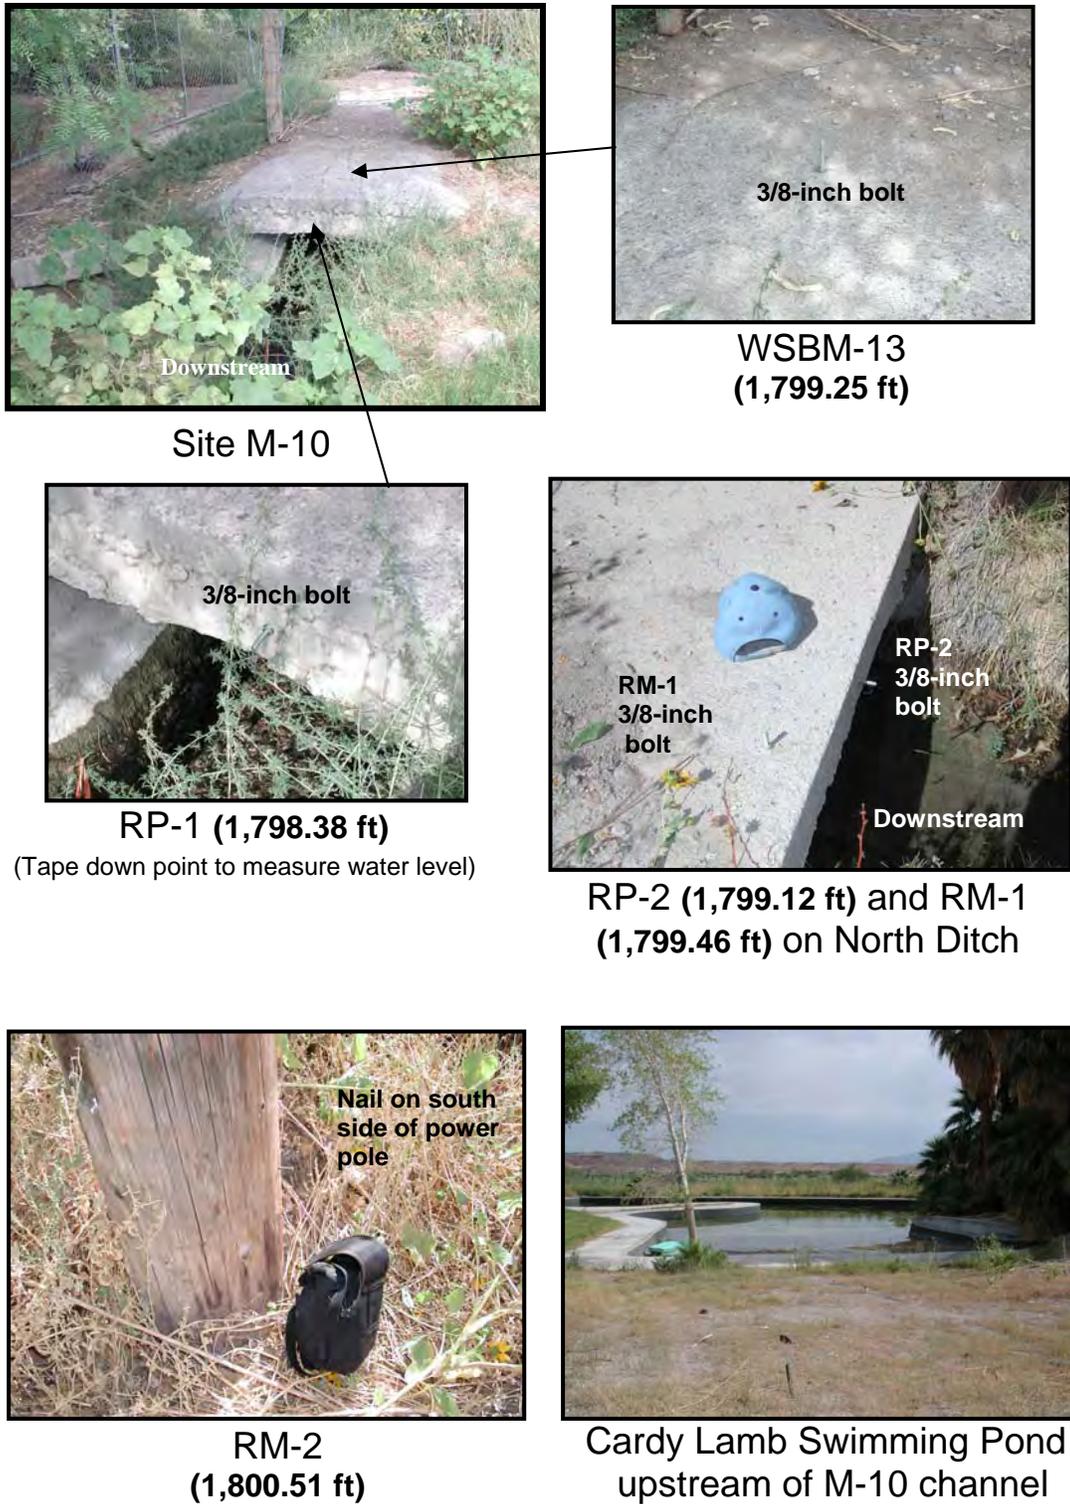
**Figure B60.** Location of bench mark WSBM-13, reference points RP-1 and RP-2, and reference marks RM-1 and RM-2 for partial-record station Muddy River Springs 10 (M-10) in the Warm Springs area near Moapa, Nevada. Photographed June 3, 2004 by D. Beck. Elevation of bench and reference marks in feet above NAVD 88.

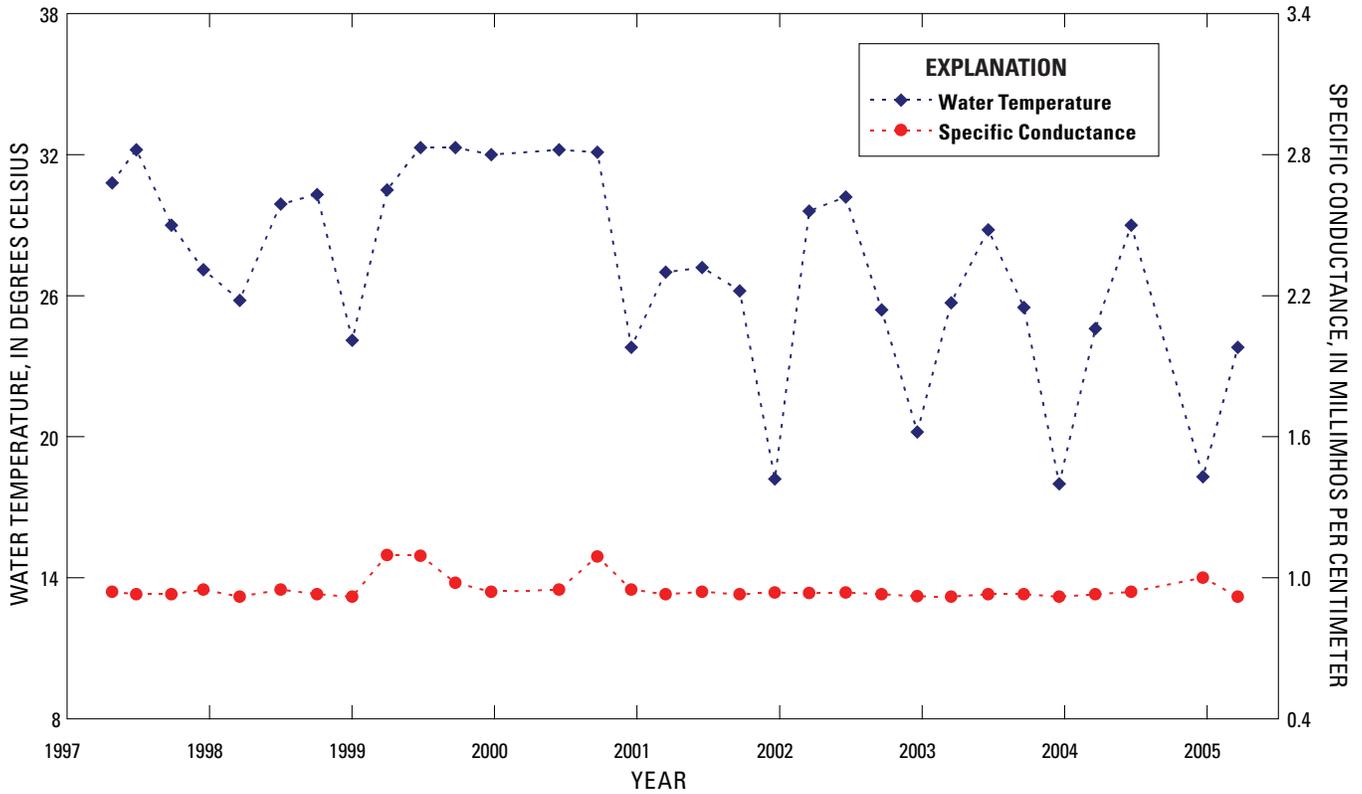
**Figure B61.** Water-temperature and specific-conductance measurements for site S15 at Cardy Lamb Springs near Moapa, Nevada, 1997–2005. Measurements provided by Converse Consultants.

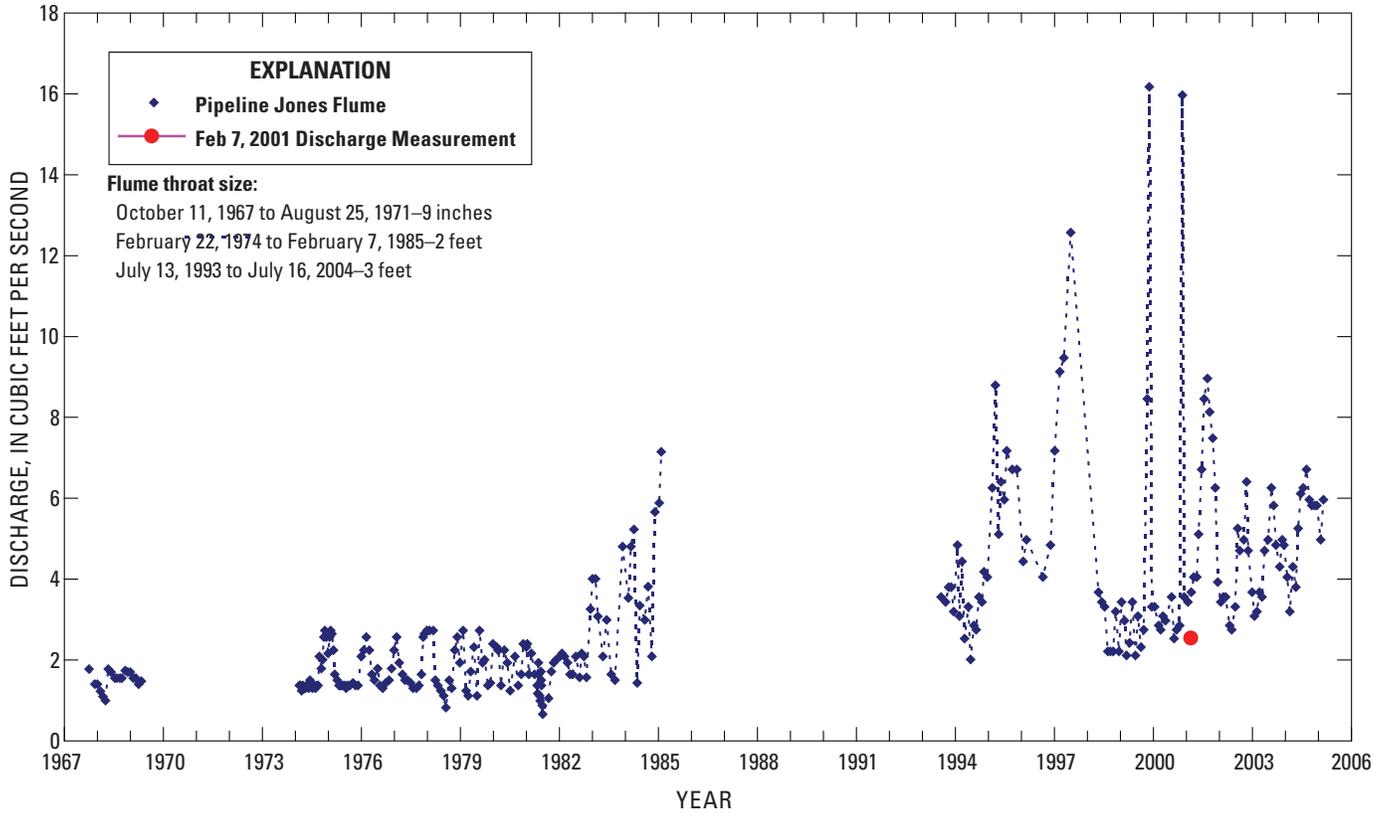
**Figure B63.** Instantaneous discharges compiled for 1967–2005, and discharge measurement made on February 7, 2001, for partial-record stream-gaging station 09415940 Apcar Stream at Pipeline Jones Flume near Moapa, Nevada.

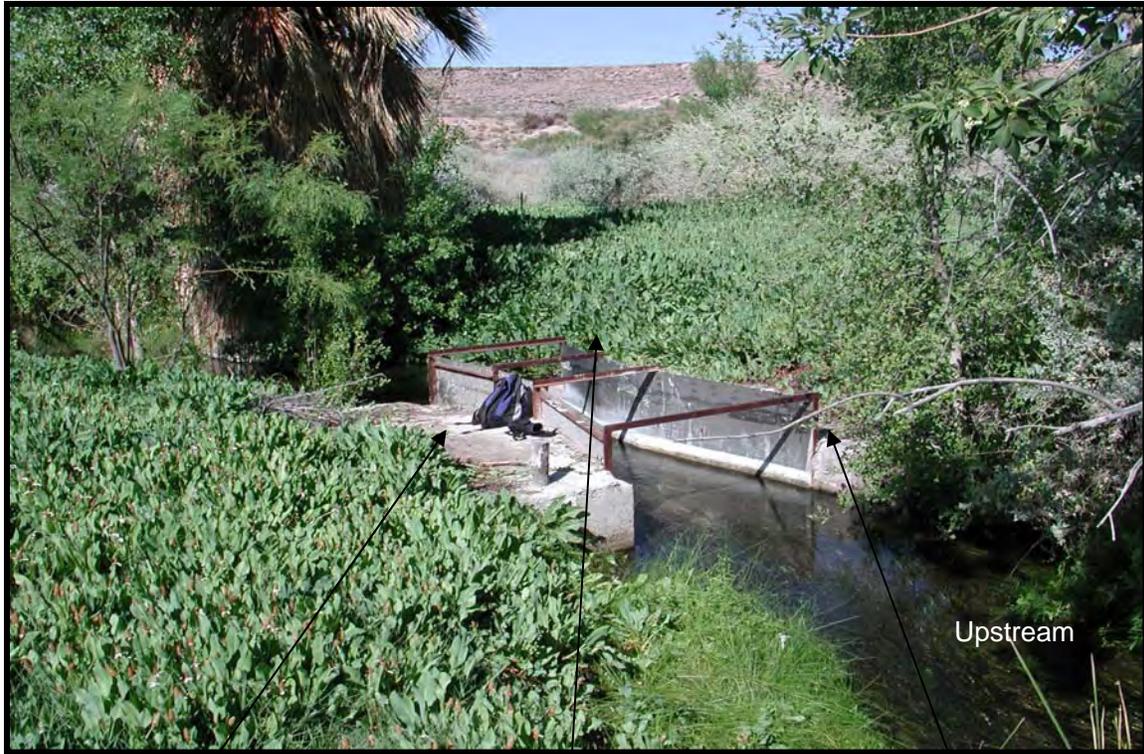
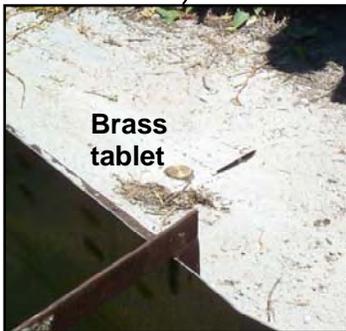
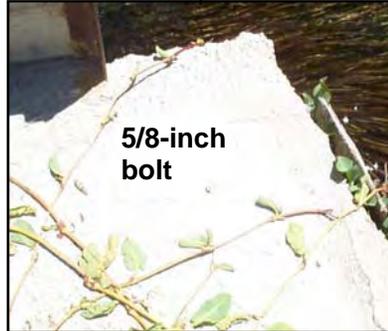
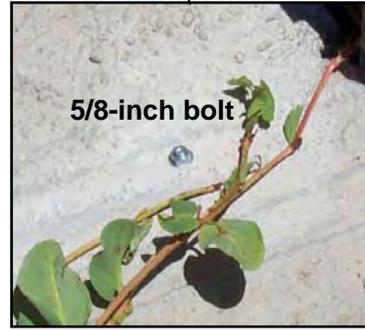
**WSBM-2**  
**(1,735.52 ft)**

**RM-1**  
**(1,735.19 ft)**

**RM-2**  
**(1,735.33 ft)**

**Figure B64.** Location of bench mark WSBM-2 and reference marks RM-1 and RM-2 at partial-record stream-gaging station 09415940 Apcar Stream at Pipeline Jones Fume near Moapa, Nevada. Photographed July 20, 2004 by D. Beck. Elevation of bench and reference marks in feet above NAVD 88.

On July 20, 2004, the U.S. Geological Survey installed a staff plate on the flume and established one bench mark and two reference marks at the site as part of this study. Photographs of the flume, bench mark, and reference marks are shown in [figure B64](#). During the installation of the staff plate, backwater conditions were observed at the flume caused by a large palm tree that had fallen across the channel about 40 ft downstream. Until the blockage is removed, computed discharges from water-level measurements will show erroneous higher rates of flow.

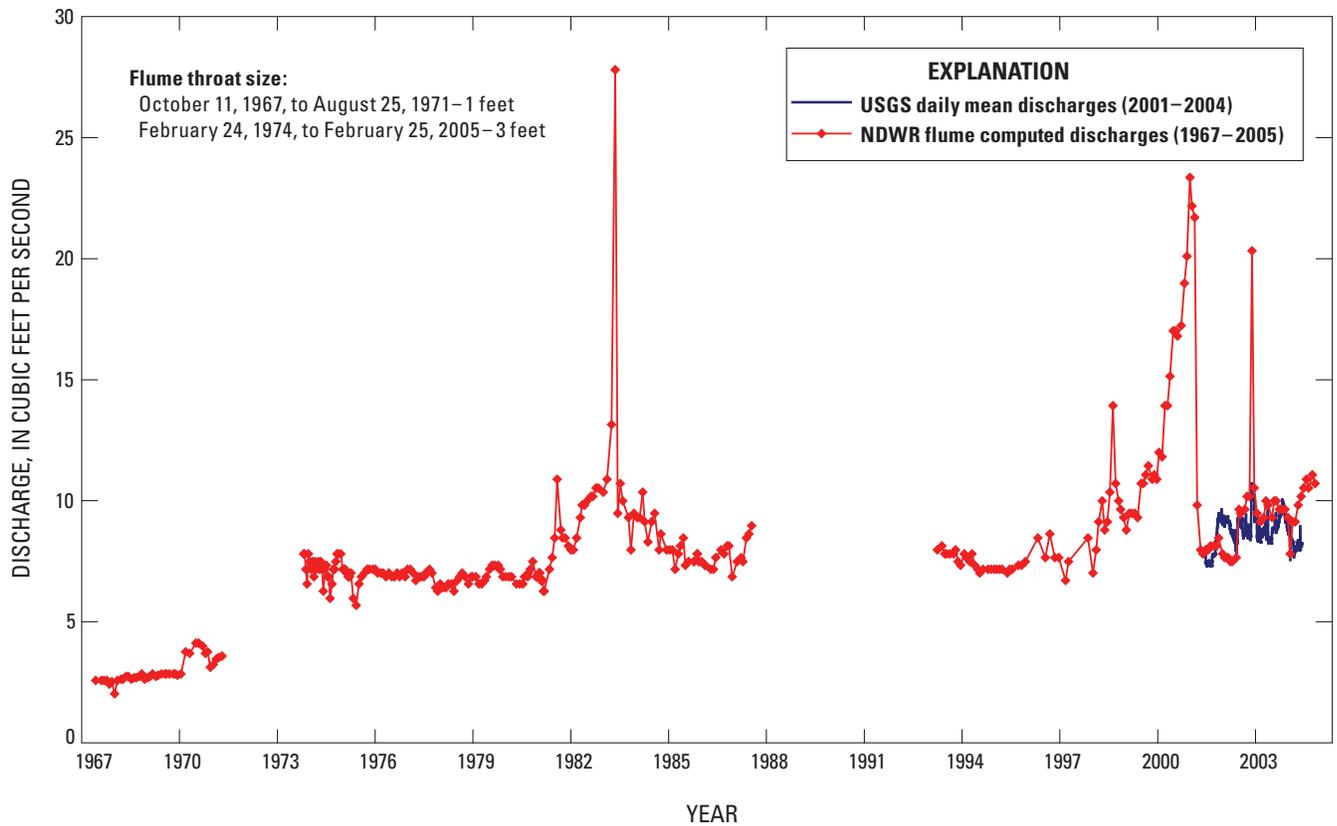
**Figure B66.** Instantaneous and daily mean discharges for continuous-record stream-gaging station 09415927 Warm Springs Confluence at Iverson Flume near Moapa, Nevada, 1967–2005. Data from U.S. Geological Survey (USGS) National Water Information System (NWIS) data base, accessed 2005 at <http://waterdata.usgs.gov>. Water level measurements used to compute discharges were provided by Nevada Division of Water Resources (NDWR).

A continuous-stage recorder was installed at the flume by the U.S. Geological Survey on October 1, 2001, and maintained through September 30, 2004. From the time that the gage was installed, submerged flow conditions have been in effect owing to the growth of a large palm tree and other plants in the channel downstream from the flume. Discharge measurements are routinely made at the site and used to define the stage-discharge relation for the flume. Daily mean discharges computed for the period of record have been included for comparison on the plot in [figure B66](#) and listed in [table B51](#). Photographs of the current flume, bench mark, and a selected reference mark established for this gage on June 3, 2004, are shown in [figure B67](#).
