**Appendix B. Water-Level, Discharge, and  
Water-Quality Data for Selected Monitoring Sites  
Within the Warm Springs Area Near Moapa, Nevada**

## 09416000 Muddy River near Moapa, Nevada

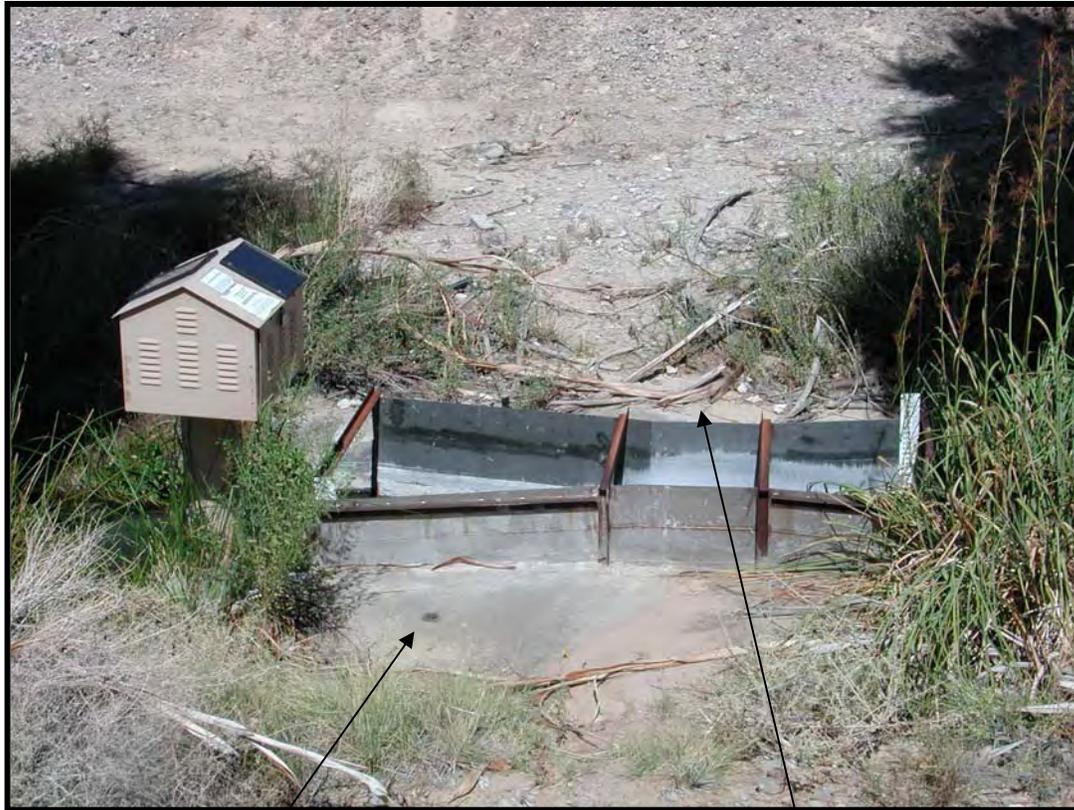
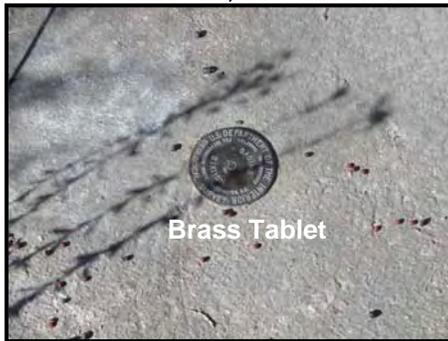
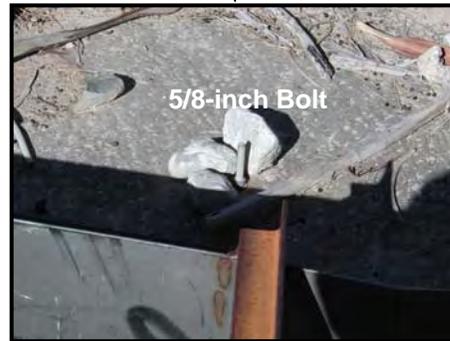
**WSBM-5**  
(1,745.97 ft)

**RM-3**  
(1,746.38 ft)

**Figure B67.** Location of bench mark WSBM-5 and reference mark RM-3 at continuous-record stream-gaging station 09415927 Warm Springs Confluence at Iverson Flume near Moapa, Nevada. Photographed June 3, 2004 by D. Beck. Elevation of bench and reference marks in feet above NAVD 88.

A continuous-stage recorder was installed at the flume by the U.S. Geological Survey on October 1, 2001, and maintained through September 30, 2004. From the time that the gage was installed, submerged flow conditions have been in effect owing to the growth of a large palm tree and other plants in the channel downstream from the flume. Discharge measurements are routinely made at the site and used to define the stage-discharge relation for the flume. Daily mean discharges computed for the period of record have been included for comparison on the plot in [figure B66](#) and listed in [table B51](#). Photographs of the current flume, bench mark, and a selected reference mark established for this gage on June 3, 2004, are shown in [figure B67](#).

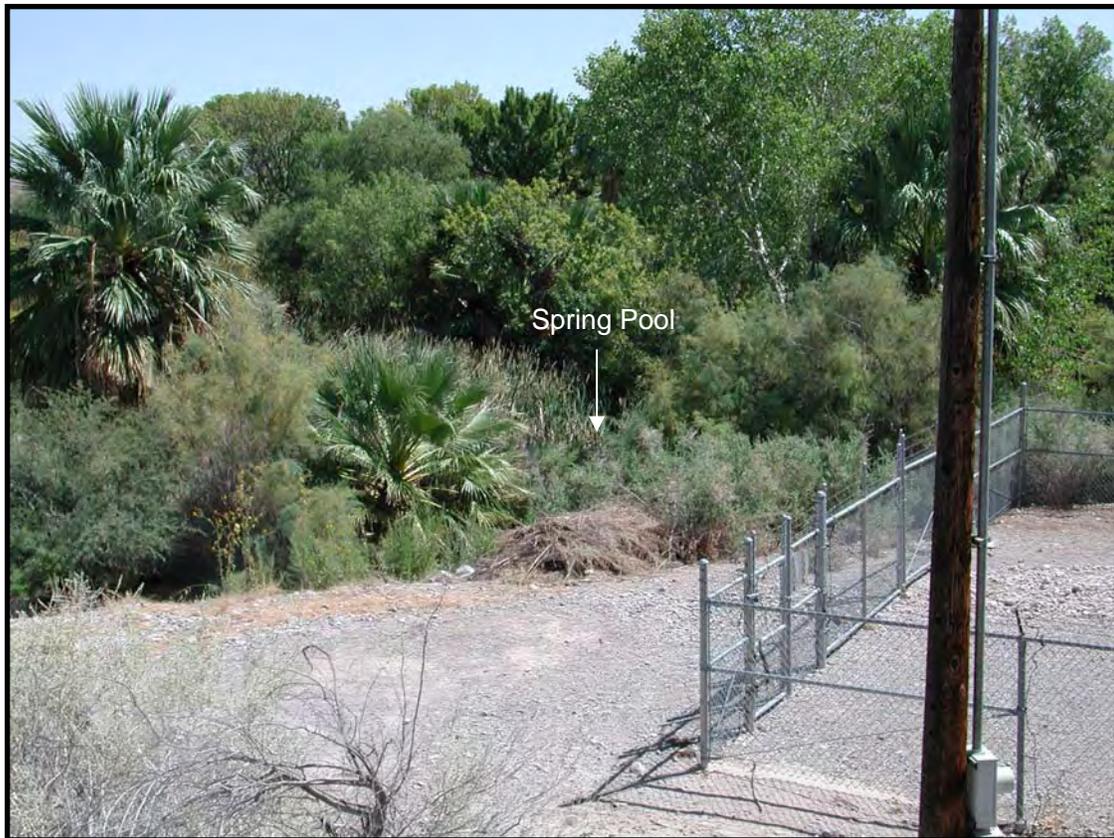
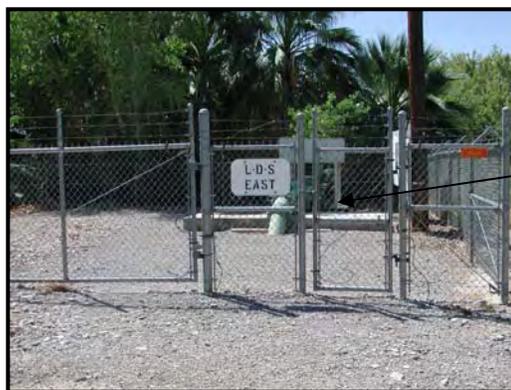
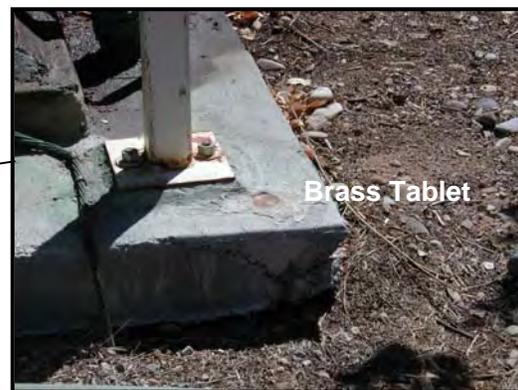
**WSBM-10**  
**(1.752.32 ft)**

**Figure B69.** Location of bench mark WSBM-10 at L.D.S. East well and spring-fed pool surveyed on August 17, 2004, at unnamed springs near Moapa, Nevada. Elevation of bench mark in feet above NAVD 88.

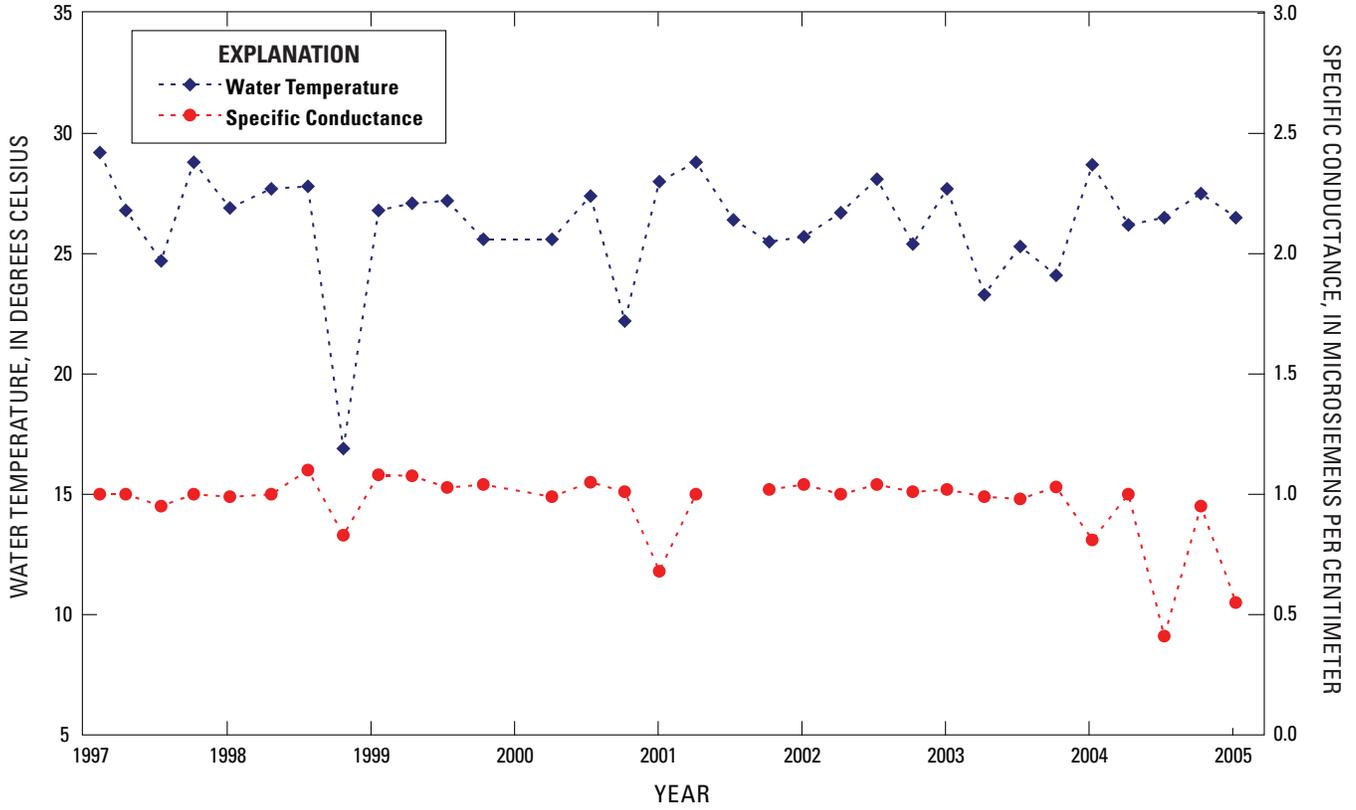
**Figure B70.** Water-temperature and specific-conductance measurements for spring pond at unnamed springs at L.D.S. East well near Moapa, Nevada, 1997–2005. Measurements provided by Converse Consultants.

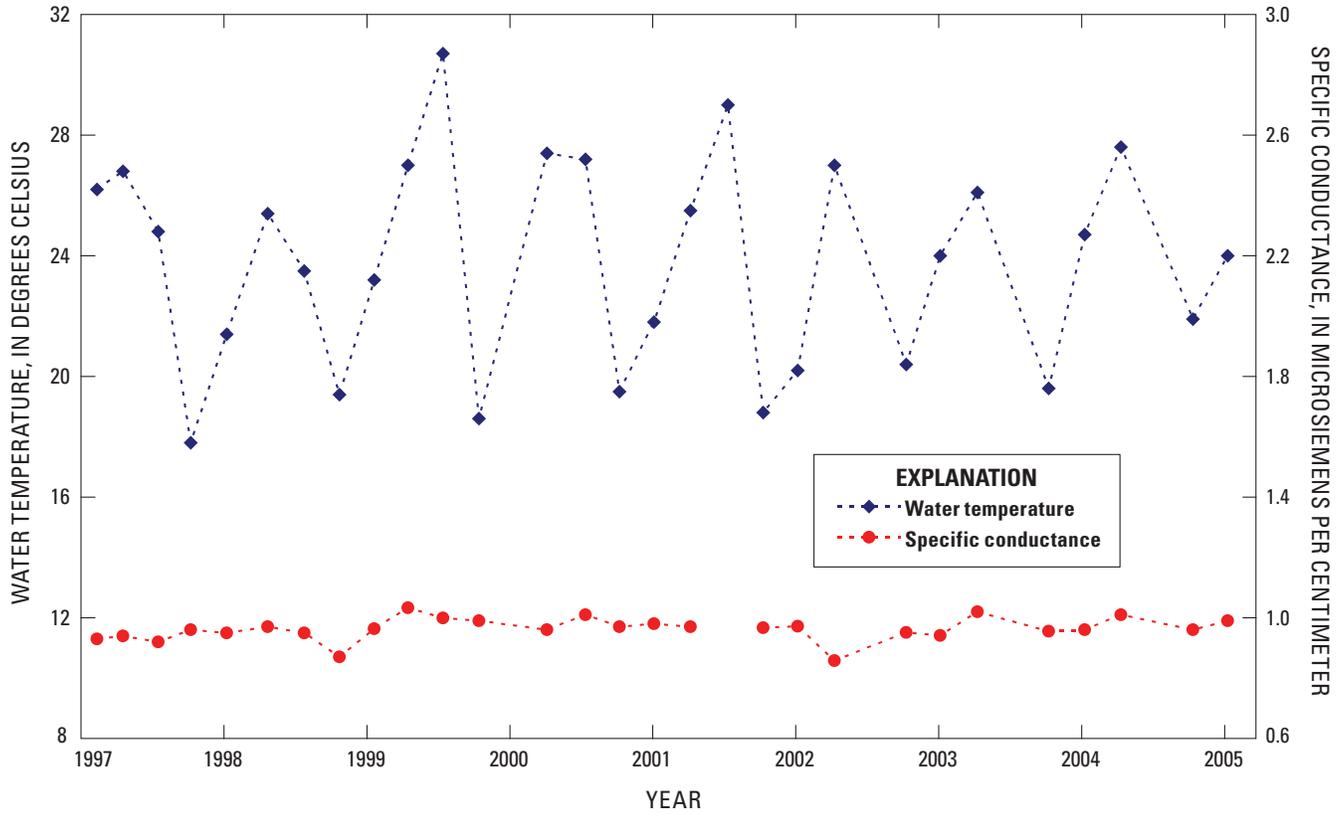
**Figure B72.** Water-temperature and specific-conductance measurements for site S6 in the Warm Springs area near Moapa, Nevada, 1997–2005. Measurements provided by Converse Consultants.

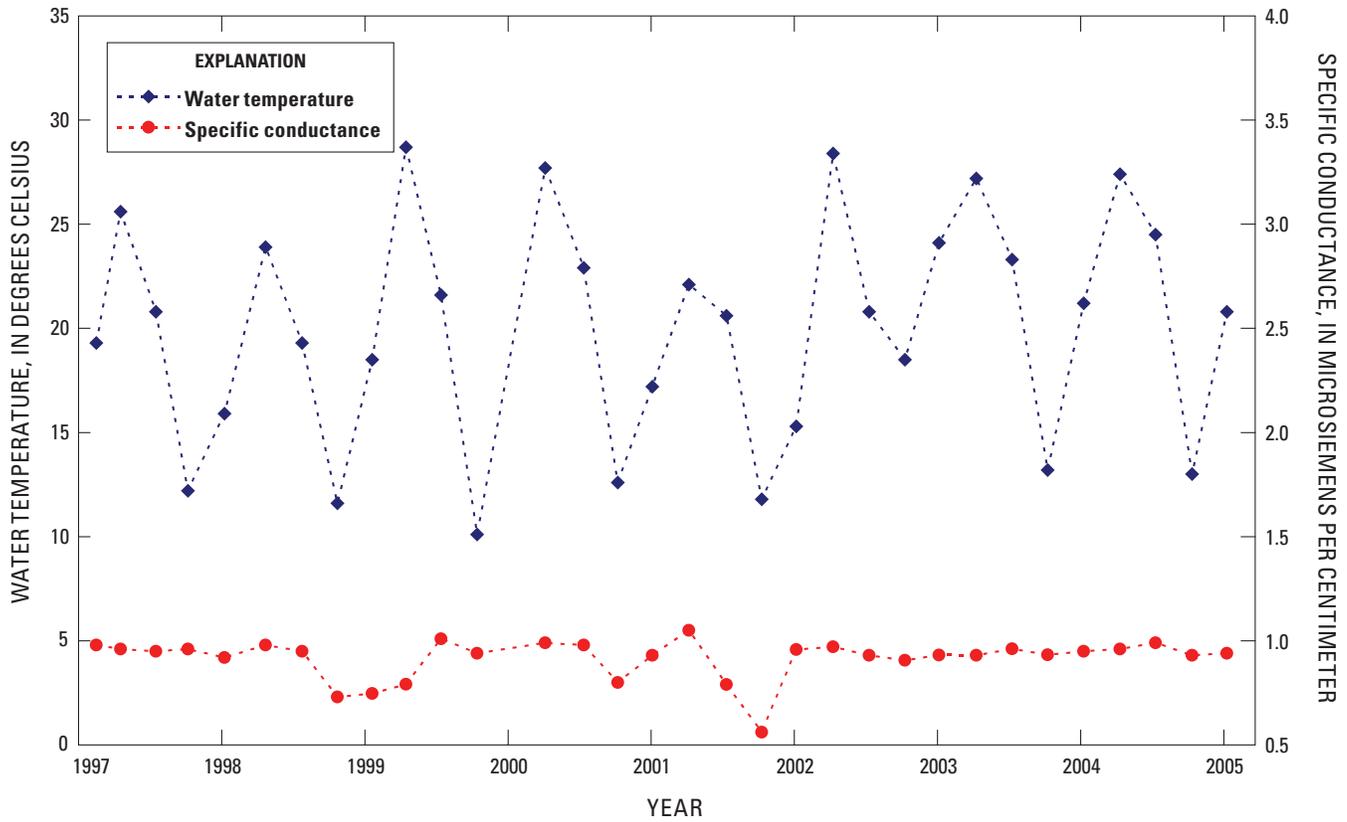
**Figure B74.** Water-temperature and specific-conductance measurements for site S65 in the Warm Springs area near Moapa, Nevada, 1997–2005. Measurements provided by Converse Consultants.
